MINERALS PROGRAM INSPECTION REPORT
PHONE: (303) 866-3567

MINE NAME: Gunnison River Gravel Pits	MINE/PROSPECTING ID#: M-2009-048	MINERAL: Sand and gravel	COUNTY: Mesa
INSPECTION TYPE: Monitoring	INSPECTOR(S): Amy Yeldell	INSP. DATE: March 17, 2021	INSP. TIME: 09:00
OPERATOR: CW Construction, LLC	OPERATOR REPRESENTATIVE: Cody Weaver and Kevin McClain	TYPE OF OPERATION: 112c - Construction Regular Operation	
REASON FOR INSPECTION: Priority	BOND CALCULATION TYPE: Complete Bond	BOND AMOUNT: \$91,664.00	
DATE OF COMPLAINT: NA	POST INSP. CONTACTS: DRMS	JOINT INSP. AGENCY: None	
WEATHER: Clear	INSPECTOR'S SIGNATURE:

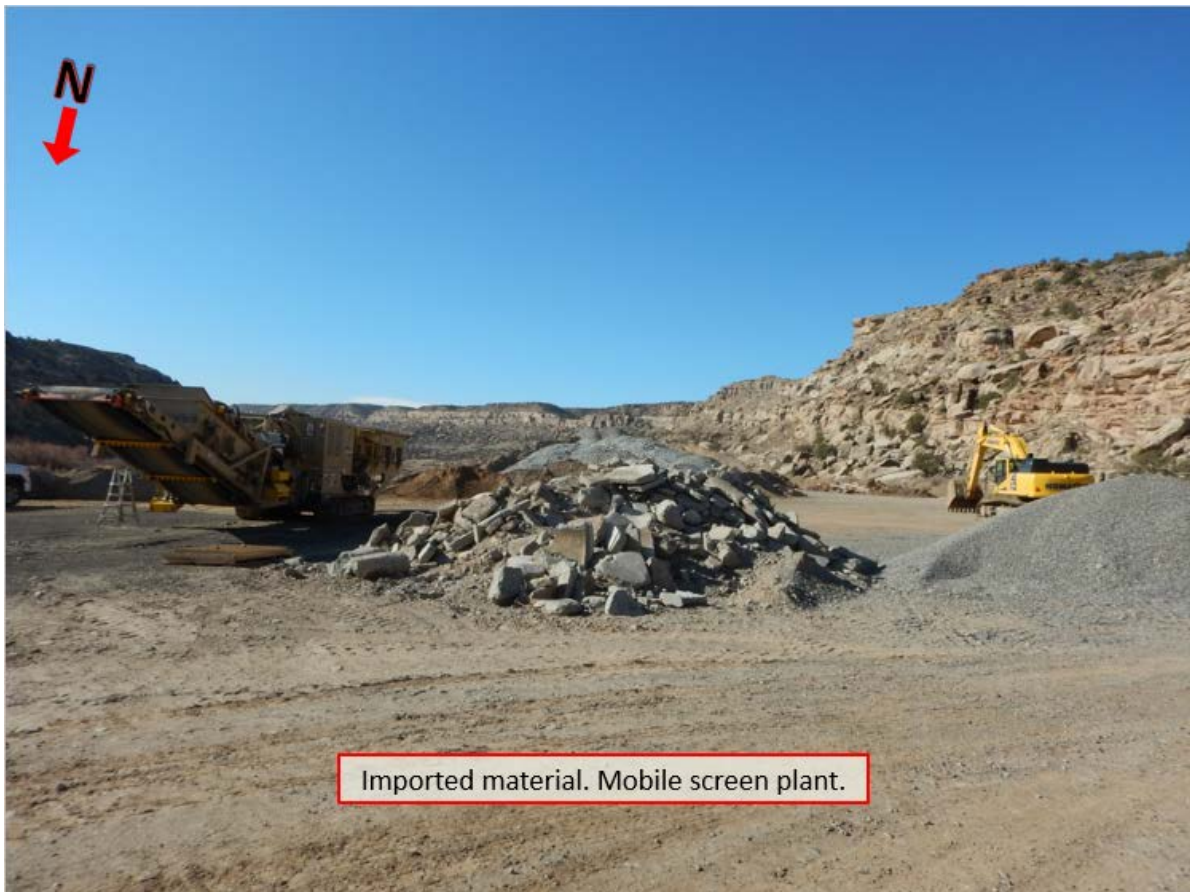
During the inspection trucks were observed importing material. In addition to the large stockpile of asphalt by the scale there are a few other small piles of cement and asphalt located within the Pit 5 area. This permit is not approved for the import of inert fill. This is cited as an inspection problem. In order to import material the operator must provide the office with notice per Rule 3.1.5 (9). The notice shall include but is not limited to: a narrative that describes the approximate location of the proposed activity; the approximate volume of inert material to be backfilled; a signed affidavit certifying that the material is clean and inert, as defined in Rule 1.1(20); the approximate dates the proposed activity will commence and end, however, such dates shall not be an enforceable condition; an explanation of how the backfilled site will result in a post-mining configuration that is compatible with the approved post-mining land use; and a general engineering plan states how the material will be place and stabilized in a manner to avoid unacceptable settling and voids." Please submit this notice in the form of a Technical Revision (TR) with the required revision fee of \$216. Alternatively the Operator may submit a written commitment to no longer import inert material until a TR is submitted and approved.

Imported material. Mobile screen plant.

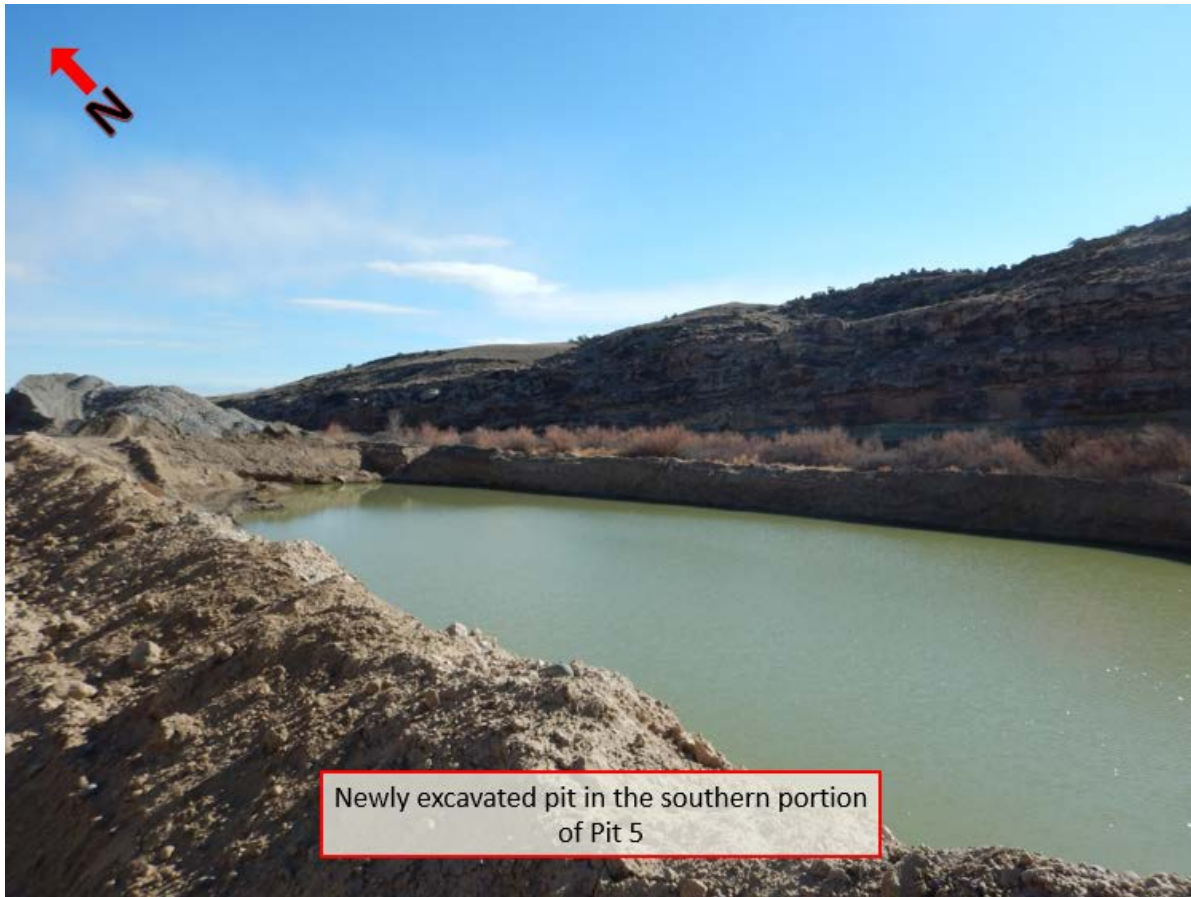
Imported woody debris is stockpiled to the south and west of the new pit. The Operator is reminded that if woody debris is buried whole it could result in voids once it degrades leading to settling issues later on. Material should either be broken down if buried or placed whole above grade to provide micro-niches for plants and animals.

Imported woody debris stored on site
