MINERALS PROGRAM INSPECTION REPORT

MINE NAME: Lyons Quarry	MINE/PROSPECTING ID#: M-1977-141	MINERAL: Quartz (quartzite/quartzose sandstone)	COUNTY: Boulder
INSPECTION TYPE: Monitoring	INSPECTOR(S): Amy Eschberger, Tim Cazier	INSP. DATE: April 28, 2021	INSP. TIME: 09:30
OPERATOR: Aggregate Industries - WCR, Inc.	OPERATOR REPRESENTATIVE: Jeremy Deuto, Joel Krech	TYPE OF OPERATION: 112c - Construction Regular Operation

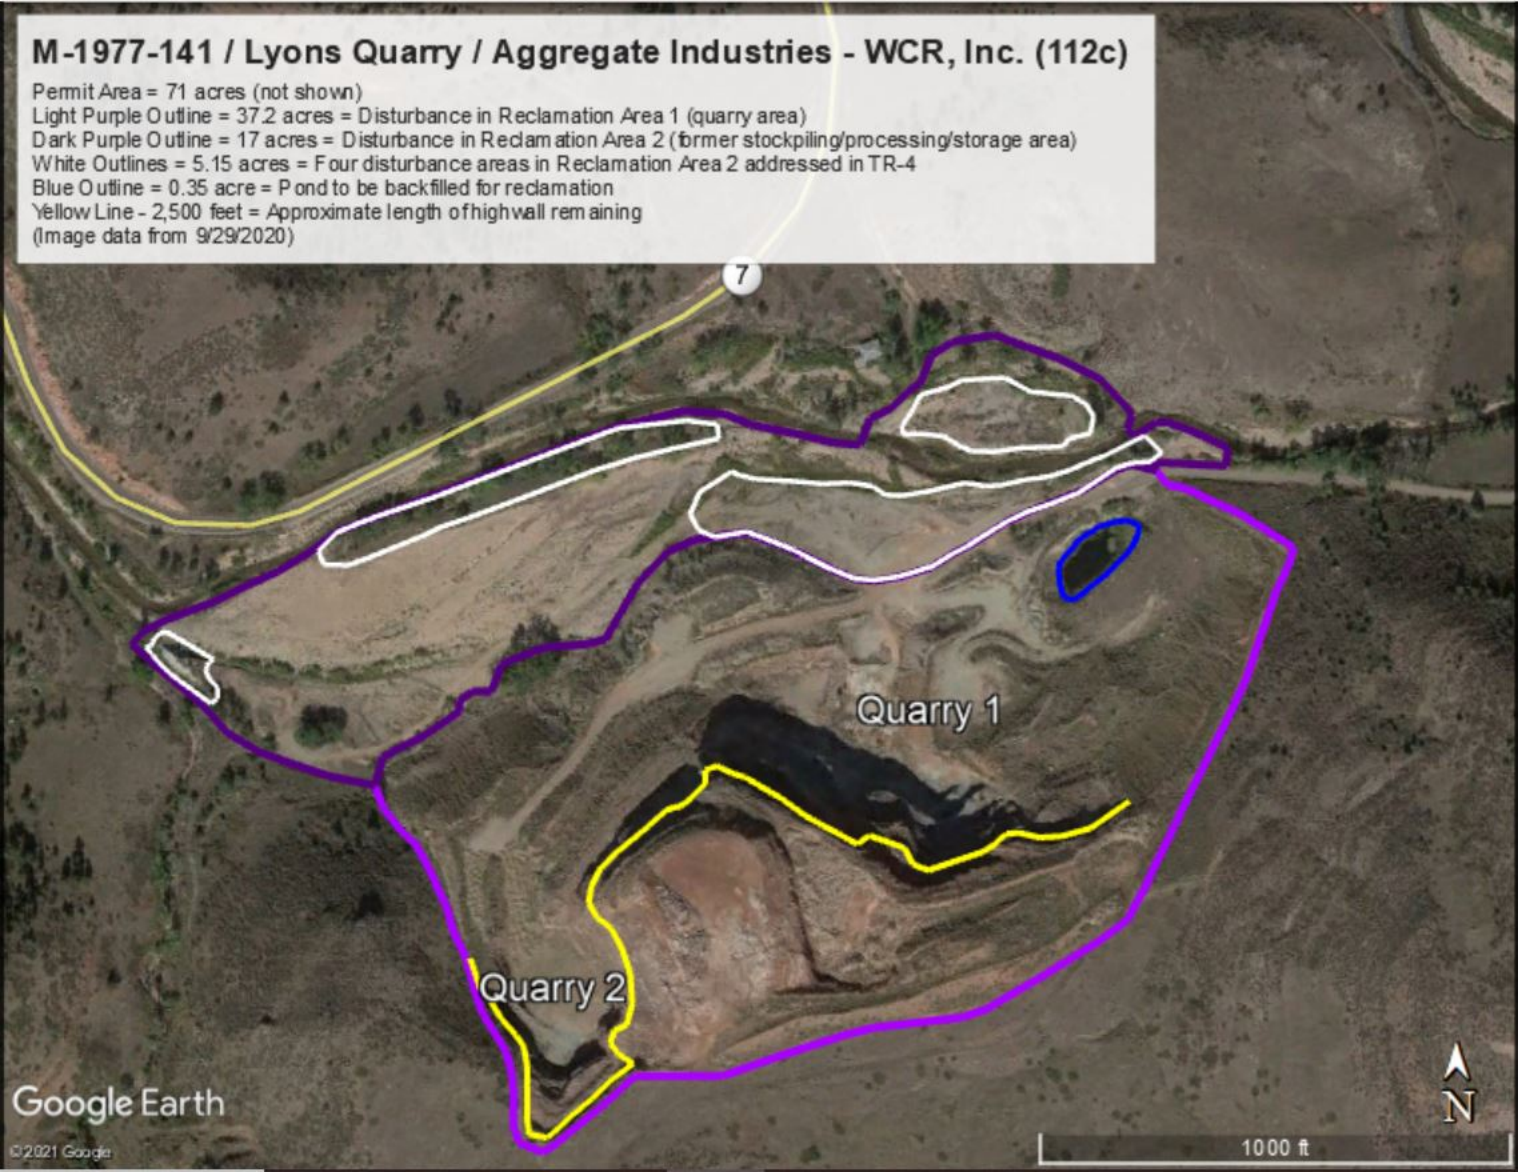
Figure 1. Plan view of Lyons Quarry showing dacite walls and proposed rockfall mitigation

As mentioned above, the Division is currently reviewing TR-5, which proposes a revised reclamation plan for the quarry area (see enclosed Figure 1 – Plan view of Lyons Quarry showing dacite walls and proposed rockfall mitigation, submitted with TR-5). This plan includes using heavy equipment or blasting to grade the overburden sedimentary rocks to an overall slope gradient of 2H:1V (from the northeast corner of Quarry 2 to the eastern extent of Quarry 1; see enclosed Final Grading Plan map and Final Grading Profile, Section & Details, submitted with TR-5), scaling and removing any loose rock from the dacite highwalls (from the northeast corner of Quarry 2 to the eastern extent of Quarry 1) and stabilizing these highwalls with rock bolts, constructing a rockfall catchment basin and/or berm coupled with restricted access (chain-link fencing) at the toe areas of the highwalls, backfilling Quarry 2 to achieve 50 foot high x 15 foot wide benches sloped at 2H:1V,
