**MINERALS PROGRAM INSPECTION REPORT**  
**PHONE: (303) 866-3567**

<b>MINE NAME:</b> Hatchery Pit	<b>MINE/PROSPECTING ID#:</b> M-2014-043	<b>MINERAL:</b> Borrow material	<b>COUNTY:</b> Adams
<b>INSPECTION TYPE:</b> Monitoring	<b>INSPECTOR(S):</b> Patrick Lennberg	<b>INSP. DATE:</b> May 5, 2021	<b>INSP. TIME:</b> 12:30
<b>OPERATOR:</b> Albert Frei & Sons Inc.	<b>OPERATOR REPRESENTATIVE:</b> Ben Frei, Steve O'Brian, Jole Bolduc	<b>TYPE OF OPERATION:</b> 112c - Construction Regular Operation	
<b>REASON FOR INSPECTION:</b> Normal I&E Program	<b>BOND CALCULATION TYPE:</b> Partial Bond	<b>BOND AMOUNT:</b> \$1,056,100.00	
<b>DATE OF COMPLAINT:</b> NA	<b>POST INSP. CONTACTS:</b> None	<b>JOINT INSP. AGENCY:</b> None	
<b>WEATHER:</b> Cloudy	<b>INSPECTOR'S SIGNATURE:</b>

## **OBSERVATIONS**

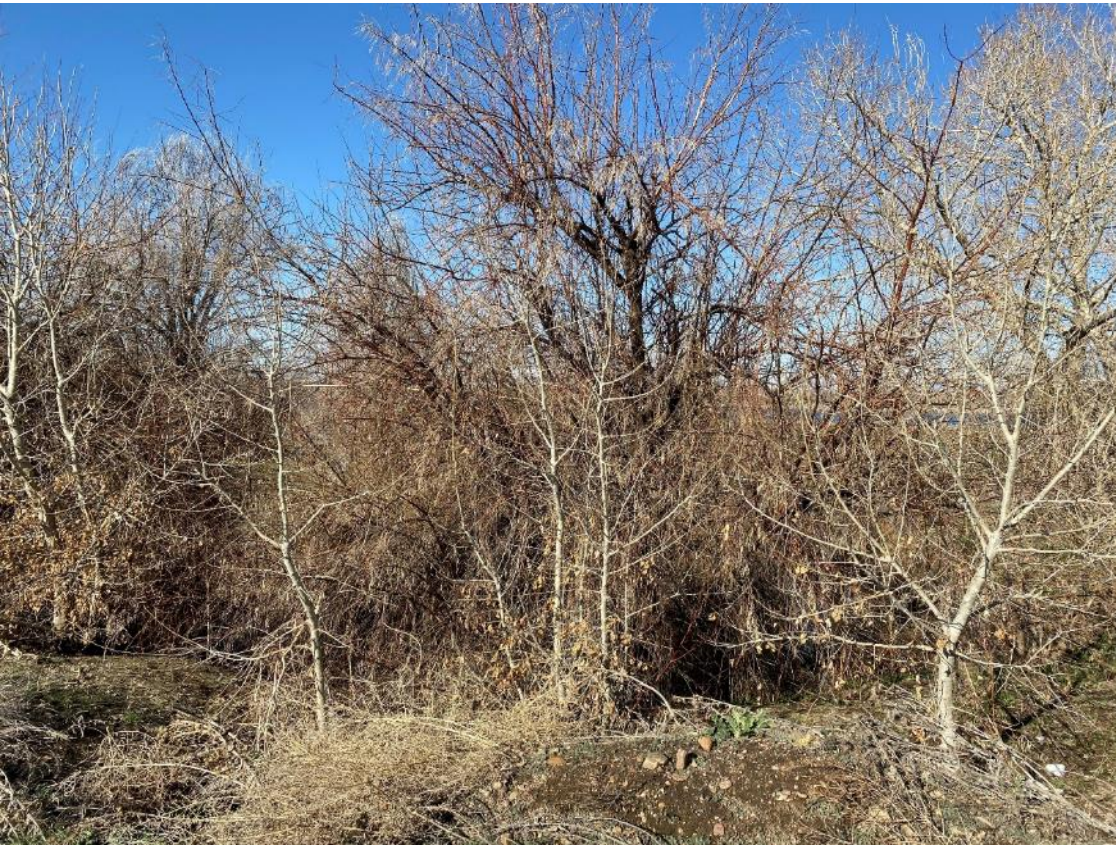
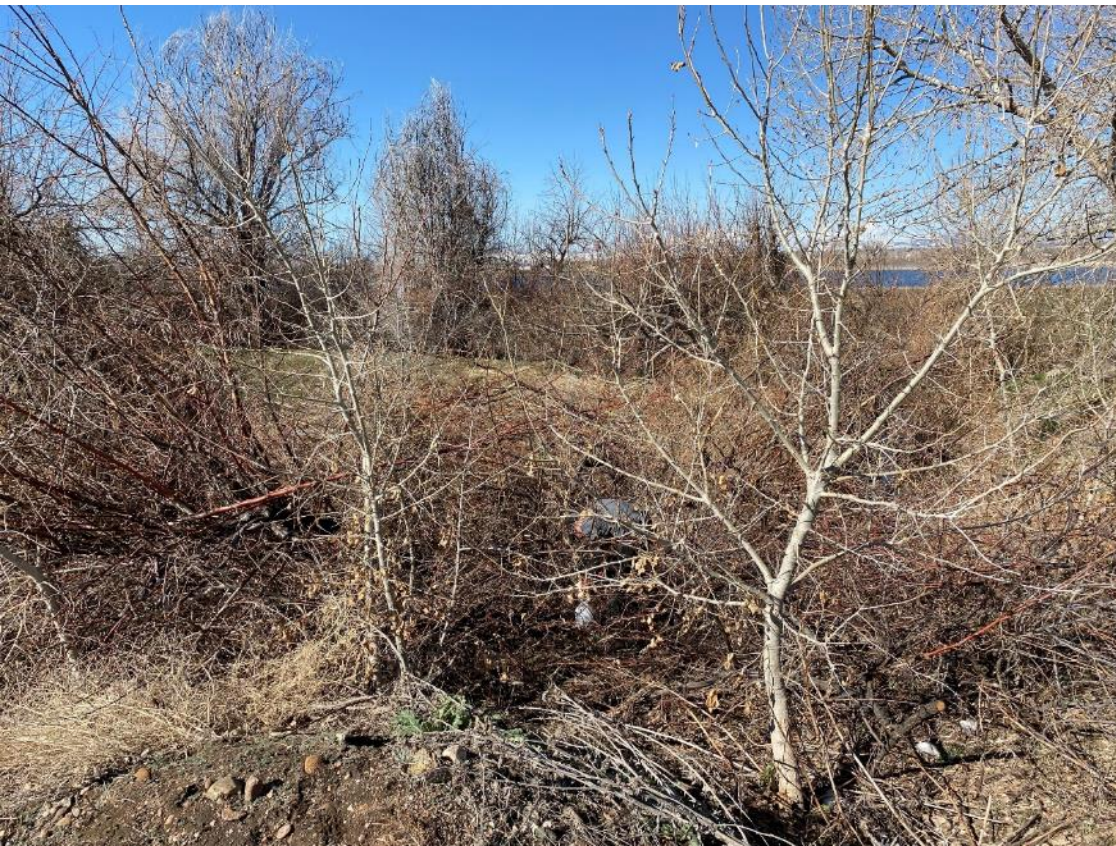
# Location 1

In April 2021 the operator removed approximately 20 Russian Olive trees from 13 locations along the north western permit boundary with the Bull Seep. The operator provided documentation of their efforts see attachment 4. During the inspection several stumps were observed where the trees used to be located.
