# **PERMIT INFORMATION**

Permit Number: C-1992-081	County: Routt			
Mine Name: Hayden Gulch Loadout	Operation Type: Loadout			
Operator: Hayden Gulch Terminal, LLC	Permit Status: Active			
Operator Address:	Ownership: Private			
Ms Miranda Kawcak				
	Operator Representative Present:			
P.O. Box 670				
Hayden, CO 81639	Kevin Copeland			
Operator Representative Signature: (Field Issuance Only)

## **INSPECTION INFORMATION**

This was an aerial inspection of the Hayden Gulch Loadout; DRMS Permit No. C-1992-081, operated by Hayden Gulch Terminal, LLC. Photos were taken by Brock Bowles on 5/12 and photos were observed by Tabetha Lynch with the Colorado Division of Reclamation, Mining, and Safety (Division) on 5/17.

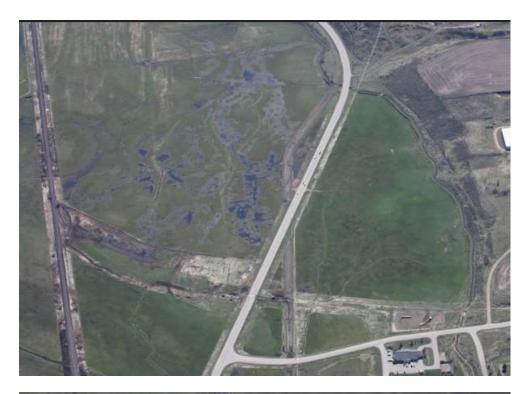
Photo above shown reclamation area, irrigation channels and surrounding flood irrigated fields. Walker ditch is on the left, tracks middle left, Hyw 40 Middle/middle right.
