To: Jerald Schnabel
Continental Materials Corp.
File: April 2021 Monitoring Summary

From: Paul Kos
Denver, CO 80222
Date: May 31, 2021

Reference: April 2021 Geotechnical Monitoring Summary Pikeview Quarry

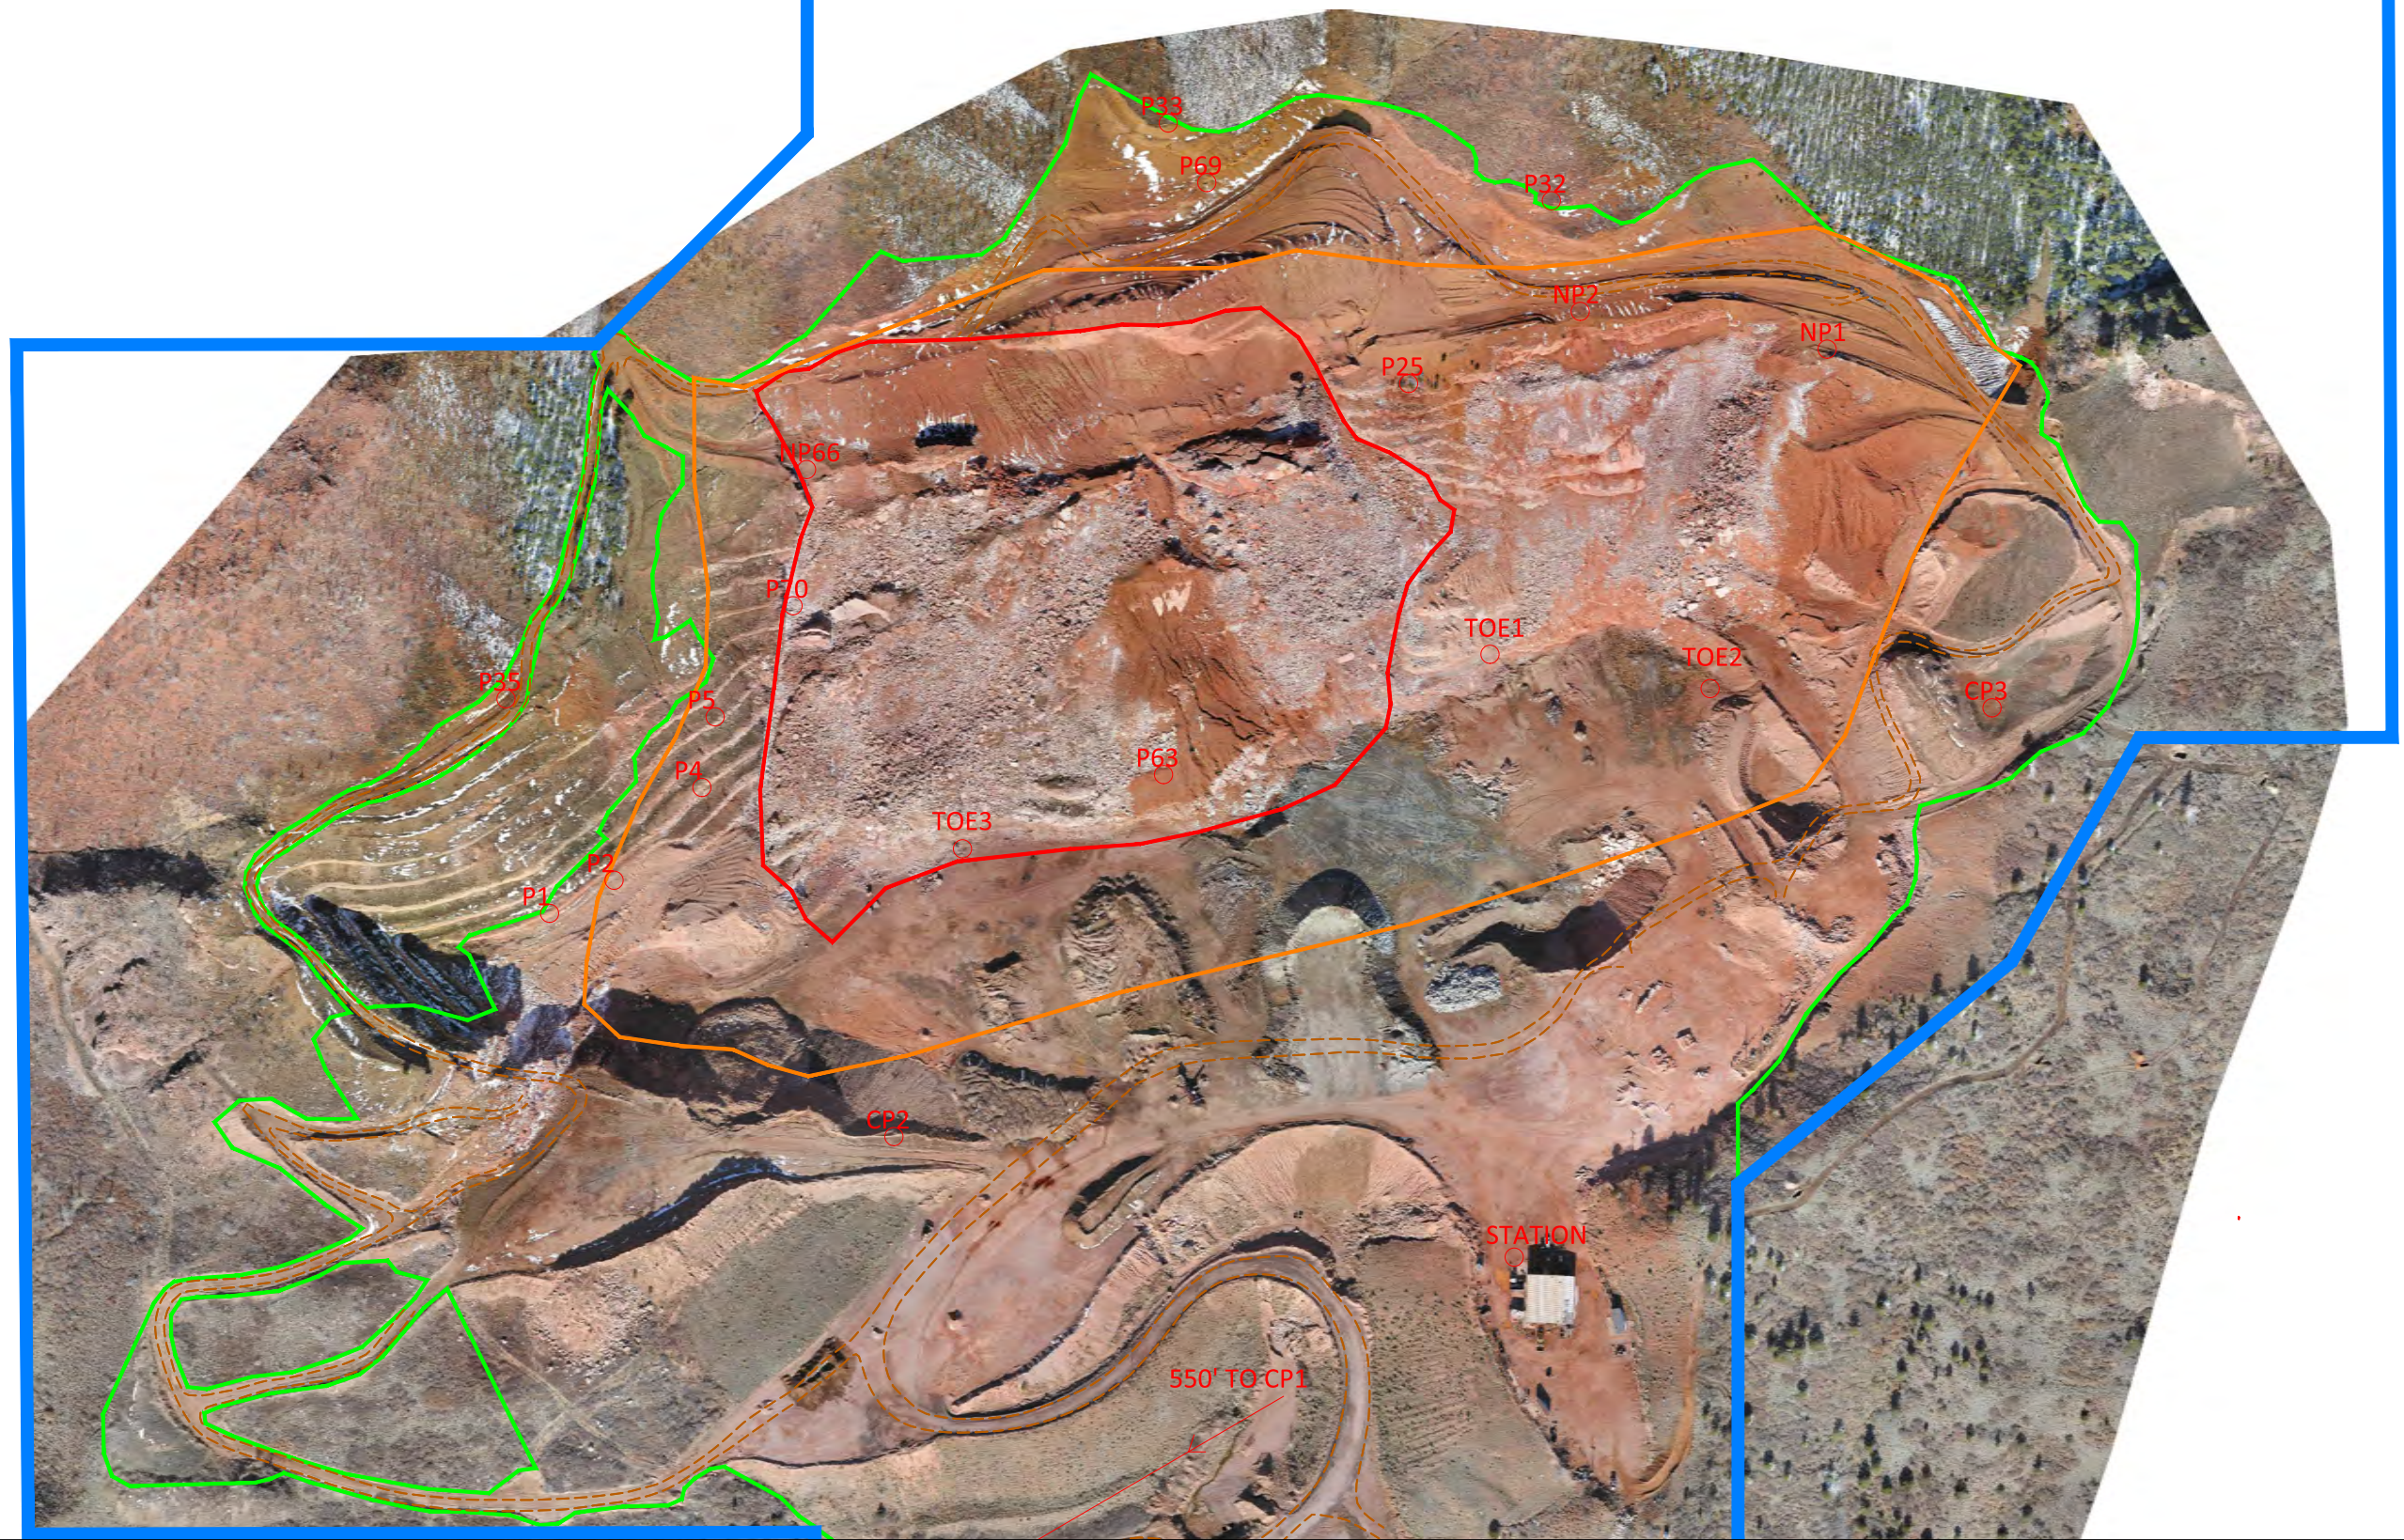
Date
2021.05.31
Figure No.
1

Title
SITE MAP

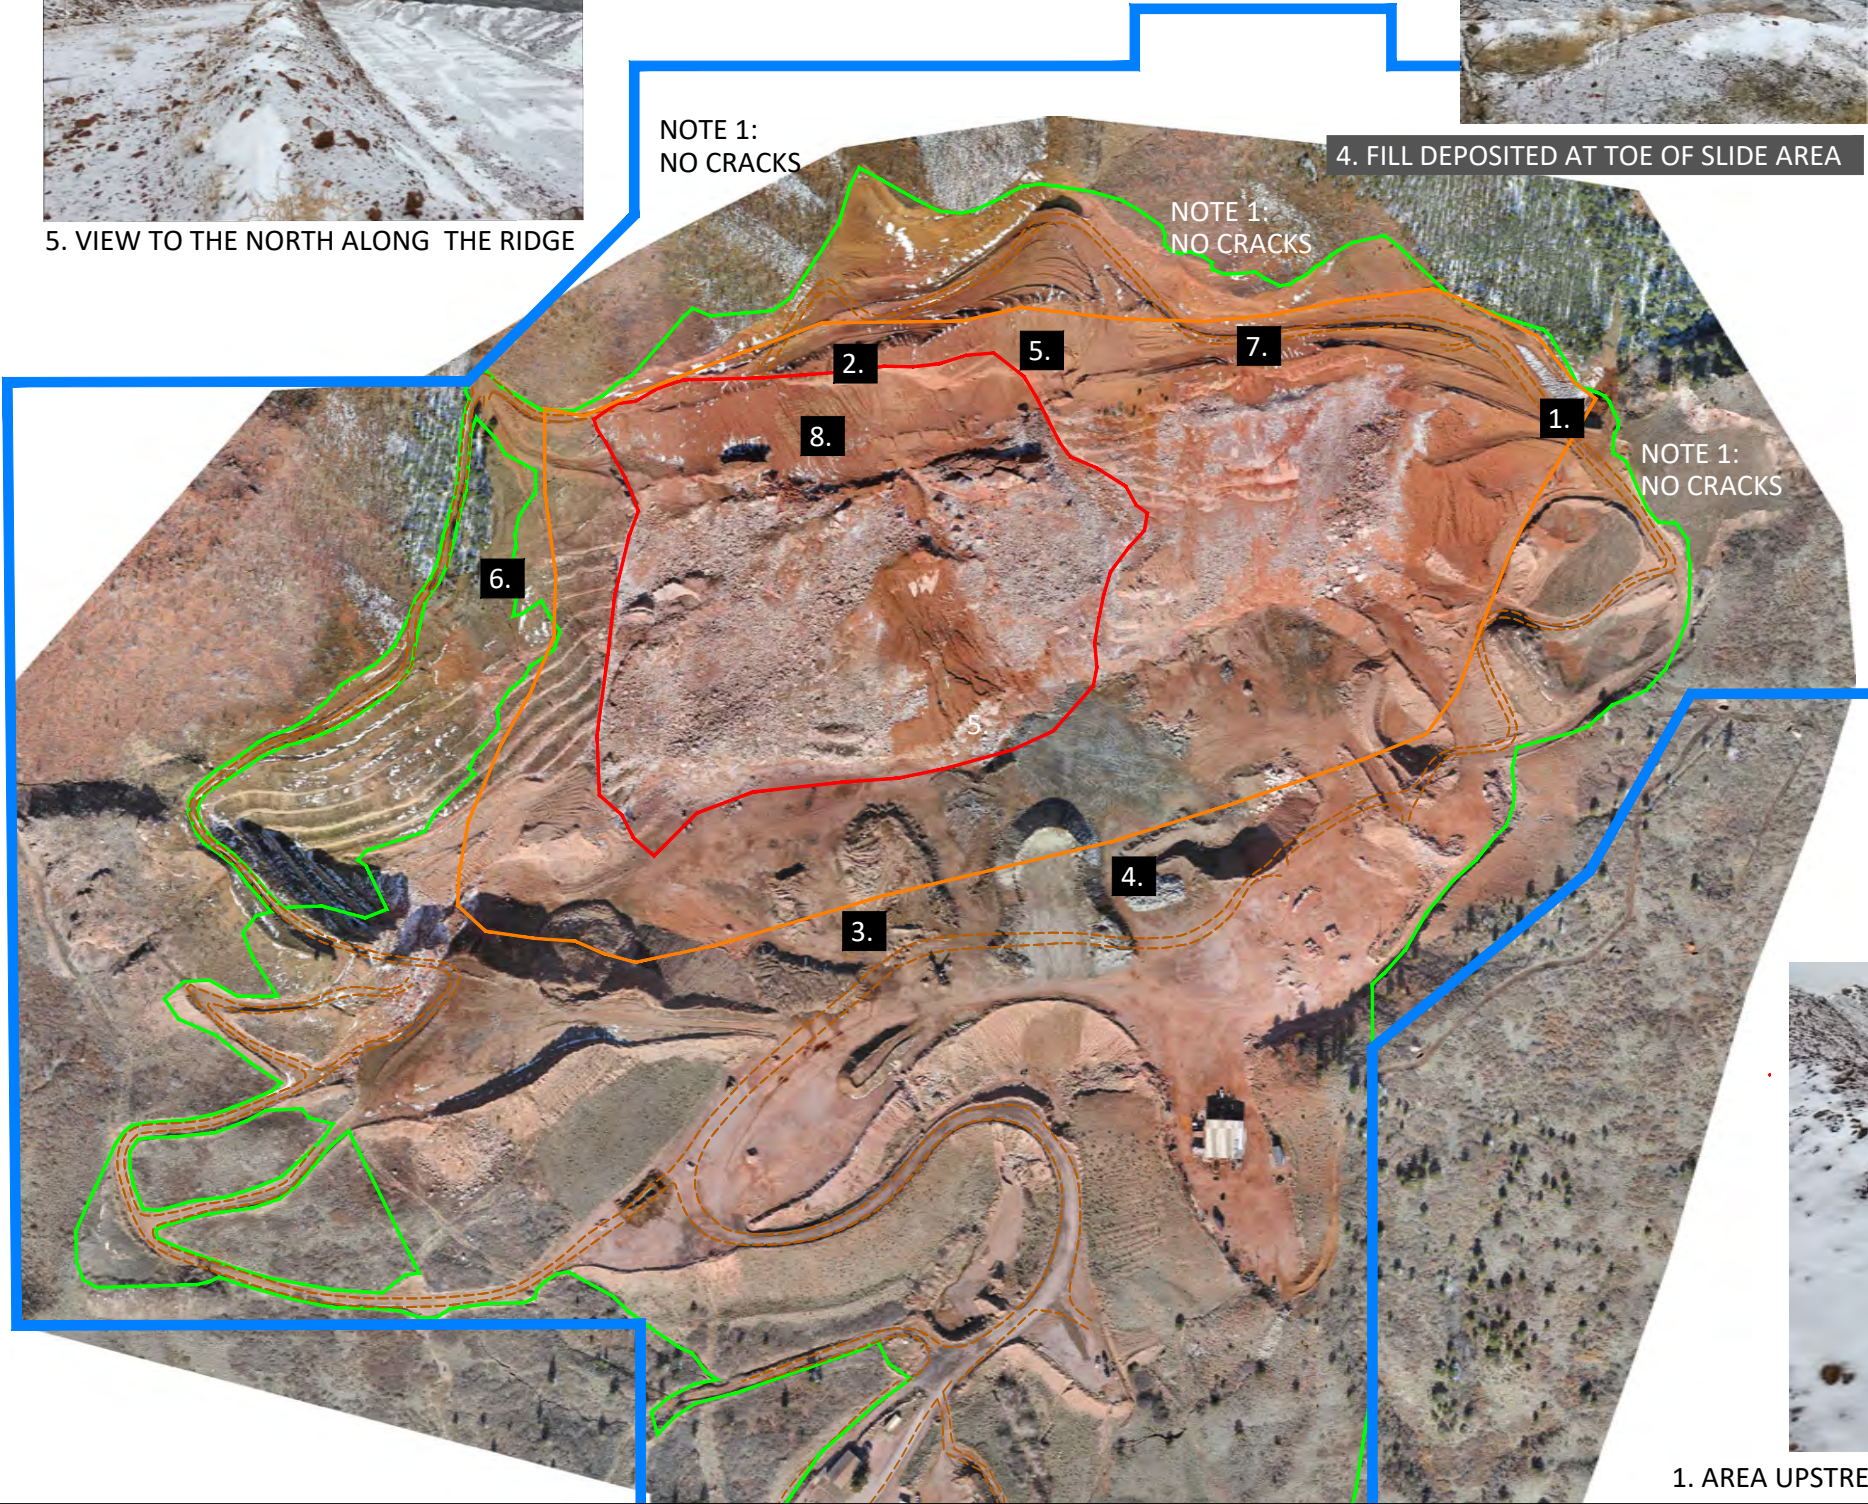
Figure No.

- Gullies and Rills: Gullies and rills have formed on the slopes above the slide area as well as in the burn areas above the quarry. (Note 8)
- Open Cracks: An open crack was observed during this visit. This feature is in an area where cracking is expected to occur as a result of ongoing slope settlement and relaxation. The edges of the crack have eroded suggesting it is not a new feature.

- Healed Cracks: A crack was observed on the slope adjacent to the slide where cracking had previously been observed. This crack runs parallel to the slide and appears to be "healed" and did not indicate any recent movement.

- Crack Free: No cracking was observed on the native granite slopes above the extents of the disturbed area. The hummocky field in the area immediately above the southern extent of the slide shows evidence of cracking but they are not fresh or active. No new or open cracks were found immediately inside or next to the slide area.

- Visual inspections of the Pikeview Quarry did not reveal any evidence of large-scale instability outside of the landslide areas previously identified. No bulging, rippling, over-steepening, depressions, slumps, or dry slip-offs were observed in areas that have been graded and/or reclaimed.

1. NO CRACKS OBSERVED IN THIS AREA.
2. ALL PHOTOS TAKEN APRIL 21, 2021.

OBSERVATIONS FROM APRIL
INSPECTION

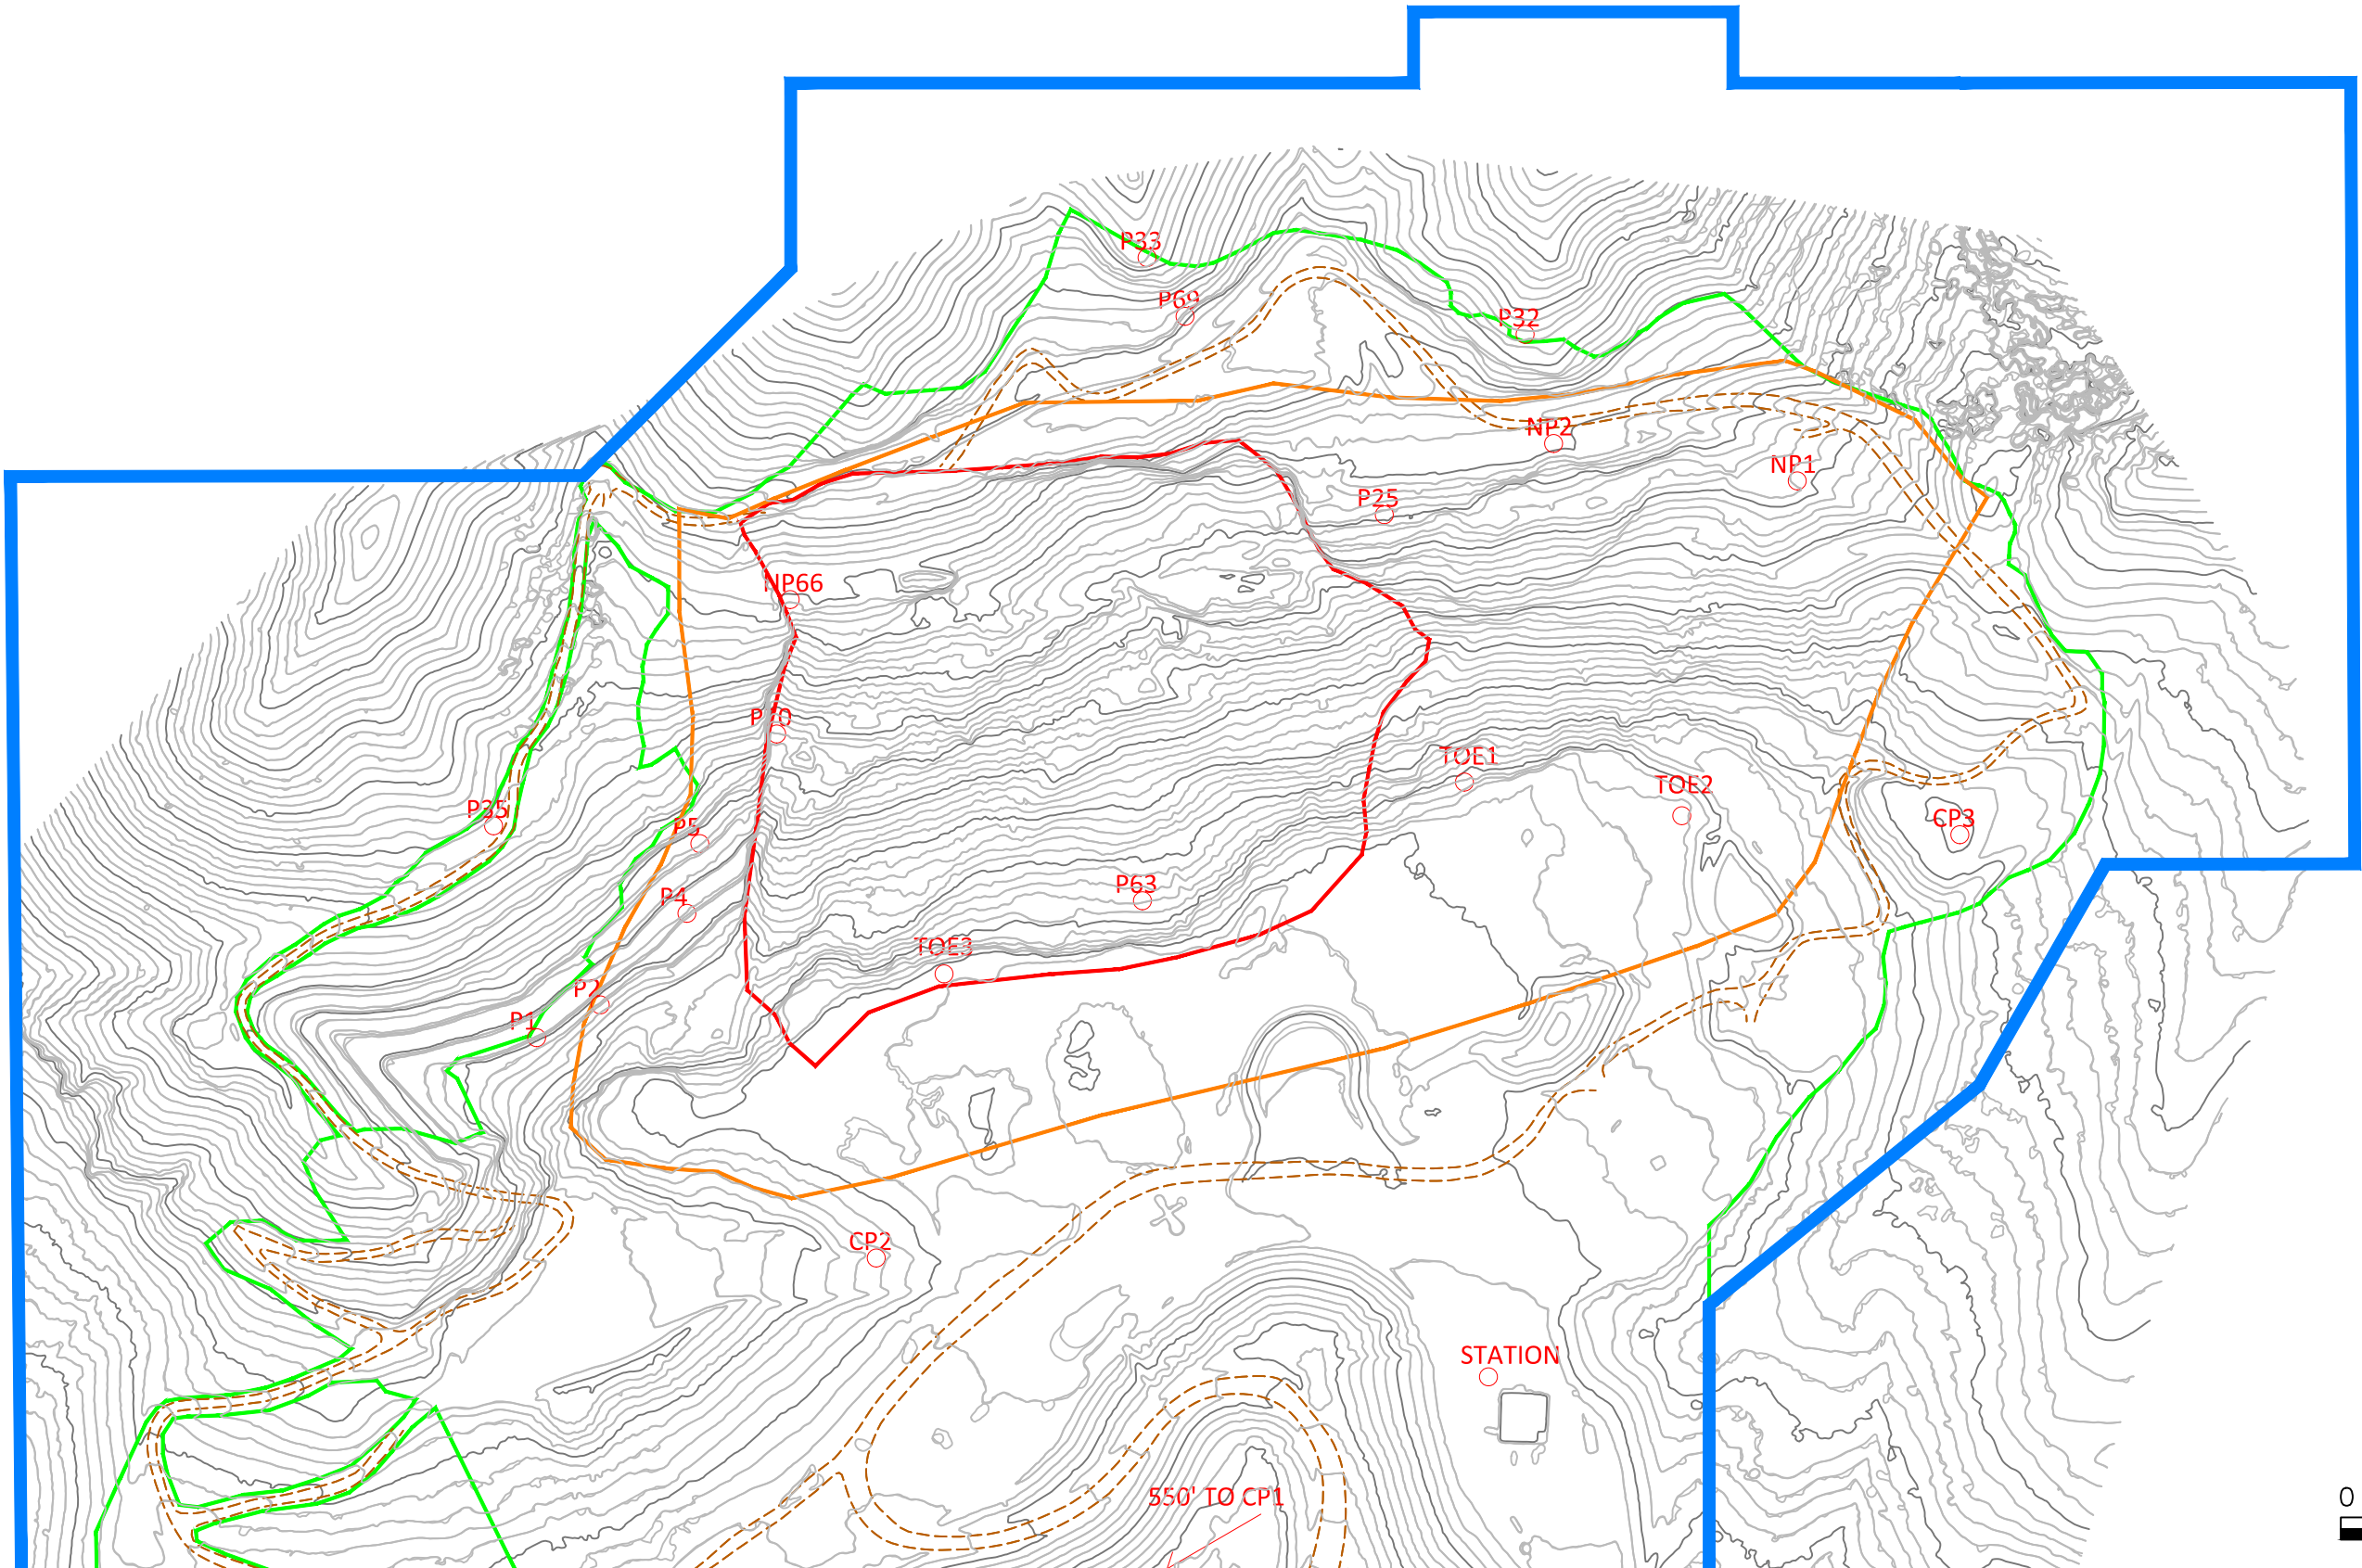
Revision #	Date
	2021.05.31
Drawn By PK	Figure No. 3

Title
EXISTING PRISMS WITH CURRENT SURFACE

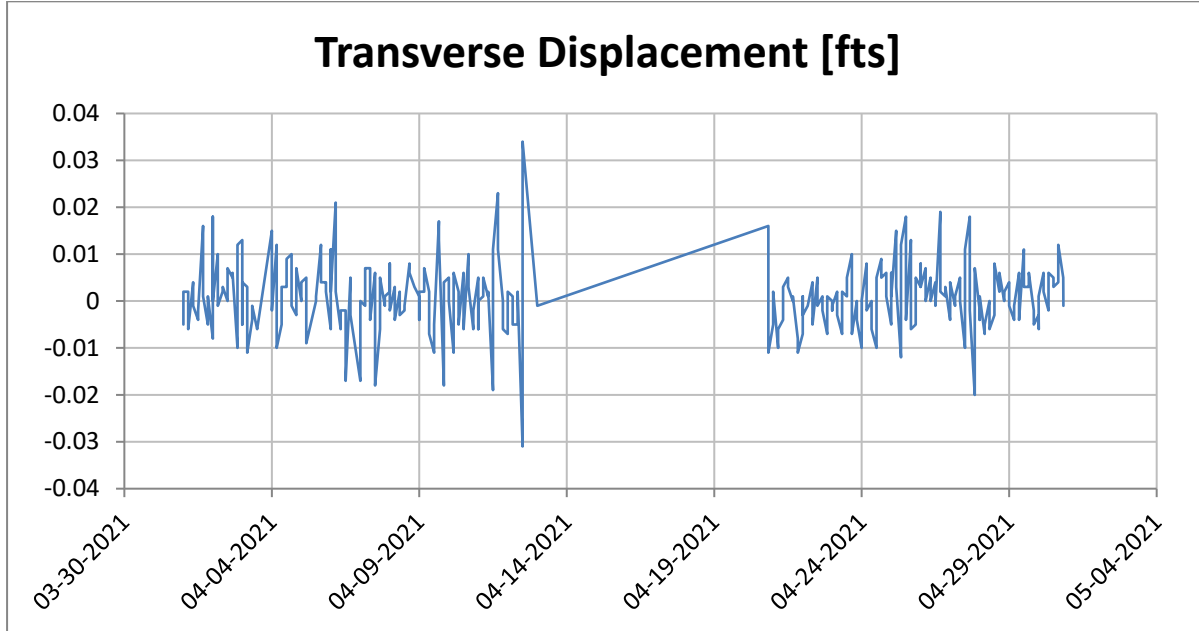
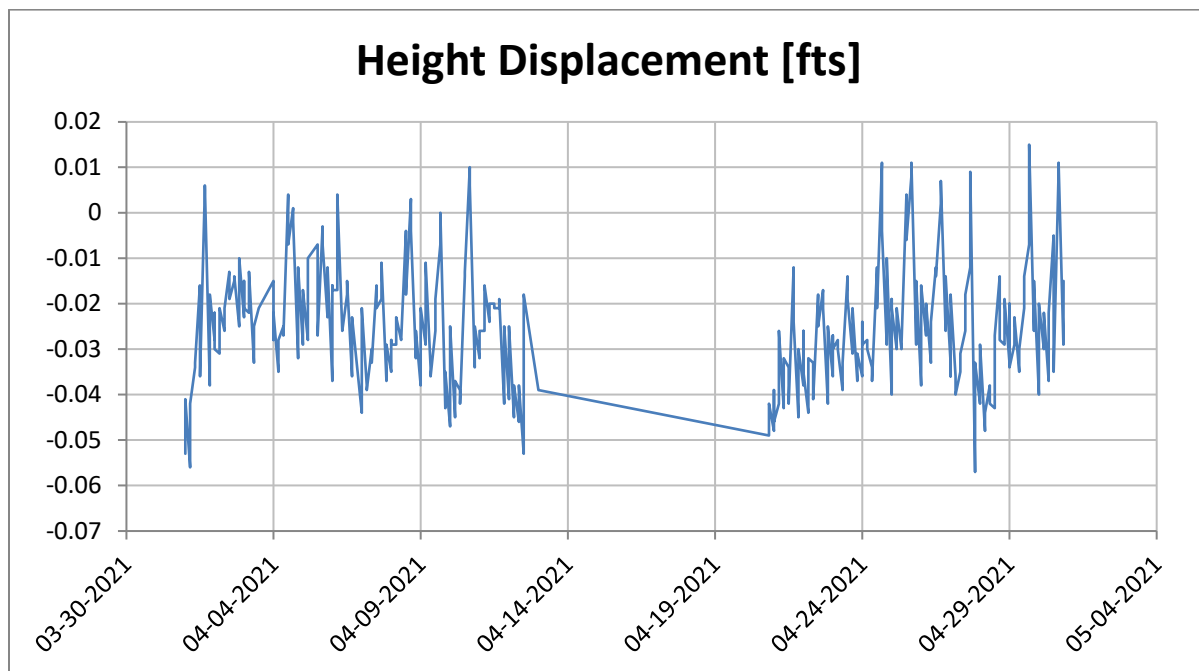
Prism CP1

Prism ID	Cumulative Transverse Displacement (ft)	Cumulative Height Displacement (ft)	Monthly Delta (ft)	Cumulative Delta (ft)	Needs / Recommendations
CP1	-0.001	-0.015	-0.0364	0.0170	
CP2	-0.057	-0.007	0.0155	0.4031	
CP3	0.348	-0.060	0.0070	0.3550	
NP1	0.167	-0.039	0.0236	0.2285	
NP2	0.048	-0.190	0.0230	0.4472	Prism was moved to replace damaged glass
NP66	0.370	-0.129	0.0190	0.4881	
P1	0.401	-0.152	0.0238	0.6252	
P2	0.362	-0.317	0.0191	0.6052	
P25	0.159	-0.256	0.0375	0.3791	
P32	15.301	-6.261	0.0208	16.5326	
P33	-0.090	-0.052	-0.0112	0.2018	
P35	-0.023	-0.027	0.0078	1.9793	
P4	-0.007	0.024	0.0073	0.1452	
P5	-0.071	-0.096	-0.0224	0.2565	
P63	-0.004	-0.070	-0.0028	0.0984	Prism at toe of slide. Movements are within expected range.
P69	0.059	-0.009	0.0096	0.0640	
P70	0.275	-0.220	0.0075	0.3574	
TOE1	0.309	0.048	0.0136	0.4837	
TOE2	0.032	-0.019	-0.0062	0.0373	
TOE3	0.148	-0.012	0.0392	0.1488	Prism at toe of slide. Movements are within expected range.
