**MINERALS PROGRAM INSPECTION REPORT**  
**PHONE: (303) 866-3567**

| <b>MINE NAME:</b><br>Treiber Lakes | <b>MINE/PROSPECTING ID#:</b><br>M-2011-049 | <b>MINERAL:</b><br>Aggregate | <b>COUNTY:</b><br>Larimer |
| <b>INSPECTION TYPE:</b><br>Monitoring | <b>INSPECTOR(S):</b><br>Amy Eschberger | <b>INSP. DATE:</b><br>May 26, 2021 | <b>INSP. TIME:</b><br>14:00 |

# M-2011-049 / Treiber Lakes / City of Greeley (112c)

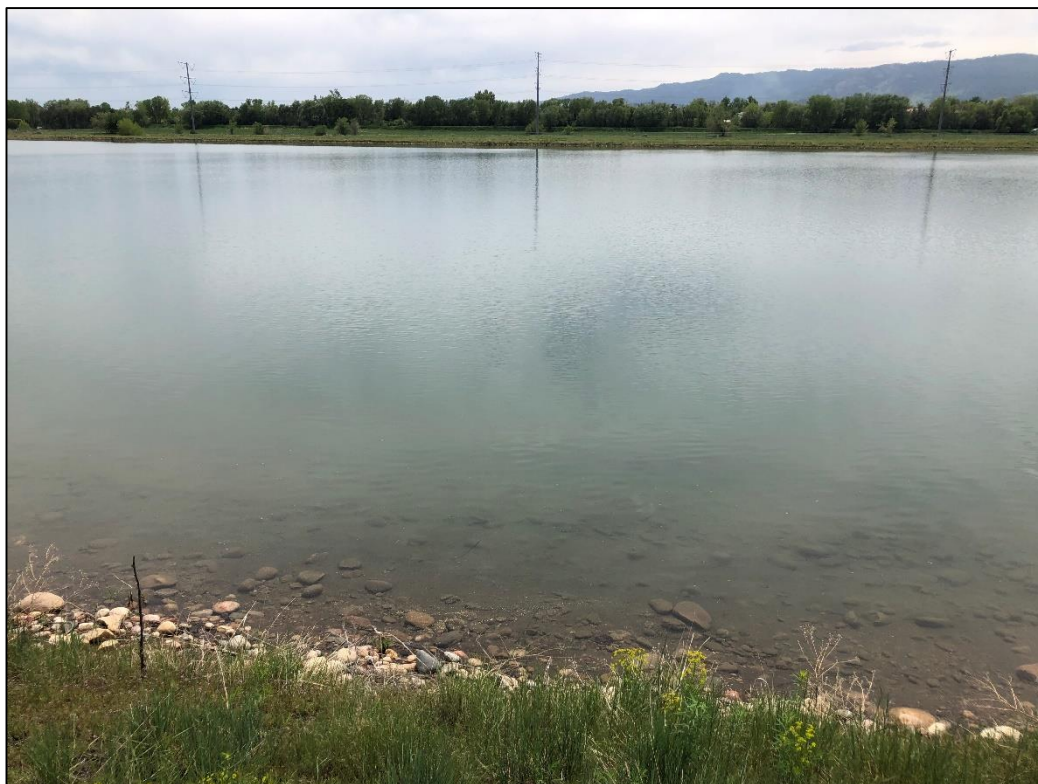
**Photo 4.** View looking south across South Reservoir from its northern shoreline.

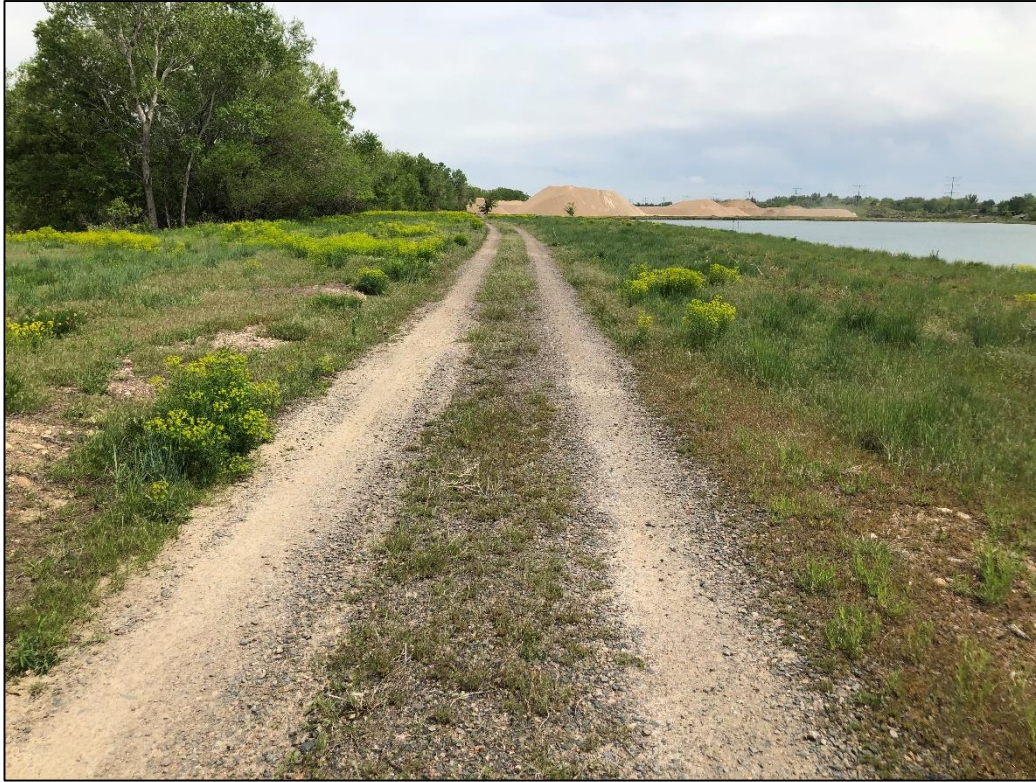
**Photo 7.** View looking southeast at dirt road along northern edge of South Reservoir which will remain for reclamation.

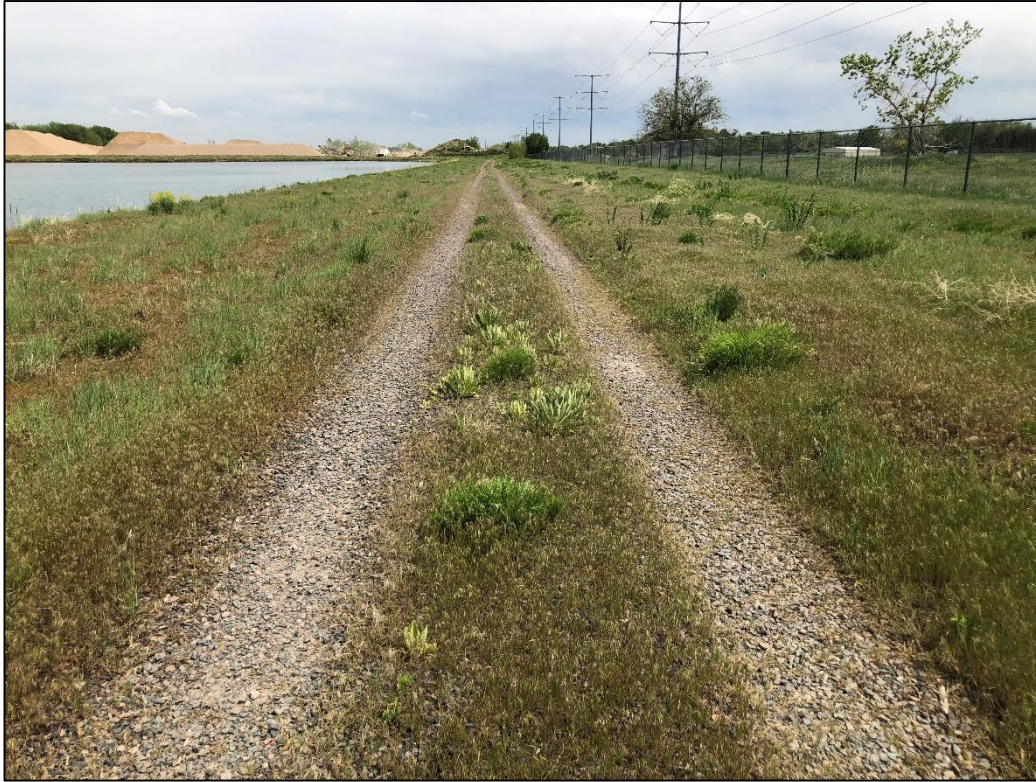
**Photo 11.** View looking southeast at dirt road along southern edge of South Reservoir which will remain for reclamation. Note fencing at right which delineates southern permit boundary.

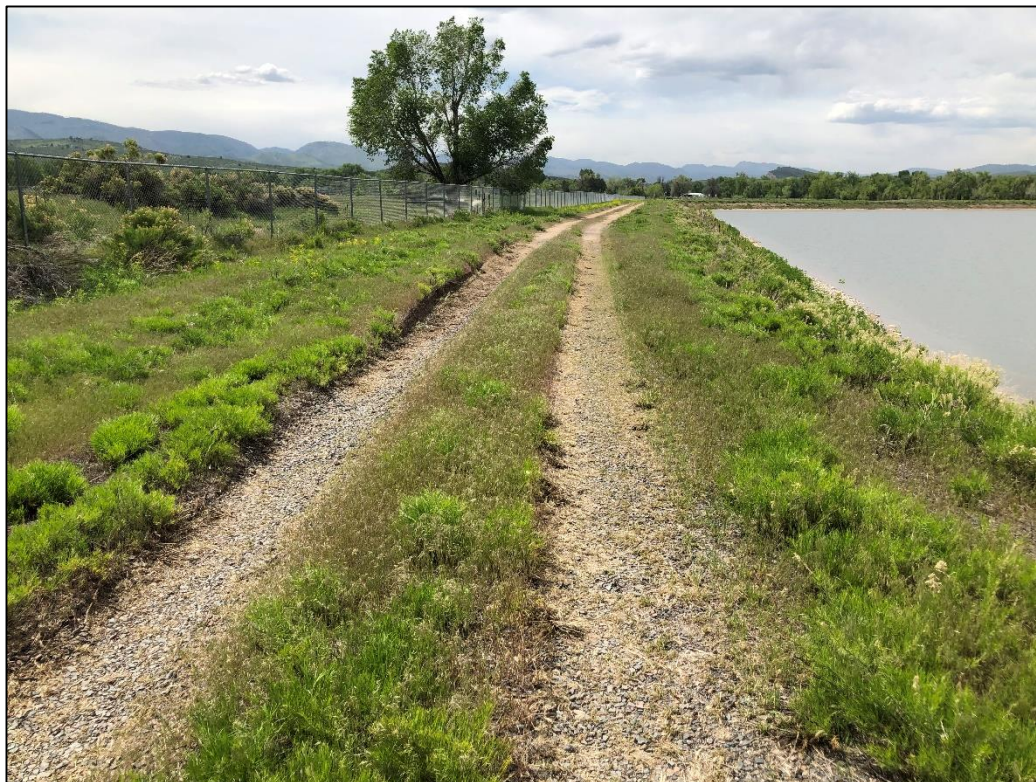
**Photo 28.** View looking northwest at dirt road along southern edge of North Reservoir which will remain for reclamation. Note fencing at left which delineates southern permit boundary.

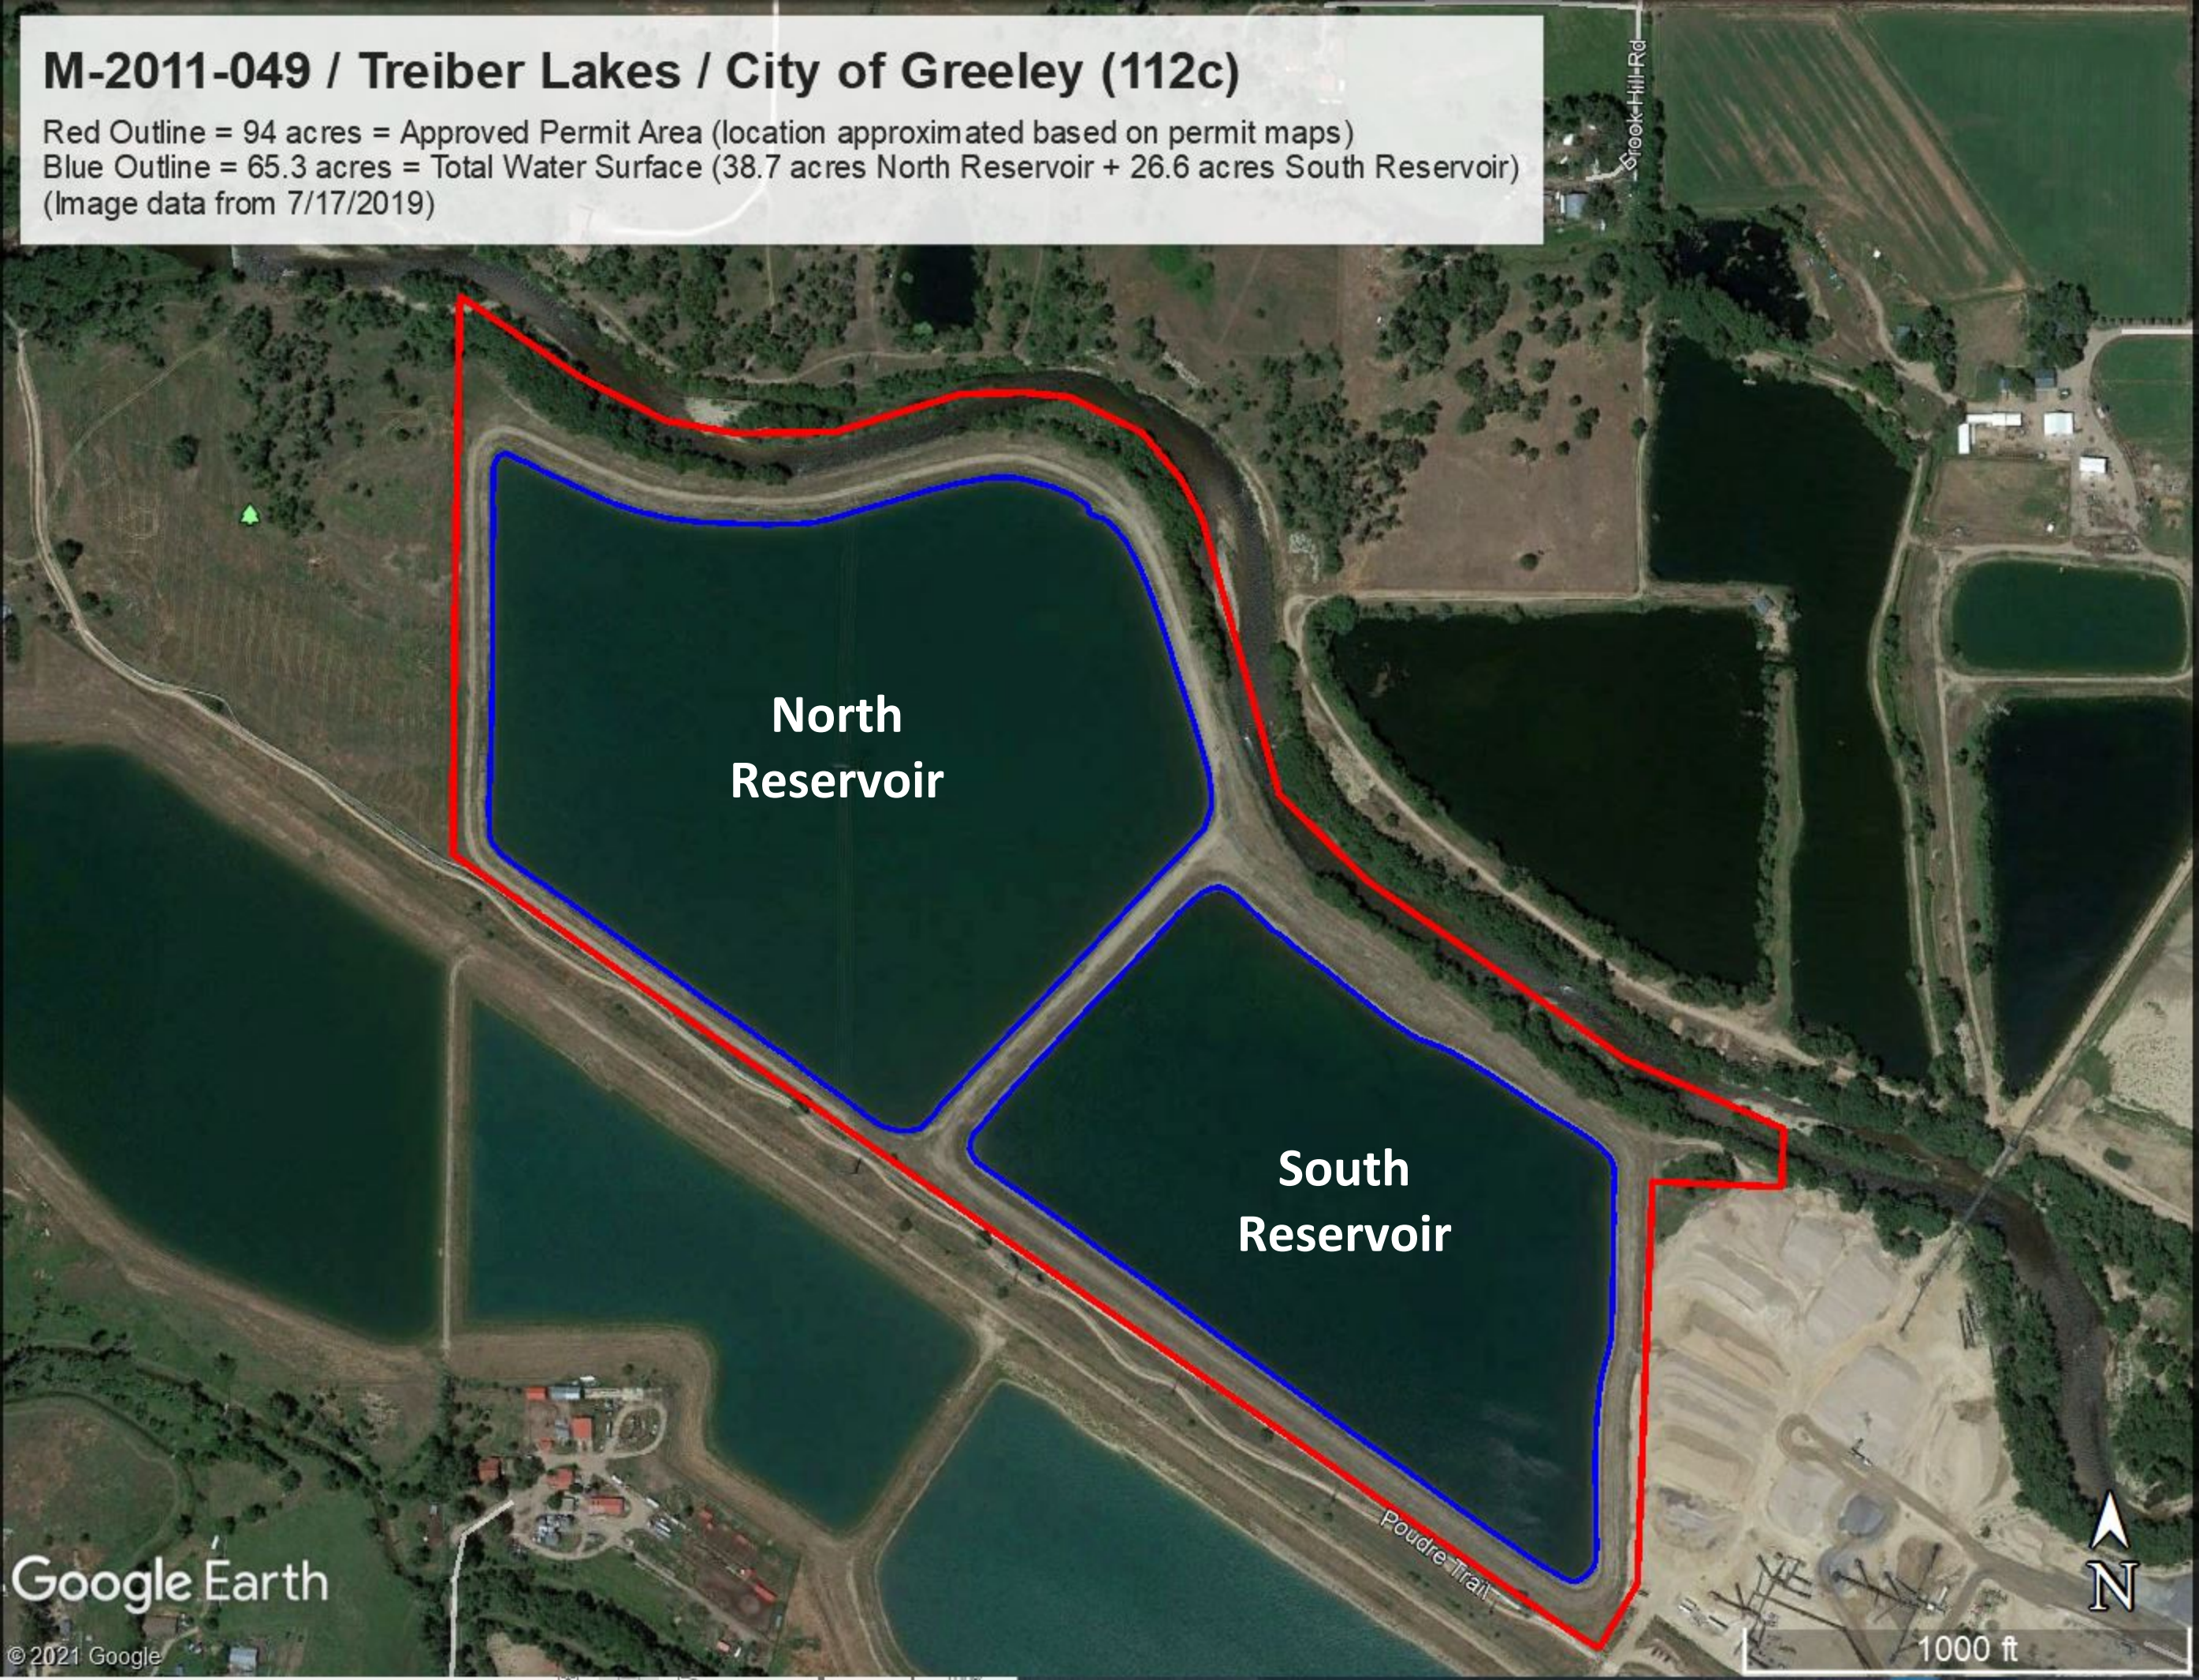
Red Outline = 94 acres = Approved Permit Area (location approximated based on permit maps)  
Blue Outline = 65.3 acres = Total Water Surface (38.7 acres North Reservoir + 26.6 acres South Reservoir)  
(Image data from 7/17/2019)
