MINERALS PROGRAM INSPECTION REPORT
PHONE: (303) 866-3567

MINE NAME: North Taft Hill Expansion Site	MINE/PROSPECTING ID#: M-2001-051	MINERAL: Sand and gravel	COUNTY: Larimer
INSPECTION TYPE: Monitoring	INSPECTOR(S): Amy Eschberger	INSP. DATE: May 26, 2021	INSP. TIME: 12:30
OPERATOR: Martin Marietta Materials, Inc.	OPERATOR REPRESENTATIVE: Julie Mikulas	TYPE OF OPERATION: 112c - Construction Regular Operation

M-2001-051 / North Taft Hill Expansion Site / Martin Marietta Materials, Inc. (112c)

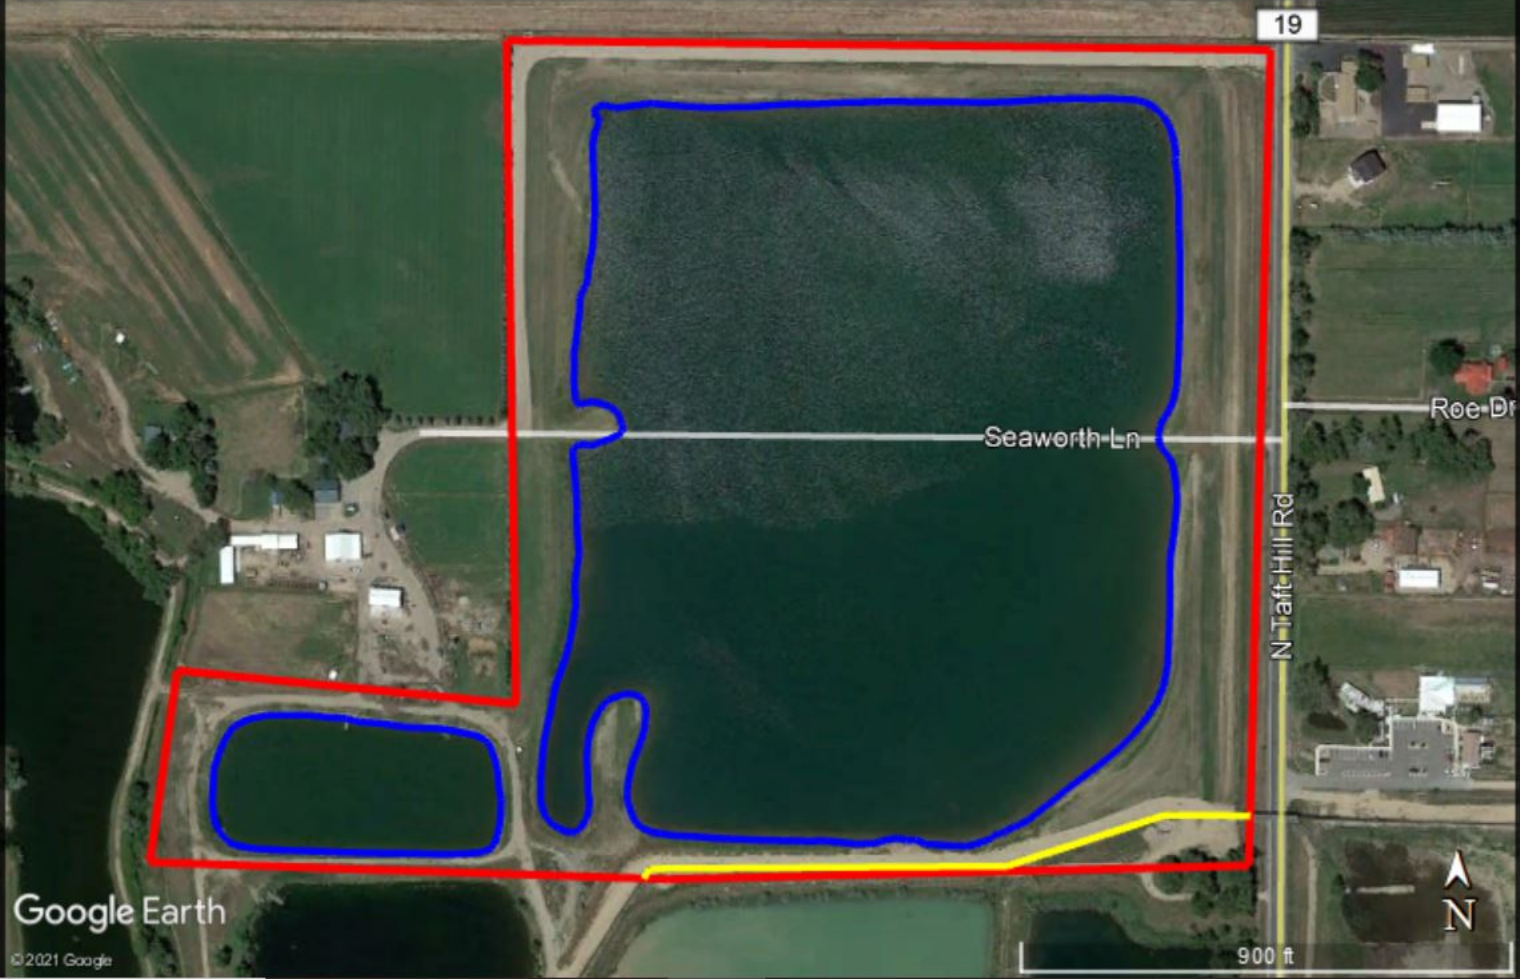
Blue outline = 34.7 acres = Total estimated pond surface area (32 acres + 2.7 acres)

Yellow line = 1,130 feet = Approximate length of conveyor located within permit area
(Image data from 7/17/2019)
