## Explanation of Slope on Map on our request for reconsidering your decisions

### **Narrative of Slope Analysis Processes**

This is not a Land Survey Plat or an Improvement Survey Plat. The purpose of these exhibits is to depict the areas where the side slopes exceed 33.33% (3:1 Slope).

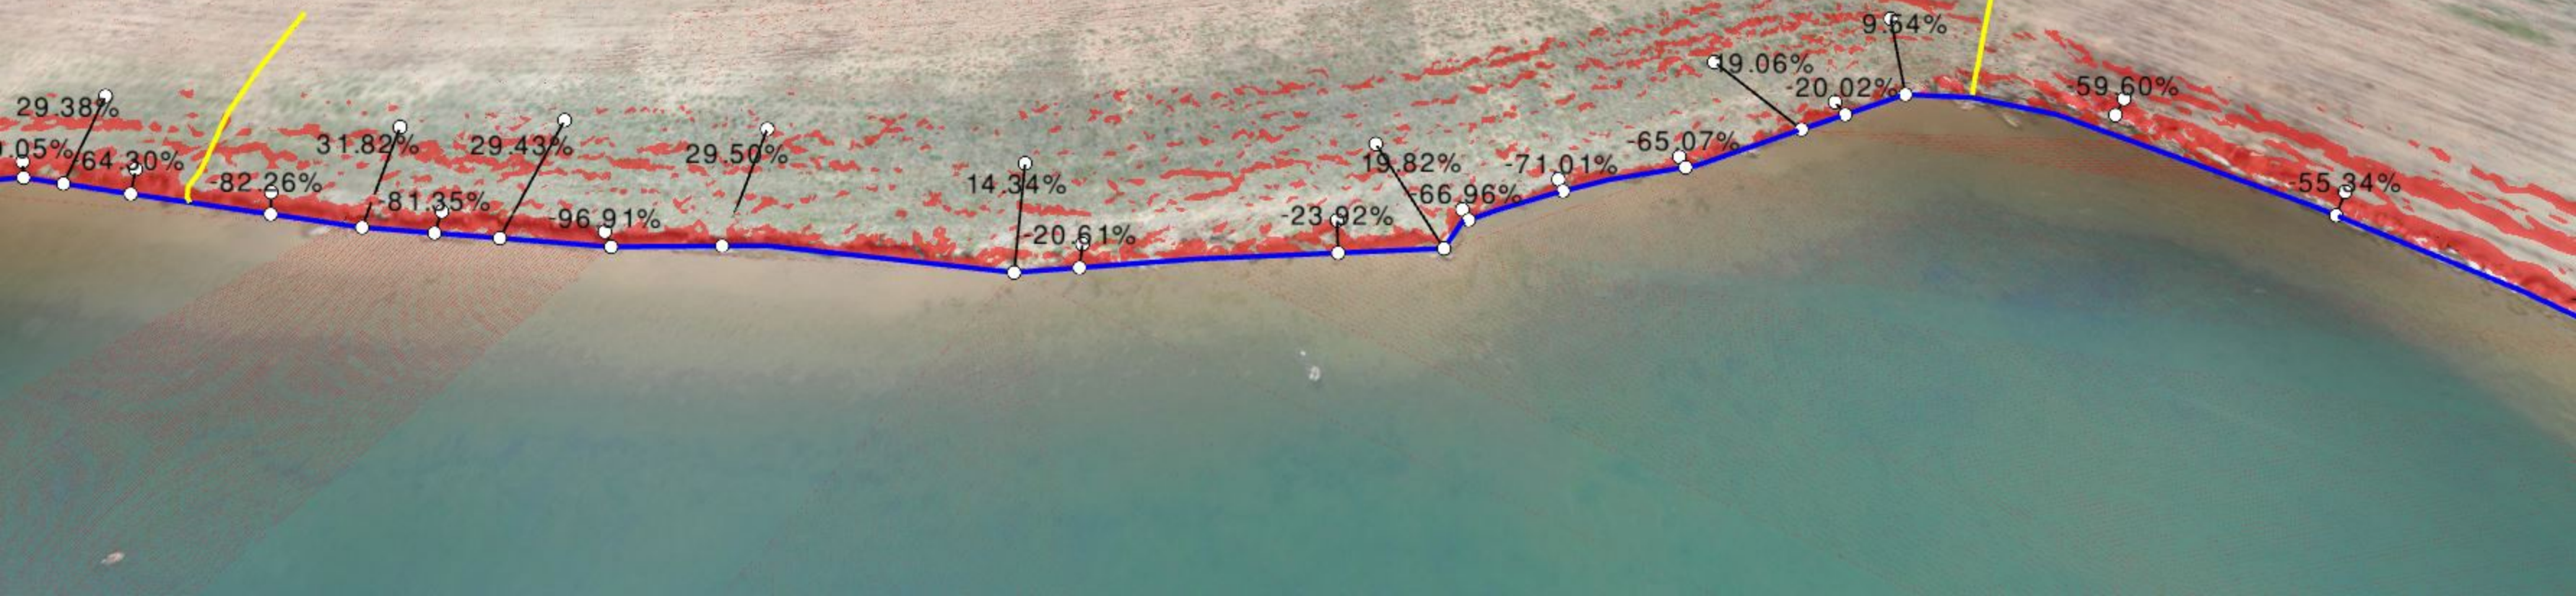
ZONE 19

Zones 19,20,21,22,23 is where the violation on the June 24th report was asked to be corrected as you can see it has not been corrected to the standard of 3:1 set by state.
