To: Jerald Schnabel
Continental Materials Corp.
File: May 2021 Monitoring Summary

From: Paul Kos
Denver, CO 80222
Date: June 30, 2021

Reference: May 2021 Geotechnical Monitoring Summary Pikeview Quarry

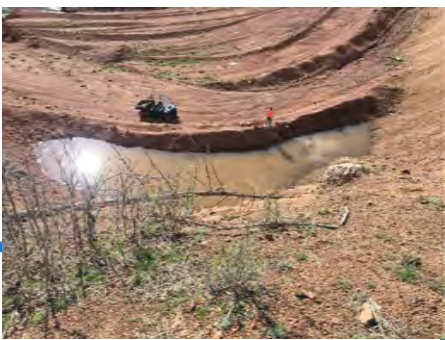
- Seepage was observed on the steep slopes of the middle peak, and in some of the haul roads along the slopes. (Photo 2)
- The water level of the pond at the top of the road near Mid-Peak is lower. (Photo 4)

POND AREA AT TOP OF THE ROAD

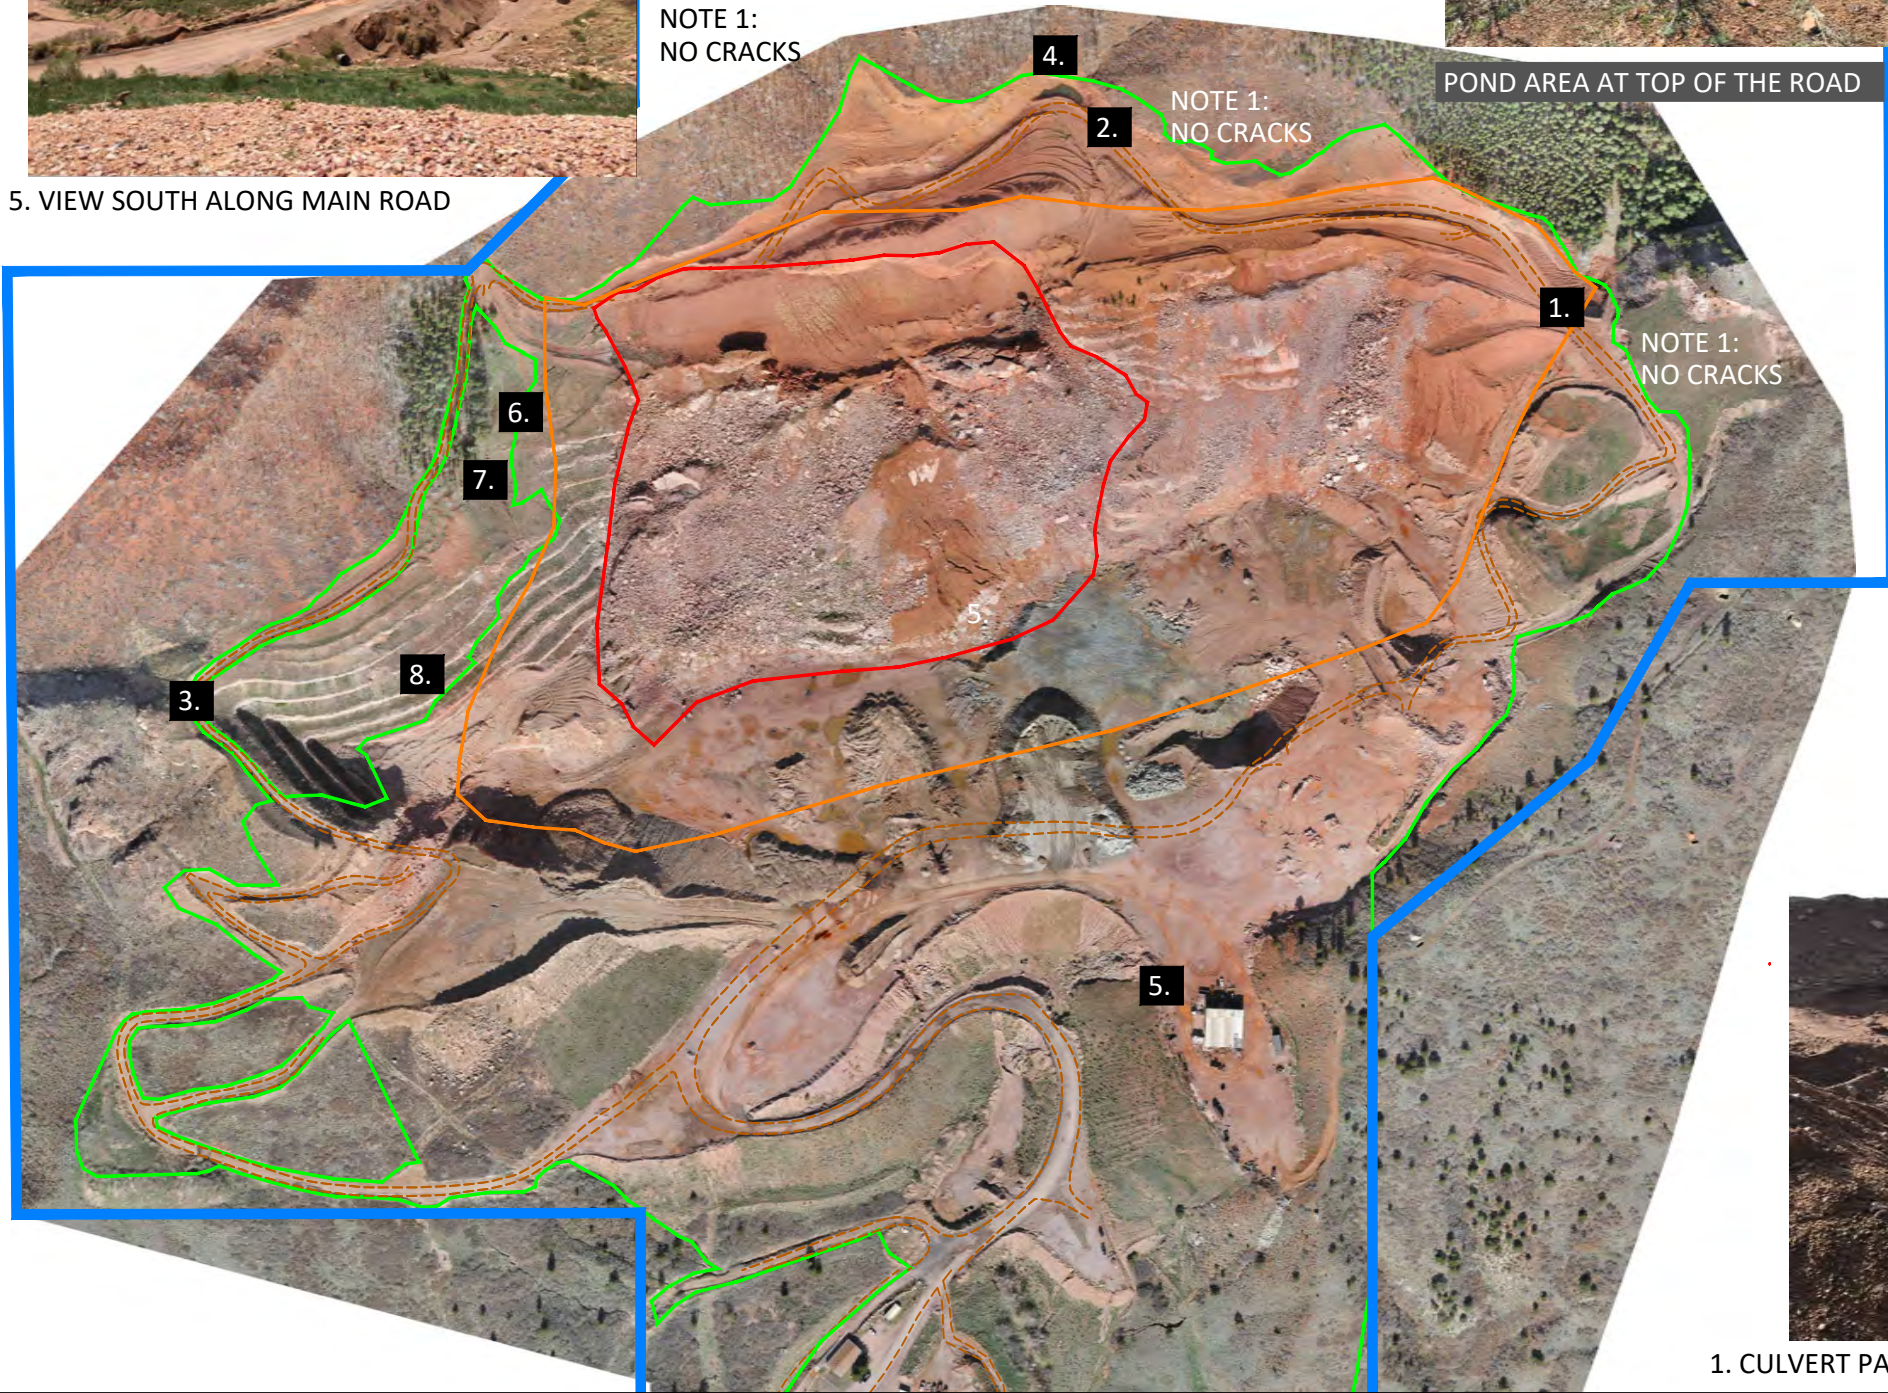
- Open Cracks: An open crack was observed during this visit. This feature is in an area where cracking is expected to occur as a result of ongoing slope settlement and relaxation. The edges of the crack have eroded suggesting it is not a new feature. (Photo 7)

7. HEALED CRACKING PARRALEL TO SLIDE

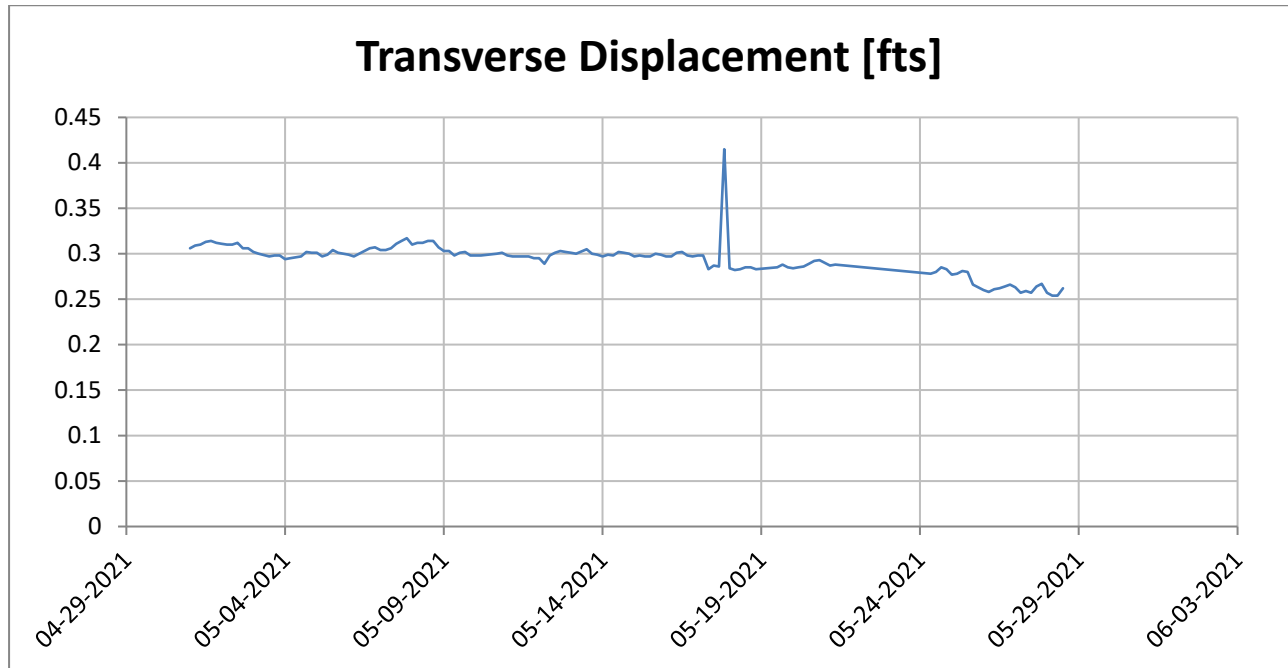
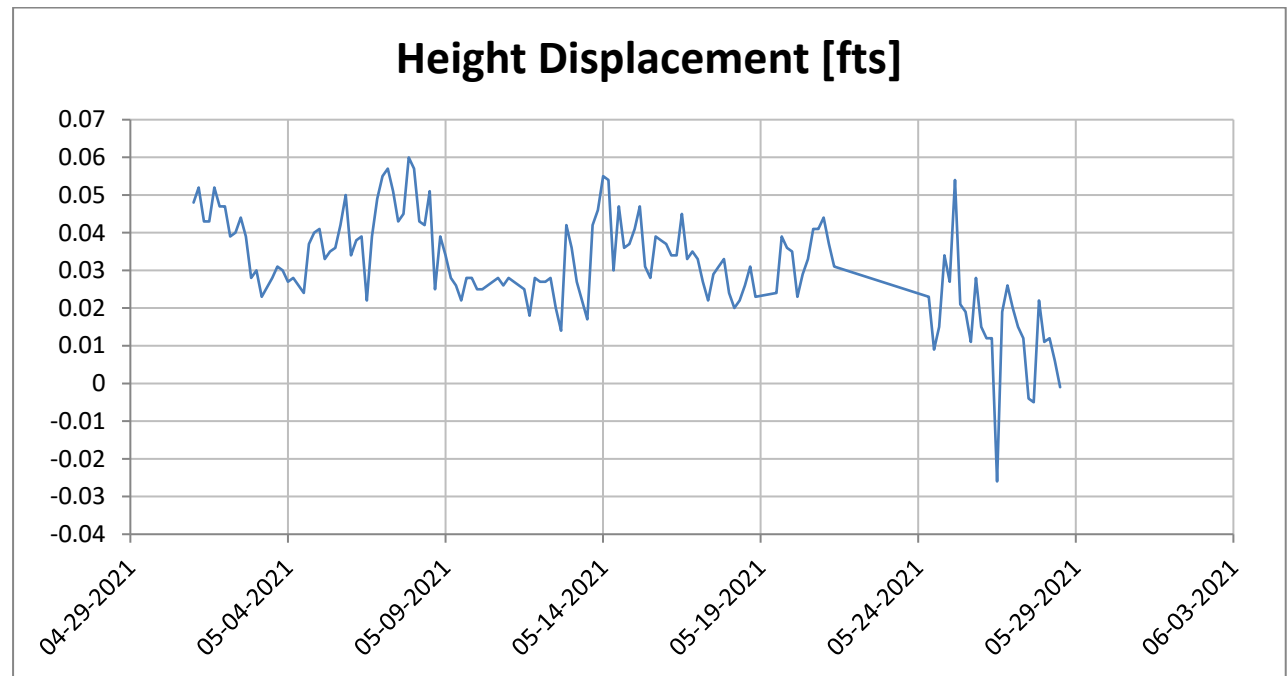
Prism TOE1

Date	Notes	Actions taken	Issue Resolved
05/02/2021 to 05/04/2021	All prisms missing after multiple scans	Snow and fog	05/04/2021
05/10/2021 to 05/13/2021	All prisms missing after multiple scans	Snow and fog	05/13/2021
05/17/2021 to 05/19/2021	All prisms missing after multiple scans	Moisture on glass in survey building, rain and fog	05/19/2021
05/22/2021	TOE1 Prism not found	Moved by animals	05/22/2021

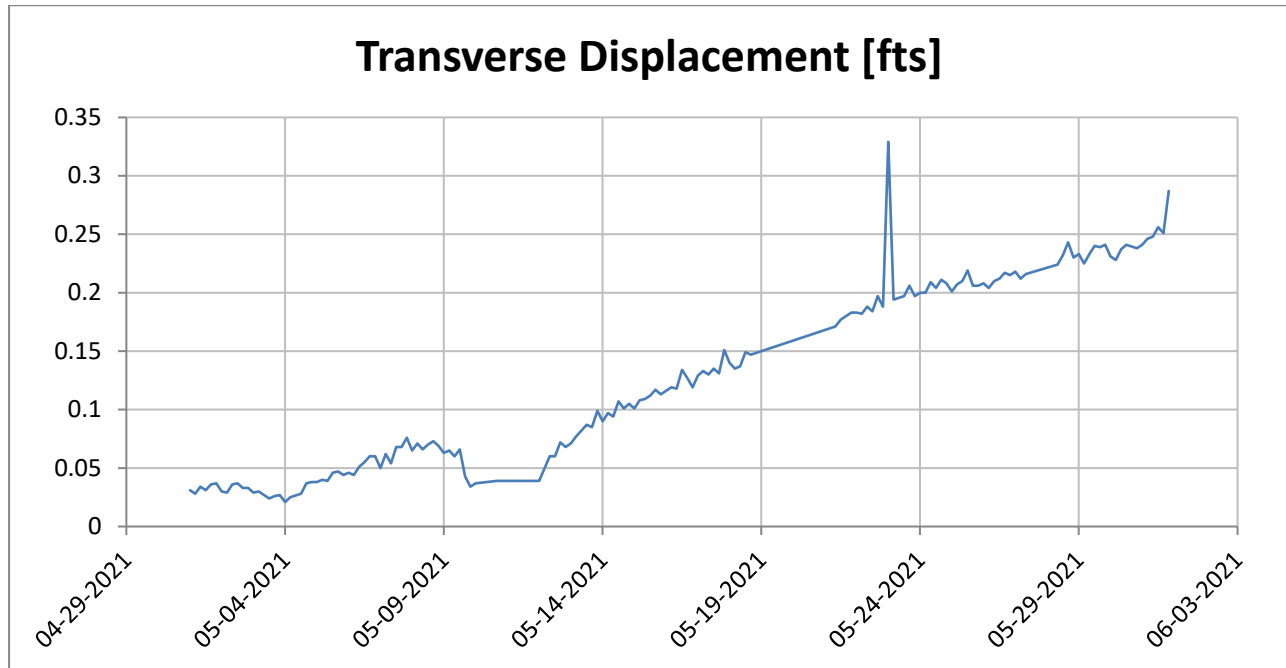
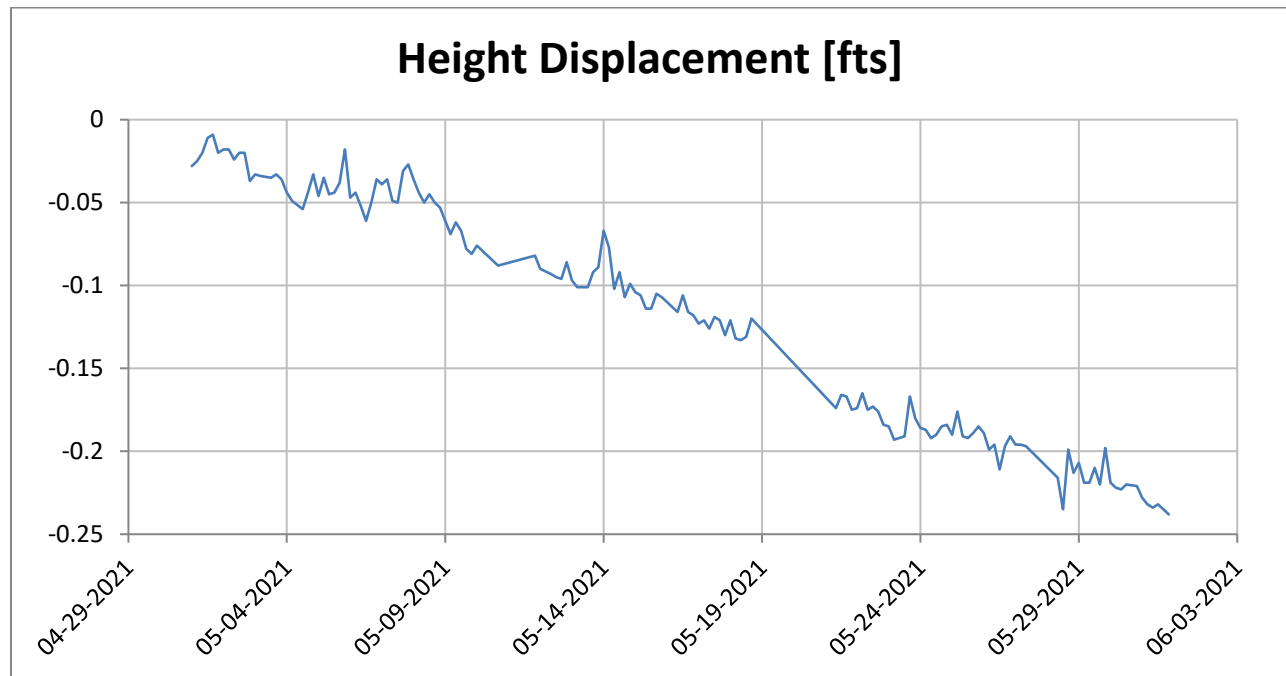
Prism TOE2

05/23/2021	Multiple prisms missing after multiple scans	Heavy rains and wind	05/23/2021
05/23/2021	TOE2 Prism not found	Moved by animals	05/23/2021
05/23/2021	CP1 Prism not found	Attempted theft of prism	05/23/2021
05/27/2021 to 05/28/2021	TOE2 Prism not found	Moved by animals	05/28/2021
05/28/2021 to 05/29/2021	TOE1 Prism not found	Moved by rock fall turning prism	05/29/2021
05/30/2021 to 05/31/2021	All prisms missing after multiple scans	Rain	05/31/2021
