To: Jerald Schnabel From: Paul Kos
Continental Materials Corp. Denver, CO 80222
File: June 2021 Monitoring Summary Date: July 31, 2021

Reference: June 2021 Geotechnical Monitoring Summary Pikeview Quarry

Stantec Consulting Services Inc. (Stantec) has prepared this June 2021 Geotechnical Monitoring Summary for the Pikeview Quarry. The Pikeview Quarry is situated along the foothills of the Rocky Mountains, northwest of Colorado Springs, Colorado. Continental Materials Corp. operates the quarry, which is currently closed, pending reclamation. A geotechnical monitoring program was established to monitor reclamation activities which will affect the geotechnical performance of the existing and reclaimed slopes during and following reclamation grading. This report presents the geotechnical monitoring results for the slope reclamation activities at the site through the month of June 2021.

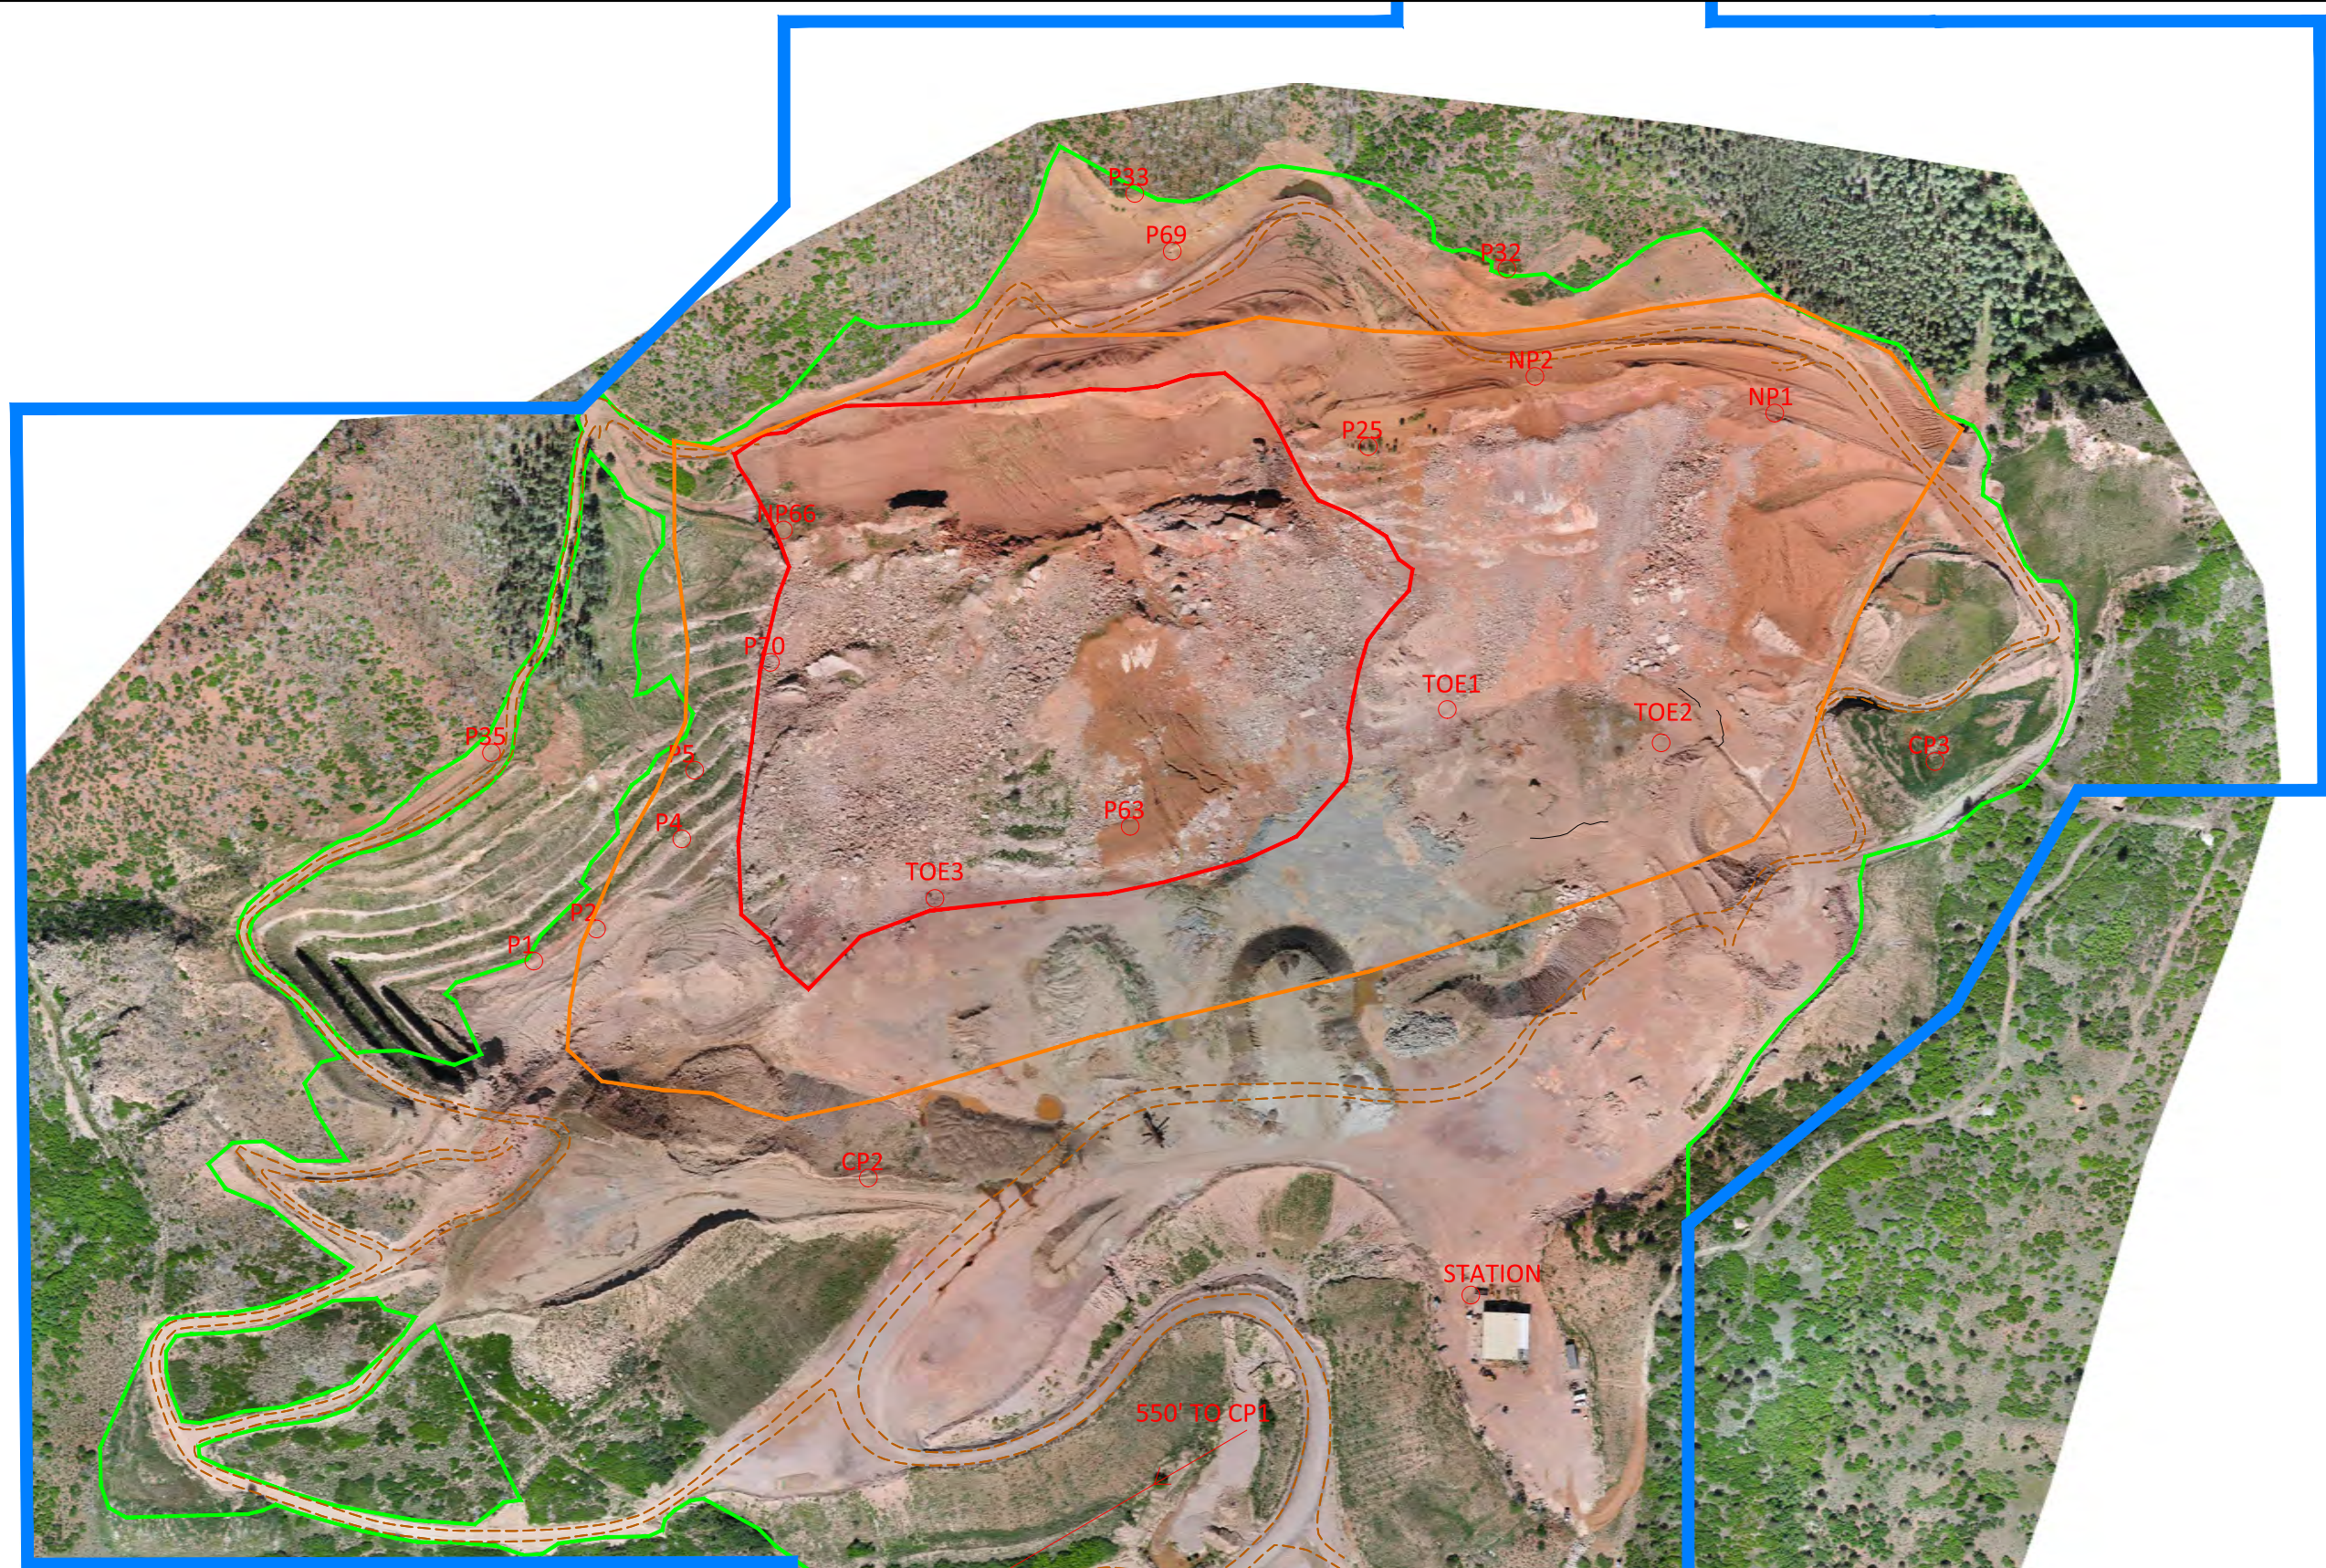
Date
2021.07.31
Figure No.
1

Title
SITE MAP

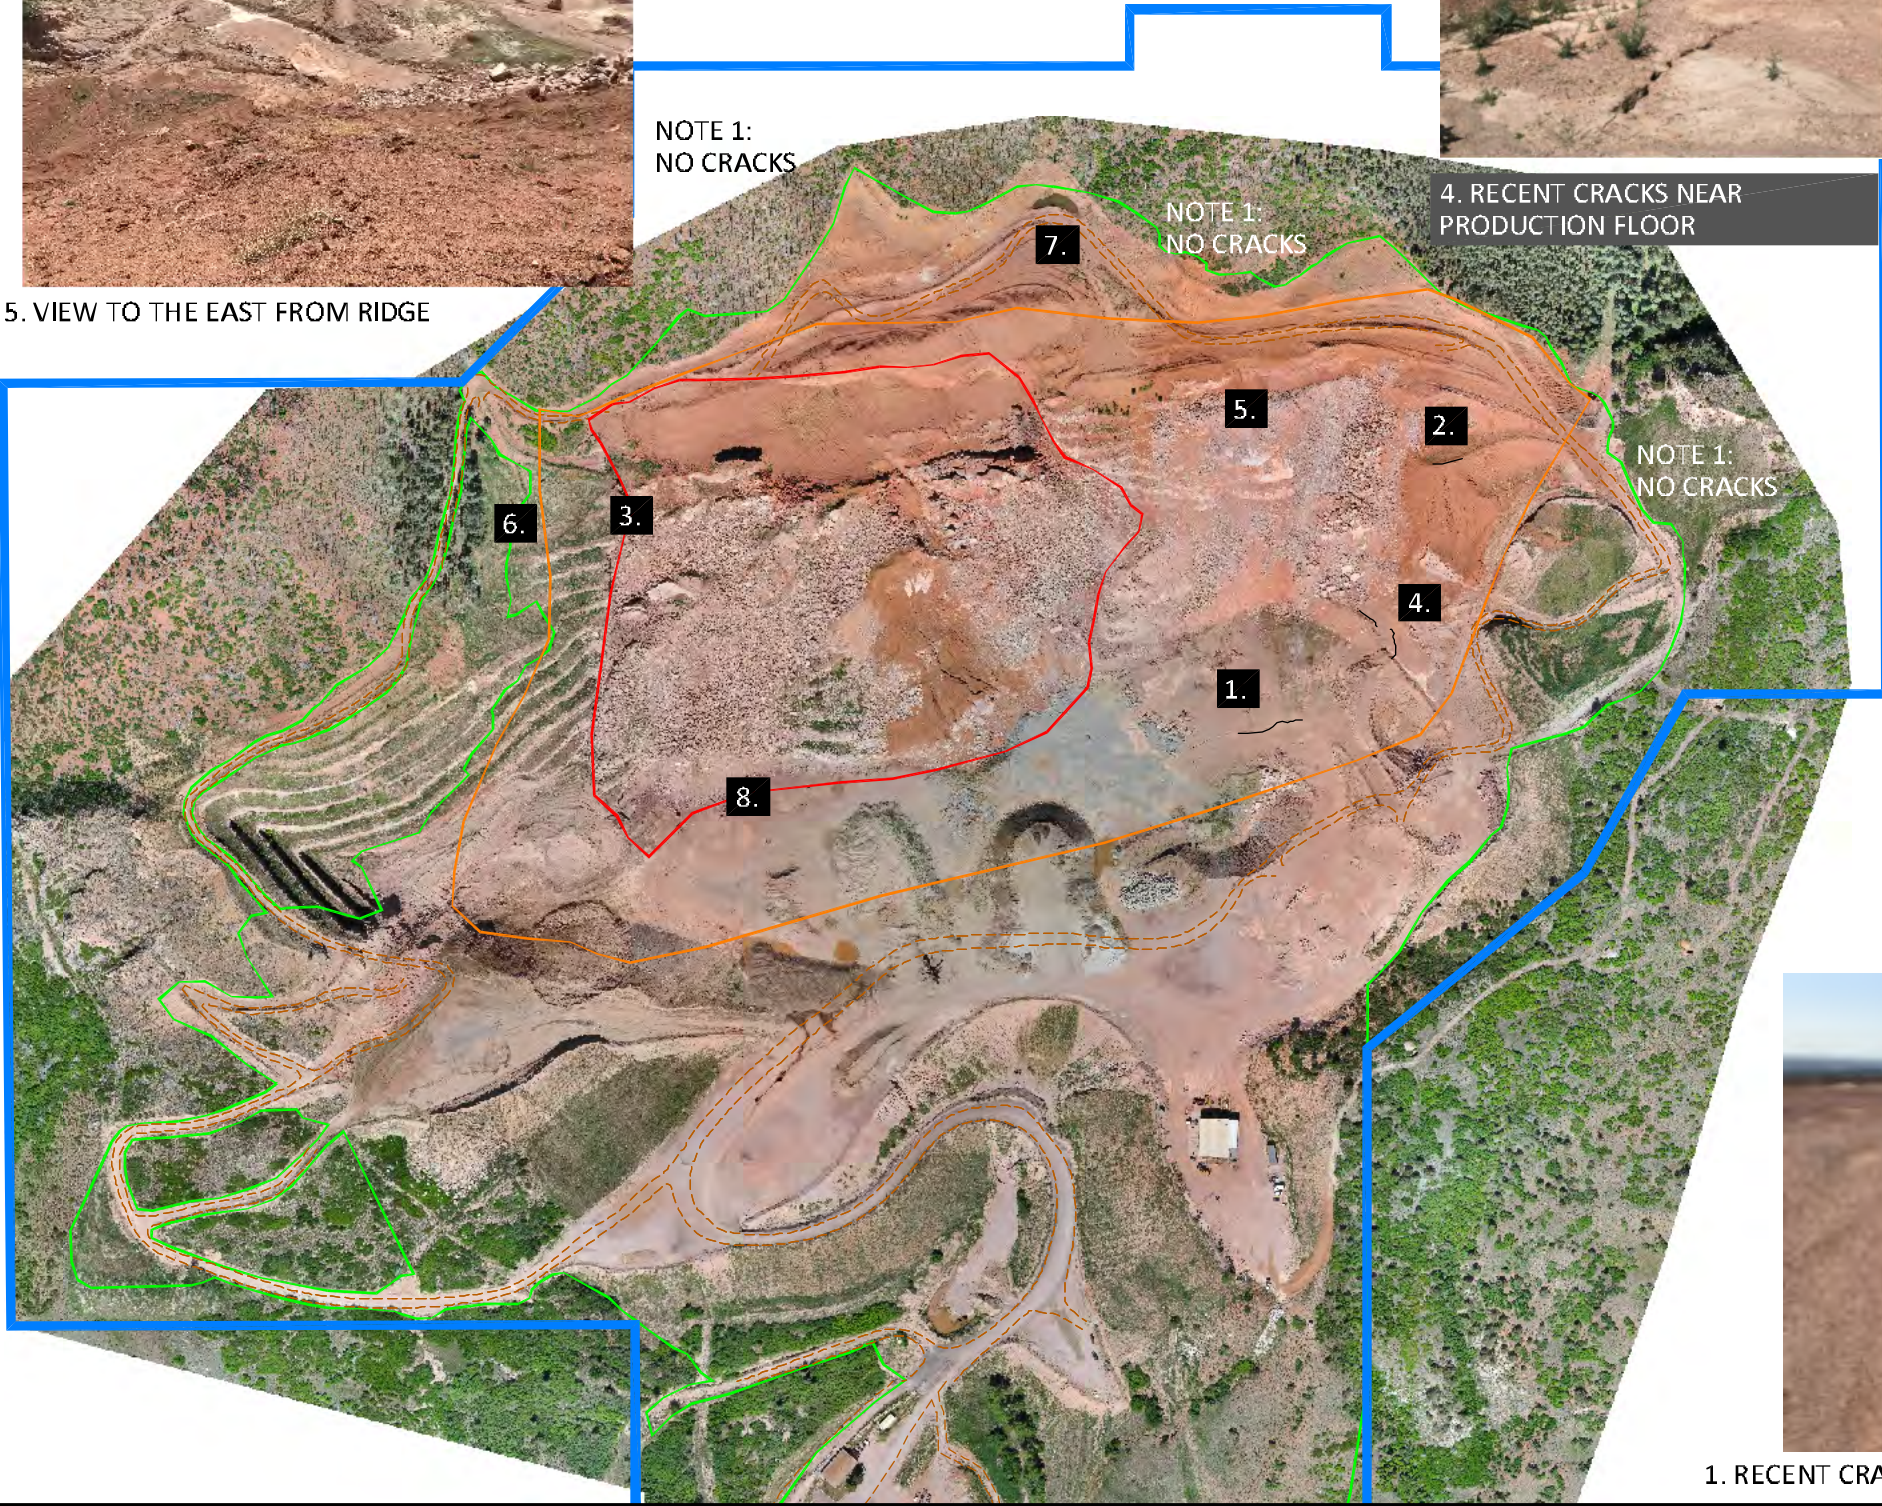
2. CRACKING ON FILL SLOPE

- New Cracks: New tension cracks were observed following the period of heavy rain. These cracks are not believed to be a problem, they are likely due to the recent heavy rain saturating the area (Photos 1, 2 and 4). **Figure 1** below is the area viewed from above with the area of interest highlighted. **Figure 2** is a close-up of the cracks in the highlighted area:

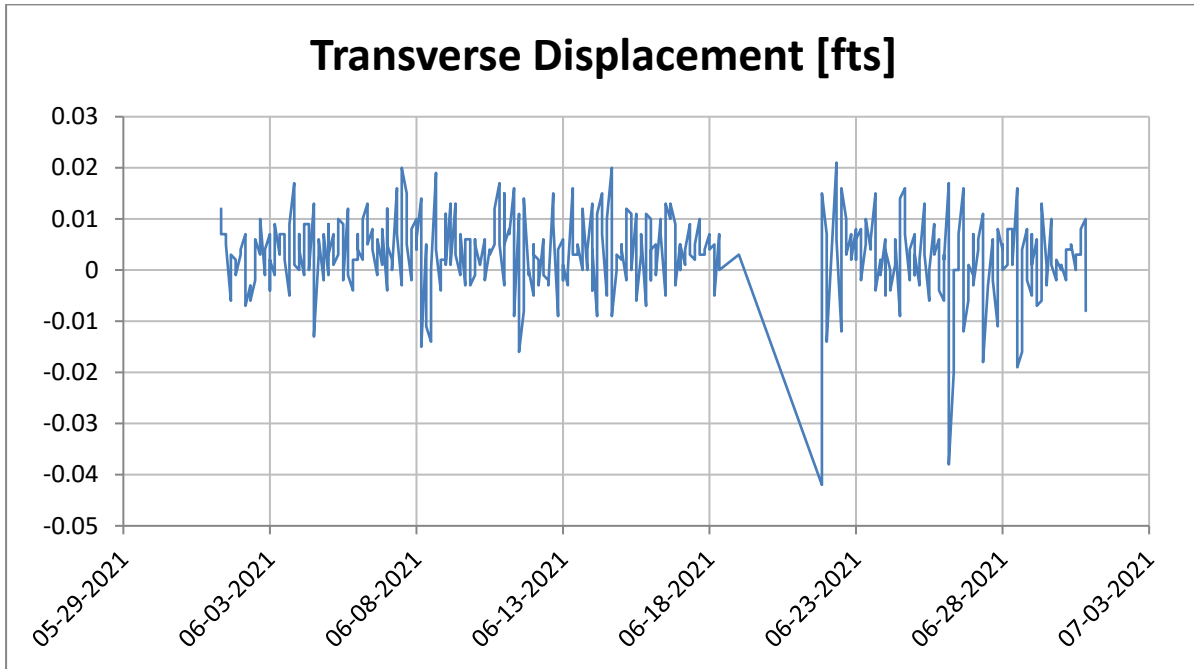
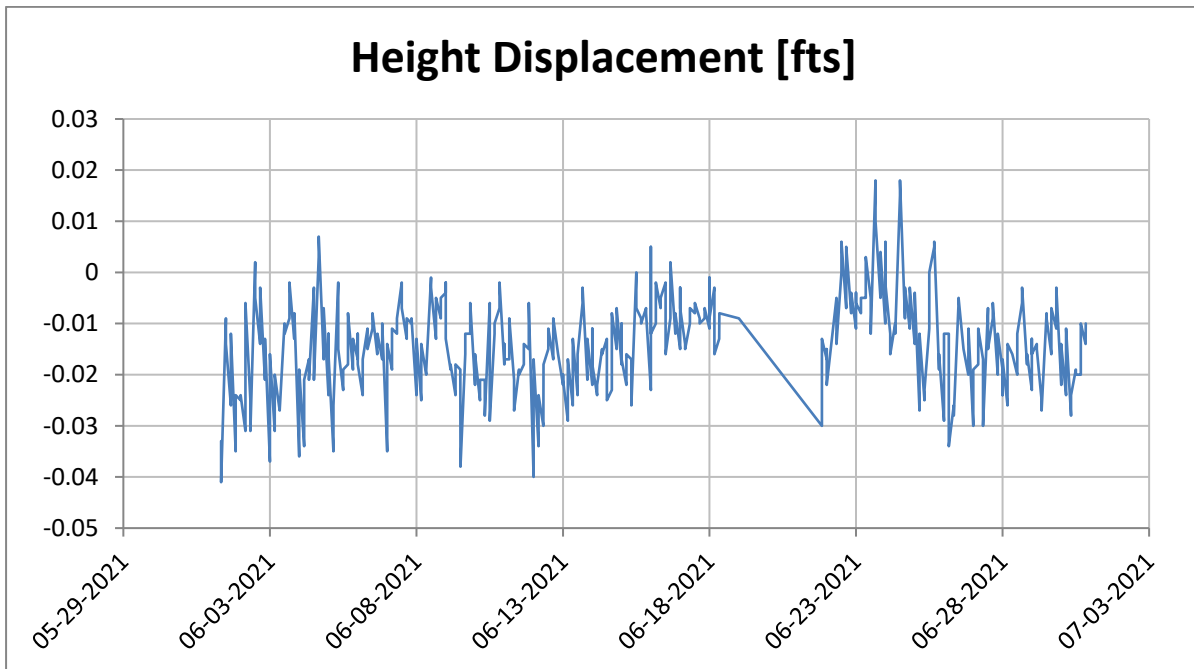
Prism CP1

Prism ID	Cumulative Transverse Displacement (ft)	Cumulative Height Displacement (ft)	Monthly Delta (ft)	Cumulative Delta (ft)	Notes / Recommendations
CP1	-0.008	-0.010	-0.0172	0.0182	
CP2	-0.060	-0.007	0.0065	0.4124	
CP3	0.282	-0.224	0.0073	0.3649	
NP1	0.225	-0.211	0.1649	0.3087	Slope creep at slow and decreasing velocity.
NP2	0.046	-0.082	0.0112	0.1241	
NP66	0.388	-0.457	0.1188	0.6872	Slope creep at slow and decreasing velocity.
P1	0.345	-0.051	-0.0026	0.3513	
P2	0.153	-0.033	0.0176	0.2274	
P25	-0.008	0.023	0.0179	0.1520	
P32	-0.068	-0.091	-0.0041	0.2646	
P33	-0.090	-0.042	0.0079	0.2135	
P35	0.042	-0.186	0.0245	0.4531	
P4	0.375	-0.130	0.0101	0.4933	
P5	0.400	-0.157	0.0173	0.6288	
P63	15.370	-6.289	0.0602	16.6071	Slope creep at slow velocity.
P69	-0.022	-0.047	-0.0040	1.9787	
P70	0.366	-0.304	0.0123	0.6095	Slope creep at slow velocity. Recorded movements match those measured in field.
TOE1	0.153	0.036	-0.1571	0.1777	Movement recorded June 6.

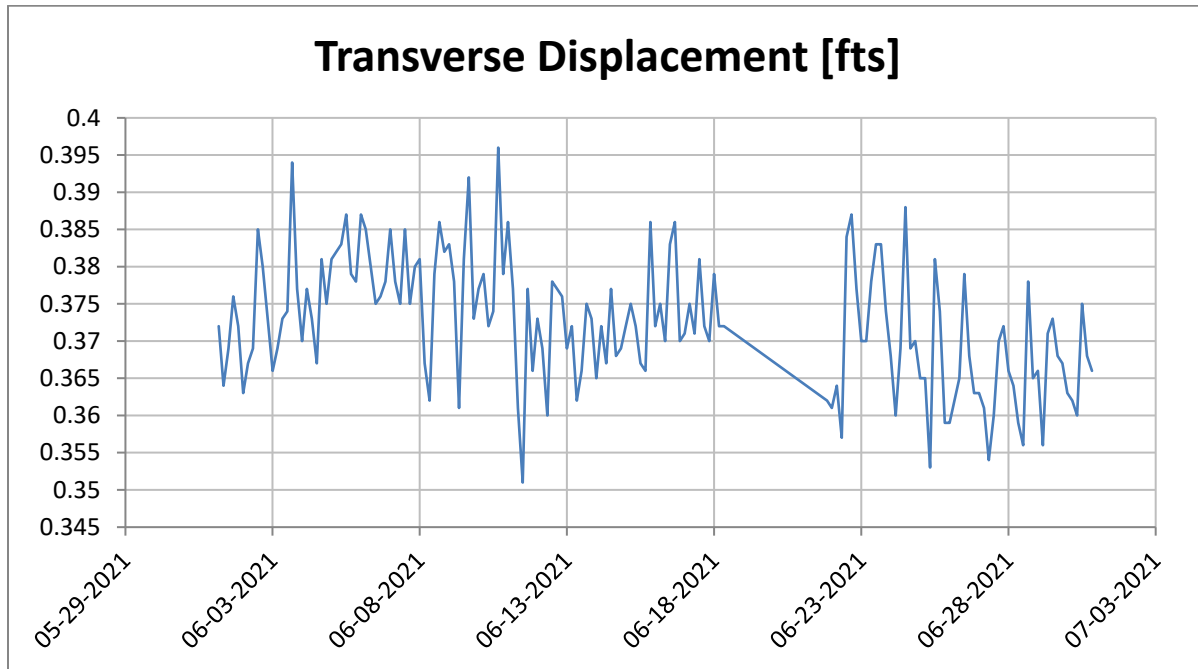
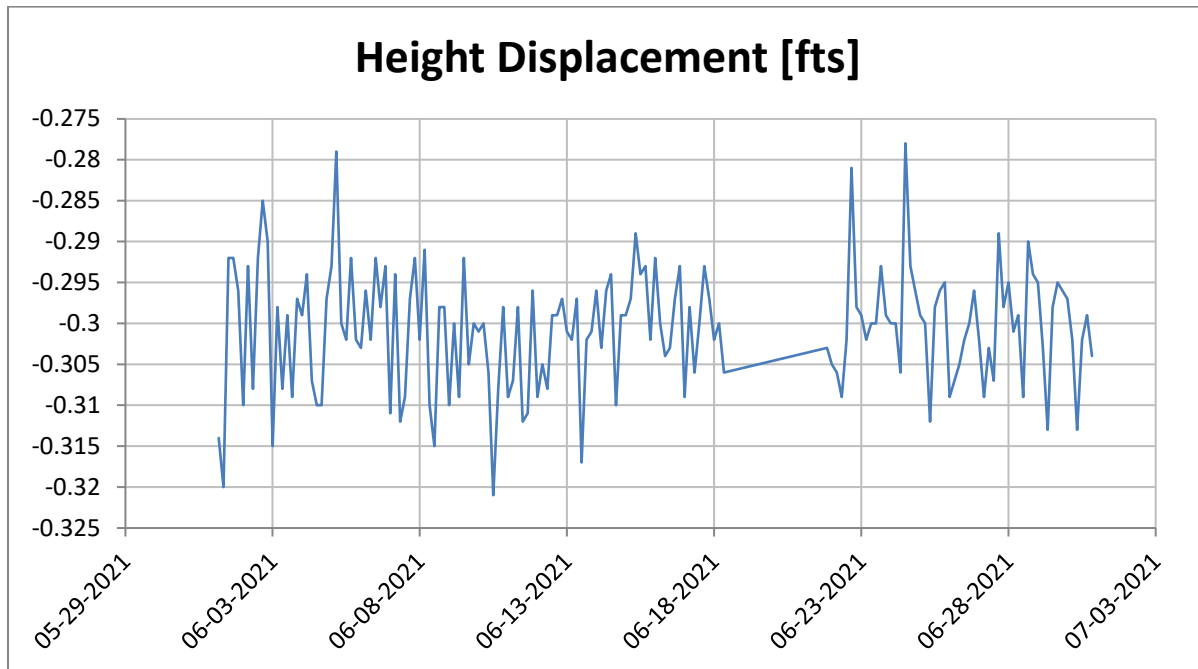
Prism P70

- Survey stakes were placed across a historic crack on the slope above and south of the landslide area to track any changes over the coming months. During this visit the stakes were observed to have moved apart by approximately $\frac{1}{4}$ ". A review of the data for the nearest prism, P70, showed similar-scale movements for the area (Photo 6).
