MINERALS PROGRAM INSPECTION REPORT
PHONE: (303) 866-3567

MINE NAME: Ghost River Gravel Pit	MINE/PROSPECTING ID#: M-2003-002	MINERAL: Sand and gravel	COUNTY: Huerfano
INSPECTION TYPE: Monitoring	INSPECTOR(S): Patrick Lennberg	INSP. DATE: July 28, 2021	INSP. TIME: 09:30
OPERATOR: HCR High Country Repair	OPERATOR REPRESENTATIVE:	TYPE OF OPERATION: 110c - Construction Limited Impact

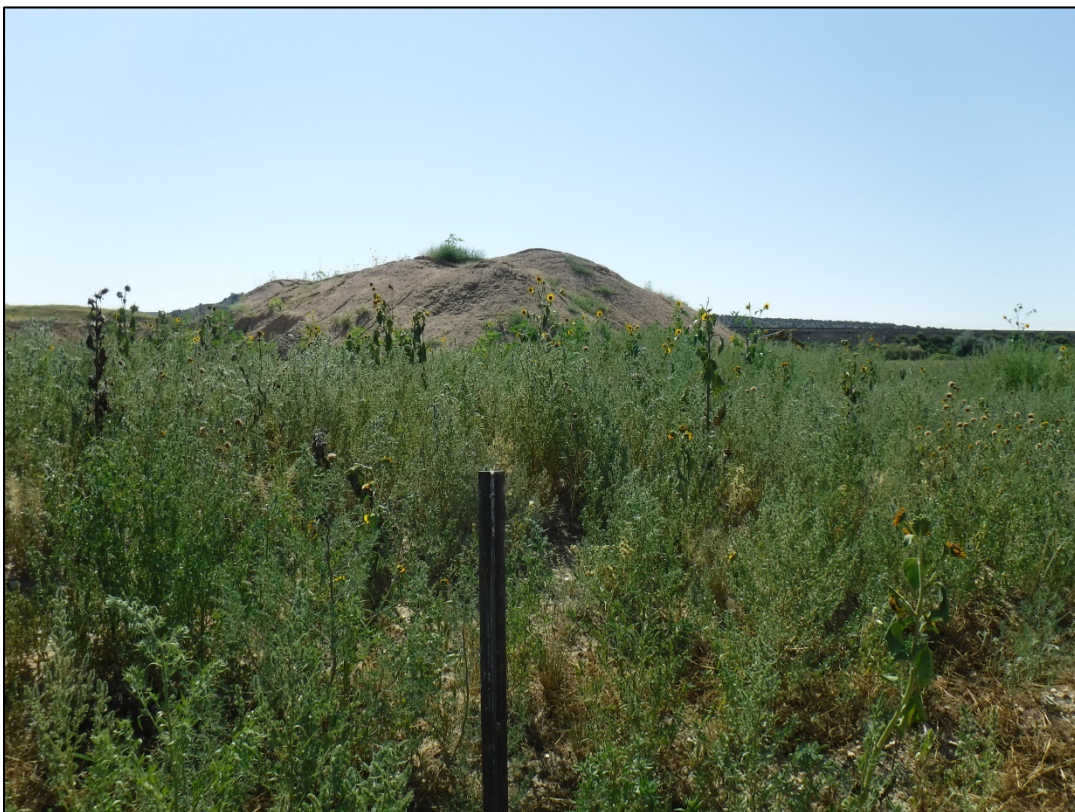
Photo 6: Looking southeast from the southwest permit marker towards the southeast permit corner

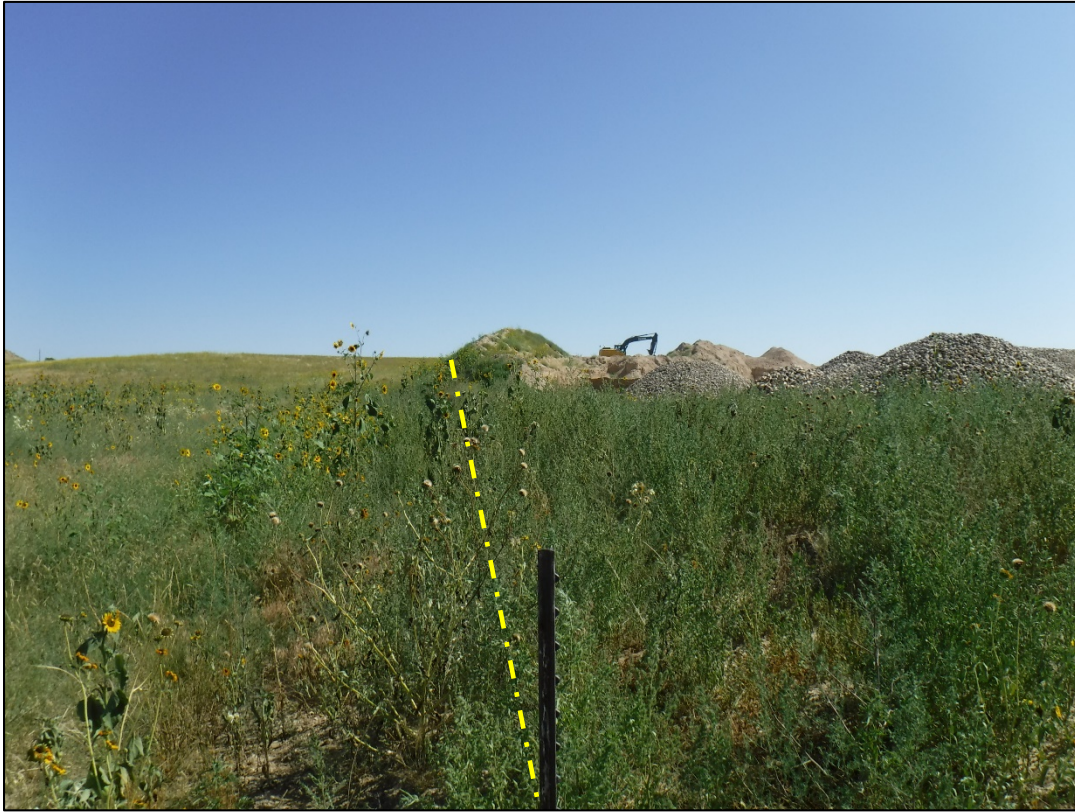
During the inspection the Division was able to locate all four permit boundary markers. At that time the Division noted that there were mining related disturbances outside the approved permit boundary. The Division used a handheld GPS unit, Garmin 64ST, to measure the perimeter of the disturbed area and determined the disturbed area was 11.8 acres, see attachment 1. The permit is only approved to affect 9.9 acres. The land affected outside the permit boundary, approximately 1.8 acres, is being cited as a Possible Violation pursuant to C.R.S. 34-32.5-116(4)(i) for failure to protect areas outside of the affected land boundary from damages occurring during the mining operation. The Division reviewed the permit area using the Huerfano County Public Map Viewer online and it appears there are some mining related disturbance has occurred on land not owned by Ms. Goldberg, see attachment 2. Additionally, the area measurement using the Map Viewer estimated the disturbance to be 11.3 acres.

Photo 7: Looking north-northeast from the southwest permit marker towards the northwest permit corner, yellow dashed line is the approximate permit boundary

CORRECTIVE ACTIONS: This possible violation will require a hearing before the Mined Land Reclamation Board. The schedule and other details for the MLRB hearing will be provided under a separate document to be sent via certified mail to the operator.

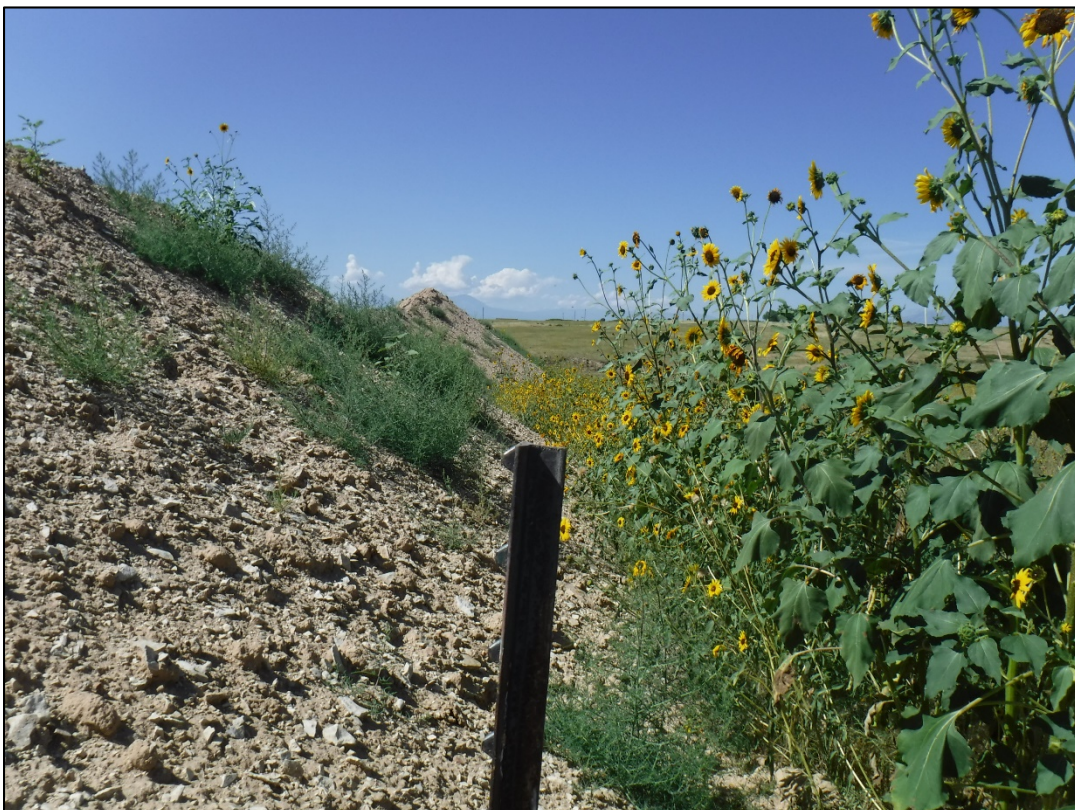
Photo 8: Looking southwest toward southwestern permit corner from mid-point boundary marker

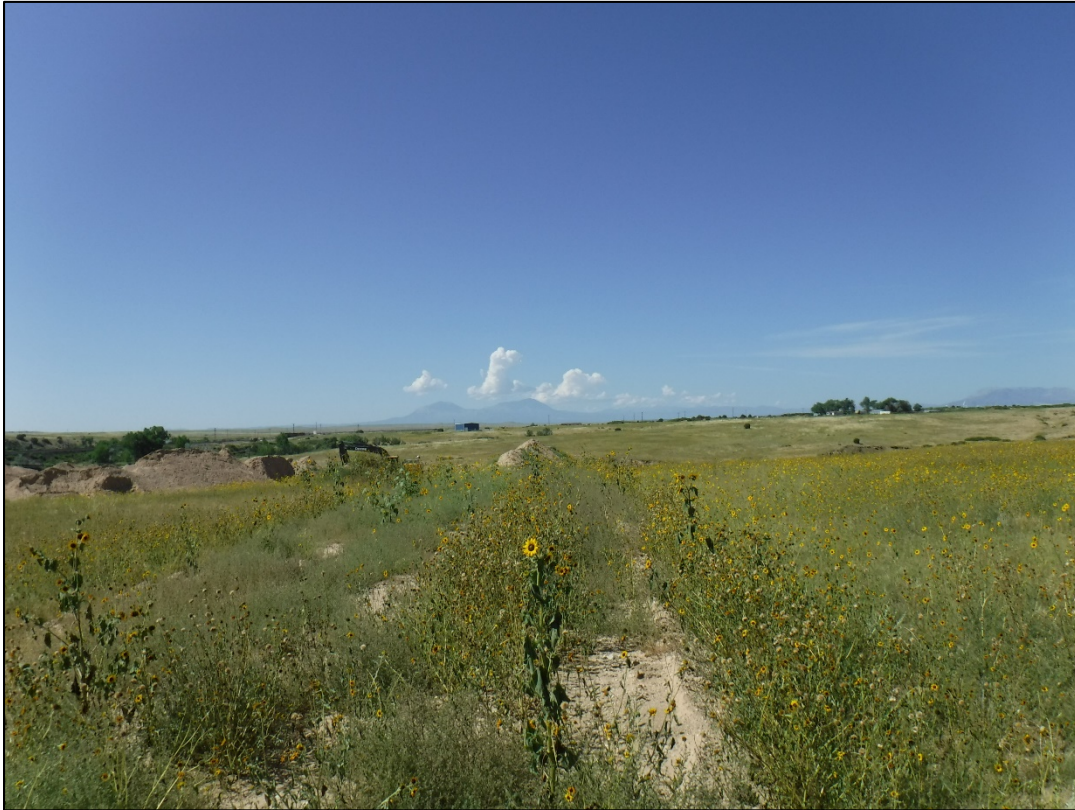
Photo 9: Looking southwest toward southwestern permit corner from northwest boundary marker

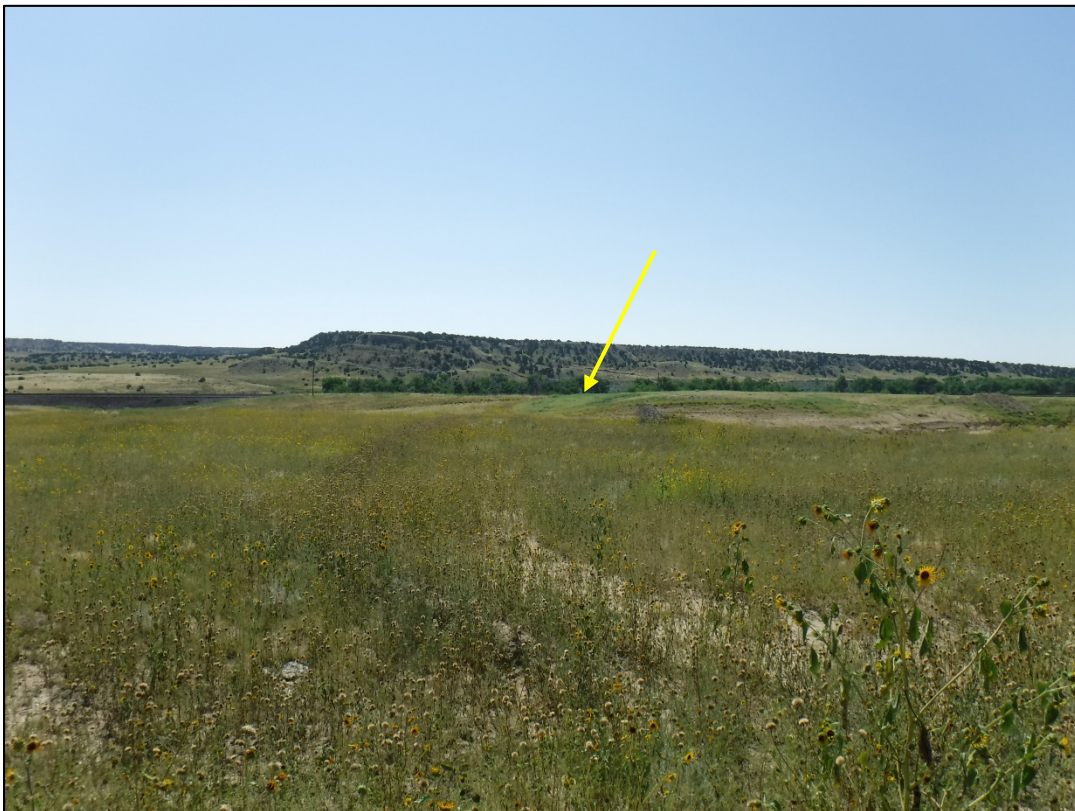
Photo 10: Looking southeast towards the northeastern permit corner, yellow arrow indicates approximate location of tee post

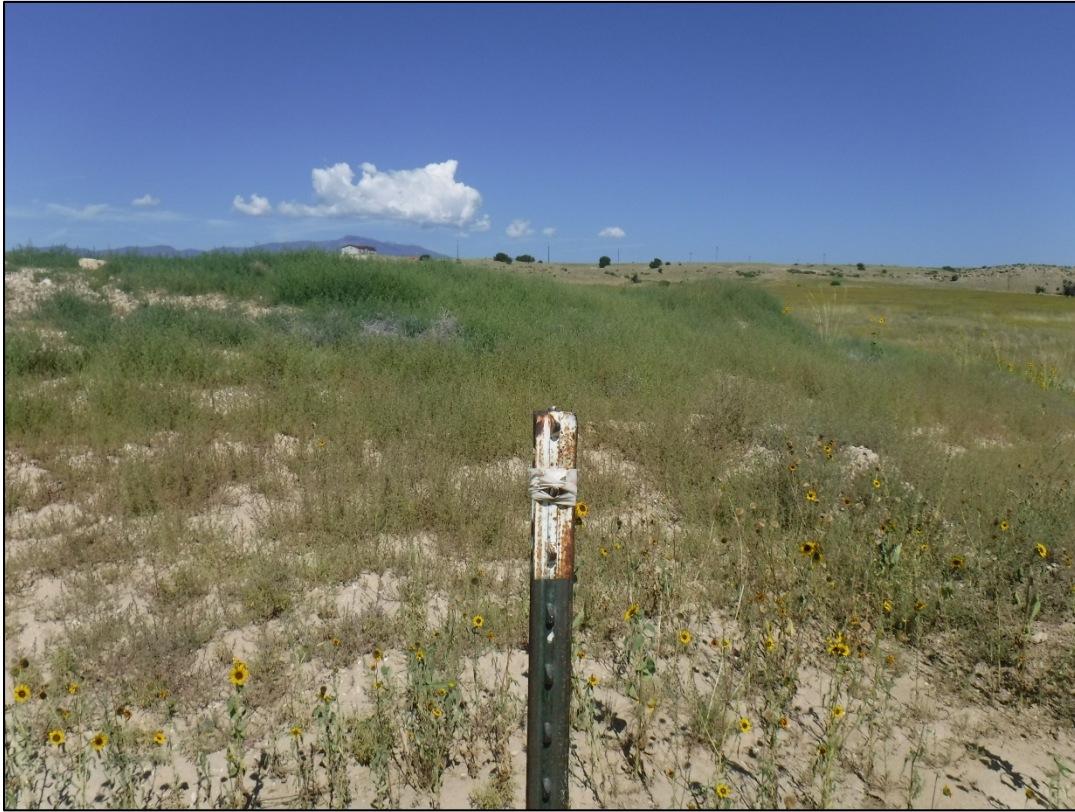
Photo 11: Looking northwest towards the northwestern permit corner

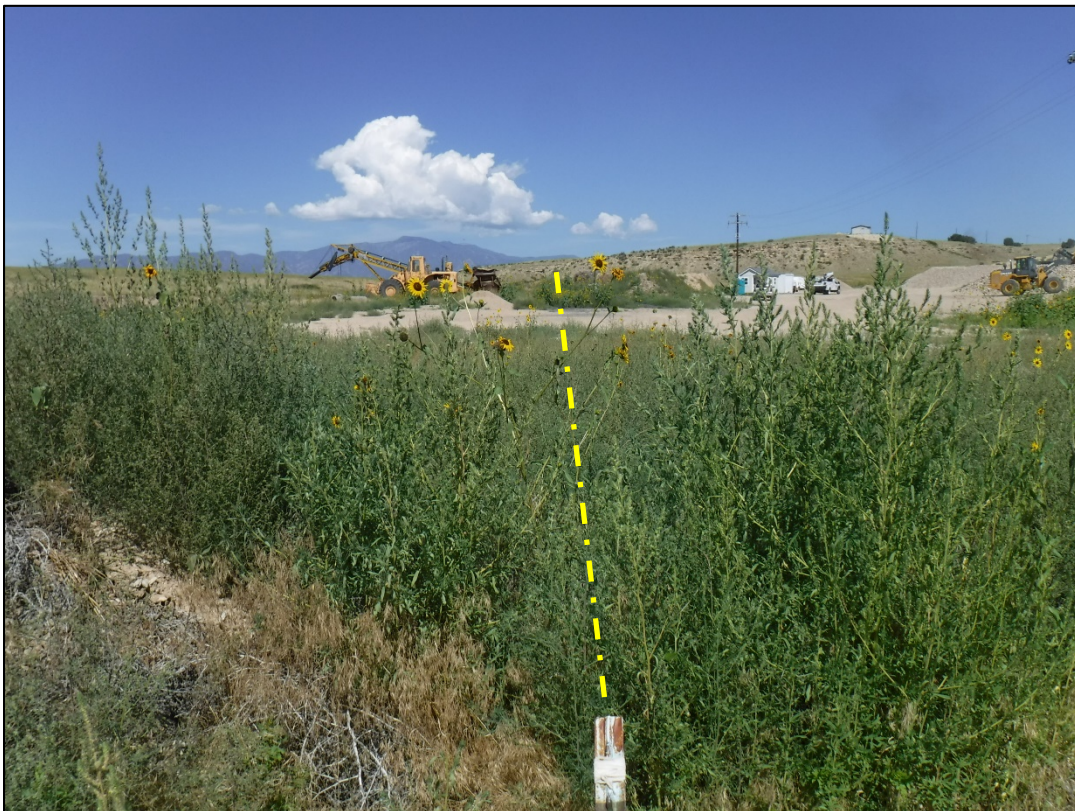
Photo 12: Looking northwest towards the southwestern permit corner,
yellow dashed line is the approximate permit boundary

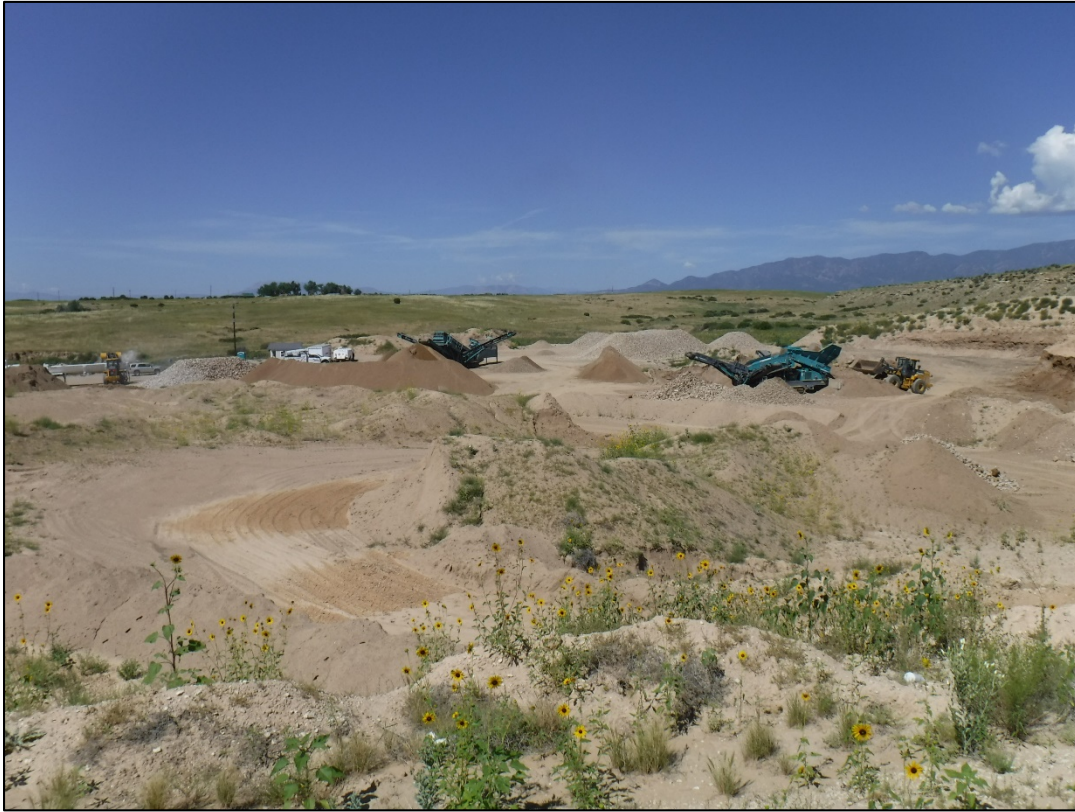
The mine was active at the time of inspection. Kevin Schramek was mining on behalf of the permittee High Country Repair. He was using a portable screening operation to process material at the site. He was working a highwall, near vertical except for safety bench, which extended across the northern portion of the permit area. The highwall was estimated, from aerial imagery, to be 650 feet long and varied in height from 15 to 30 feet. The highwall was benched and bermed by Mr. Schramek for safety purposes. The mining plan states the depth of overburden to be 8-inches to 8 feet depth with the estimated depth of mining to be near 30 feet in depth. The mining plan does not provide details of the highwall configuration.

Photo 13: Current south area mining operations and associated stockpiles
