## MINERALS PROGRAM INSPECTION REPORT PHONE: (303) 866-3567

MINE NAME:	MINE/PROSPECTING ID#:	MINERAL:		COUNTY:
Young Ranch Resource Quarry	M-2021-009	Granite, granite gneiss and gravel		Gilpin
<b>INSPECTION TYPE:</b>	INSPECTOR(S):	INSP. DATE:		<b>INSP. TIME:</b>
Preoperation Inspection	Amy Eschberger, Michael Cunningham,	August 4, 2021		09:00
	Rob Zuber, Zach Trujillo	_		
OPERATOR:	<b>OPERATOR REPRESENTATIVE(S):</b>	TYPE OF OPERATION:		
Young Ranch Resource LLC	Robert Young Jr., Katie Todt	112c - Construction Regular Operation		
<b>REASON FOR INSPECTION:</b>	BOND CALCULATION TYPE:		BOND AMOUNT:	
Preoperation Inspection	Complete Bond		No Bond Held	
DATE OF COMPLAINT:	POST INSP. CONTACTS:		JOINT INSP. AGENCY:	
NA	None		None	
WEATHER:	INSPECTOR'S SIGNATURE:		SIGNATURE DATE:	
Clear	Clarry Exchanger		August 19, 2021

#### PERMIT #: M-2021-009 INSPECTOR'S INITIALS: AME INSPECTION DATE: August 4, 2021

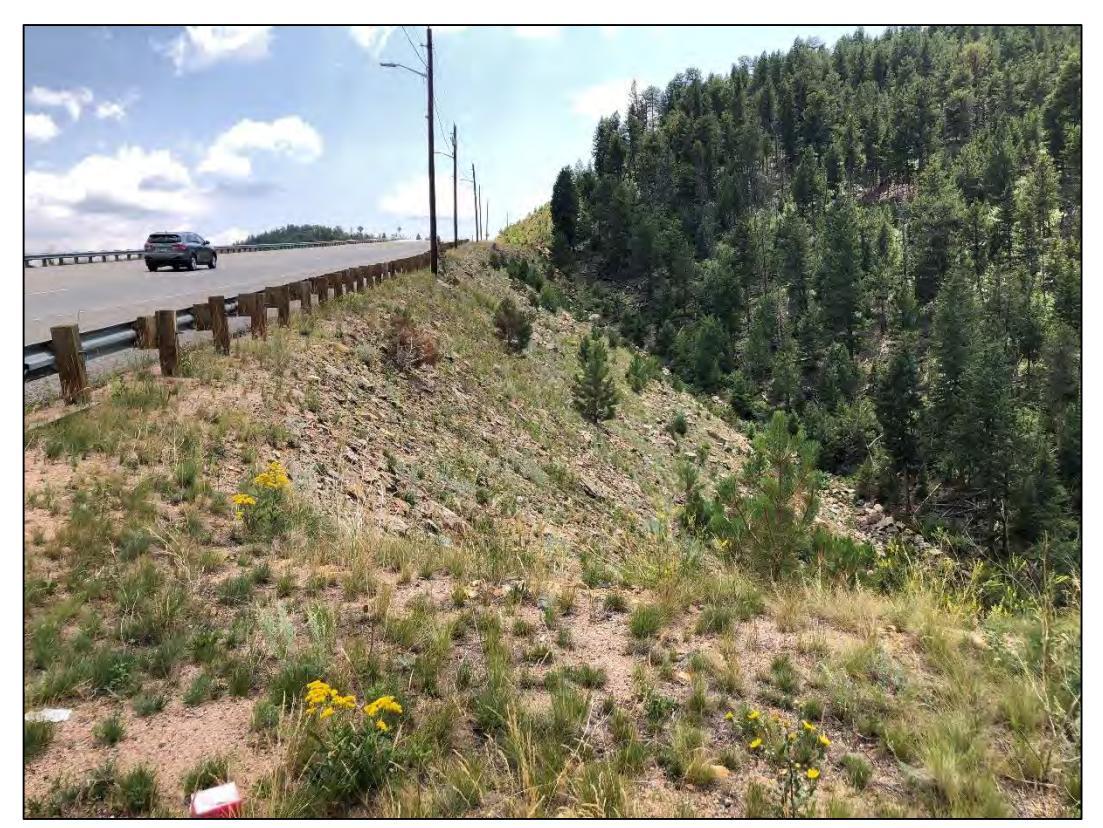
Photo 2. View looking southeast across area directly west of CCP proposed for Phase 1 processing area.

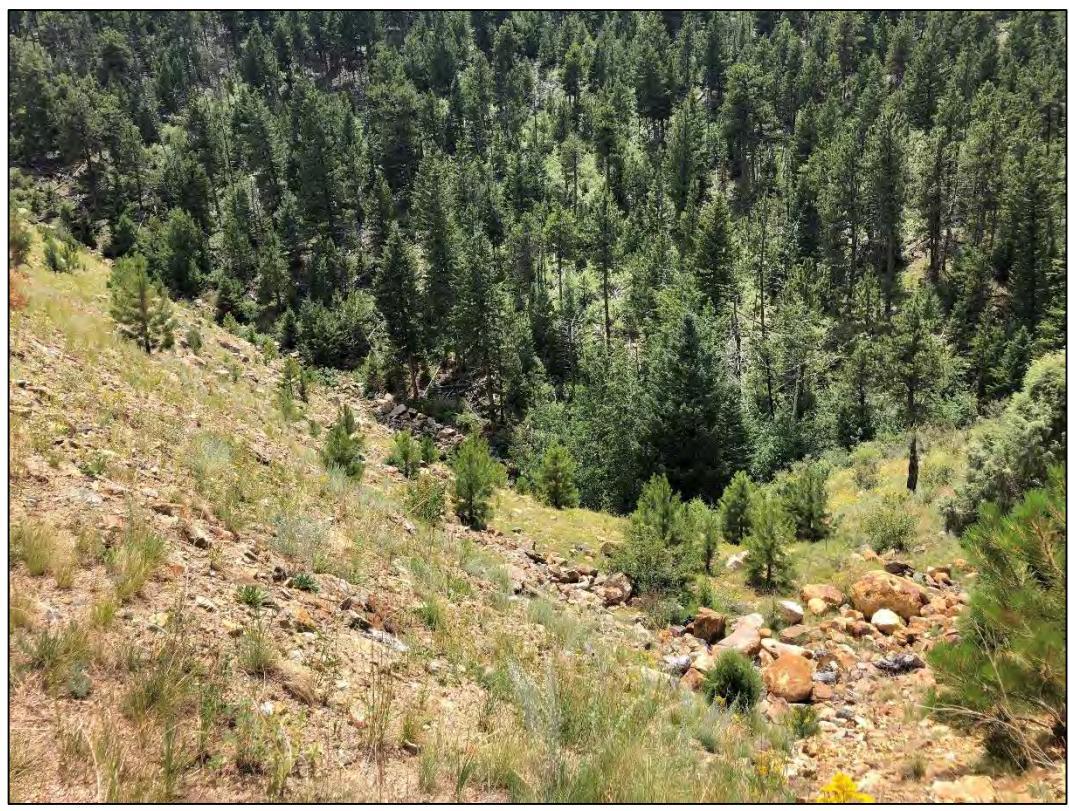
**Photo 3.** View looking south across basin directly west of CCP which will be filled to create Phase 1 processing area.

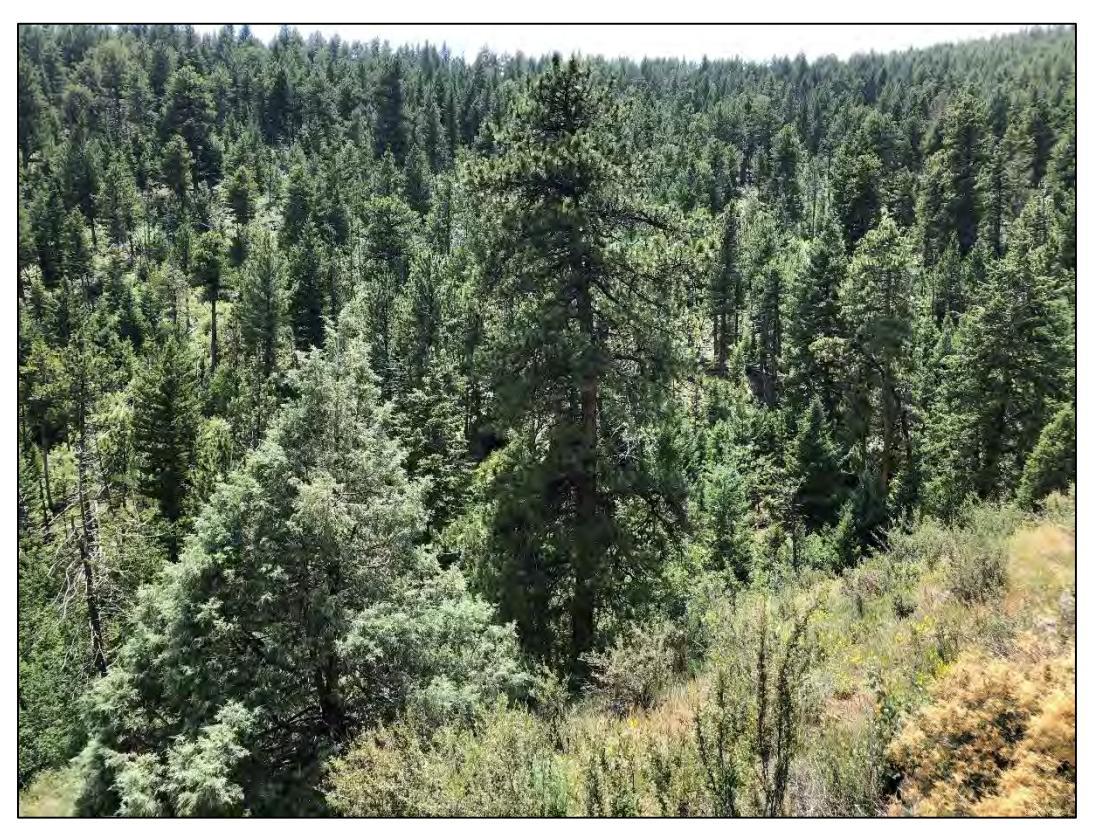
**Photo 4.** View looking south (from proposed quarry entrance off CCP) across forested north-facing slope of ridge to be mined during Phase 3.

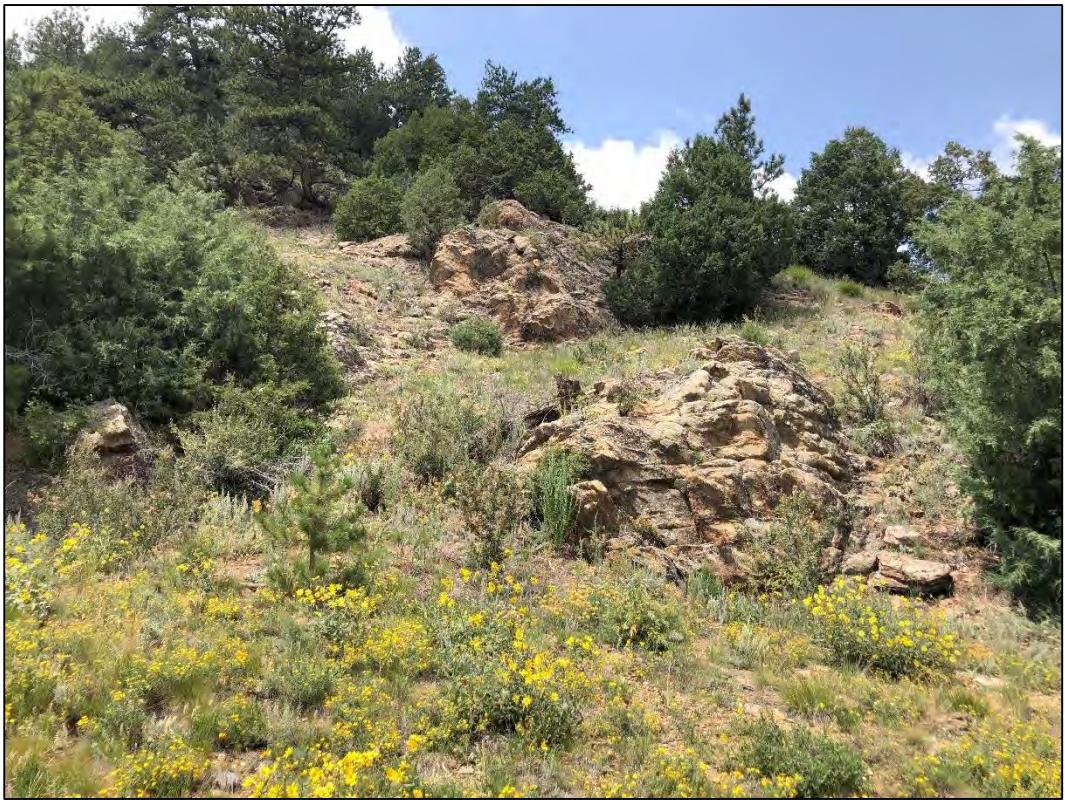
**Photo 5.** View looking north across south-facing slope of ridge to be mined during Phase 1. Note natural rock outcrops on this slope which applicant proposes to imitate for highwall reclamation.

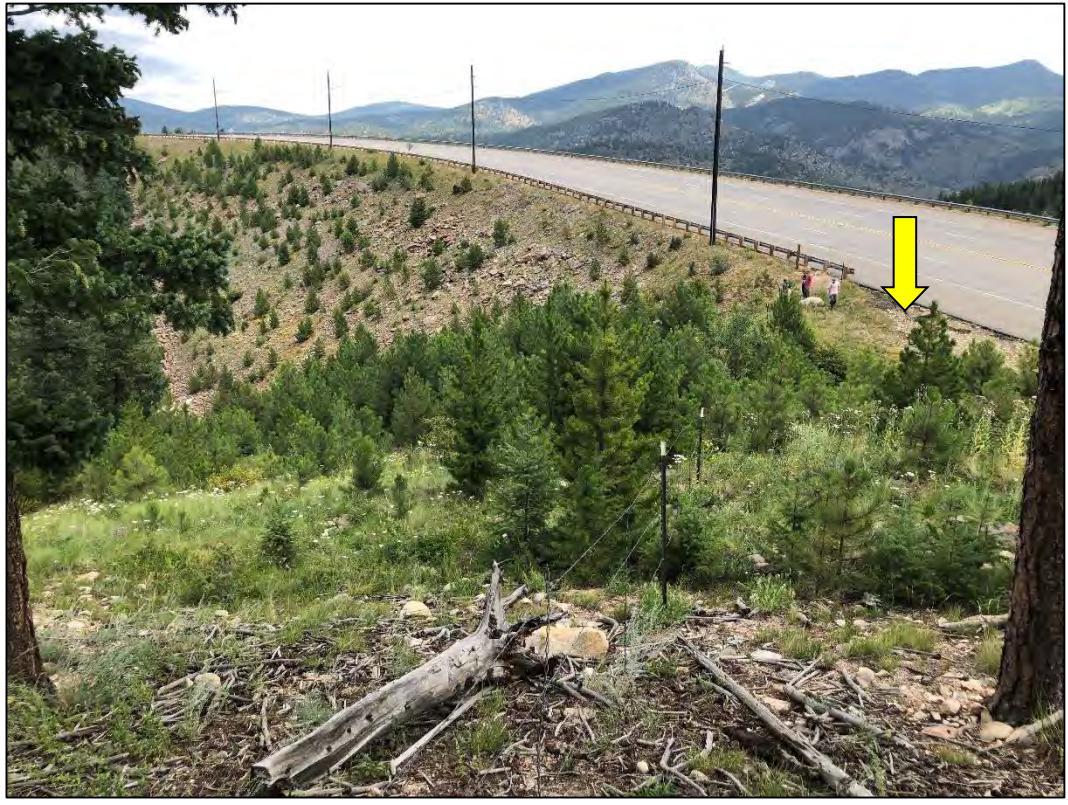
**Photo 7.** View looking northeast at access off CCP (indicated) to ridgeline which roughly follows Clear Creek-Gilpin County Line (west of CCP). Note barbed wire fence present in this area (in foreground).

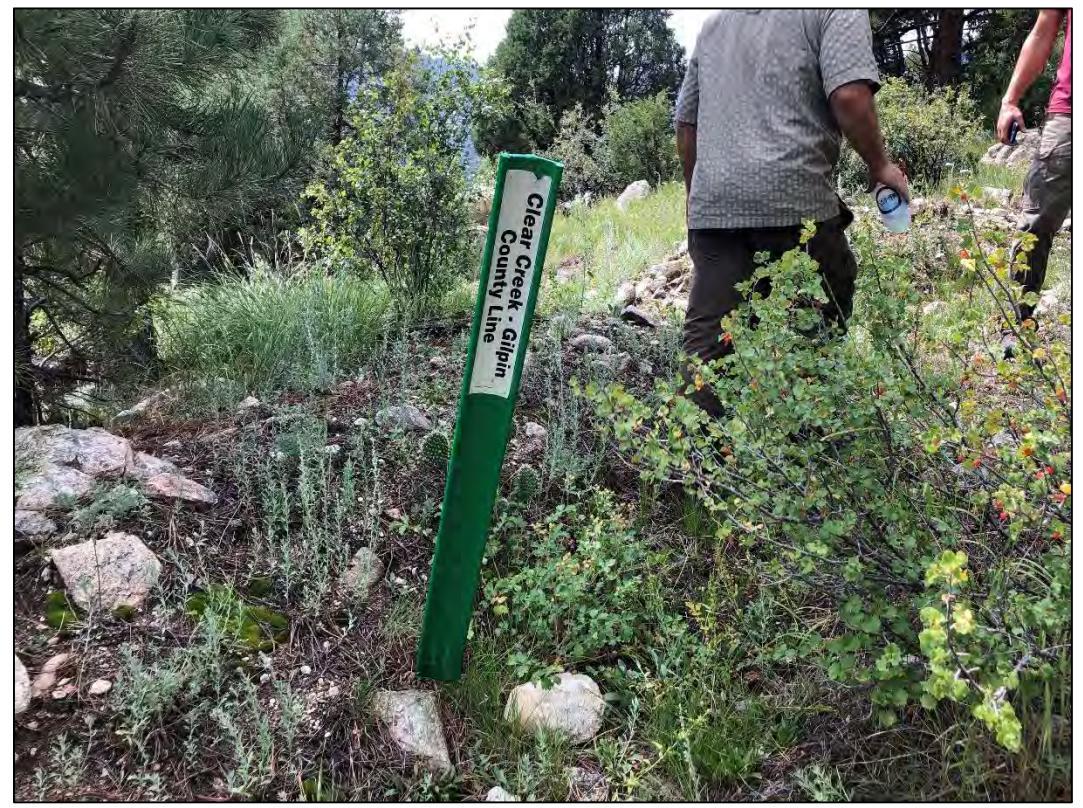
**Photo 8.** View of marker delineating Clear Creek-Gilpin County Line which roughly follows ridgeline west of CCP (within proposed quarry area).

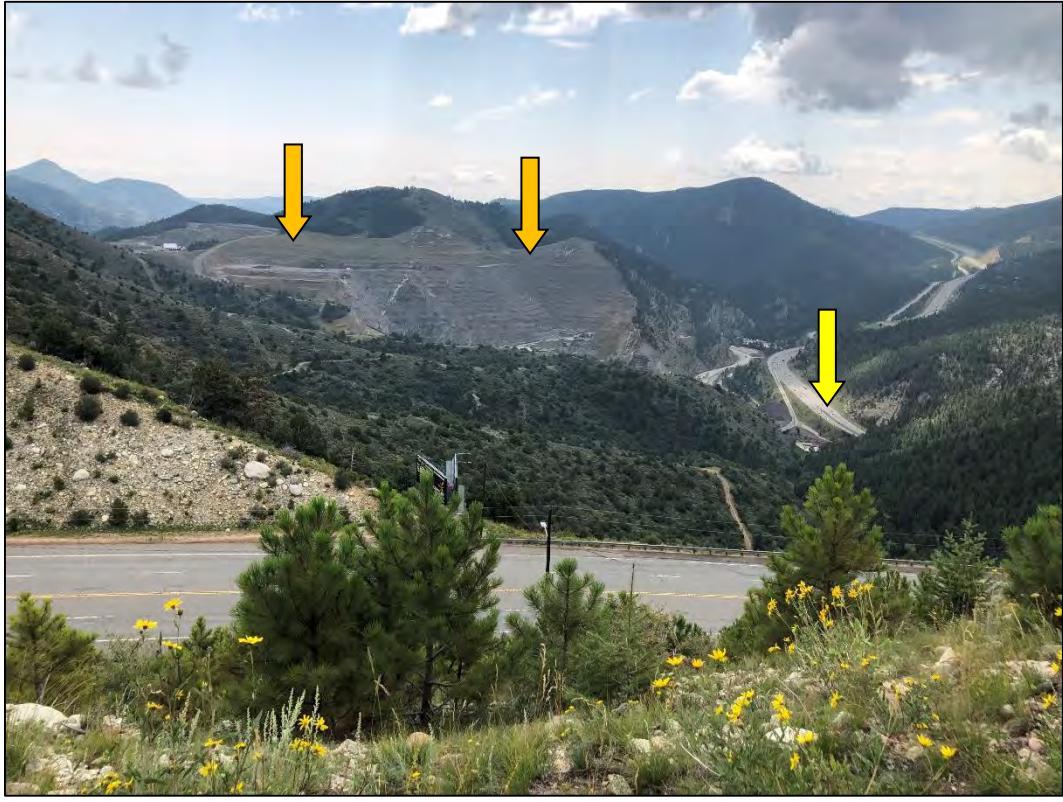
**Photo 9.** View looking southeast from ridgeline west of CCP, showing I-70 (indicated with yellow arrow) and Walstrum Quarry, Permit No. M-1983-033 (indicated with orange arrows) in background. Walstrum Quarry is located approximately <sup>3</sup>/<sub>4</sub> mile SE from proposed Young Ranch Resource Quarry.

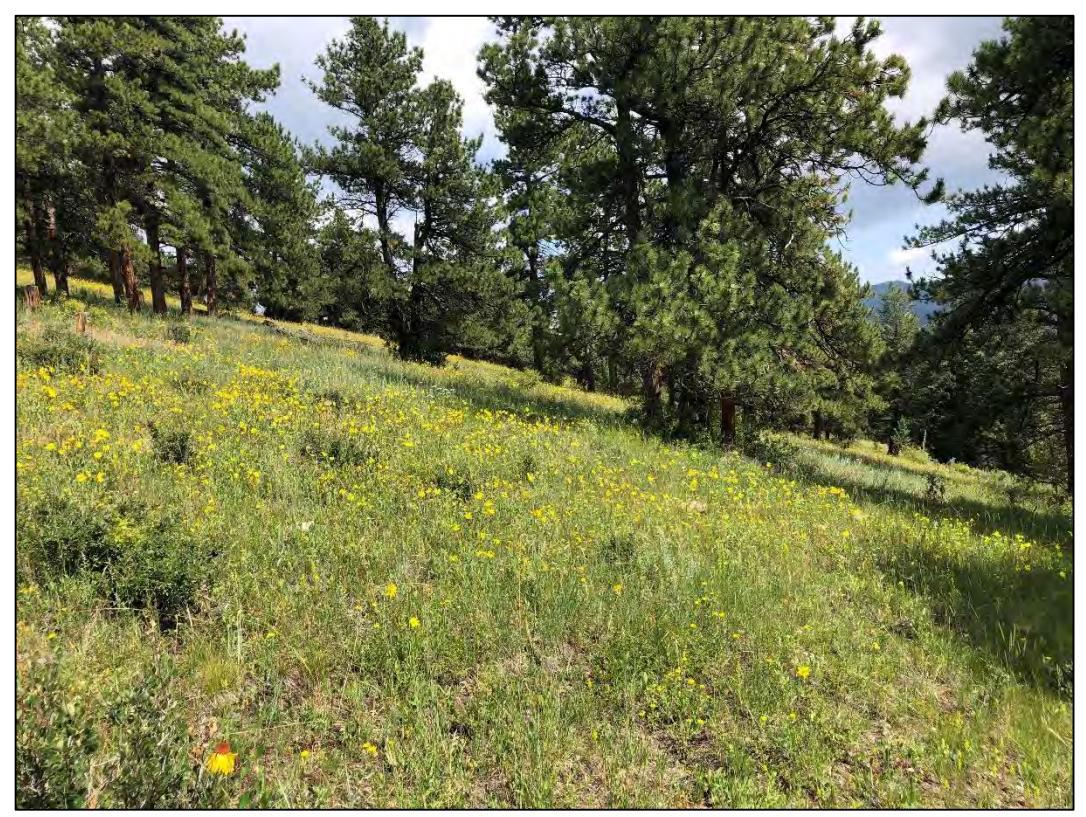
**Photo 10.** View looking northwest across north-facing slope of ridge west of CCP with mixed forest and grassland, to be mined during Phase 3.

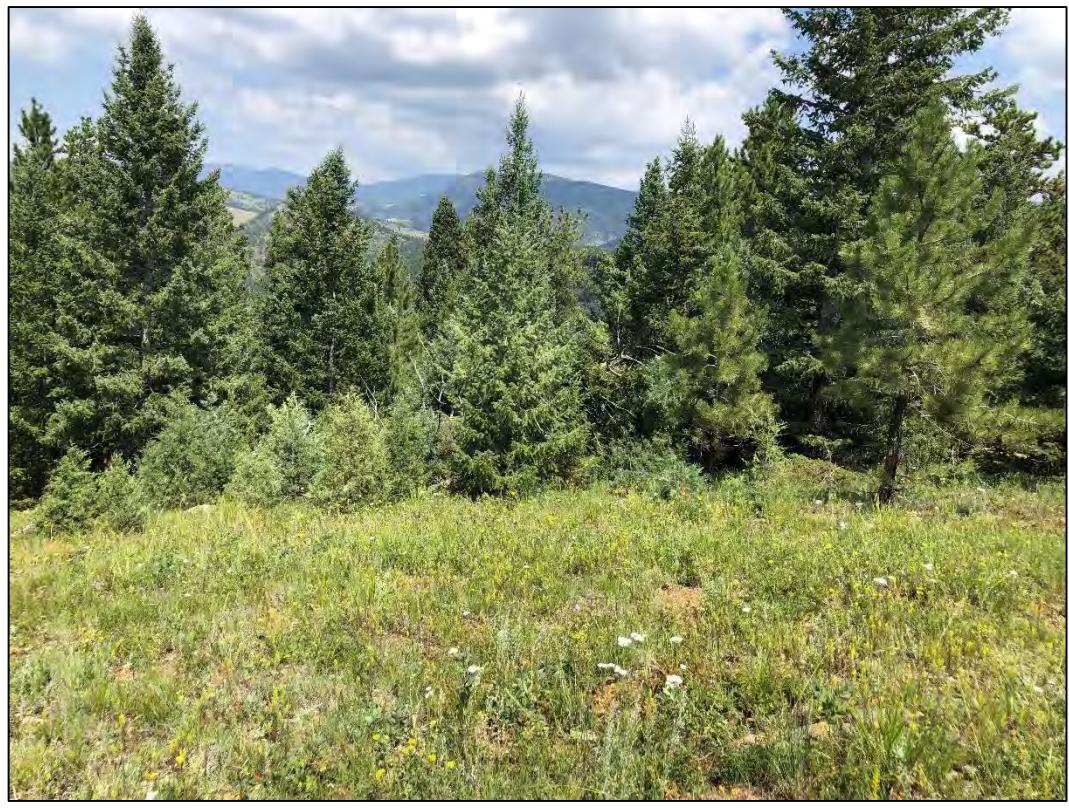
**Photo 11.** View looking north across north-facing slope of ridge west of CCP with mixed forest and grassland, to be mined during Phase 3.

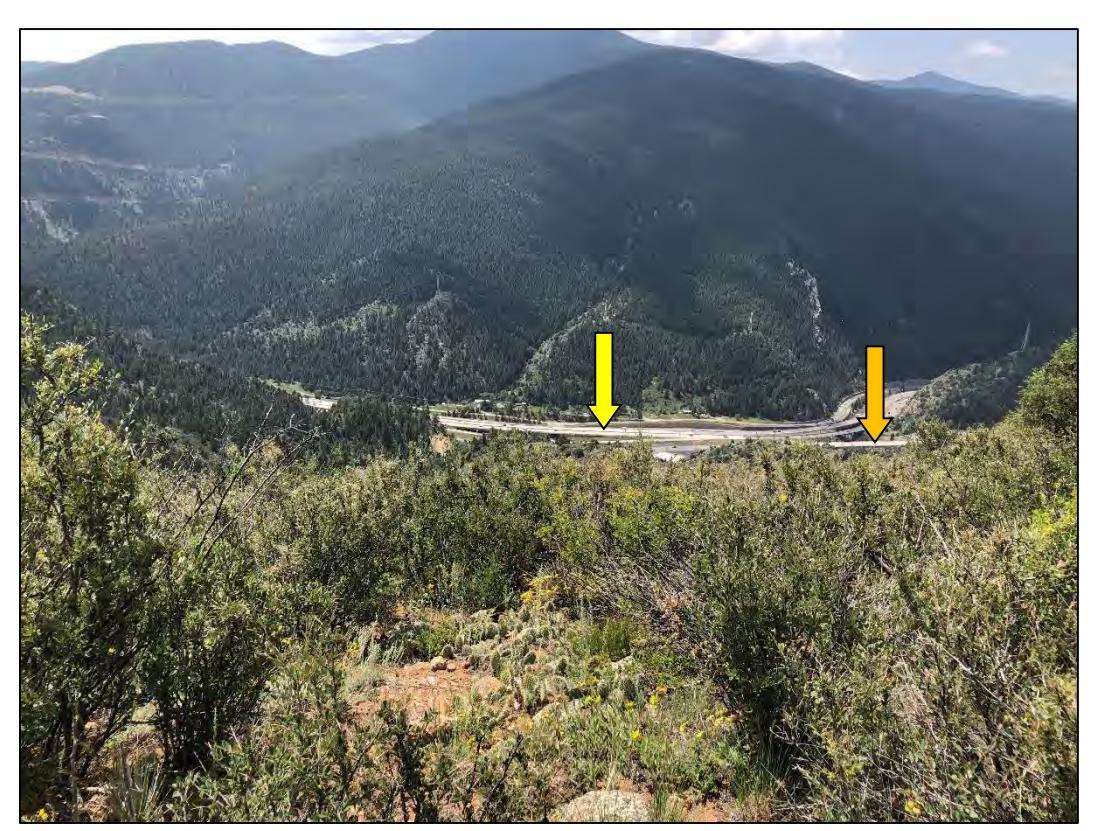
**Photo 12.** View looking south across south-facing slope of ridge west of CCP with primarily shrub and cactus vegetation, to be partially mined during Phase 3. This is approximate location of CCP realignment. I-70 (indicated with yellow arrow) and existing CCP (indicated with orange arrow) are visible below.

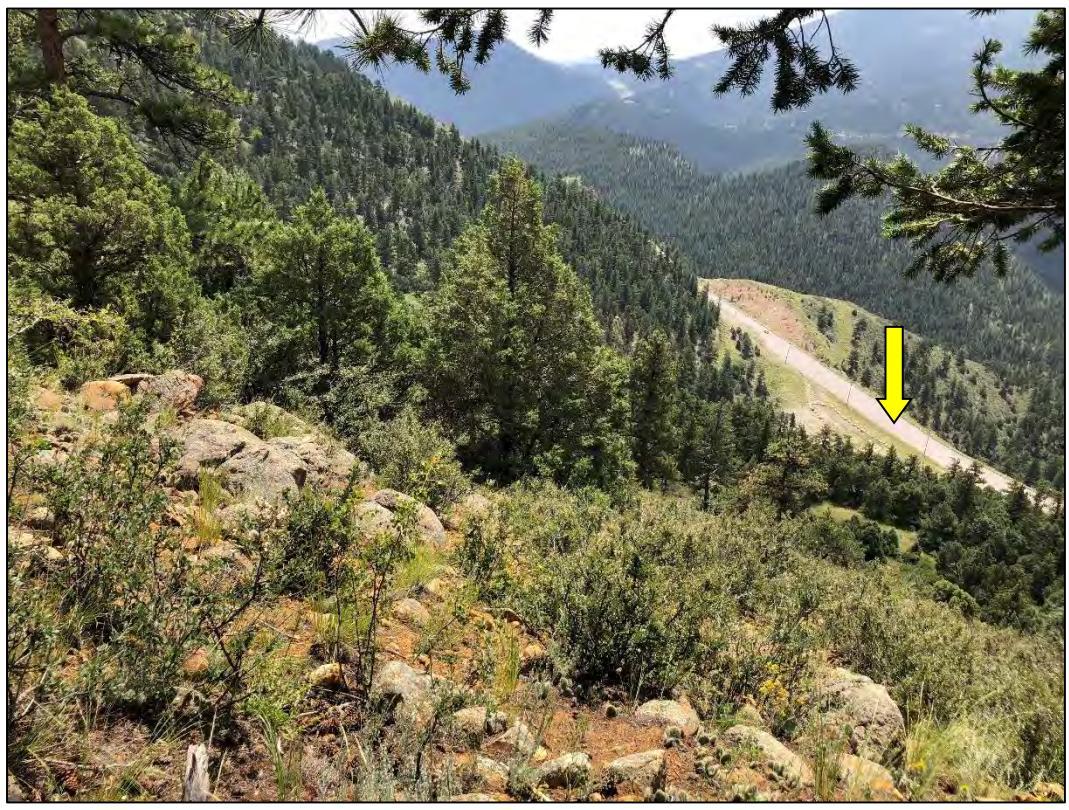
**Photo 13.** View looking southeast across south-facing slope of ridgeline west of CCP (indicated). The proposed CCP realignment would cross the ridge in this general area.

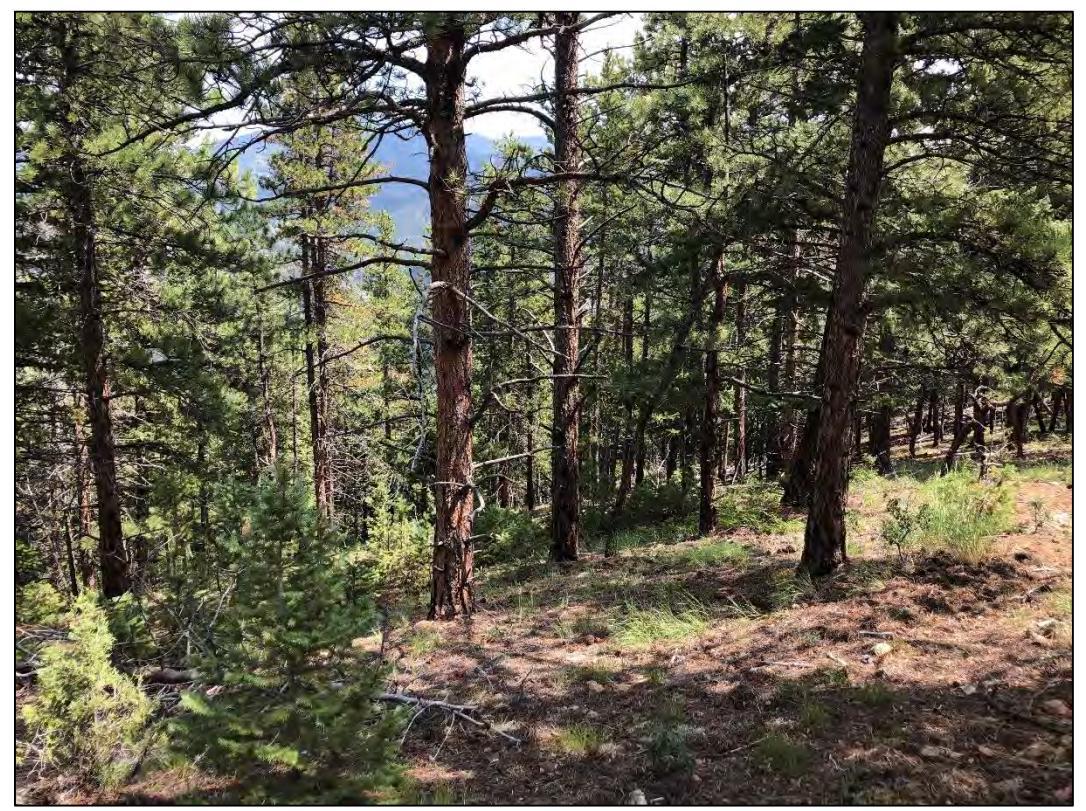
**Photo 14.** View looking northeast across forested north-facing slope of ridge west of CCP, to be mined during Phase 2.

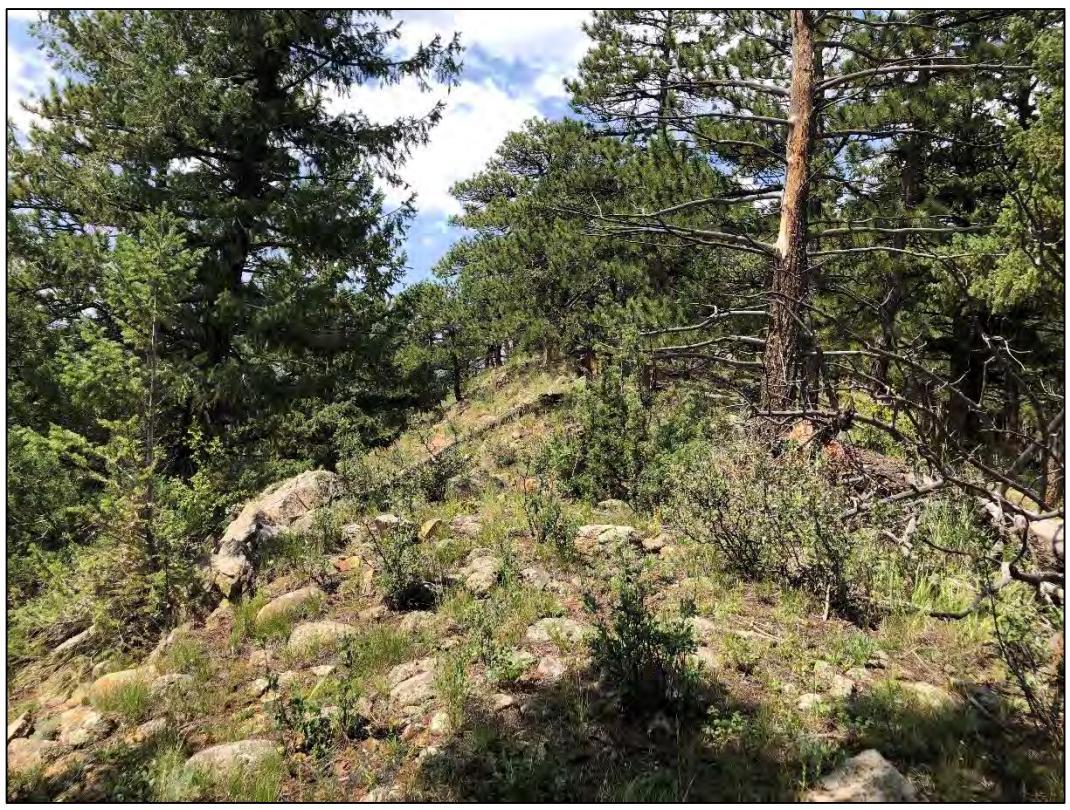
**Photo 15.** View looking west across ridgeline which will be mined during Phase 2, moving ridgeline approximately 450-600 feet to the south.

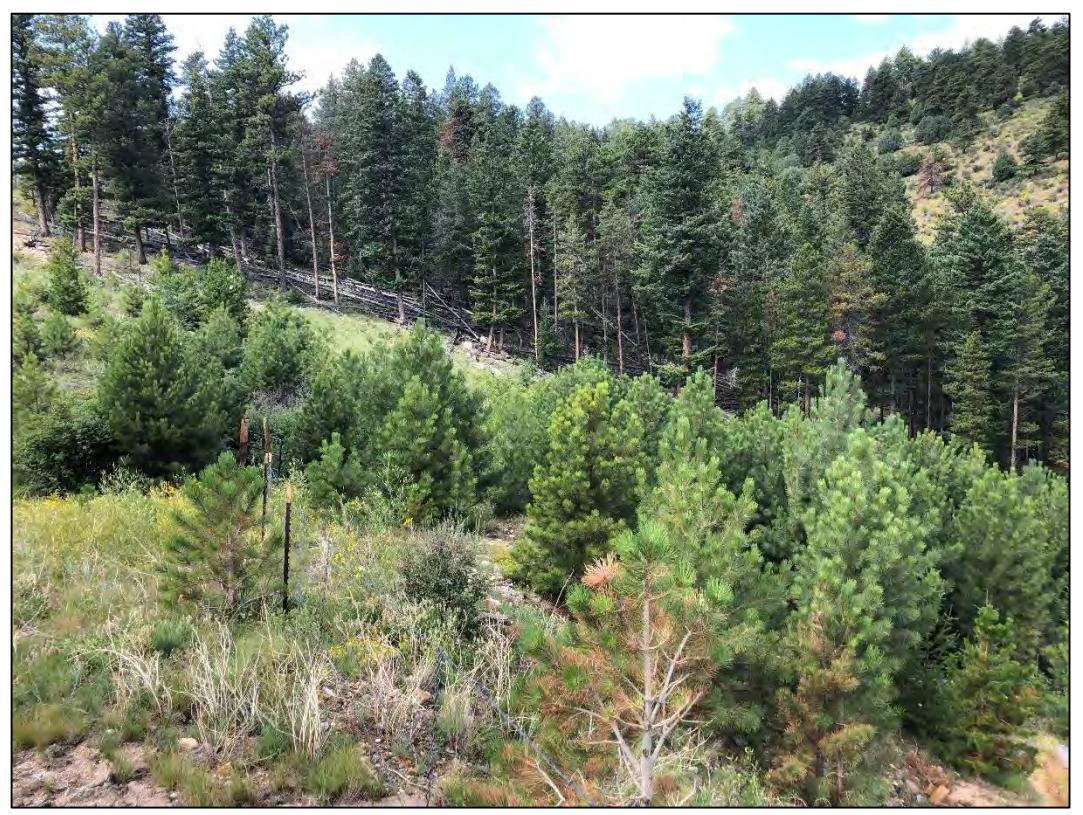
**Photo 18.** View looking southwest across eastern edge of proposed wildlife mitigation corridor (directly west of CCP), which will remain undisturbed by operation throughout life of mine. Note barbed wire fence present in this area (in foreground).

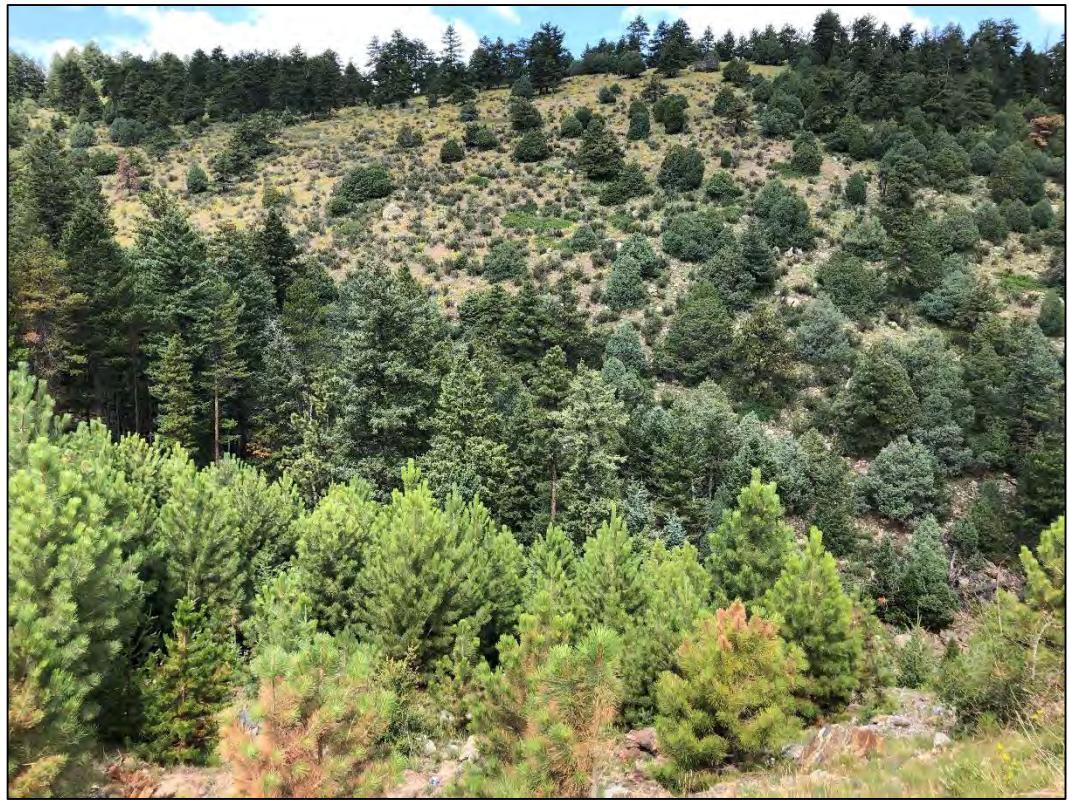
**Photo 19.** View looking north across south-facing slope of ridge (directly west of CCP) to be mined during Phase 3.

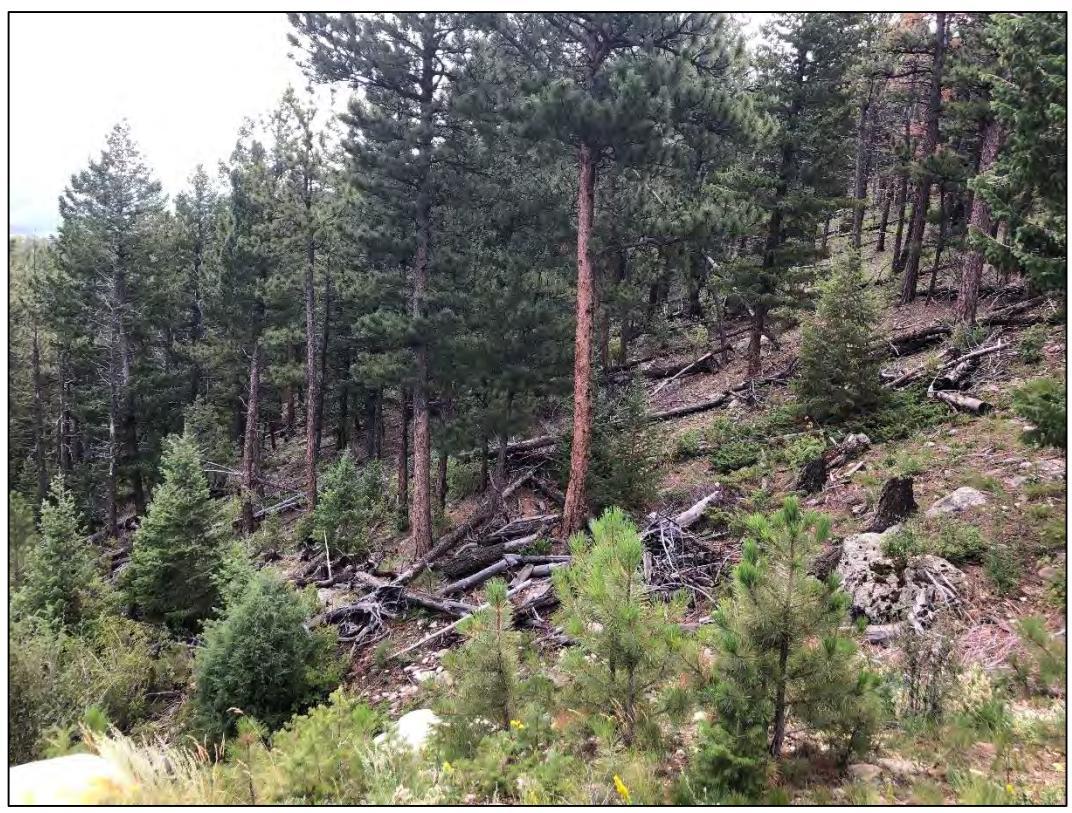
Photo 21. View looking northeast at forested eastern side slope of larger (east) drainage located east of CCP proposed for WRL.

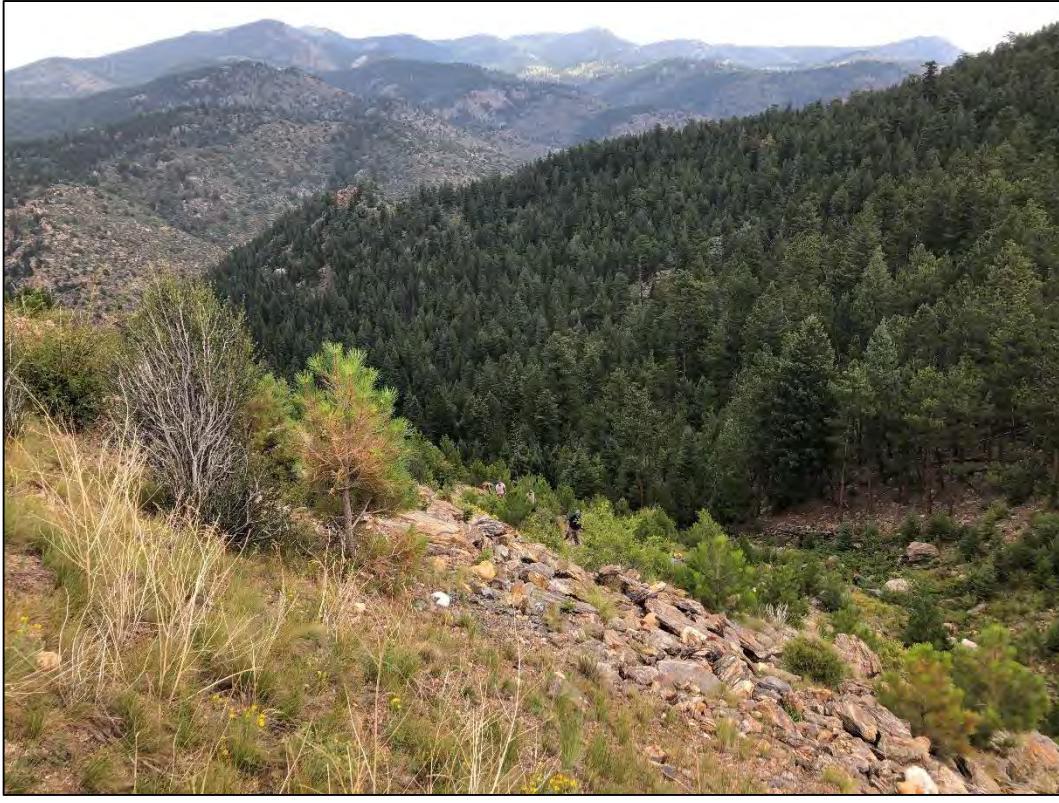
**Photo 23.** View looking northeast at larger (east) drainage located east of CCP proposed for WRL. Note forested east side slope of drainage and less vegetated western scree slope (in foreground) from fill material placed in upper western portion of drainage during CCP construction in 2004.

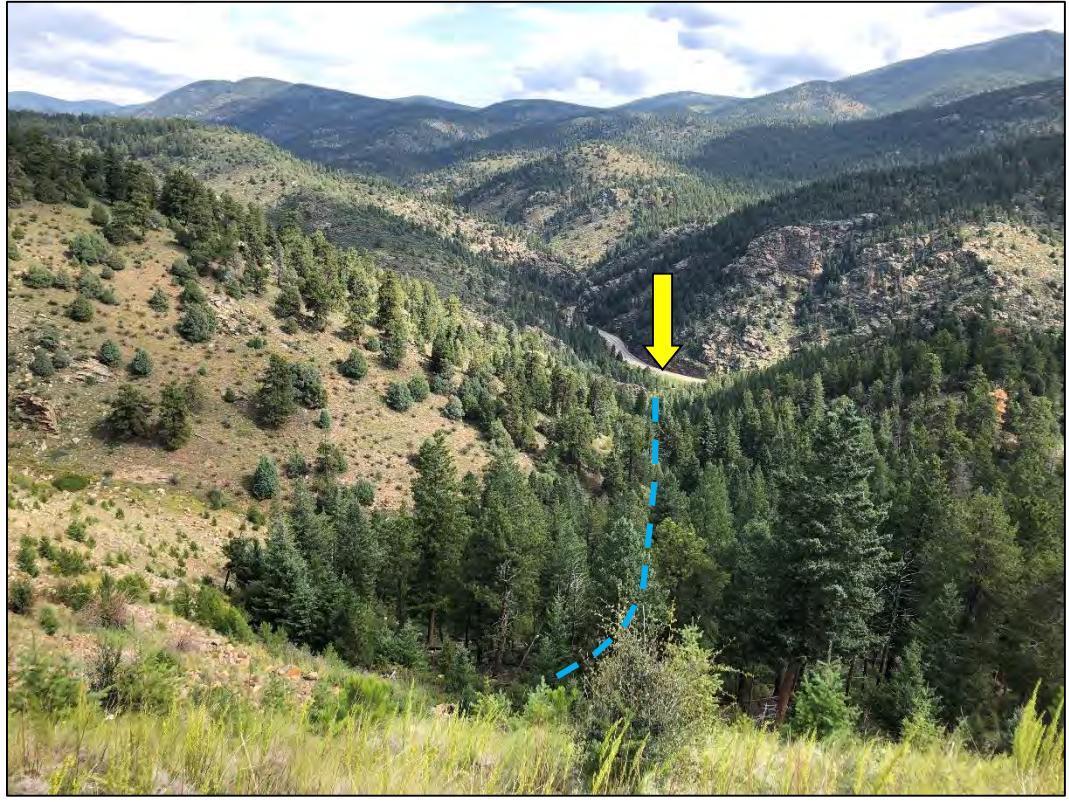
**Photo 27.** View looking north at smaller (west) drainage located east of CCP (approximate location delineated with blue dashed line) proposed for WRL. Note Hwy 119 visible in background (indicated).

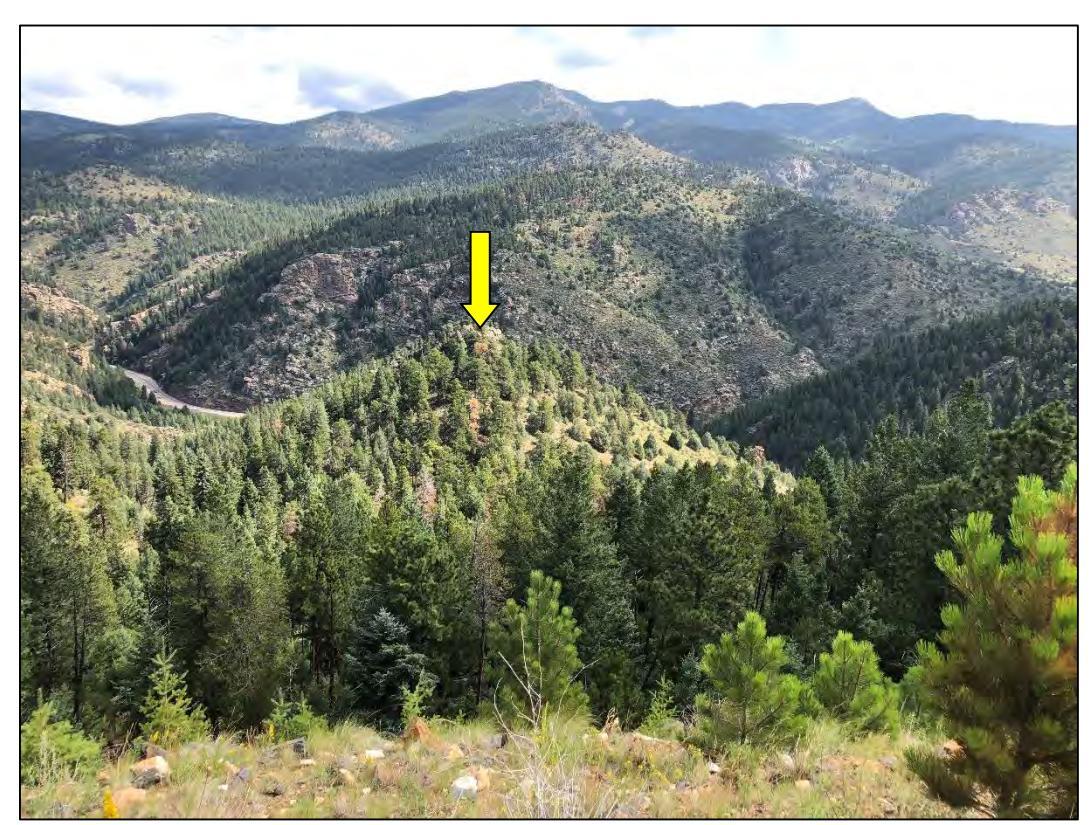
**Photo 28.** View looking northeast at natural saddle (indicated) separating smaller (west) drainage (left of saddle) and larger (east) drainage (right of saddle) proposed for WRL. The separate WRLs will merge above this saddle during Phase 2 to create one large WRL.

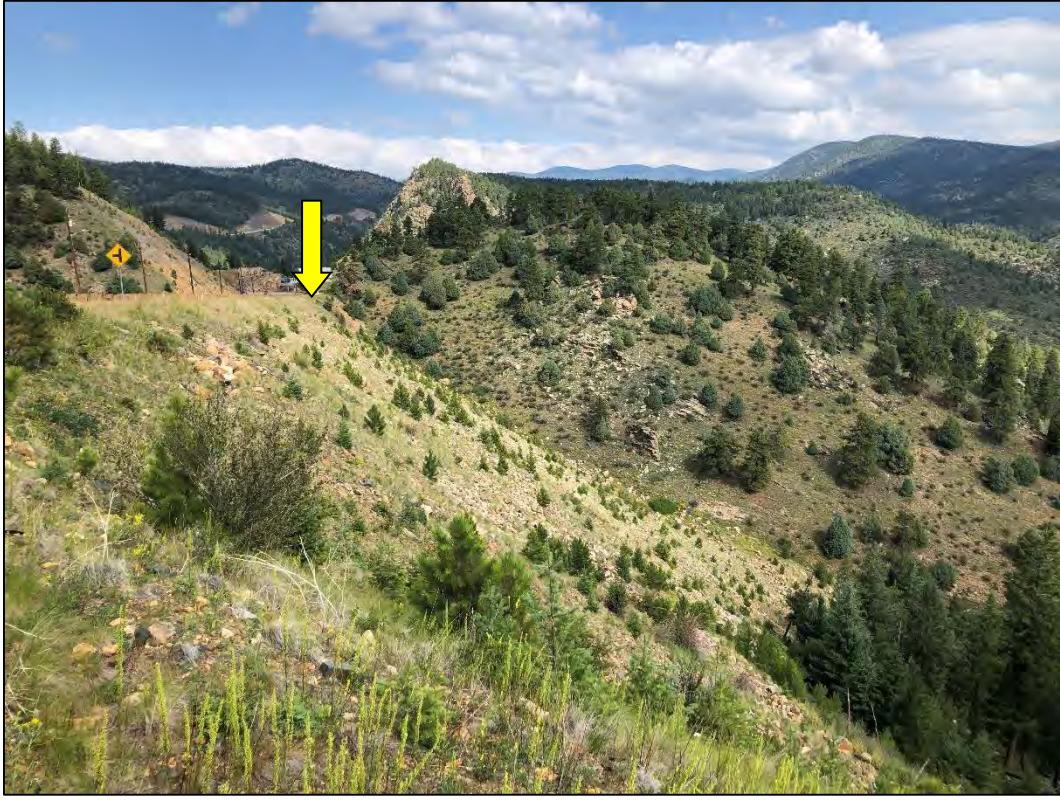
**Photo 29.** View looking northwest at proposed WRL entrance off east side of CCP (approximate location indicated). Note scree slope (at left) from fill material placed in drainage during CCP construction in 2004. The combined WRL will fill much of this area during Phase 2.

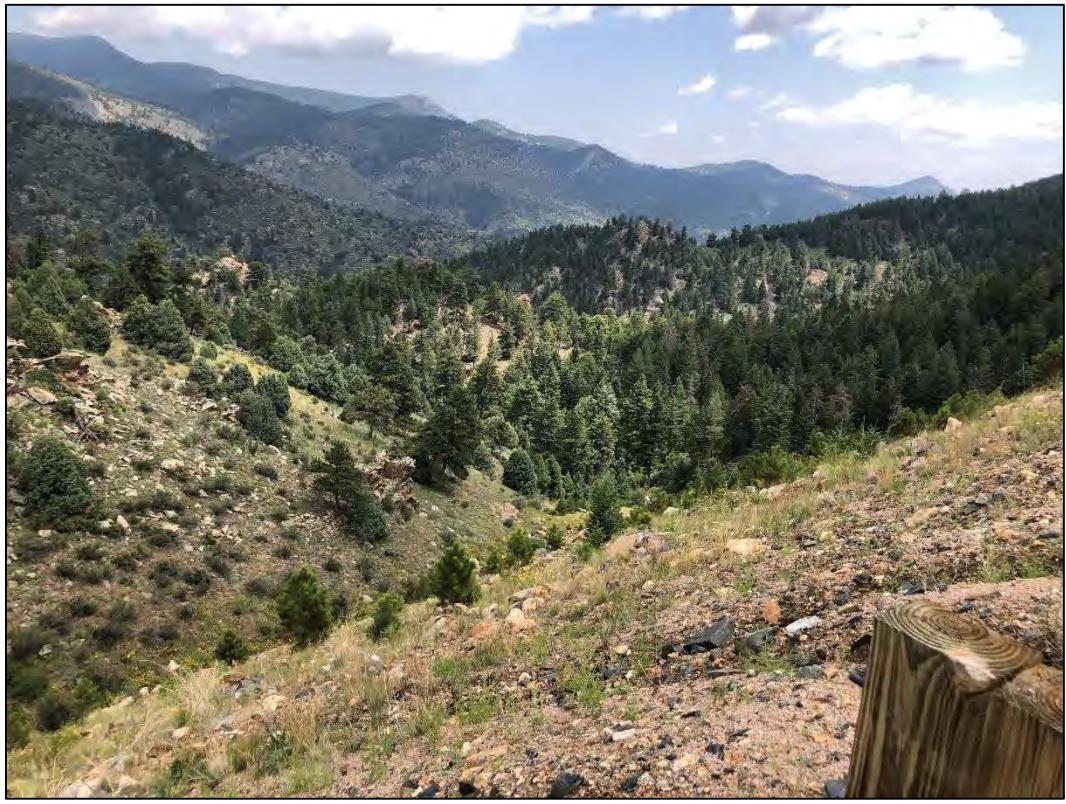
**Photo 31.** View looking east at drainage (oriented roughly east-west) near proposed WRL entrance off CCP in which road to WRLs will be constructed during Phase 1. The combined WRL will fill this area during Phase 2.
