**COLORADO**  
Division of Reclamation,  
Mining and Safety  
Department of Natural Resources

| <b>Permit Number:</b> C-1981-041<br><b>Mine Name:</b> Roadside Portals<br><b>Operator:</b> Snowcap Coal Company, Inc.<br><b>Operator Address:</b><br>Ms. Tonya Hammond<br>P.O. Box 1430<br>Palisade, CO 81526 | <b>County:</b> Mesa<br><b>Operation Type:</b> Underground<br><b>Permit Status:</b> Active<br><b>Ownership:</b> Private |

| <b>Inspection Start Date:</b> August 10, 2021<br><b>Inspection Start Time:</b> 10:00<br><b>Inspection End Date:</b> August 10, 2021<br><b>Inspection End Time:</b> 14:00 | | <b>Inspection Type:</b> Coal Partial Inspection<br><b>Inspection Reason:</b> 10 Day Notice Follow-up<br><b>Weather:</b> Clear | |

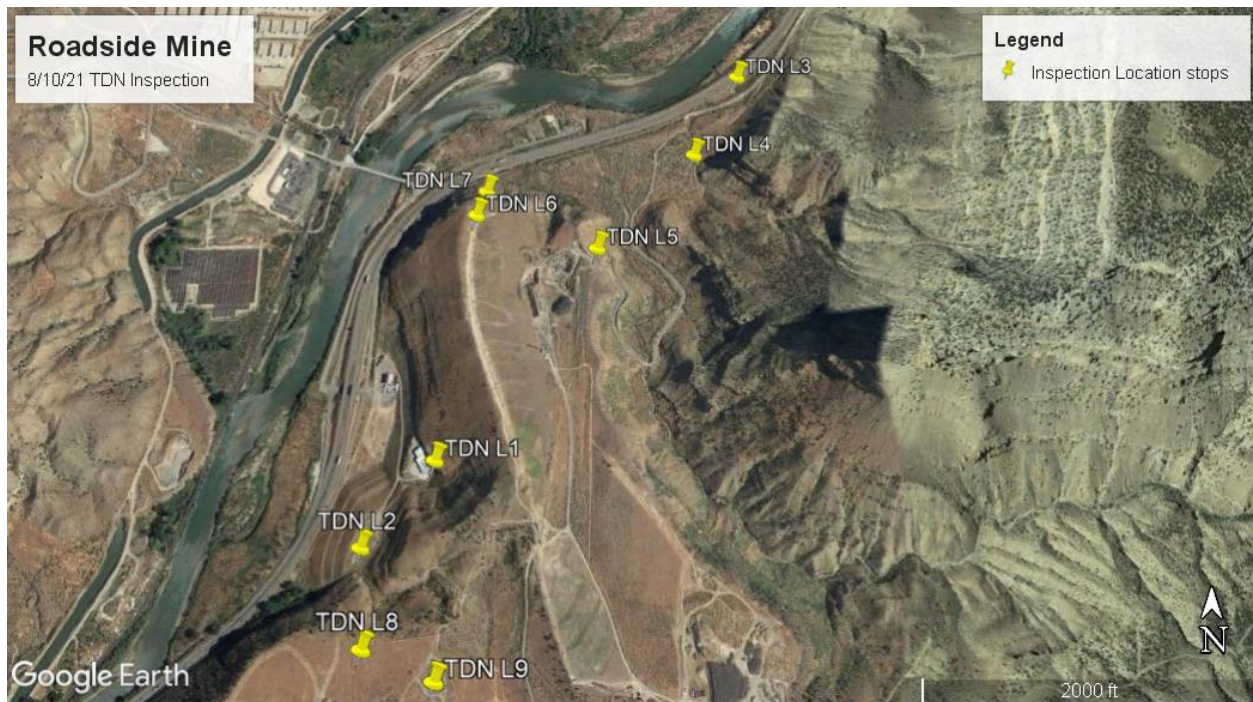
**Figure 1**

which each stop during the inspection was made. These locations are identified on Figure 1 attached with this report.

Each stop during the inspection is identified in figure 1 as a yellow pin. The pins are number in the order in which each location was visit
