MINERALS PROGRAM INSPECTION REPORT
PHONE: (303) 866-3567

MINE NAME: Kester Pit	MINE/PROSPECTING ID#: M-2021-037	MINERAL: Sand and gravel	COUNTY: Costilla
INSPECTION TYPE: Preoperation Inspection	INSPECTOR(S): Lucas West	INSP. DATE: August 24, 2021	INSP. TIME: 13:30
OPERATOR: RMS Utilities, Inc.	OPERATOR REPRESENTATIVE: Kaitlyn Gallardo	TYPE OF OPERATION: 110c - Construction Limited Impact	
REASON FOR INSPECTION: Pre-operation Inspection	BOND CALCULATION TYPE: None	BOND AMOUNT: No Bond Held	
DATE OF COMPLAINT: NA	POST INSP. CONTACTS: None	JOINT INSP. AGENCY: None	
WEATHER: Clear	INSPECTOR'S SIGNATURE:

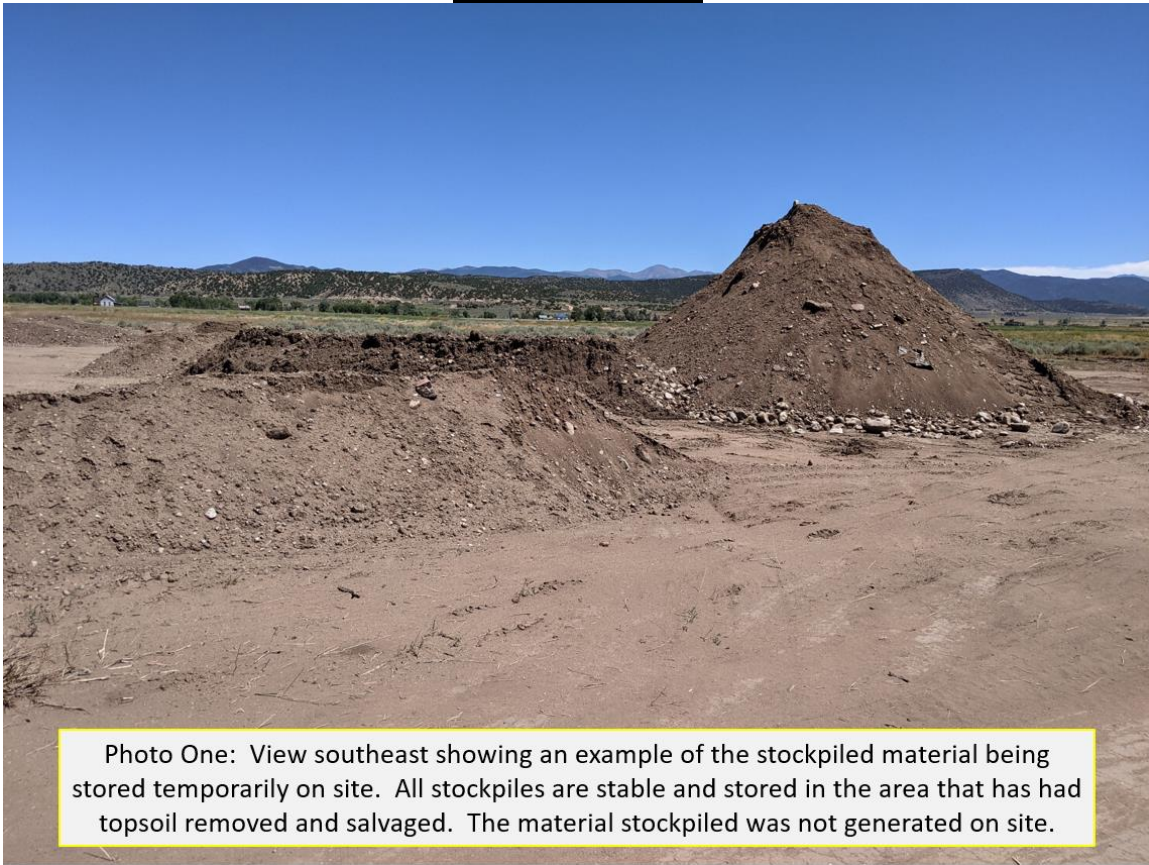
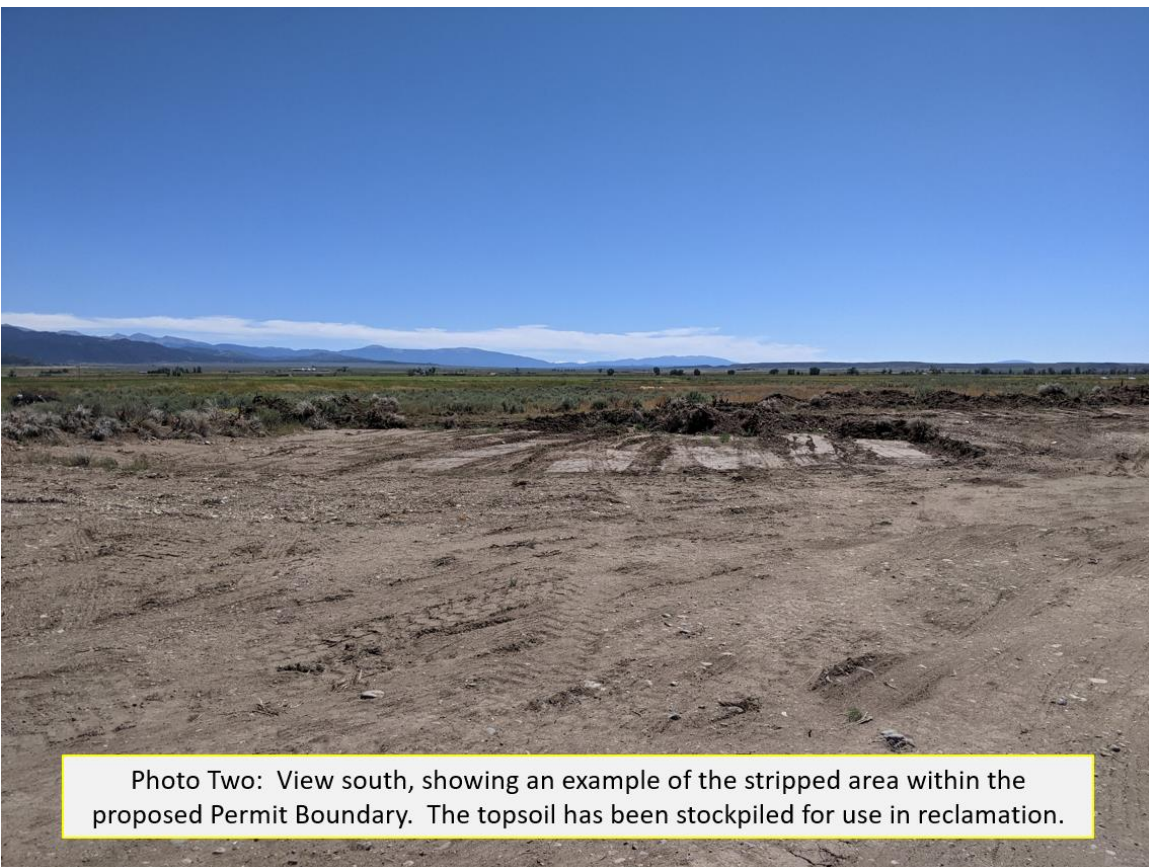
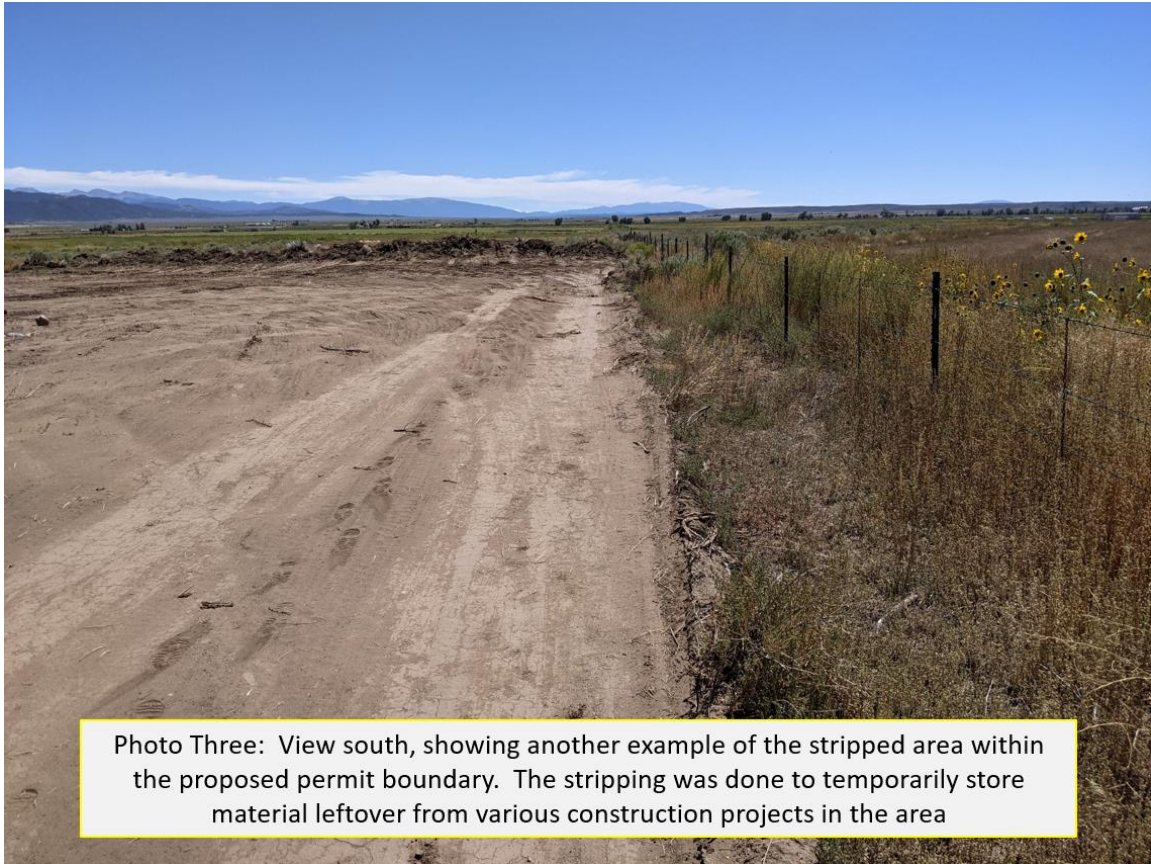
The proper notice sign was observed at the entrance to the site. The site was inactive and no mining equipment was present on site as the application has yet to be approved. The proposed permit area is currently being used as a storage area. Several stockpiles of excavated dirt are located within the permit area. This material was not generated on site, rather hauled in for temporary storage by the applicant. Discussions with the applicant indicate the material has been generated from various construction projects in the area and will be removed shortly. All stockpiles were stable at the time of the inspection and an example of the stockpiles can be seen in Photo One. The majority of the proposed permit area has been graded and stripped of topsoil to allow for material storage, the stripped material will be incorporated into the permit and saved for reclamation of the site. Photos Two and Three show the stripped area. The areas that have not been stripped to the east and the south, are typical of the fringe area of a center pivot irrigated field. The areas are well vegetated with annual weeds, native grasses and sage brush. An example of these areas can be seen in Photo Four.

The only notable permanent man-made structures located within 200 feet of the proposed permit area include County Road GG, the fence-lines that border the north and west side of the site, and an irrigation lateral that runs along the west side of the site. The irrigation lateral ditch, shown in Photo Five, was observed and contained no running water at the time of the inspection. The ditch is overgrown with vegetation and shows no signs of recent maintenance. It is unclear at this time if the ditch is owned and operated by an irrigation company, and is addressed in the Division's adequacy Review. The application details a set back from the property line, which puts the mining extents approximately 20 feet to the east of the ditch. On site discussions detailed that a structure agreement would need to be executed for the ditch, however if the agreement cannot be executed an engineering evaluation may be performed to demonstrate mining and reclamation activities will not affect the ditch pursuant to Construction Materials Rule 6.3.12(b).
