To: Jerald Schnabel  
Continental Materials Corp.  
File: August 2021 Monitoring Summary

**Reference: August 2021 Geotechnical Monitoring Summary Pikeview Quarry**

Client/Project  
**CONTINENTAL MATERIALS  
 CORP.  
 PIKEVIEW QUARRY SLOPE  
 MONITORING**

Title  
OBSERVATIONS FROM  
SEPTEMBER INSPECTION

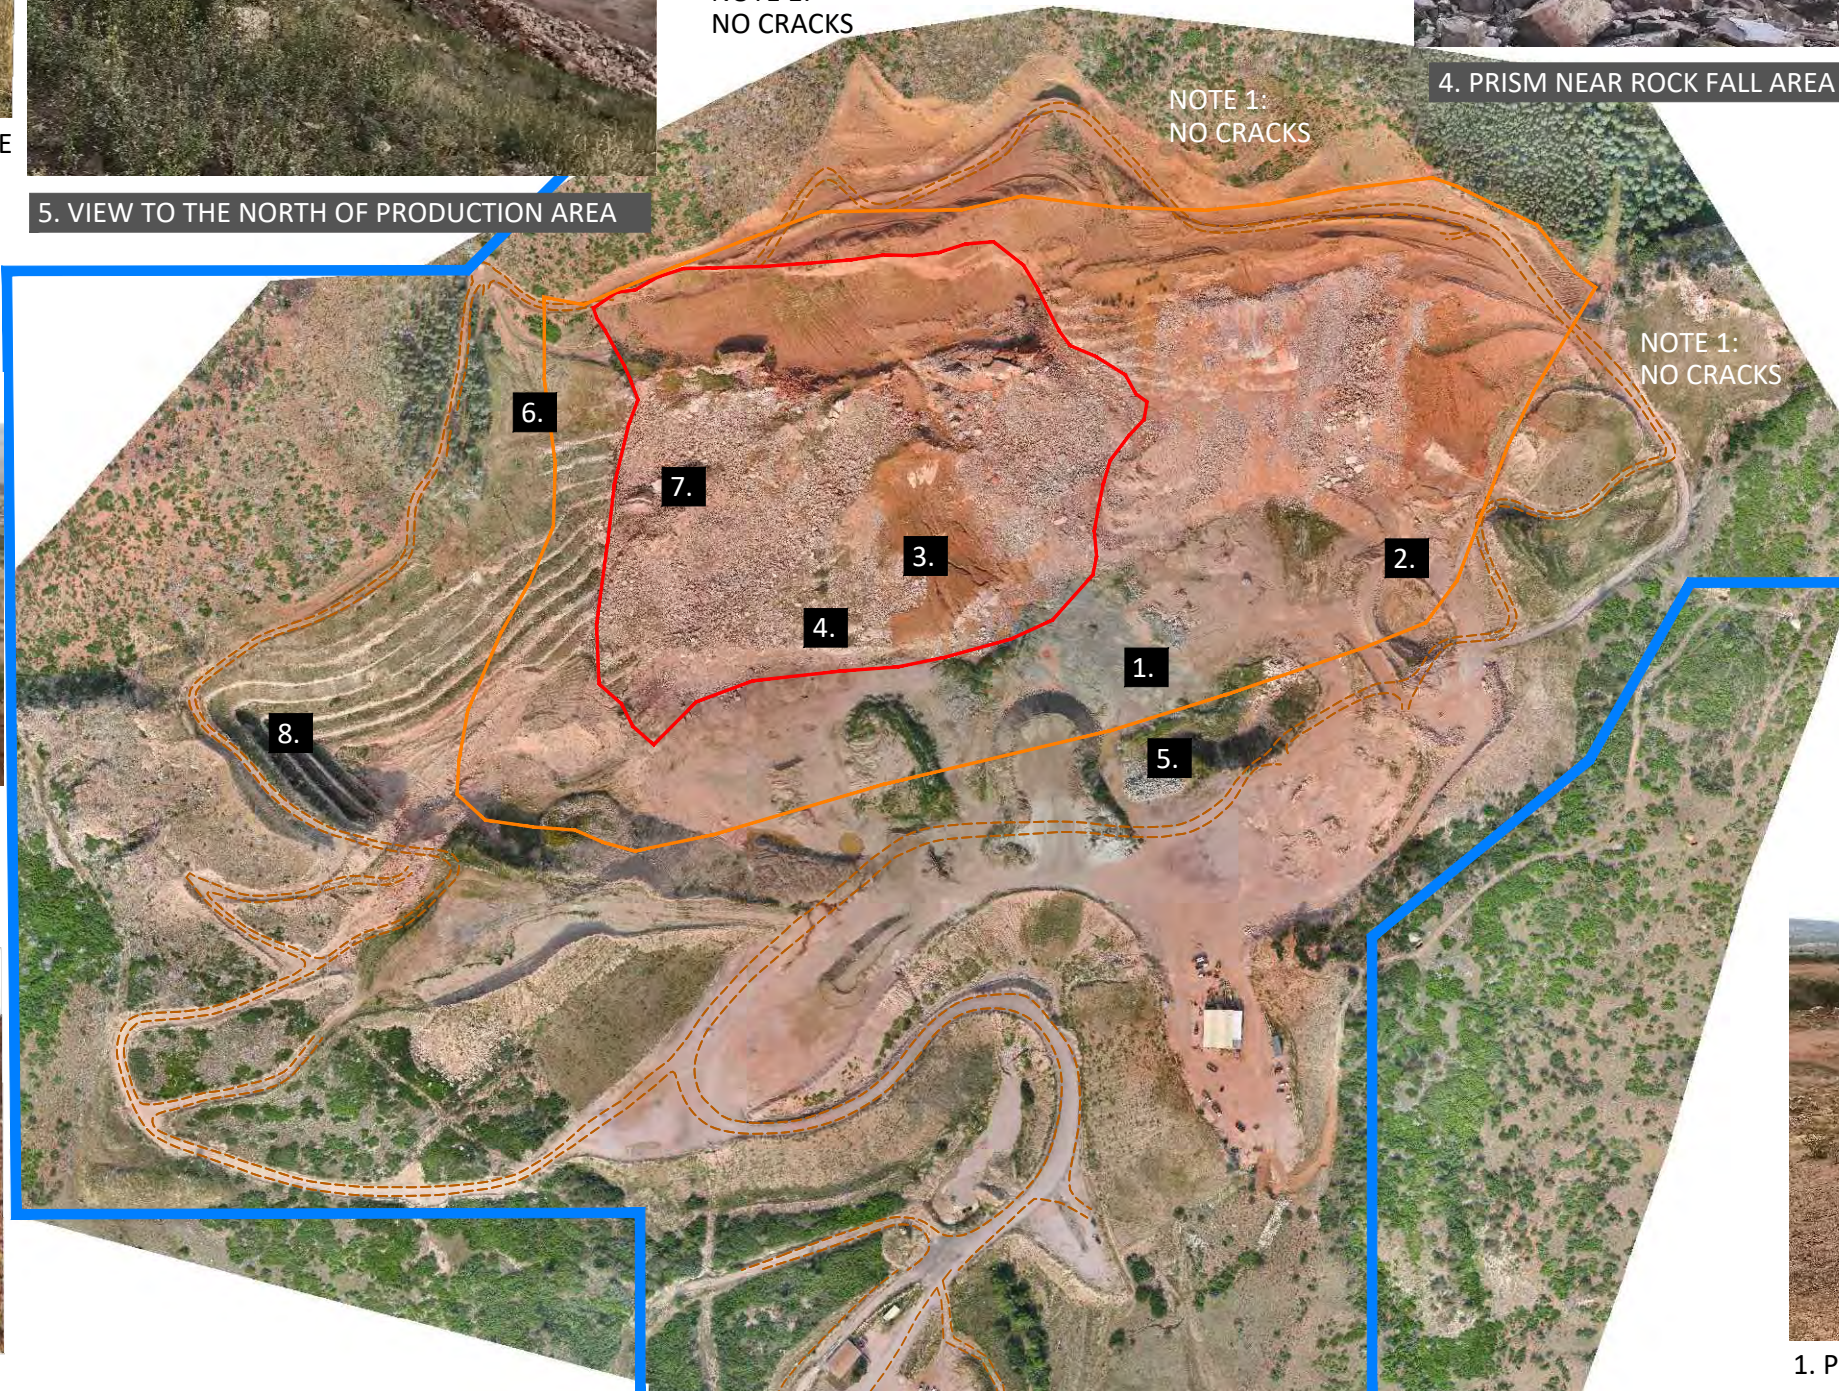
NOTE 1:  
NO CRACKS

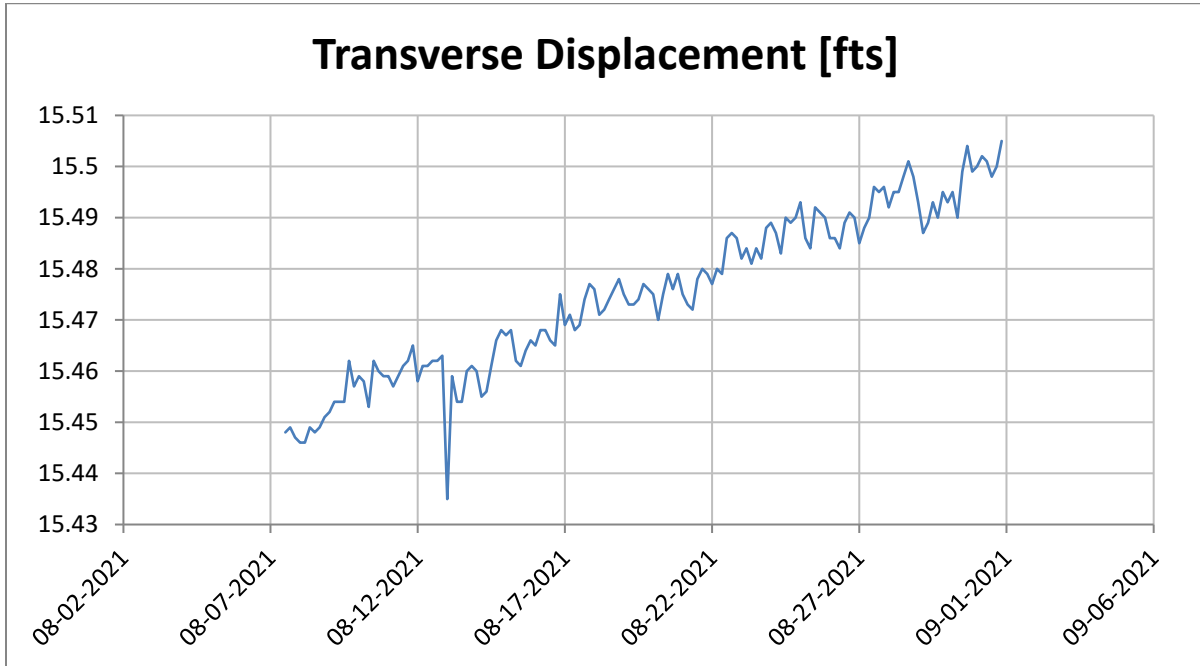
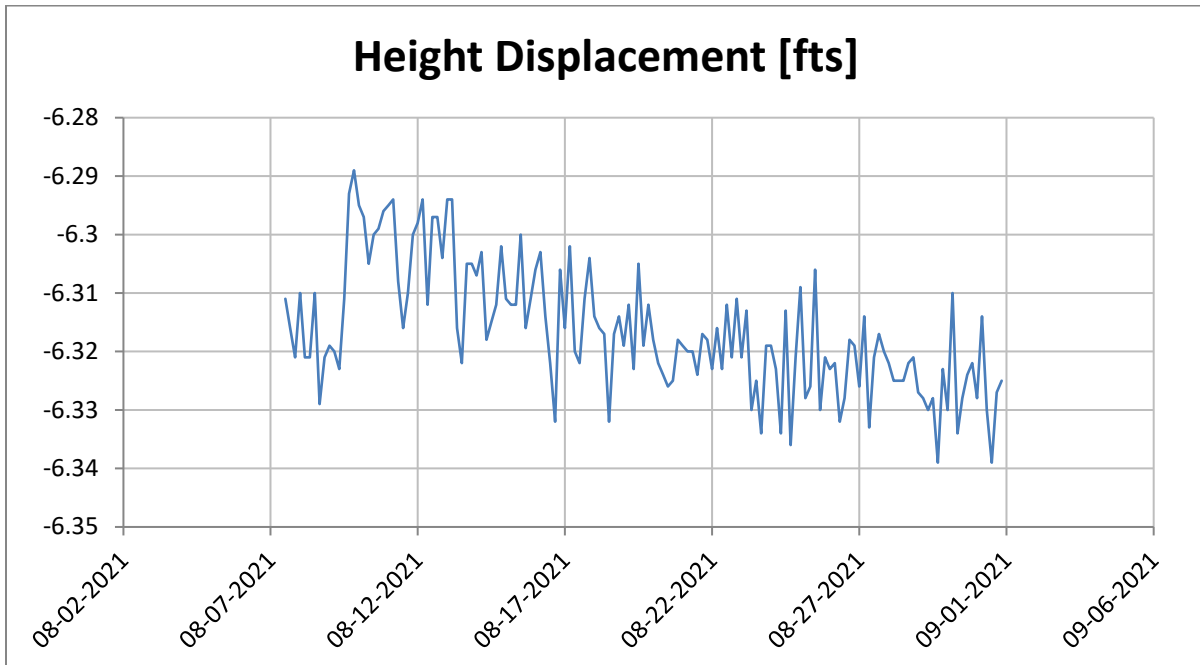
## Prism P63

The data show stable conditions with no movement for 16 of 20 prisms with recorded displacements limited to data scatter and not actual movements. Prisms P63, TOE2, and TOE3 are located at the toe of the landslide, and these locations showed slope creep movements at slow velocities (approximately 0.001 feet per day or less). Prism NP66 is located above the landslide, and this prism also recorded slope creep movements at slow velocity. This settlement is likely related to the increased moisture causing the landslide material to consolidate. Plots of the transverse and height displacements for each prism are included in Appendix B.
