MINERALS PROGRAM INSPECTION REPORT
PHONE: (303) 866-3567

| MINE NAME: Idarado Mining Co | MINE/PROSPECTING ID#: M-1977-403-HR | MINERAL: Lead, zinc, copper, c gold | COUNTY: San Miguel |
| INSPECTION TYPE: Monitoring | INSPECTOR(S): Lucas West | INSP. DATE: August 25, 2021 | INSP. TIME: 15:58 |

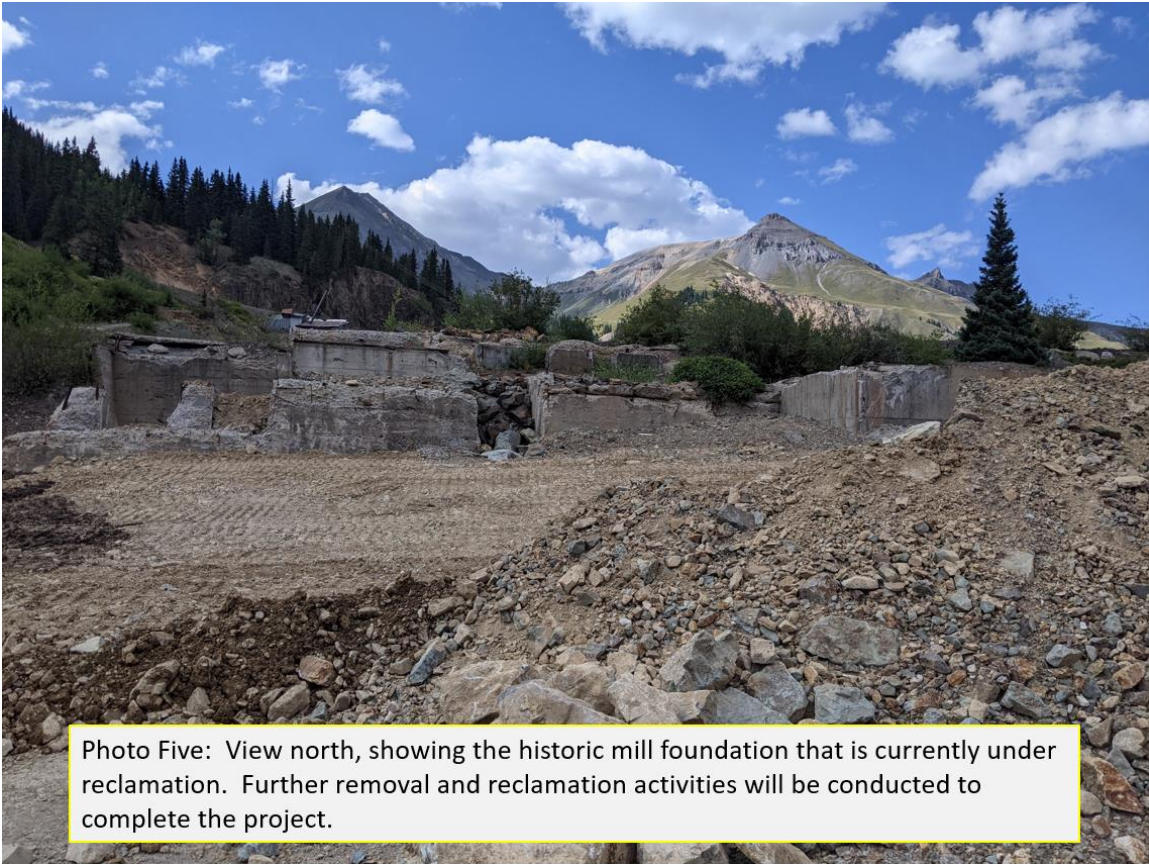
Other reclamation activities are ongoing, several historic tanks and other various mining related debris has been staged for removal. All items are stored in neat and orderly fashion and can be seen in Photo **Four**. Discussions with the Operator indicate that further reclamation of the historic mill foundation located on site is slated to take place over the next years. The foundation can be seen in Photo **Five**. The portal, shown in Photo **Six**, was also observed, and secured. No signs of vandalism or attempted unauthorized entry was noted.

Photo Four: View south, showing various equipment and mining related debris staged for removal.
