Bowie 2 inspection report

Permit Number: C-1996-083 Mine Name: Bowie No. 2 Mine Operator: Bowie Resources, LLC Operator Address: Mr. Basil Bear P.O. Box 1488 Paonia, CO 81428 County: Delta Operation Type: Underground Permit Status: Active Ownership: Private

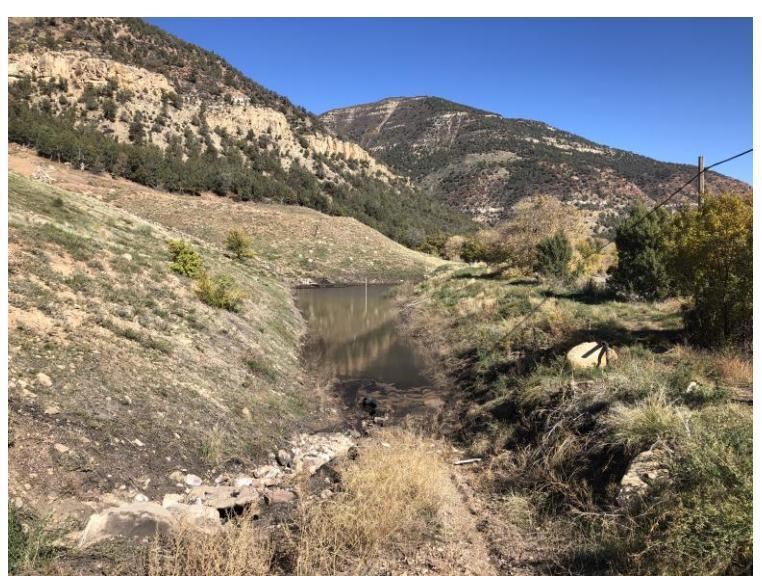
Data collection location for VWPs under Gob Pile #3
