MINERALS PROGRAM INSPECTION REPORT
PHONE: (303) 866-3567

MINE NAME: Revenue Mine	MINE/PROSPECTING ID#: M-2012-032	MINERAL: Lead, silver and gold	COUNTY: Ouray
INSPECTION TYPE: Monitoring	INSPECTOR(S): Lucas West	INSP. DATE: October 19, 2021	INSP. TIME: 10:10
OPERATOR: Ouray Silver Mines Inc.	OPERATOR REPRESENTATIVE: Todd Jesse	TYPE OF OPERATION: 112d-1 - Designated Mining Operation	
REASON FOR INSPECTION: Normal I&E Program	BOND CALCULATION TYPE: None	BOND AMOUNT: \$517,219.00	
DATE OF COMPLAINT: NA	POST INSP. CONTACTS: None	JOINT INSP. AGENCY: None	
WEATHER: Clear	INSPECTOR'S SIGNATURE:

Reagent Room Inspection

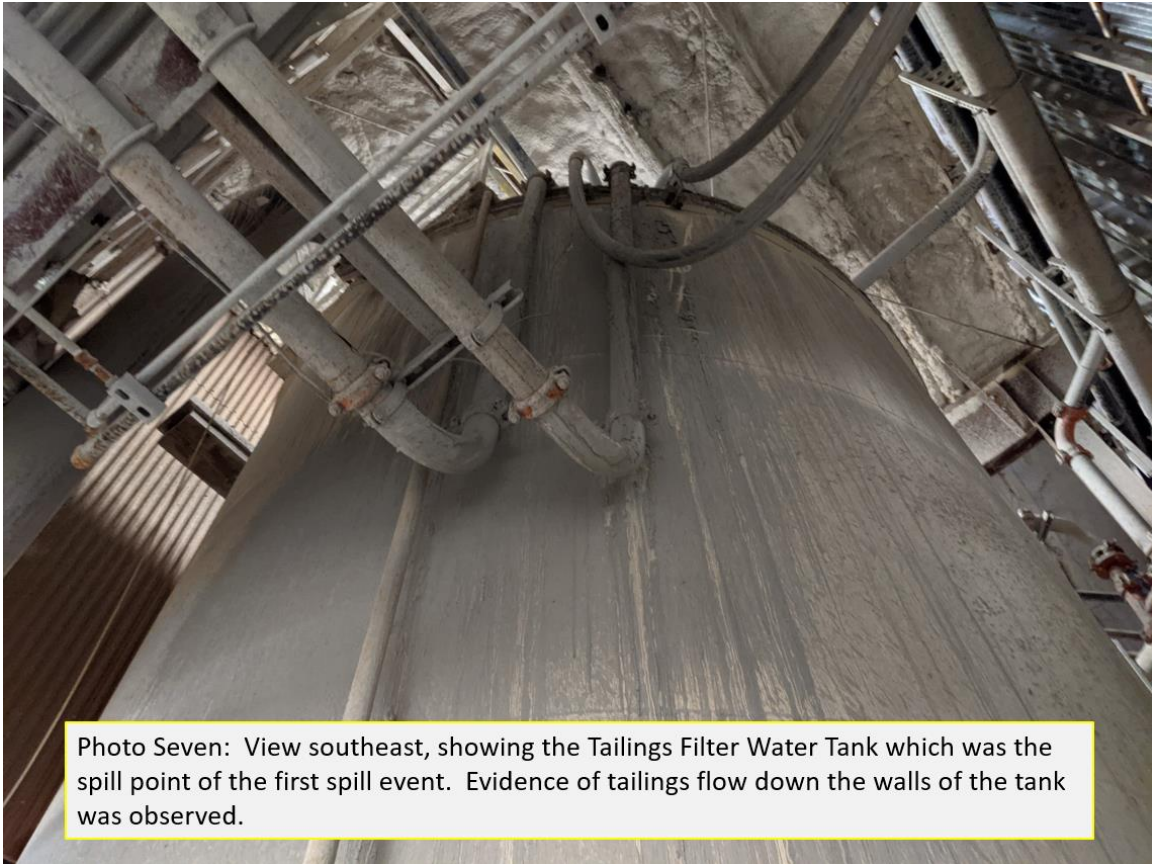
On October 6 and 11, 2021 the Division received two spill notifications for separate events that occurred from the same area, the Process Water and Tailings Filter Water Tank room. Both spills were small, and response and cleanup was conducted immediately by the Operator. The root cause of the spills has been determined and investigated by the Operator. The first event was caused by an overflow of tailings in the tailings thickener, which was caught by secondary containment structures associated with the tailings thickener. That material was then pumped back to the Tailings Filter Water tank, however a runaway pump and faulty tank

level sensor caused the tank to overtop into the secondary containment of that area. The Tailings Filter Water Tank can be seen in Photo Seven. A breach in the secondary containment structure located adjacent to the access door of that area, allowed the material to flow out of the containment structure to the exterior pad and a small area outside the pad. The breach in the containment structure can be seen in Photo Eight. Immediate action by the Operator shut down the pumps eliminating the source of flow. Immediately following, the Operator cleaned up the spilled material as well as the impacted waste rock surrounding the exterior pad, collected a sample for analysis and placed the material within the compacted clay liner of the Revenue Tailings Storage Facility.

Photo Seven: View southeast, showing the Tailings Filter Water Tank which was the spill point of the first spill event. Evidence of tailings flow down the walls of the tank was observed.

Since the time of both events, the Operator has installed measures to prevent future release. The measures include automation of the pump and tank level controls that are tied back to the Mill Control Room for monitoring. In addition the sump pump located in the Process Water and Tailings Filter Water tank room has been repaired and also automated for monitoring. The breach in the containment of the room was temporarily repaired with sandbags, and the day of the inspection, permanent concrete curbing was installed. As of October 22, 2021 the Division has received written notification of the corrective action, and the problem has been resolved. Mill commissioning and testing has resumed and no further action is necessary.
