## MINERALS PROGRAM INSPECTION REPORT

<b>MINE NAME:</b> Jenkins Site	<b>MINE/PROSPECTING ID#:</b> M-1977-393	<b>MINERAL:</b> Sand and gravel	<b>COUNTY:</b> Boulder
<b>INSPECTION TYPE:</b> Monitoring	<b>INSPECTOR(S):</b> Amy Eschberger	<b>INSP. DATE:</b> October 28, 2021	<b>INSP. TIME:</b> 13:30
<b>OPERATOR:</b> City of Boulder	<b>OPERATOR REPRESENTATIVE(S):</b> Chris Lawlor, Megan Bowes	<b>TYPE OF OPERATION:</b> 112c - Construction Regular Operation	
<b>REASON FOR INSPECTION:</b> Normal I&E Program	<b>BOND CALCULATION TYPE:</b> None	<b>BOND AMOUNT:</b> \$0.00	
<b>DATE OF COMPLAINT:</b> NA	<b>POST INSP. CONTACTS:</b> None	<b>JOINT INSP. AGENCY:</b> None	
<b>WEATHER:</b> Clear	<b>INSPECTOR'S SIGNATURE:</b>

# M-1977-393 / Jenkins Site / City of Boulder (112c)

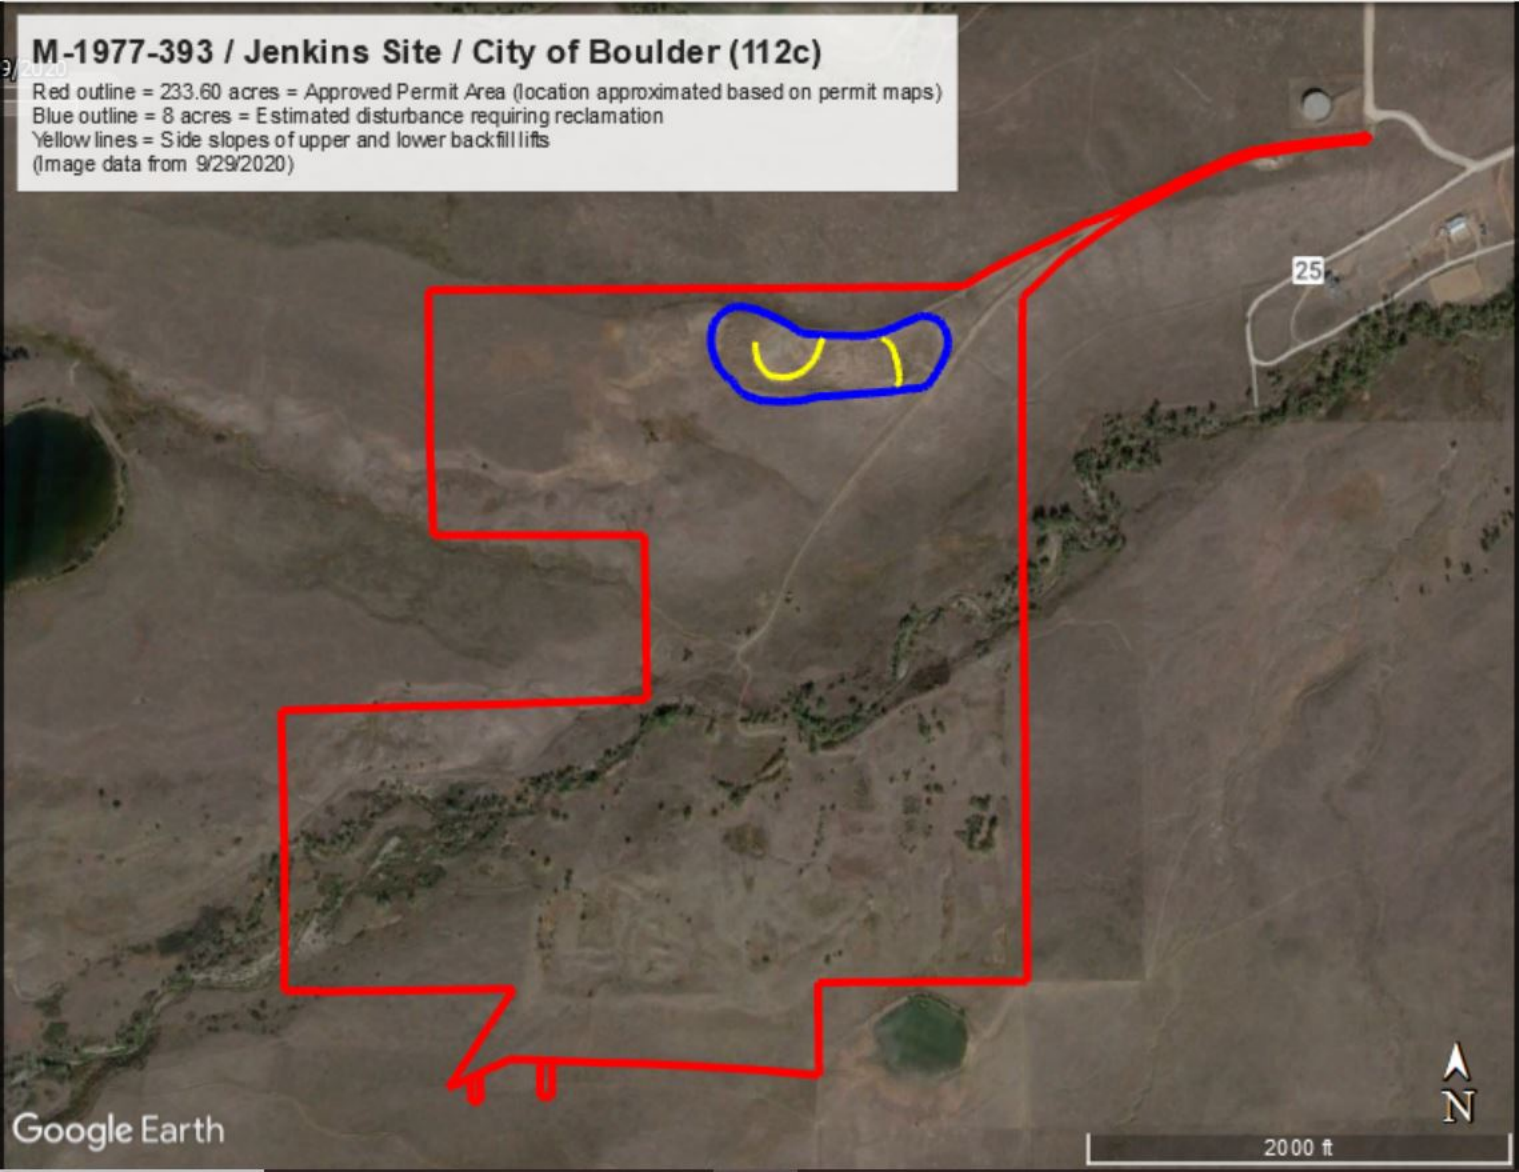
Yellow lines = Side slopes of upper and lower backfill lifts

(Image data from 9/29/2020)

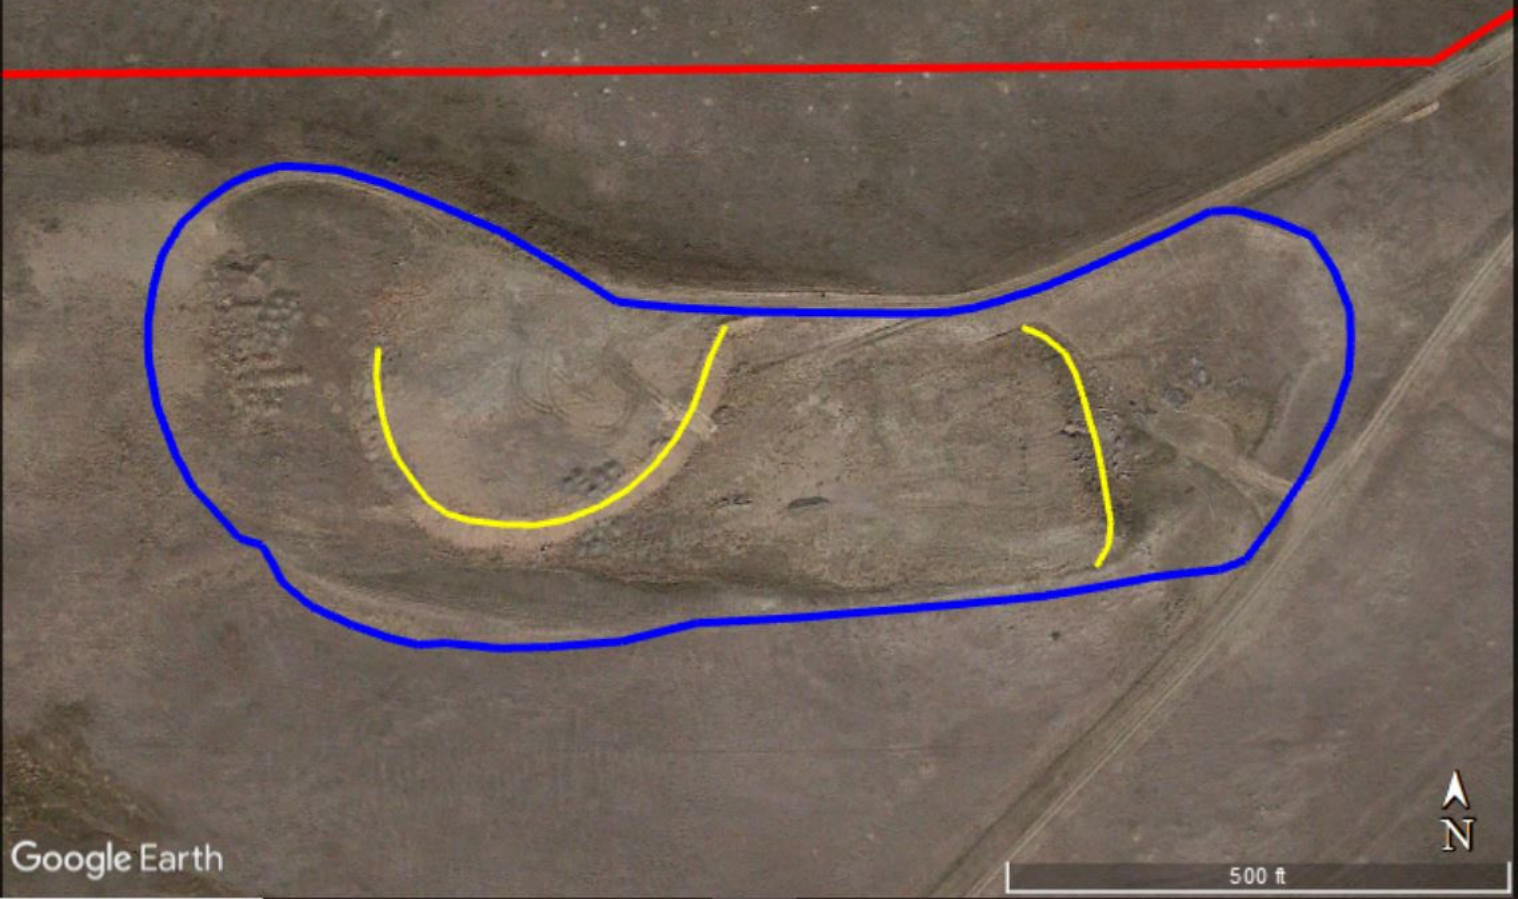
Closer view of disturbed area.

Red outline = 233.60 acres = Approved Permit Area (location approximated based on permit maps)

Blue outline = 8 acres = Estimated disturbance requiring reclamation

Yellow lines = Side slopes of upper and lower backfill lifts  
(Image data from 9/29/2020)
