To: Jerald Schnabel From: Paul Kos
Continental Materials Corp. Denver, CO 80222
File: September 2021 Monitoring Summary Date: October 31, 2021

Reference: September 2021 Geotechnical Monitoring Summary Pikeview Quarry

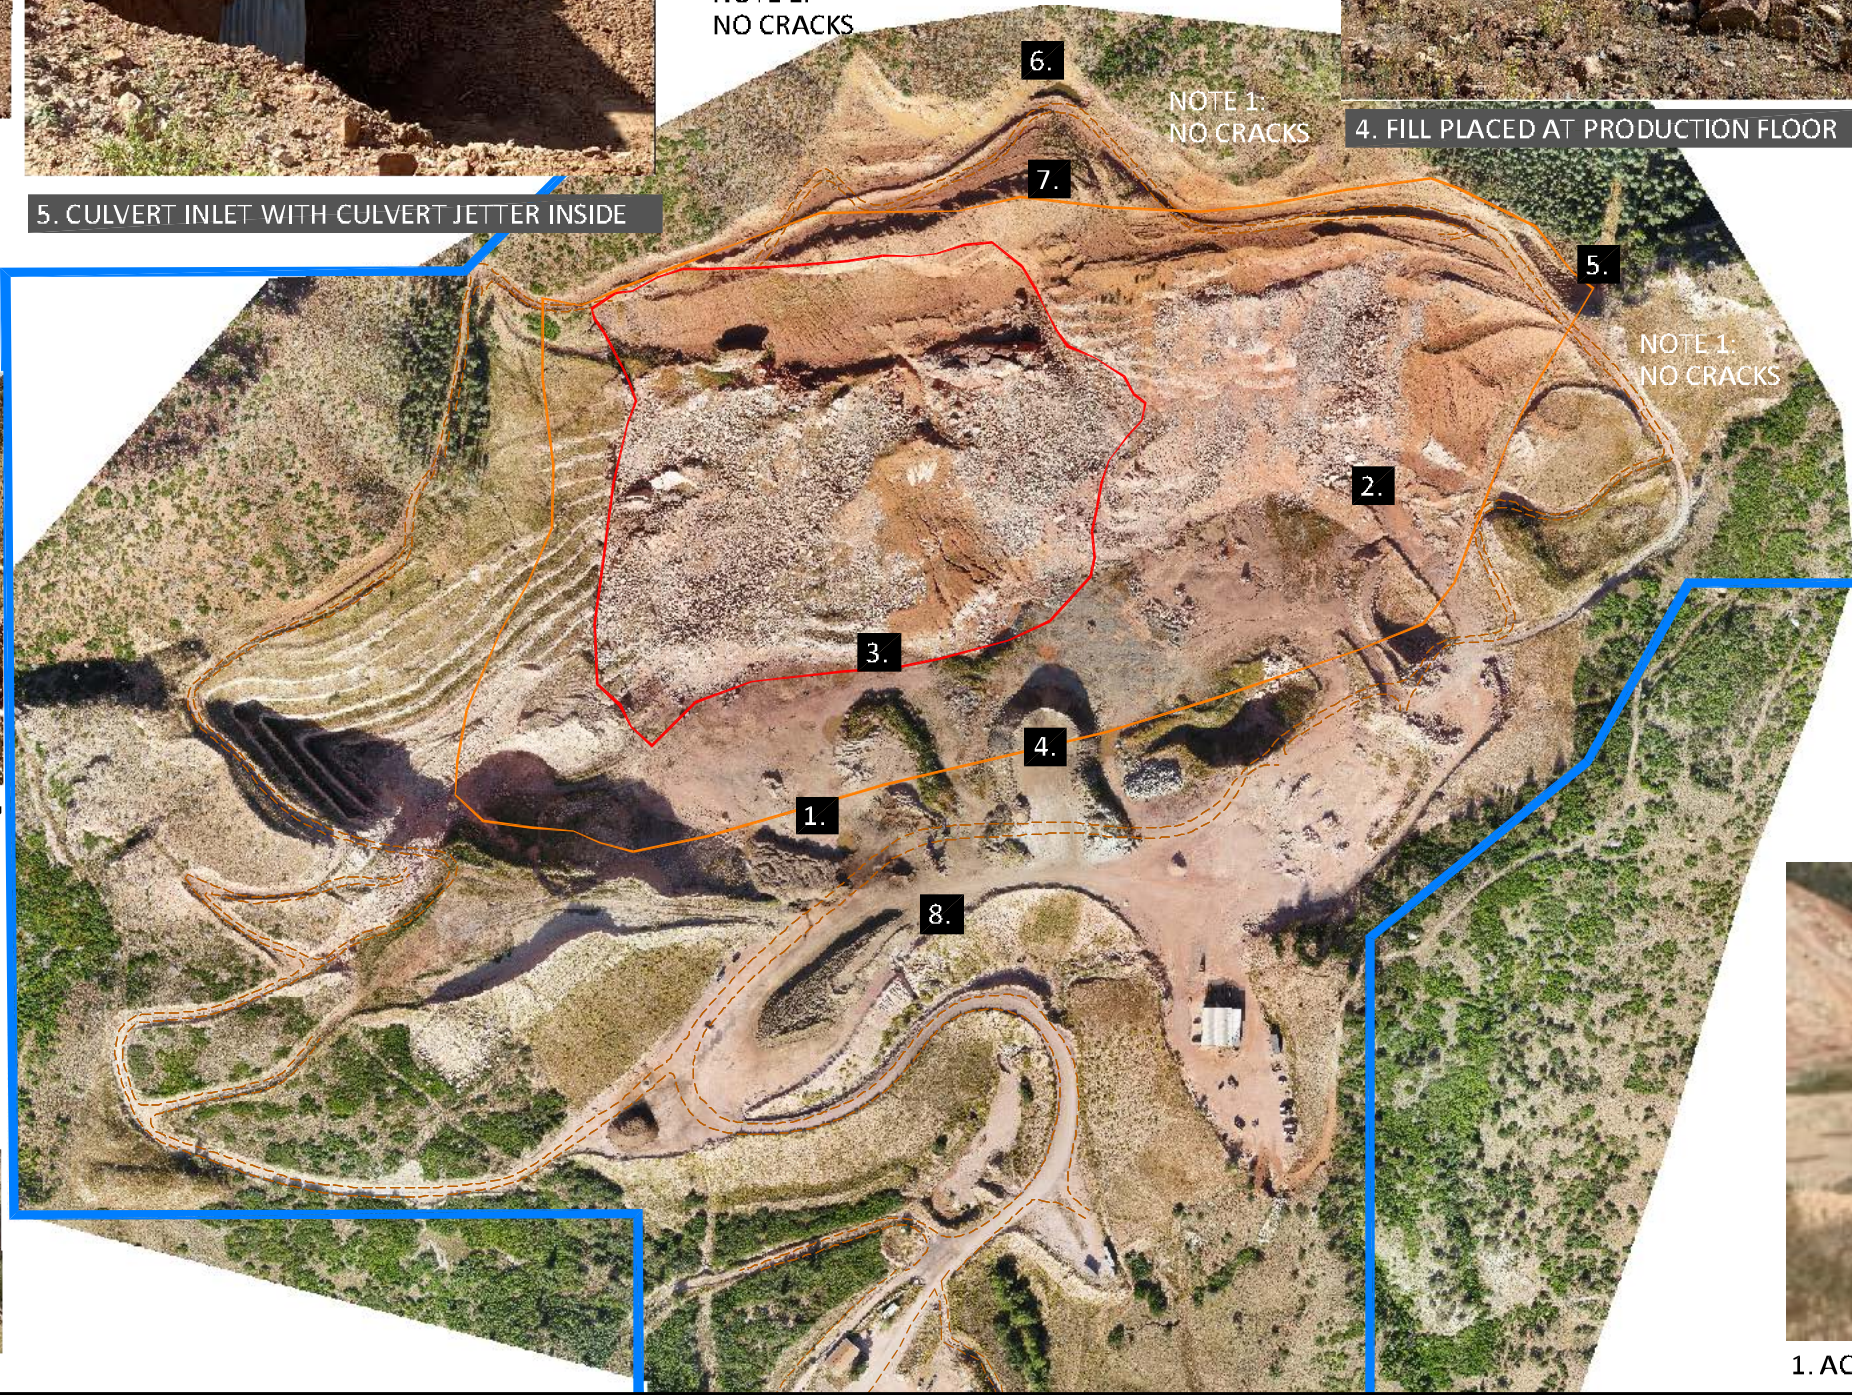
NOTE 1:
NO CRACKS

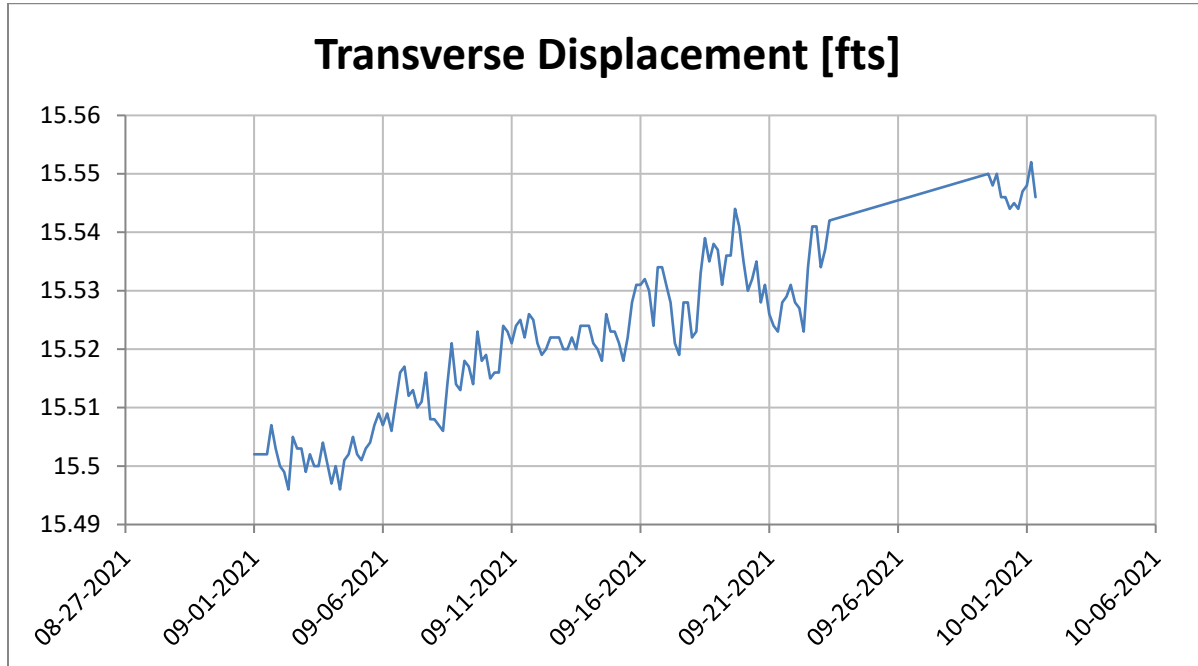
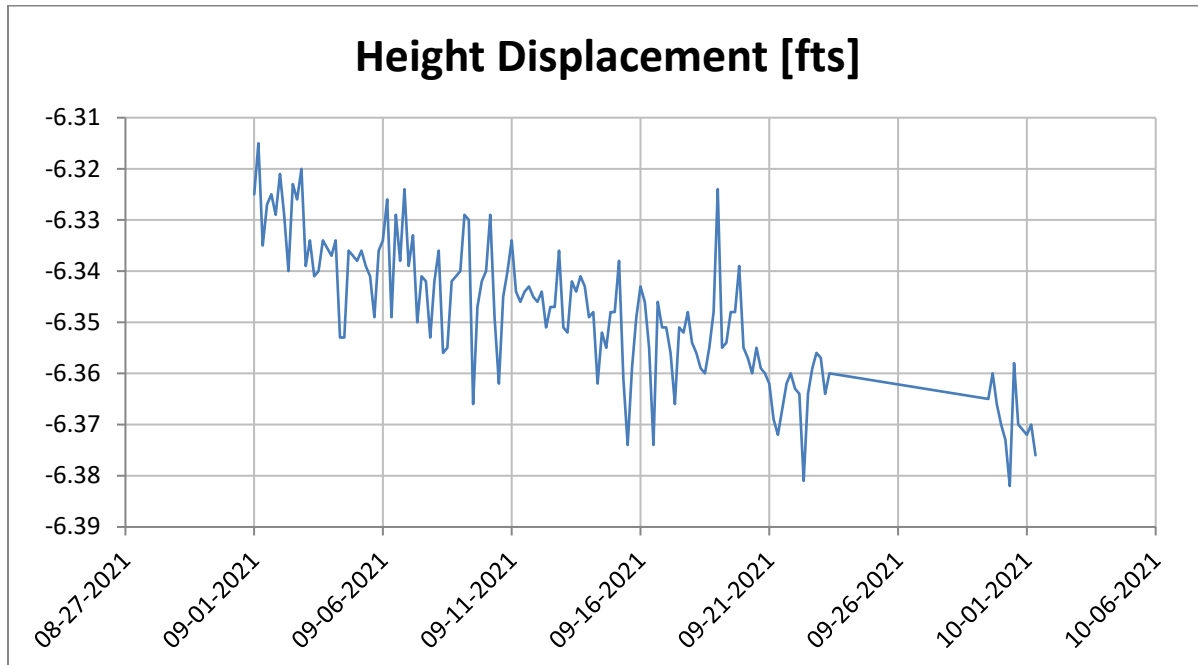
Prism P63

The data show stable conditions with no movement for 16 of 20 prisms with recorded displacements limited to data scatter and not actual movements. Prisms P63, TOE2, and TOE3 are located at the toe of the landslide, and these locations showed slope creep movements at slow velocities (approximately 0.001 feet per day or less). Prism NP66 is located above the landslide, and this prism also recorded slope creep movements at slow velocity. This settlement is likely related to the increased moisture causing the landslide material to consolidate. Plots of the transverse and height displacements for each prism are included in Appendix B.
