MINERALS PROGRAM INSPECTION REPORT
PHONE: (303) 866-3567

MINE NAME: Lamar Pit	MINE/PROSPECTING ID#: M-1987-079	MINERAL: Sand and gravel	COUNTY: Prowers
INSPECTION TYPE: Monitoring	INSPECTOR(S): Amy Eschberger	INSP. DATE: October 20, 2021	INSP. TIME: 14:45
OPERATOR: All-Rite Paving & Redi-Mix, Inc.	OPERATOR REPRESENTATIVE: Mario Ambrosio	TYPE OF OPERATION: 112c - Construction Regular Operation

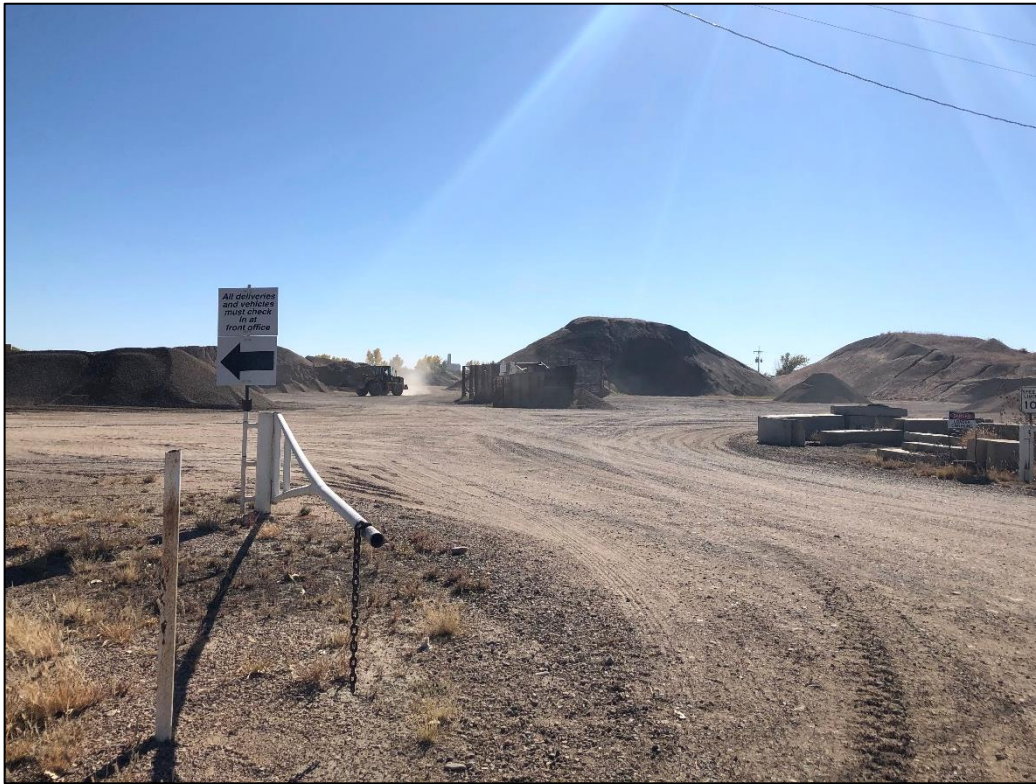
Photo 1. View looking south from northern permit boundary across northwestern portion of industrial yard. Note material stockpiles stored in this area (not derived from this site).

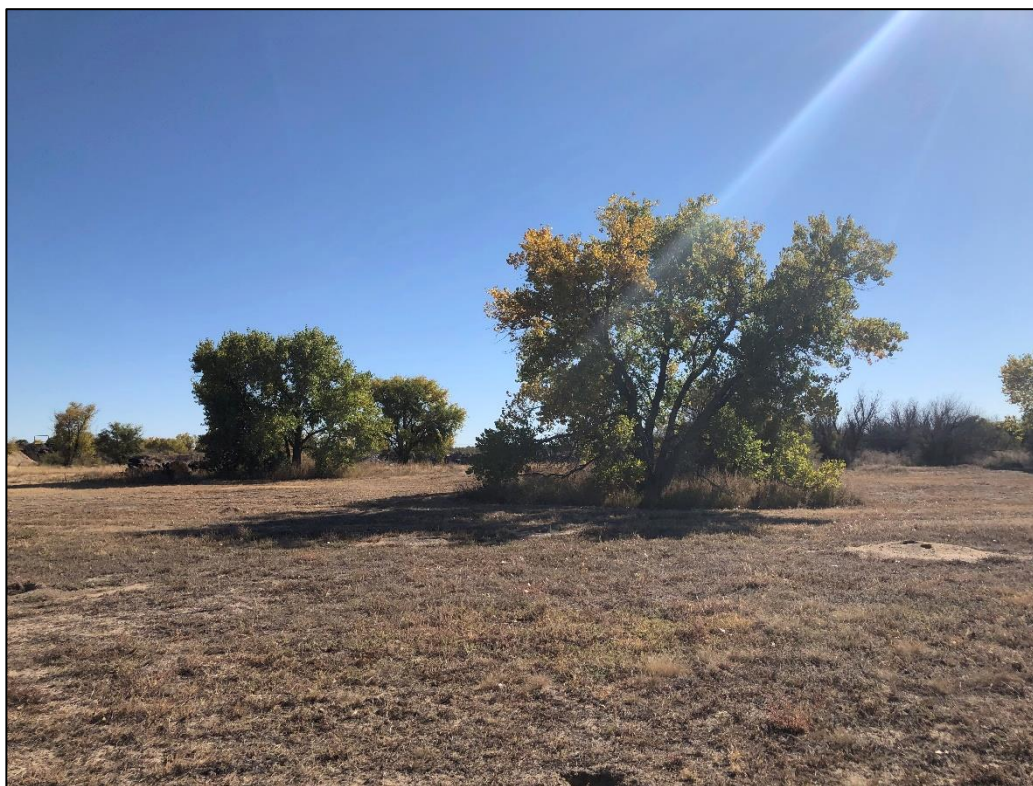
Photo 4. View looking south across central portion of Phase 2 mine area, not mined by operation.

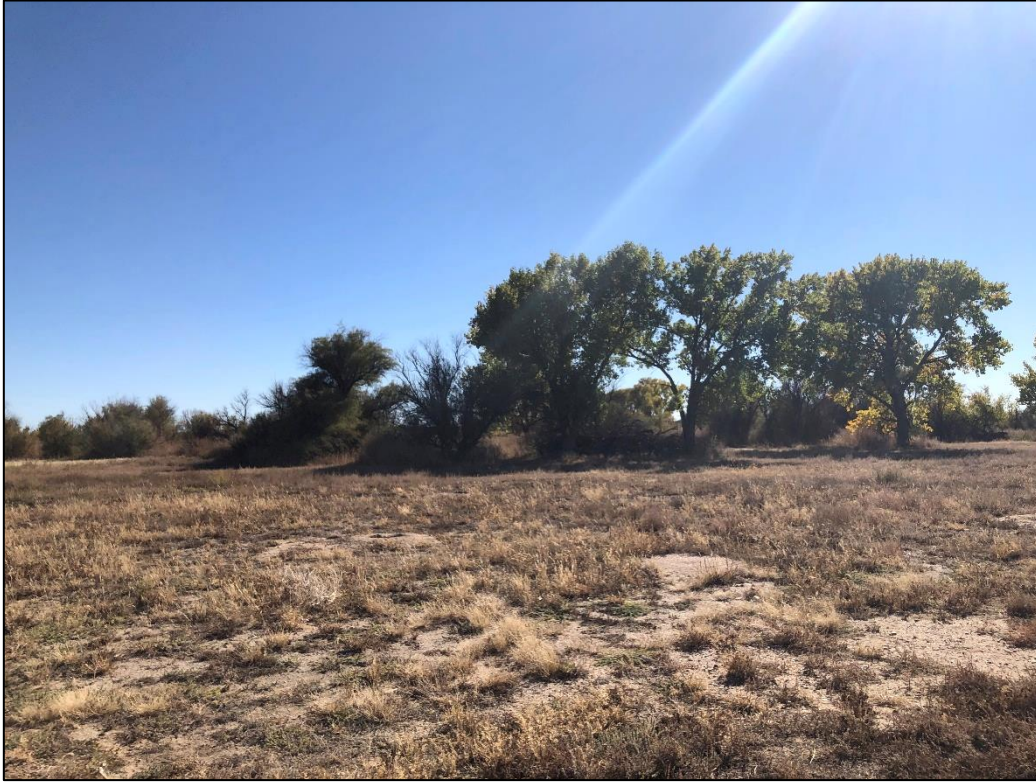
Photo 5. View looking south across western portion of Phase 2 mine area, not mined by operation.

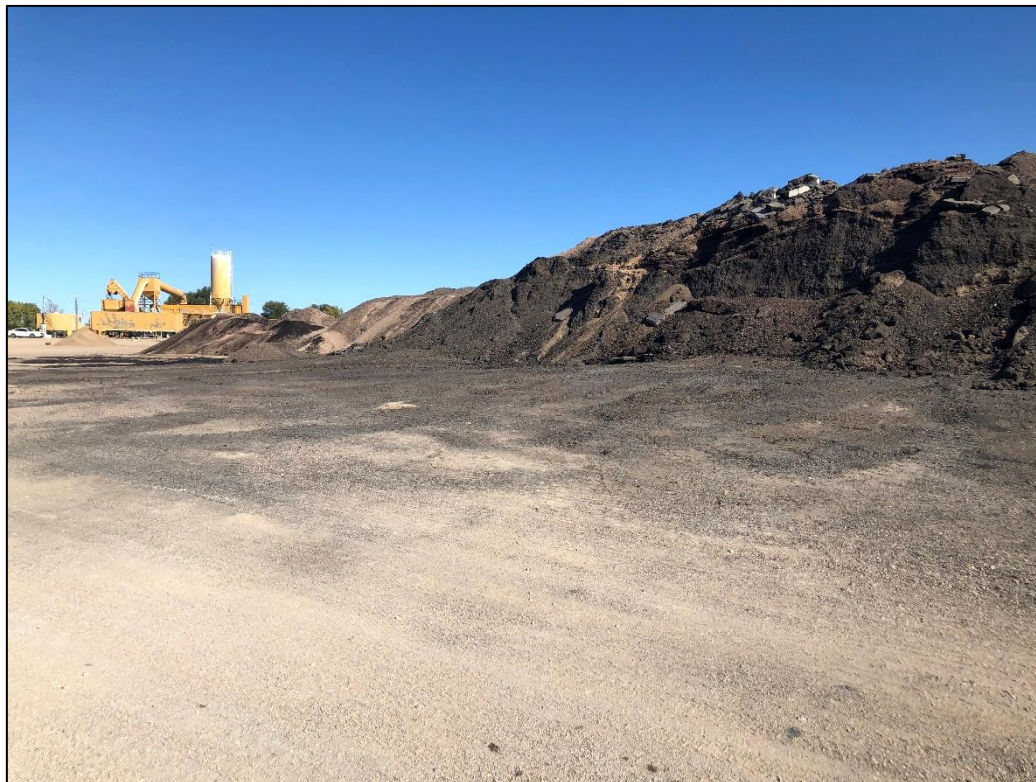
Photo 14. View looking east/northeast across industrial yard located in eastern portion of permit area, showing large asphalt stockpile (in foreground) and asphalt plant (in background) present in this area.

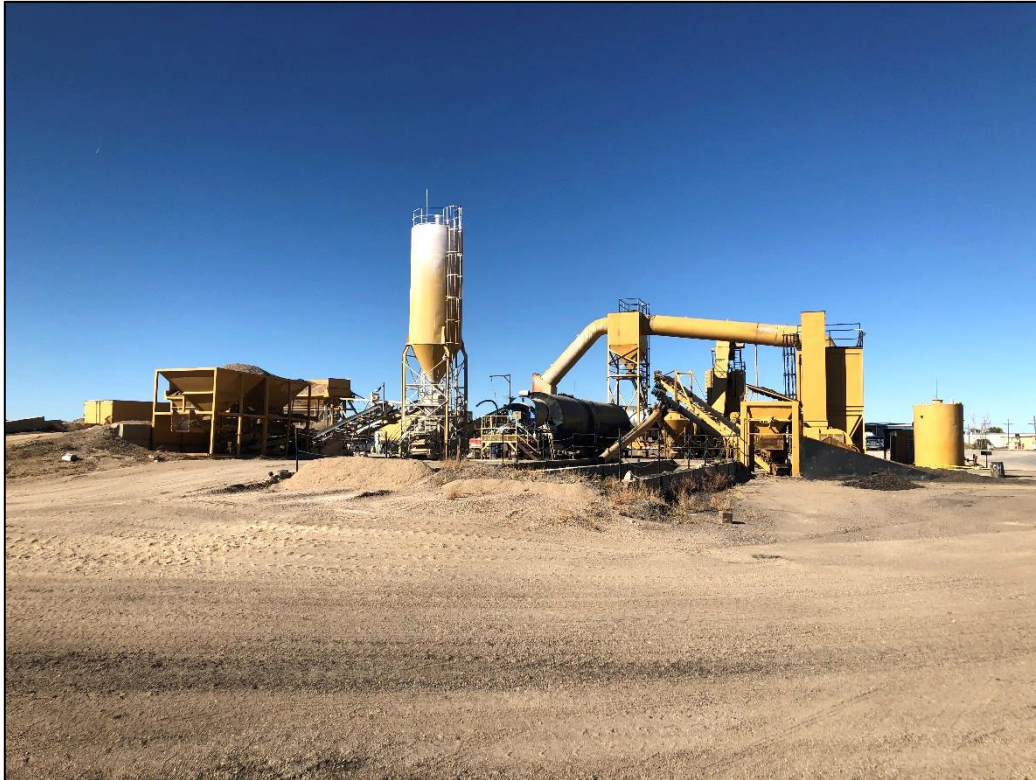
Photo 15. View looking north at asphalt plant present in industrial yard located in eastern portion of permit area.

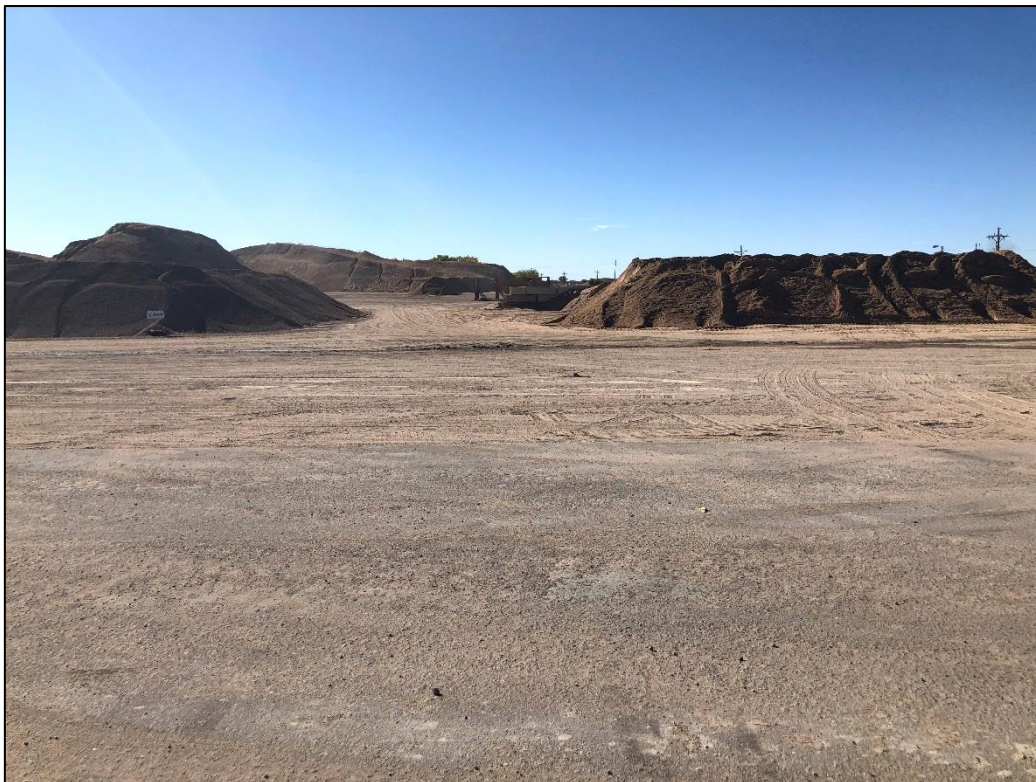
Photo 16. View looking west across industrial yard located in eastern portion of permit area, showing material stockpiles present in this area (not derived from this site).

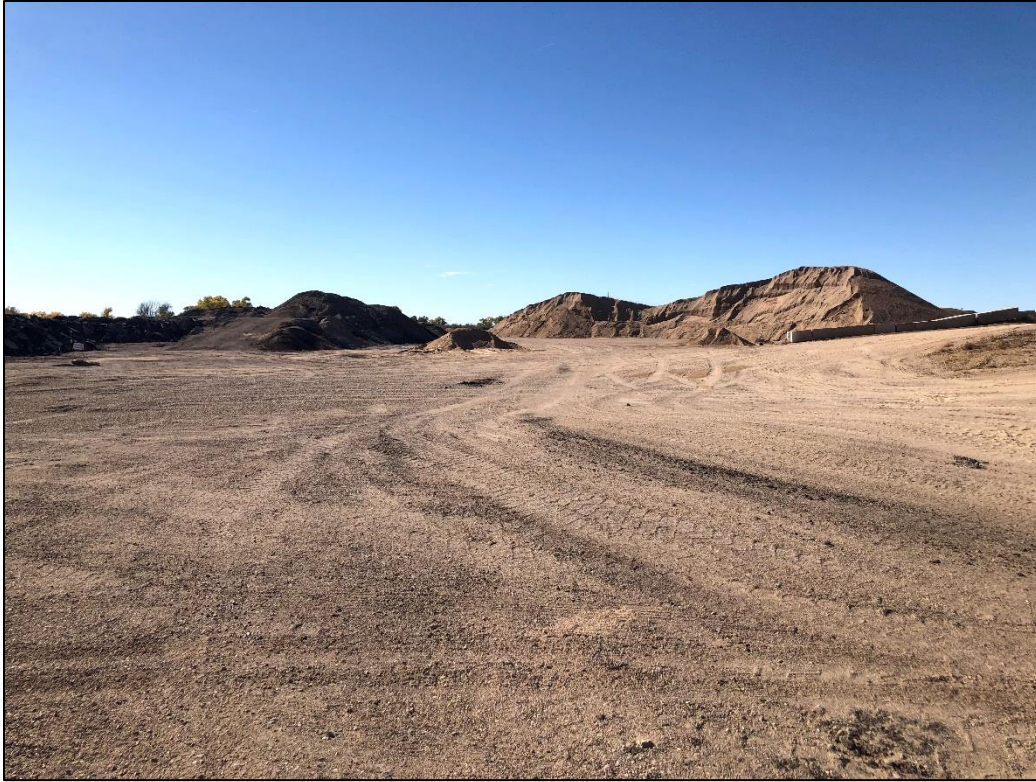
Photo 17. View looking southwest across industrial yard located in eastern portion of permit area, showing material stockpiles present in this area (not derived from this site).

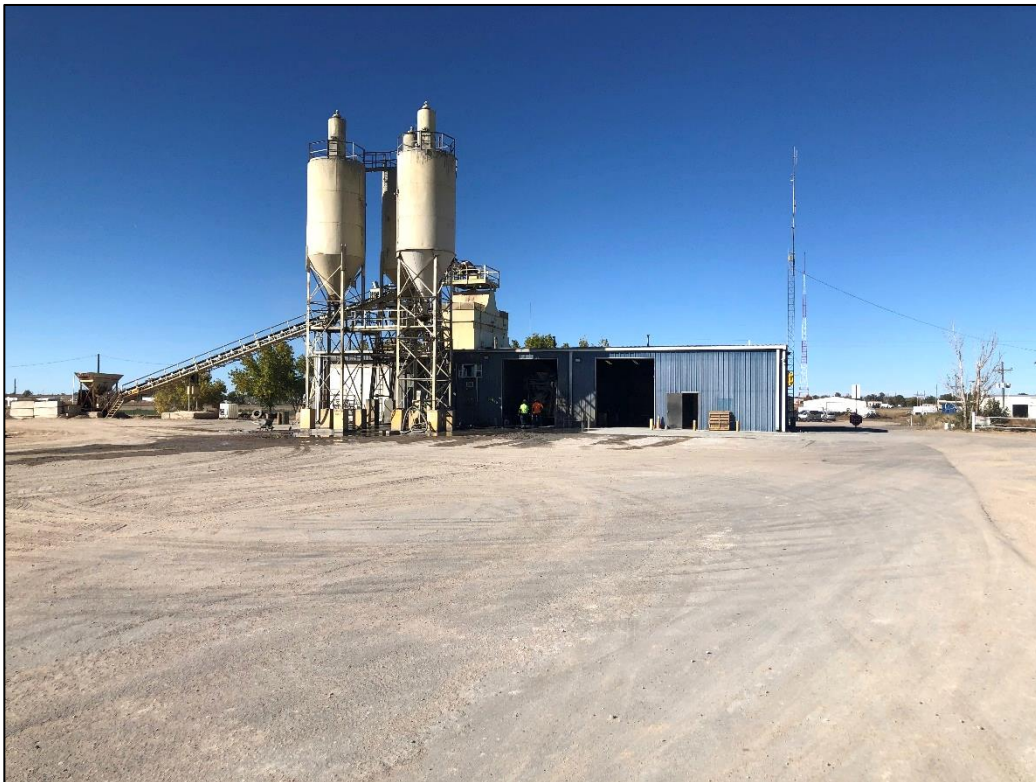
Photo 18. View looking north at concrete plant present in industrial yard located in eastern portion of permit area.
