To: Jerald Schnabel From: Paul Kos  
Continental Materials Corp. Denver, CO 80222  
File: October 2021 Monitoring Summary Date: November 30, 2021

**Reference: October 2021 Geotechnical Monitoring Summary Pikeview Quarry**

Title OBSERVATIONS FROM OCTOBER INSPECTION	
Revision #	Date 2021.11.30
Drawn By PK	Figure No. 2

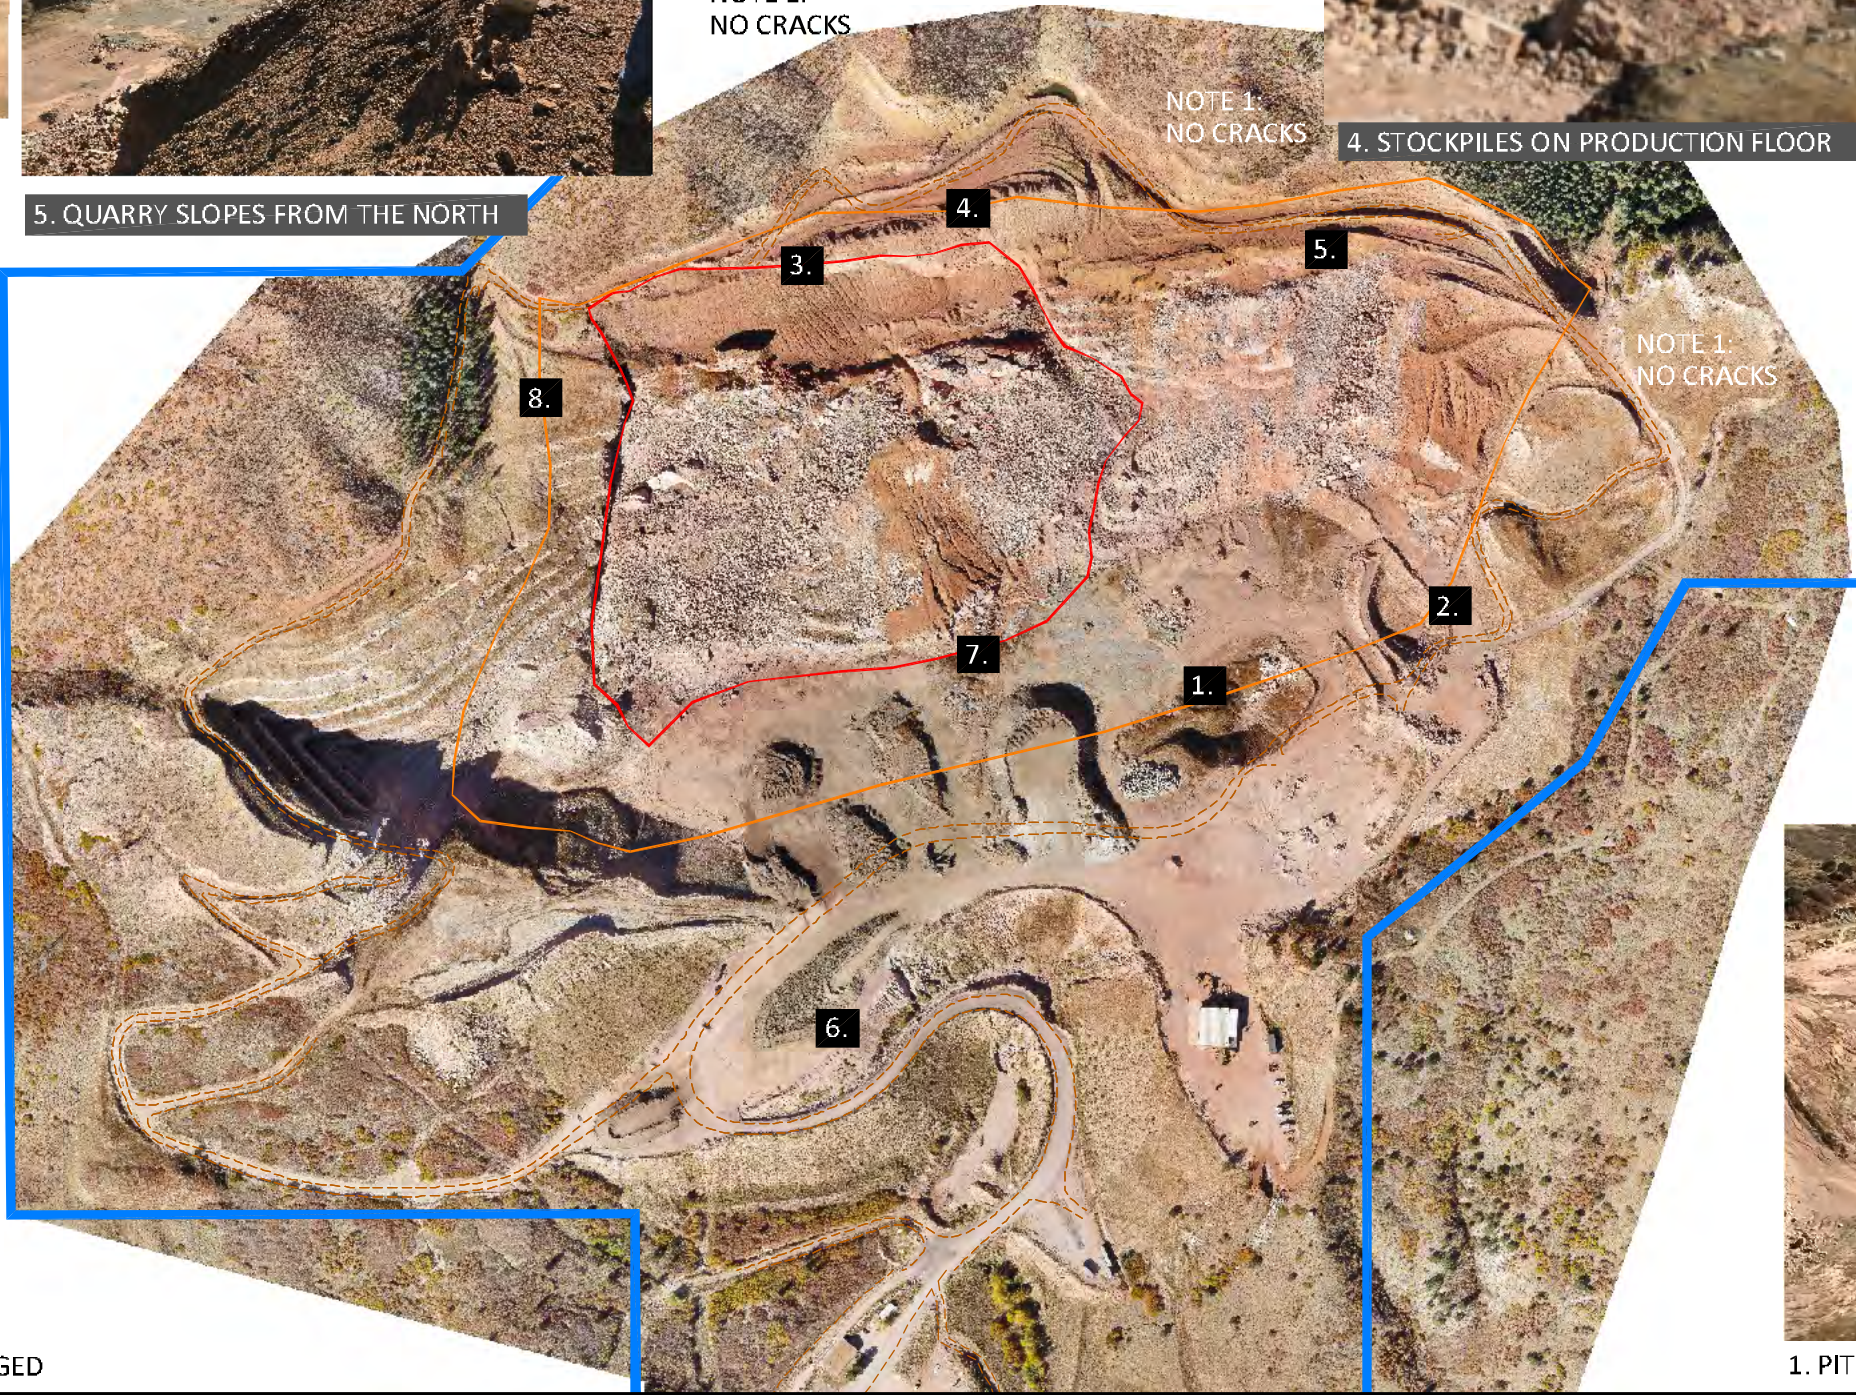
- Previously Observed Cracks: Previously observed tension cracks remain on the production floor and at the crest of fill slopes. These cracks were observed following the period of heavy rain and are likely due to the recent heavy rain allowing consolidation of the material in this area. (Photo 2)

2. CRACKING NEAR PRODUCTION FLOOR
