MINERALS PROGRAM INSPECTION REPORT
PHONE: (303) 866-3567

MINE NAME: Golden Wonder Mine	MINE/PROSPECTING ID#: M-1978-091-UG	MINERAL: Gold	COUNTY: Hinsdale
INSPECTION TYPE: Monitoring	INSPECTOR(S): Stephanie Mitchell	INSP. DATE: August 13, 2020	INSP. TIME: 11:00
OPERATOR: LKA International Inc.	OPERATOR REPRESENTATIVE: Kye Abraham	TYPE OF OPERATION: 110d - Designated Limited Impact	
REASON FOR INSPECTION: Normal I&E Program	BOND CALCULATION TYPE: None	BOND AMOUNT: \$136,046.10	
DATE OF COMPLAINT: NA	POST INSP. CONTACTS: None	JOINT INSP. AGENCY: None	
WEATHER: Clear	INSPECTOR'S SIGNATURE:

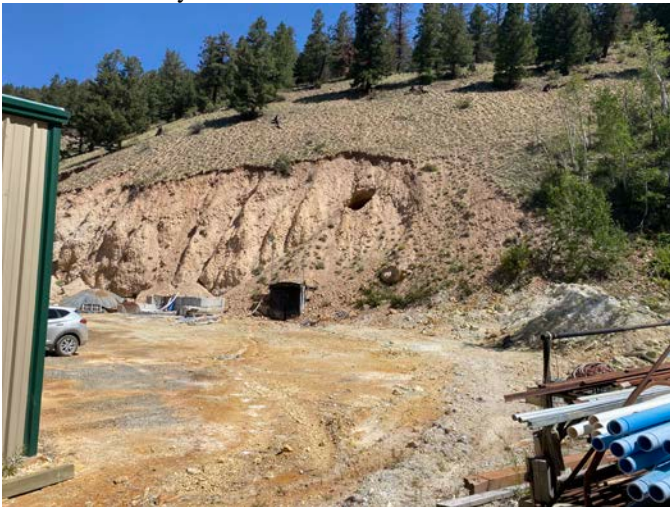
Portal- level 6

Above the portal at the level 6, there appears to be some subsidence or collapsing. The Operator is encouraged to repair the feature to reduce future collapsing.

Subsidence/collapse to be repaired
