**MINERALS PROGRAM INSPECTION REPORT**  
**PHONE: (303) 866-3567**

<b>MINE NAME:</b> Golden Wonder Mine	<b>MINE/PROSPECTING ID#:</b> M-1978-091-UG	<b>MINERAL:</b> Gold	<b>COUNTY:</b> Hinsdale
<b>INSPECTION TYPE:</b> Multi Person Inspection	<b>INSPECTOR(S):</b> Lucas West	<b>INSP. DATE:</b> December 8, 2021	<b>INSP. TIME:</b> 11:15
<b>OPERATOR:</b> LKA International Inc.	<b>OPERATOR REPRESENTATIVE:</b> Kye Abraham	<b>TYPE OF OPERATION:</b> 110d - Designated Limited Impact	
<b>REASON FOR INSPECTION:</b> High Priority	<b>BOND CALCULATION TYPE:</b> None	<b>BOND AMOUNT:</b> \$136,046.10	
<b>DATE OF COMPLAINT:</b> NA	<b>POST INSP. CONTACTS:</b> None	<b>JOINT INSP. AGENCY:</b> None	
<b>WEATHER:</b> Cloudy	<b>INSPECTOR'S SIGNATURE:</b>

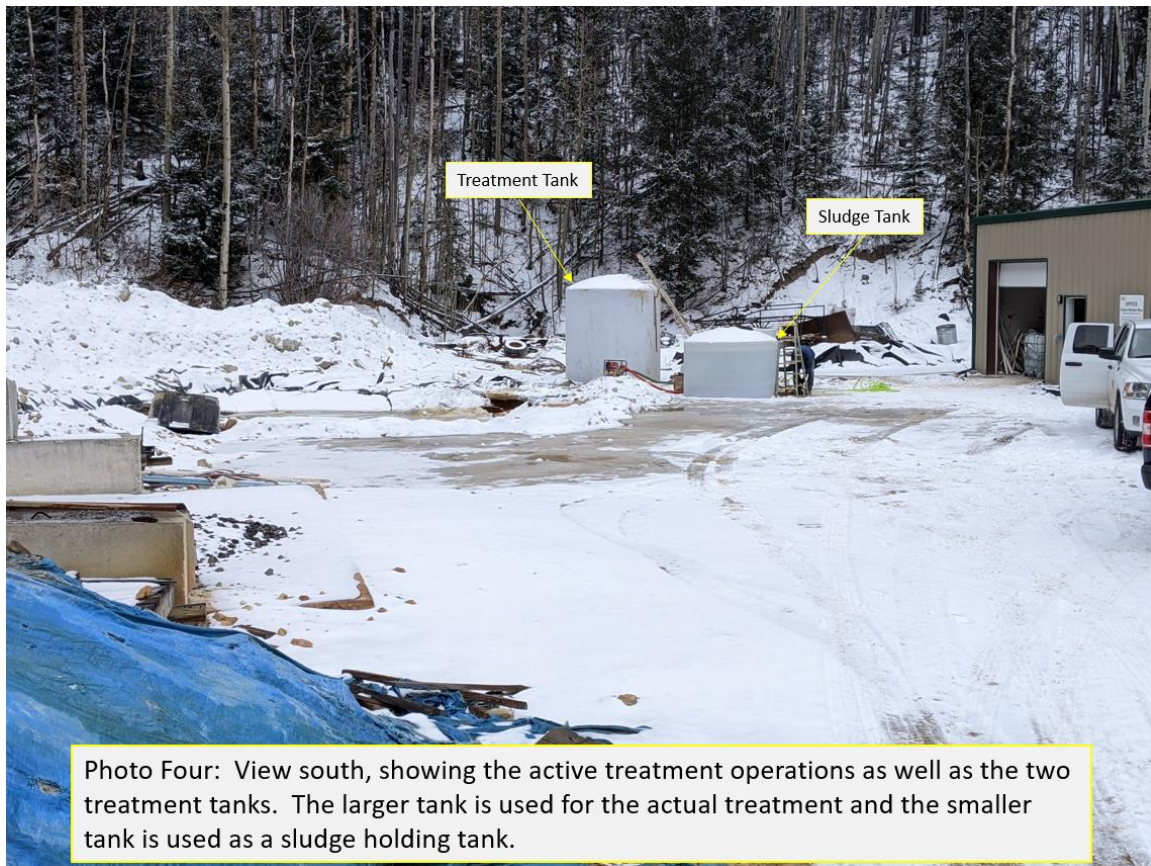
During the inspection, water treatment operations were actively being conducted. Water from the Mine Water Pond was being pumped into the 5,000 gallon treatment tank, where chemicals were being added to adjust the pH and precipitate out metals. Once the precipitant had settled, the sludge was pumped to a smaller holding tank, and treated water was tested and discharged. The condition of the Mine Water Pond can be seen in Photo Three. Photo Four shows the tanks being utilized in the treatment process. Discussions with the Operator indicate that once the Mine Water Pond was pumped down sufficiently the Storm Water Pond would be pumped and treated in the same manner. Photo Five shows the condition of the Storm Water Pond as observed at the time of the inspection. The treated water is being conveyed down the limestone channel via PVC pipe and discharged as seen in Photo Six.
