MINERALS PROGRAM INSPECTION REPORT

MINE NAME: Cross Gold Mine	MINE/PROSPECTING ID#: M-1977-410	MINERAL: Gold, copper, silver, zinc and lead	COUNTY: Boulder
INSPECTION TYPE: Monitoring	INSPECTOR(S): Amy Eschberger, Michael Cunningham, Russ Means	INSP. DATE: January 11, 2022	INSP. TIME: 09:45
OPERATOR: Grand Island Resources LLC	OPERATOR REPRESENTATIVE(S): Richard Mittasch, Daniel Pollock, Daniel Takami	TYPE OF OPERATION: 110(2) - Hard Rock Limited Impact

M-1977-410 / Cross Gold Mine / Grand Island Resources LLC / 110(2) Permit

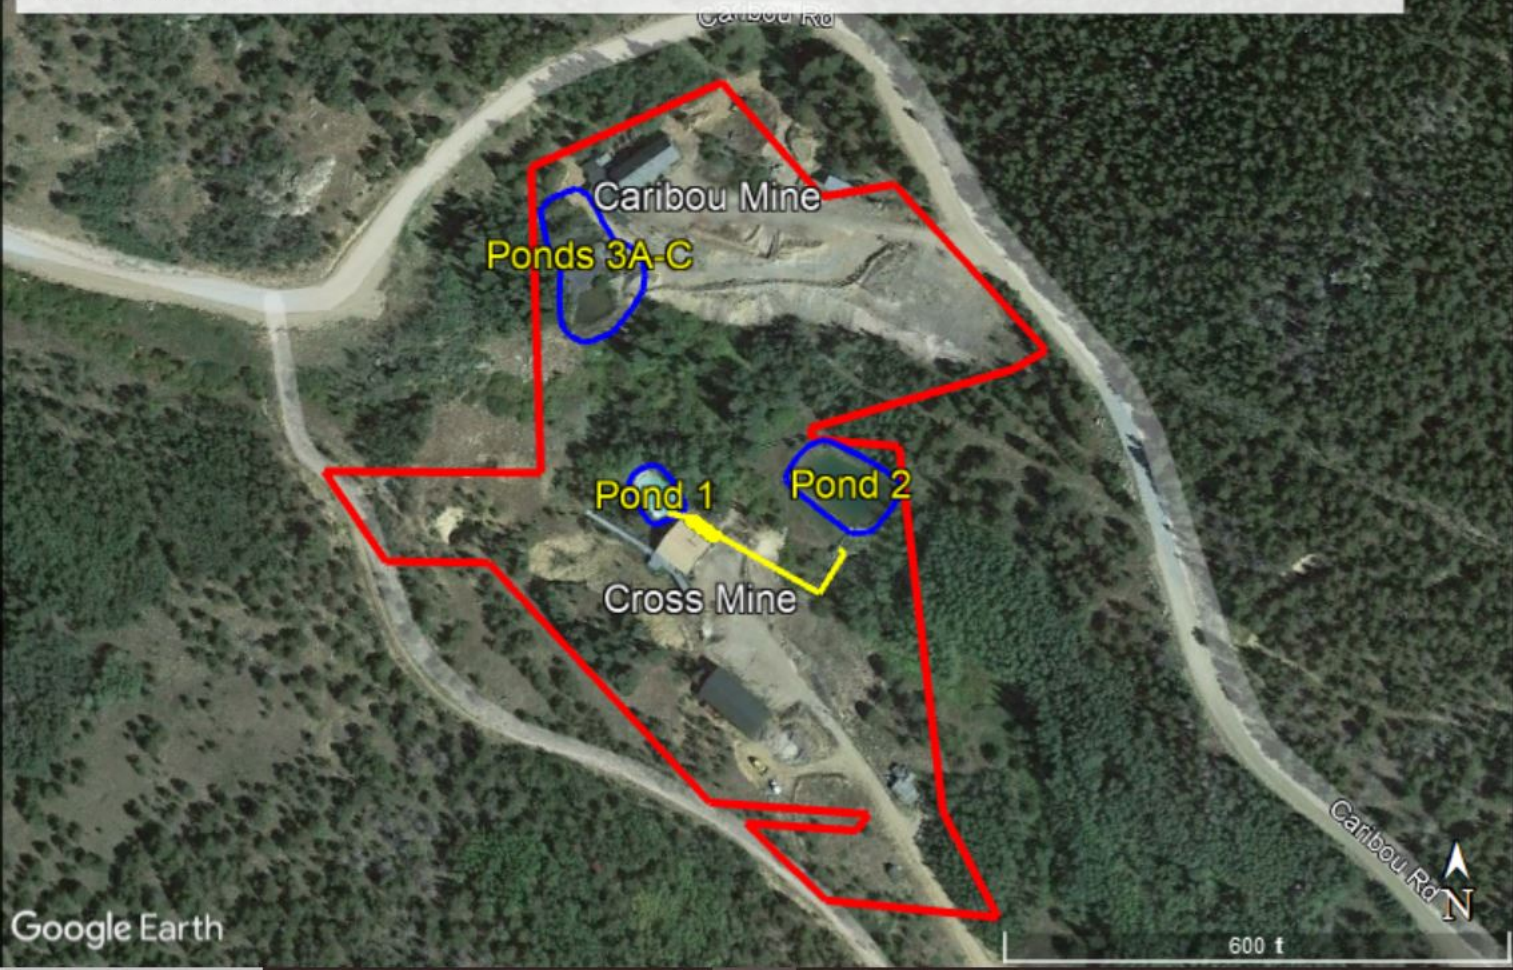
Yellow box = Approx. location of Conex box housing new water treatment system

Yellow line = Approx. location of new pipelines installed to direct water from Pond 1 through new treatment system then to existing discharge pipeline
(Image data from 9/13/2019)

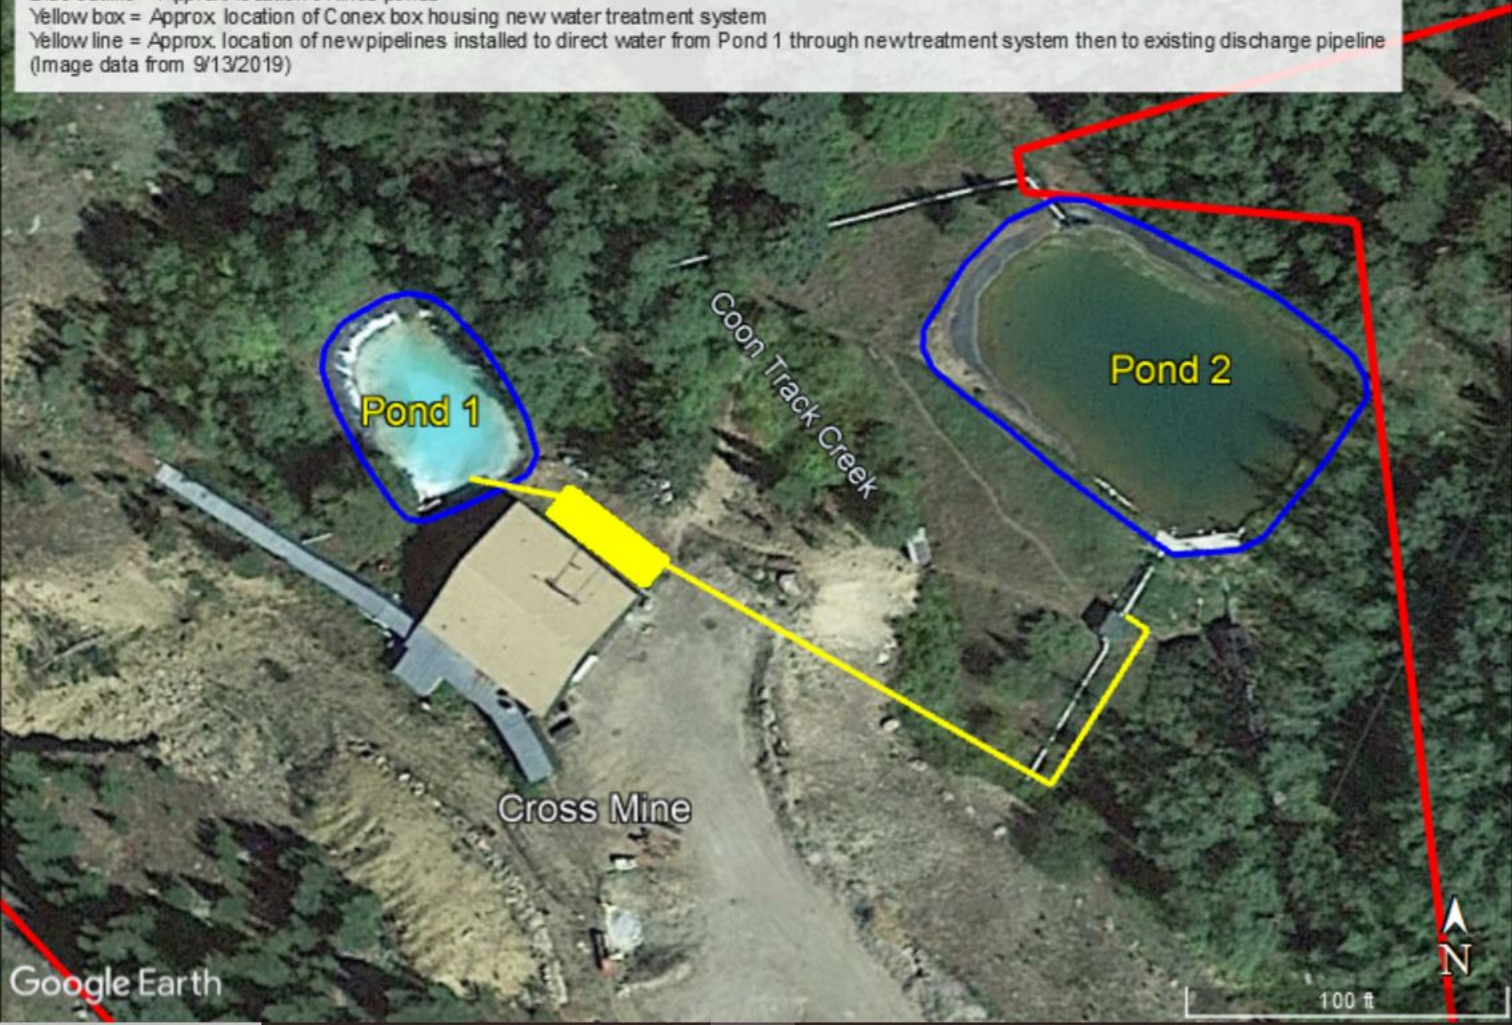
M-1977-410 / Cross Gold Mine / Grand Island Resources LLC / 110(2) Permit

(Closer view of new water treatment infrastructure)

Red outline = 8.95 acres = Approved permit area (location approximated based on permit maps)

Blue outline = Approx. location of lined ponds

Yellow box = Approx. location of Conex box housing new water treatment system

Yellow line = Approx. location of new pipelines installed to direct water from Pond 1 through new treatment system then to existing discharge pipeline (Image data from 9/13/2019)
