To: Jerald Schnabel From: Paul Kos
Continental Materials Corp. Denver, CO 80222
File: December 2021 Monitoring Summary Date: January 31, 2022

Reference: December 2021 Geotechnical Monitoring Summary Pikeview Quarry

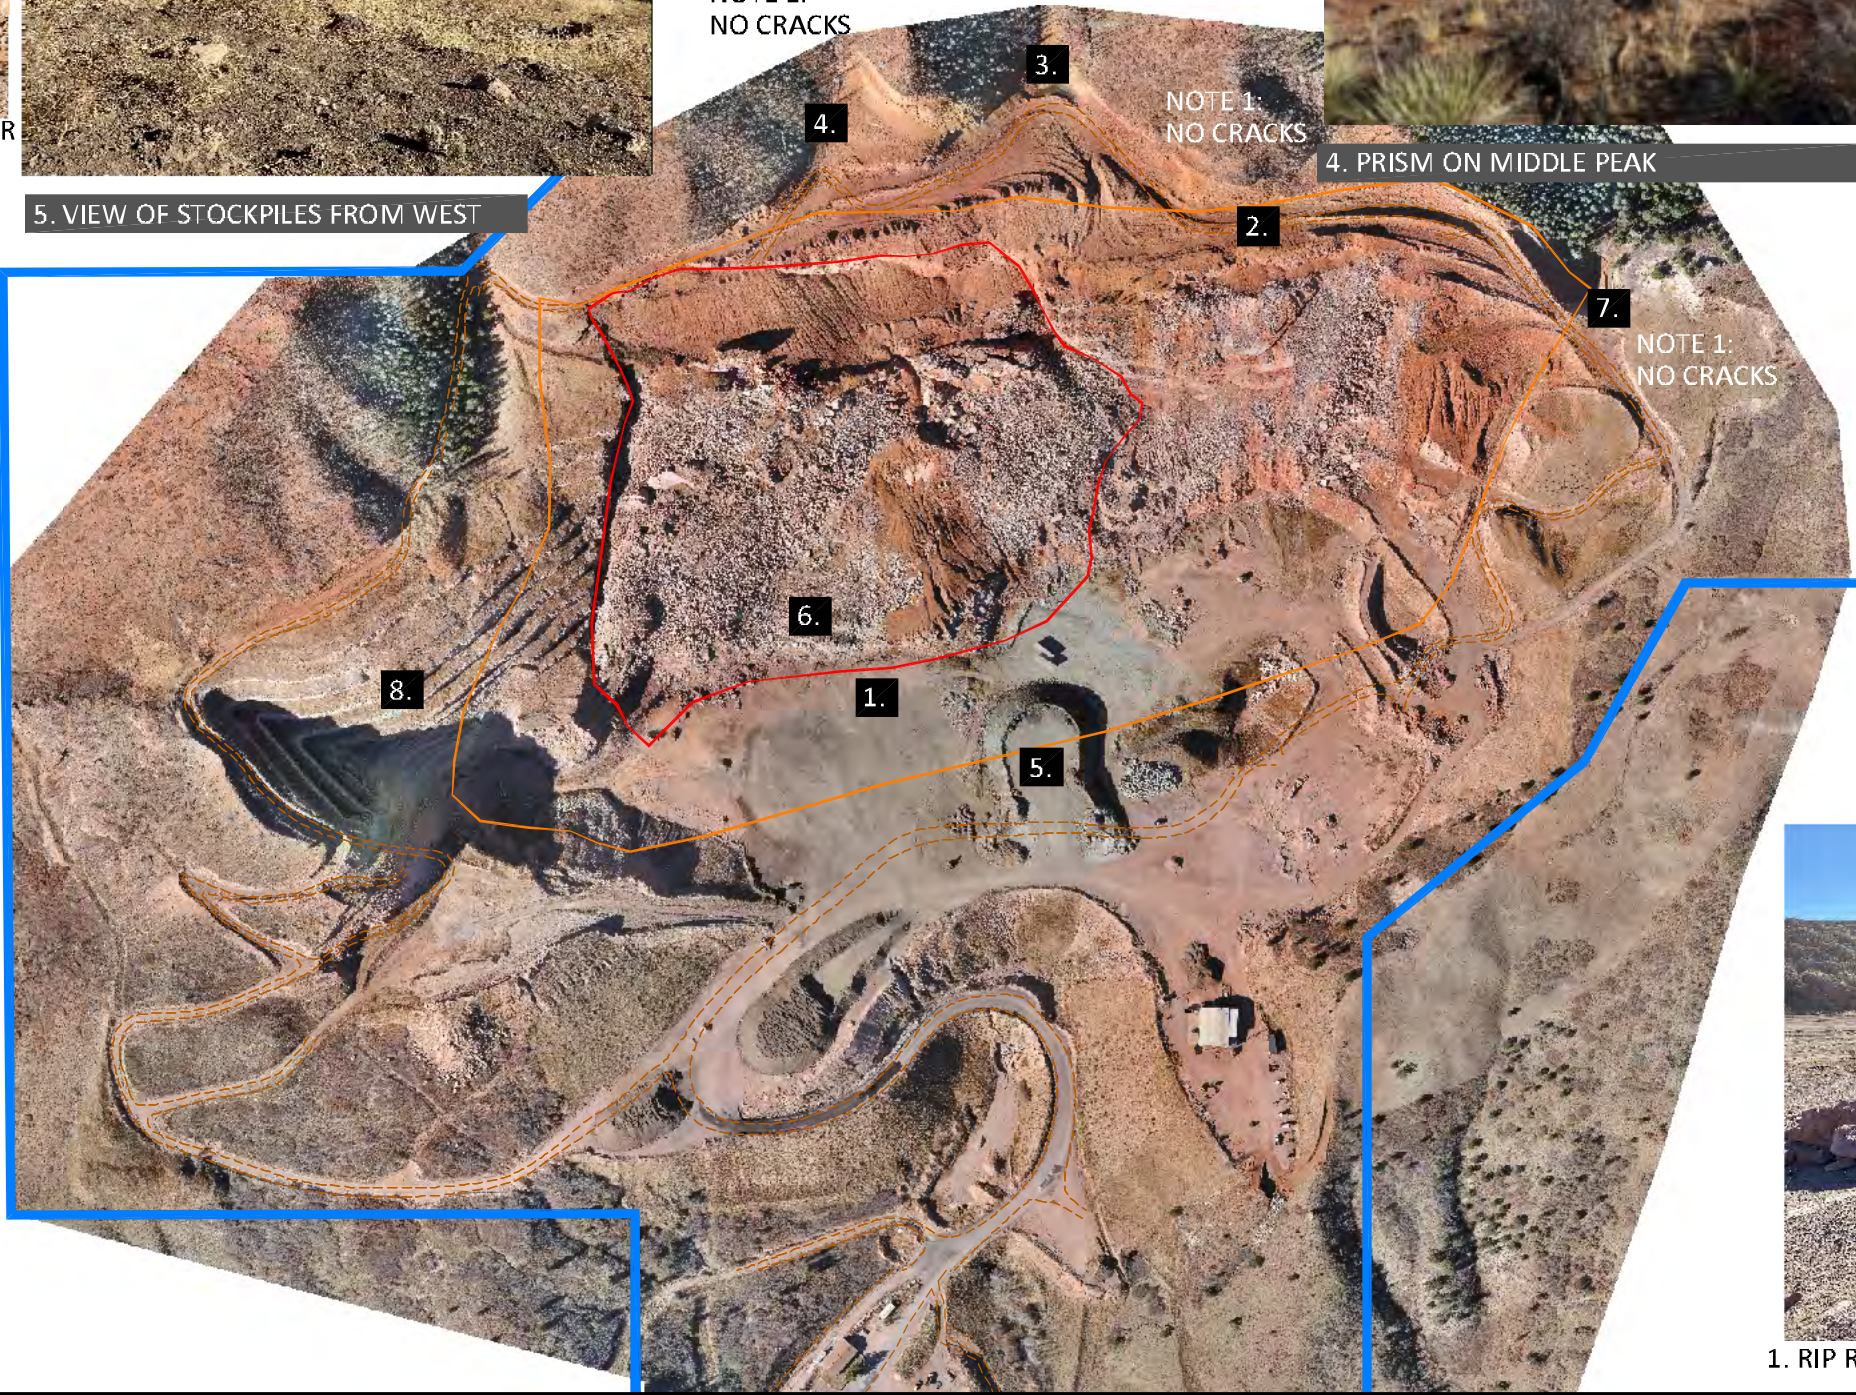
- Imported fill material and topsoil are being stockpiled in several areas on the production floor. (Photo 5)
- The culvert remains cleared but mostly blocked inside. CMC has partially cleared the debris, but access limitations and supports within the culvert inhibit clearing all the debris. CMC has procured a pump and will begin pumping operations if any water collects behind the culvert. CMC inspects the culvert for ponded water following rain events, and should any water be observed, it will be removed using pumps. To date, no ponding has been observed. (Photo 7)

2. VIEW OF GROWTH MEDIUM AND TOP SOIL
