MINERALS PROGRAM INSPECTION REPORT
PHONE: (303) 866-3567

MINE NAME: SR-13A Mine	MINE/PROSPECTING ID#: M-1977-311	MINERAL: Uranium and vanadium	COUNTY: San Miguel
INSPECTION TYPE: Surety Release Inspection	INSPECTOR(S): Lucas West	INSP. DATE: December 9, 2021	INSP. TIME: 14:11
OPERATOR: Highbury Resources Inc.	OPERATOR REPRESENTATIVE: Scott Potorff	TYPE OF OPERATION: 110d - Designated Limited Impact	
REASON FOR INSPECTION: Surety Release Requested	BOND CALCULATION TYPE: None	BOND AMOUNT: \$200.00	
DATE OF COMPLAINT: NA	POST INSP. CONTACTS: None	JOINT INSP. AGENCY: None	
WEATHER: Snowing	INSPECTOR'S SIGNATURE:

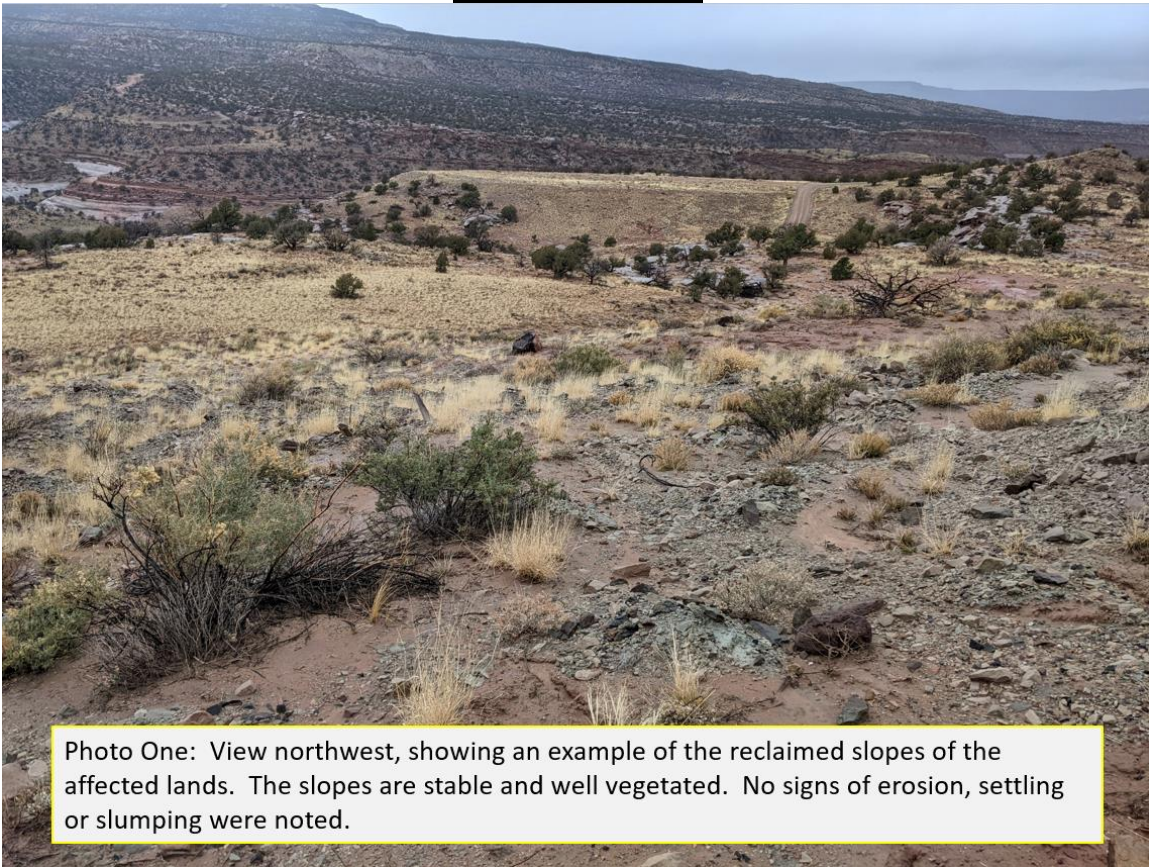
The proper mine identification signage was posted at the entrance to the site. There was no equipment on site and the site was not active during the inspection. Final reclamation had been completed at the site some years ago, with ongoing monitoring and active weed control. All grading and dirt work was stable at the time of the inspection. The waste piles have on site have been graded to a 2H: 1V or shallower configuration and appear to be stable and in good condition. Examples of the reclaimed slopes can be seen in Photos One and Two. The slopes were all "pocked" to prevent erosion and assist the vegetation growth. The slopes show no significant signs of erosion and the vegetation appears to be as good as or better than surrounding undisturbed areas. The vegetation is adequate in both density and diversity, and multiple years biomass was observed indicating it is self-sufficient. Other disturbed areas have been blended to match the existing rock outcrops and are also in excellent condition. Photo Three shows the blended areas.
