2022 ANNUAL REPORT STRUCTURAL GEOLOGY EVALUATION SPECIFICATIONS AGGREGATE QUARRY

**Martin Marietta Materials
Golden, Colorado**

21C64003.00
January 26, 2022

**Subject: Project 21C64003.00, 2022 Annual Report, Structural Geology Evaluation,
Specification Aggregates Quarry, Golden, Colorado**

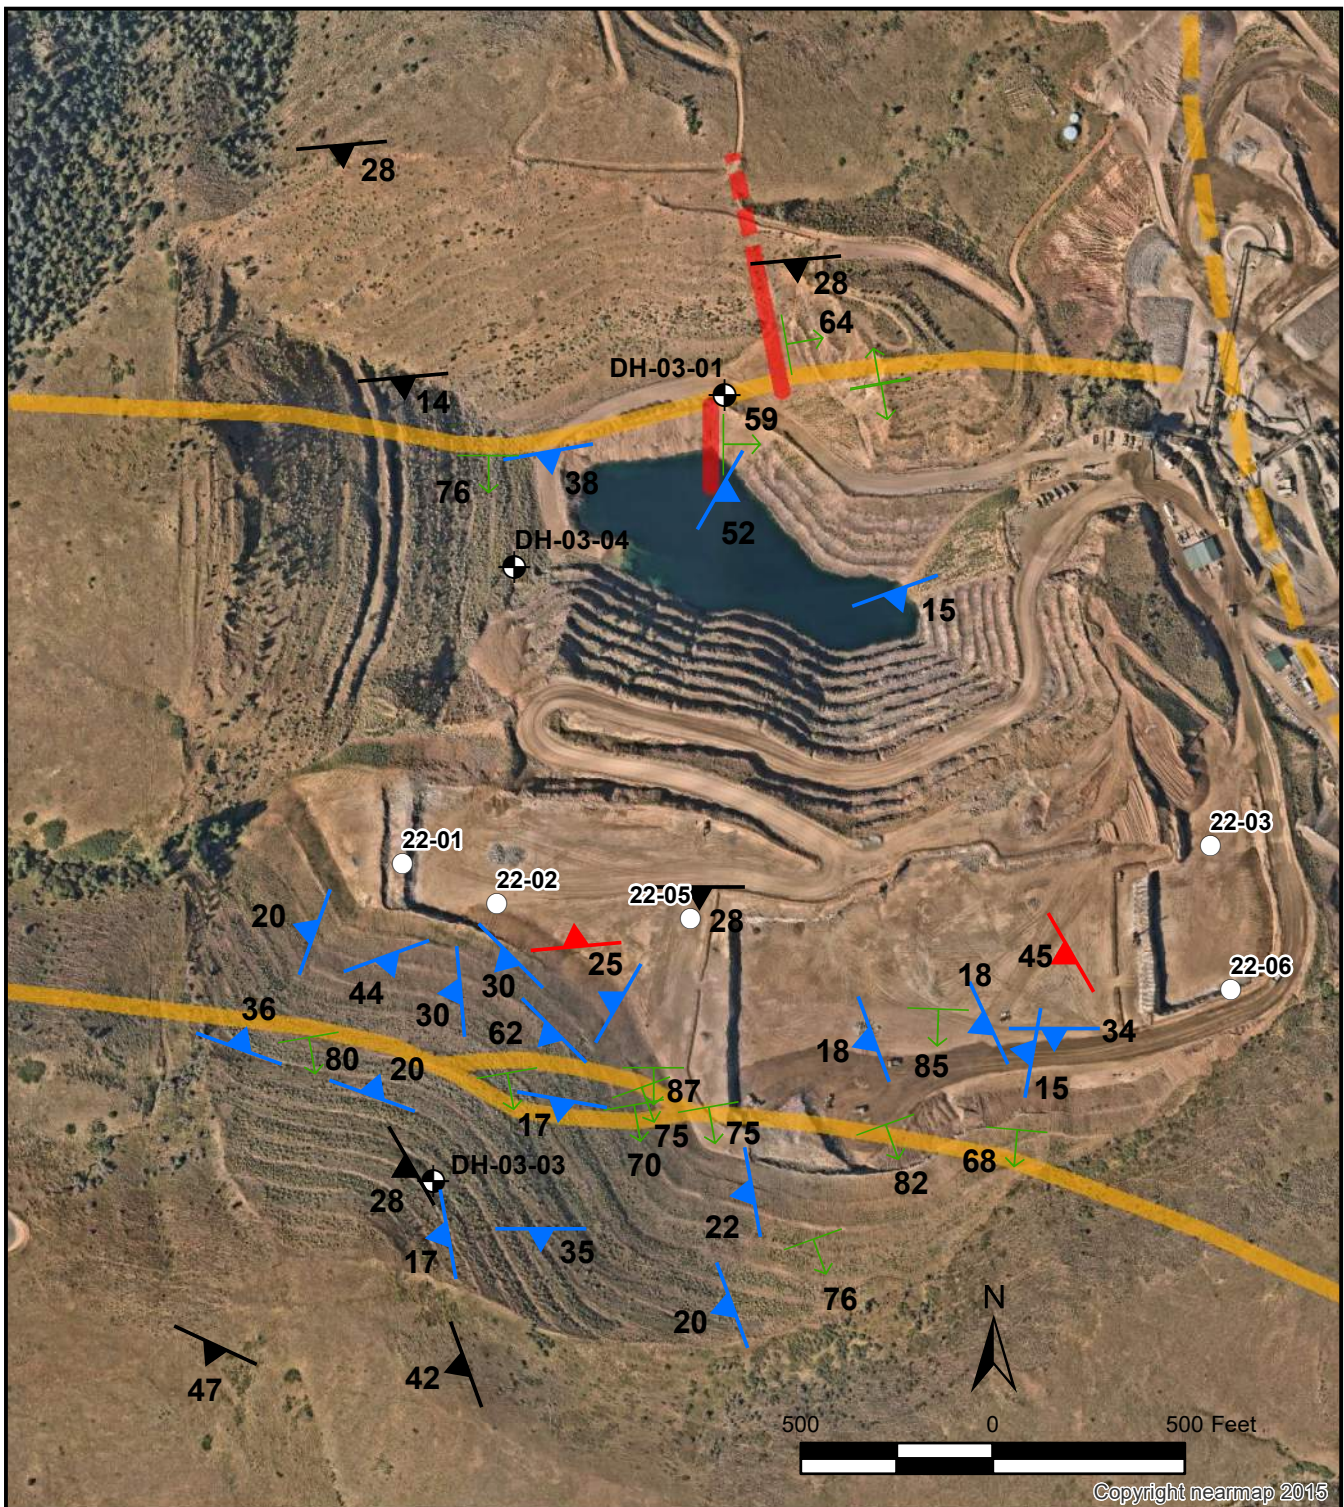
Figure 3

We also recommend that known faults are tracked and observed in new exposures to confirm orientation and character for supplemental stability analysis, as needed. We expect the southern fault identified by Gable (1968) and in previous years site visits (Figure 3) may be exposed in other locations as excavation continues in the Southern Expansion Area. Additionally, the unmapped fault generally located in the central portion of the quarry may be exposed for mapping in the future. As recommended in the previous reports, evaluations will be conducted during future investigations to assess whether or not any of the foliation sets (F-1 through F-3) are caused due to localized faulting that may have resulted in “structural regions” that have created areas in which the varying orientation of the foliation planes occur. These questions will continue to be addressed as more data is collected.

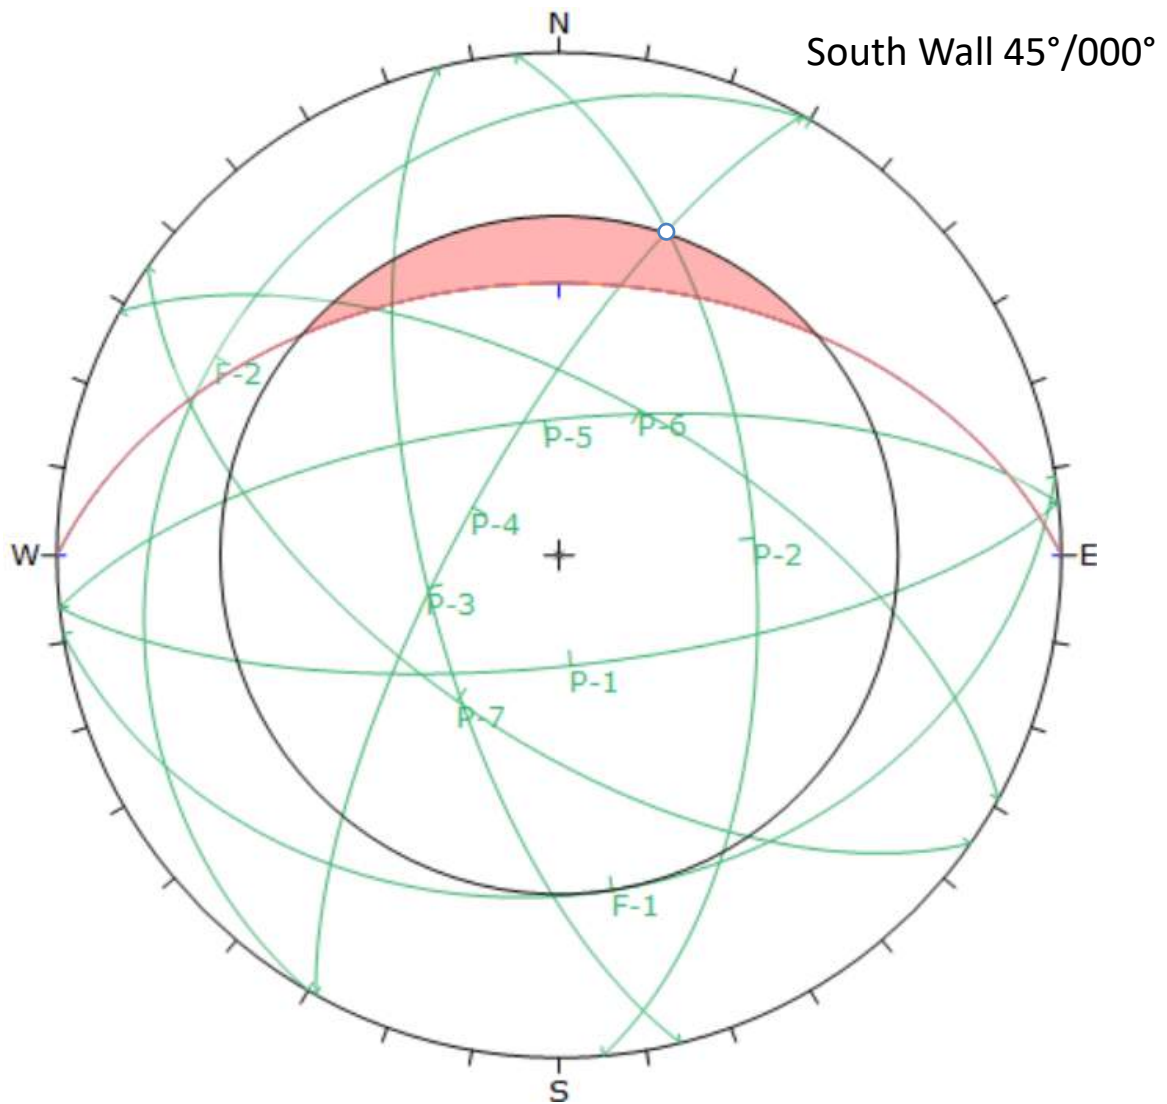
Figure 13

The stereonet plots for the Southwest Wall 1, Southwest Wall 2, and South Wall show one discontinuity intersection that falls within the failure envelope, suggesting that wedge failure is kinematically possible for this slope orientation (Figures 13 and 14). The intersecting sets that may result in wedge failure are joint sets P-2 and P-4. Based on the current as well as previous year's data set, joint set P-4 has a weak signature represented by relatively few measured orientations representing this feature (Figure 6). Planar failure is not indicated in the stereonet plot for these three walls (Figures 13 and 14).
