Attachment D

SPCC C-1 Diesel and Gas Storage & Filling Station

Date of Inspection	2021-01-28
Inspection Frequency	Monthly

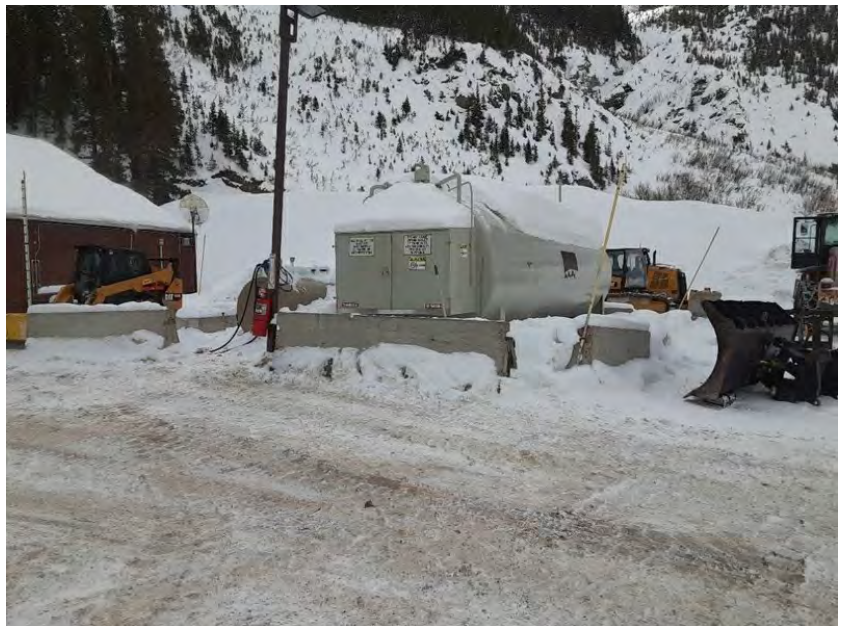
Tank photos (both tanks)

Do gas tank surfaces show signs of leakage?	No
Is gas tank damaged, rusted or otherwise deteriorating?	No
Are gas tank supports damaged, rusted or otherwise deteriorating?	No
Are gas tank foundations eroded or settled?	No
Gas tank fill level gauge functional?	Yes
Note gas fill level (inches)	24
Are gas vents free of obstruction?	Yes
Is gas secondary containment damaged?	No
Is any maintenance required for gas tank?	No
Note corrective action needed for gas tank	NA

Do diesel tank surfaces show signs of leakage?	No
Is diesel tank damaged, rusted or otherwise deteriorating?	No
Are diesel tank supports damaged, rusted or otherwise deteriorating?	No
Are diesel tank foundations eroded or settled?	No
Diesel fill level gauge functional?	Yes
Note diesel fill level (inches)	45
Are diesel tank vents free of obstruction?	Yes
Is diesel secondary containment damaged?	No
Is any maintenance required for diesel tank?	No
Note corrective action needed for diesel tank	NA

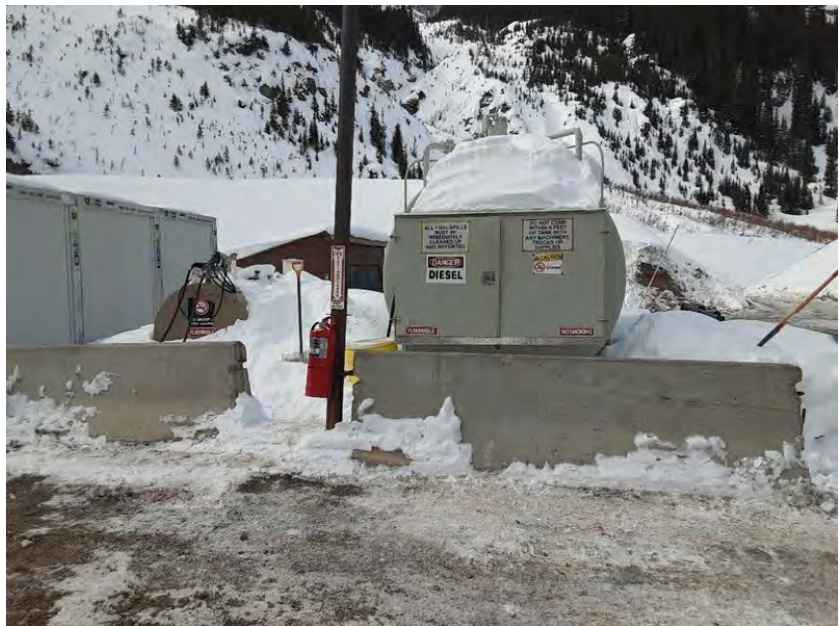
Tank photos (both tanks)

Do gas tank surfaces show signs of leakage?	No
Is gas tank damaged, rusted or otherwise deteriorating?	No
Are gas tank supports damaged, rusted or otherwise deteriorating?	No
Are gas tank foundations eroded or settled?	No
Gas tank fill level gauge functional?	Yes
Note gas fill level (inches)	9
Are gas vents free of obstruction?	Yes
Is gas secondary containment damaged?	No
Is any maintenance required for gas tank?	No
Note corrective action needed for gas tank	NA

Do diesel tank surfaces show signs of leakage?	No
Is diesel tank damaged, rusted or otherwise deteriorating?	No
Are diesel tank supports damaged, rusted or otherwise deteriorating?	No
Are diesel tank foundations eroded or settled?	No
Diesel fill level gauge functional?	Yes
Note diesel fill level (inches)	44
Are diesel tank vents free of obstruction?	Yes
Is diesel secondary containment damaged?	No
Is any maintenance required for diesel tank?	No
Note corrective action needed for diesel tank	NA

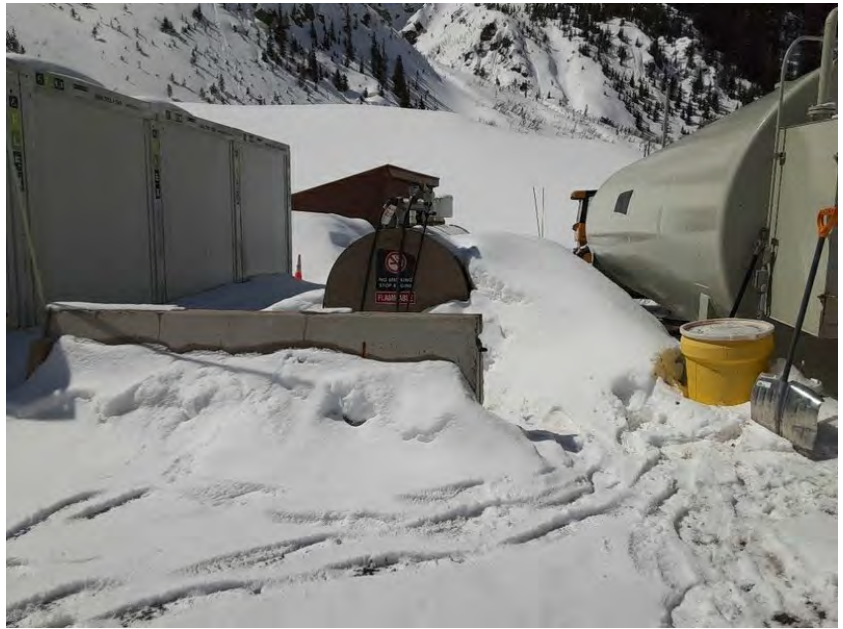
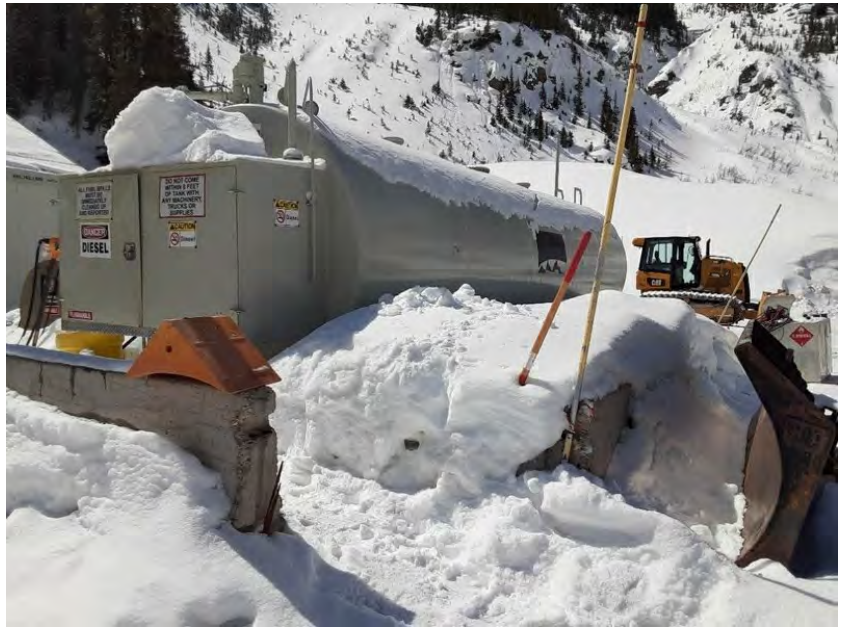
Tank photos (both tanks)

Do gas tank surfaces show signs of leakage?	No
Is gas tank damaged, rusted or otherwise deteriorating?	No
Are gas tank supports damaged, rusted or otherwise deteriorating?	No
Are gas tank foundations eroded or settled?	No
Gas tank fill level gauge functional?	Yes
Note gas fill level (inches)	0
Are gas vents free of obstruction?	Yes
Is gas secondary containment damaged?	No
Is any maintenance required for gas tank?	No
Note corrective action needed for gas tank	NA

Do diesel tank surfaces show signs of leakage?	No
Is diesel tank damaged, rusted or otherwise deteriorating?	No
Are diesel tank supports damaged, rusted or otherwise deteriorating?	No
Are diesel tank foundations eroded or settled?	No
Diesel fill level gauge functional?	Yes
Note diesel fill level (inches)	17
Are diesel tank vents free of obstruction?	Yes
Is diesel secondary containment damaged?	No
Is any maintenance required for diesel tank?	No
Note corrective action needed for diesel tank	NA

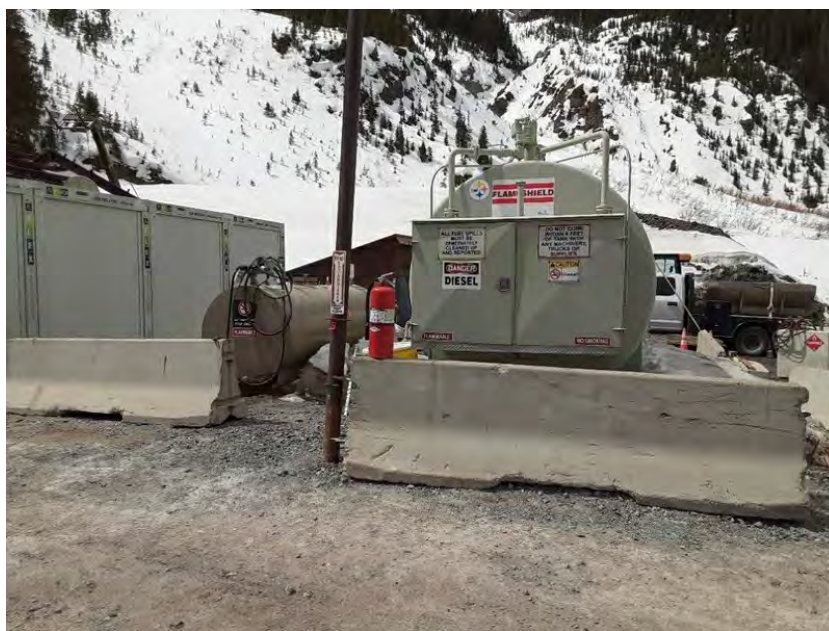
Tank photos (both tanks)

Do gas tank surfaces show signs of leakage?	No
Is gas tank damaged, rusted or otherwise deteriorating?	No
Are gas tank supports damaged, rusted or otherwise deteriorating?	No
Are gas tank foundations eroded or settled?	No
Gas tank fill level gauge functional?	Yes
Note gas fill level (inches)	6
Are gas vents free of obstruction?	Yes
Is gas secondary containment damaged?	No
Is any maintenance required for gas tank?	No

Do diesel tank surfaces show signs of leakage?	No
Is diesel tank damaged, rusted or otherwise deteriorating?	No
Are diesel tank supports damaged, rusted or otherwise deteriorating?	No
Are diesel tank foundations eroded or settled?	No
Diesel fill level gauge functional?	Yes
Note diesel fill level (inches)	34
Are diesel tank vents free of obstruction?	Yes
Is diesel secondary containment damaged?	No
Is any maintenance required for diesel tank?	No
Note corrective action needed for diesel tank	NA

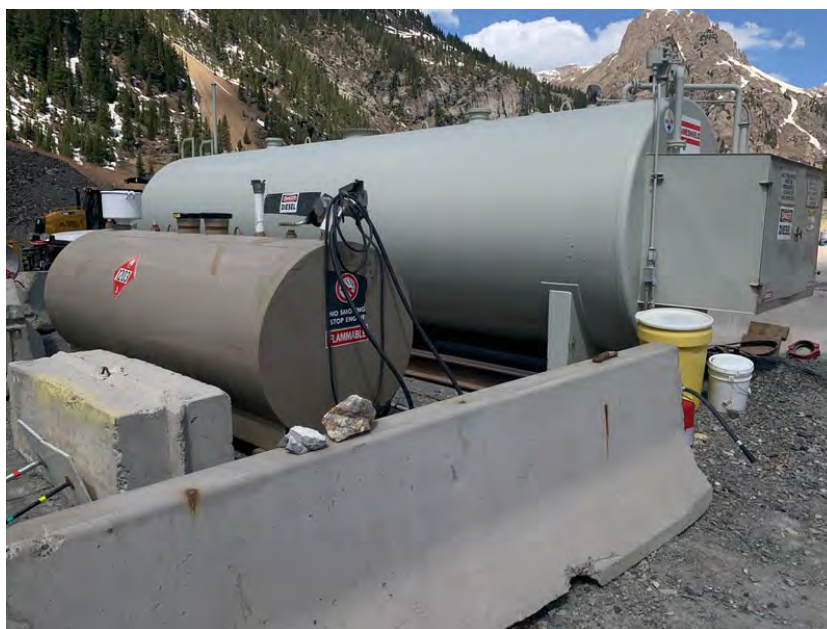
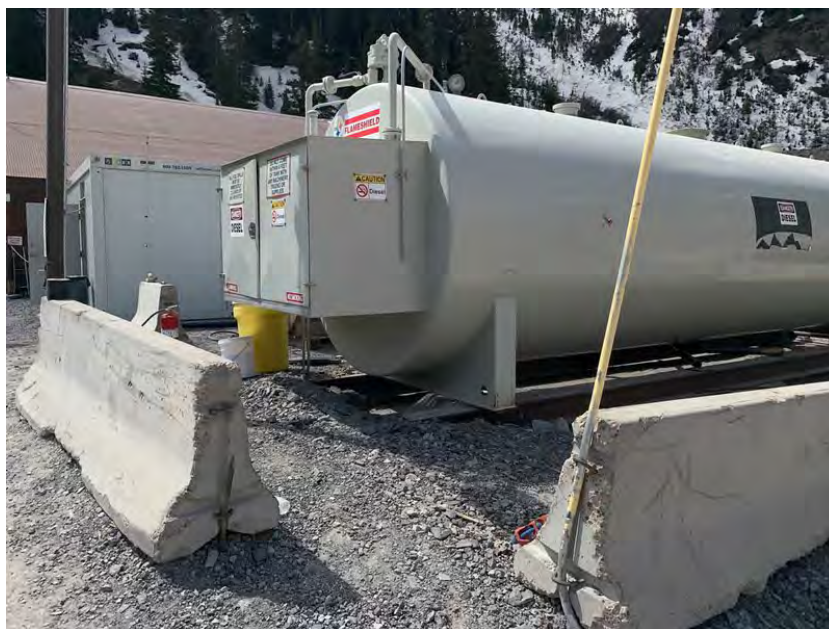
Tank photos (both tanks)

Are diesel pipelines or supports damaged, rusted or otherwise deteriorating?	No
Do diesel joints, valves, valve seals, gaskets or other appurtenances show signs of leakage?	Yes
Loading/unloading deisel connections are capped or blank flanged?	Yes
Is any maintenance required on diesel connections?	Yes
Note corrective action needed for diesel transfer and connections	Check for leaks or confirm it's spill

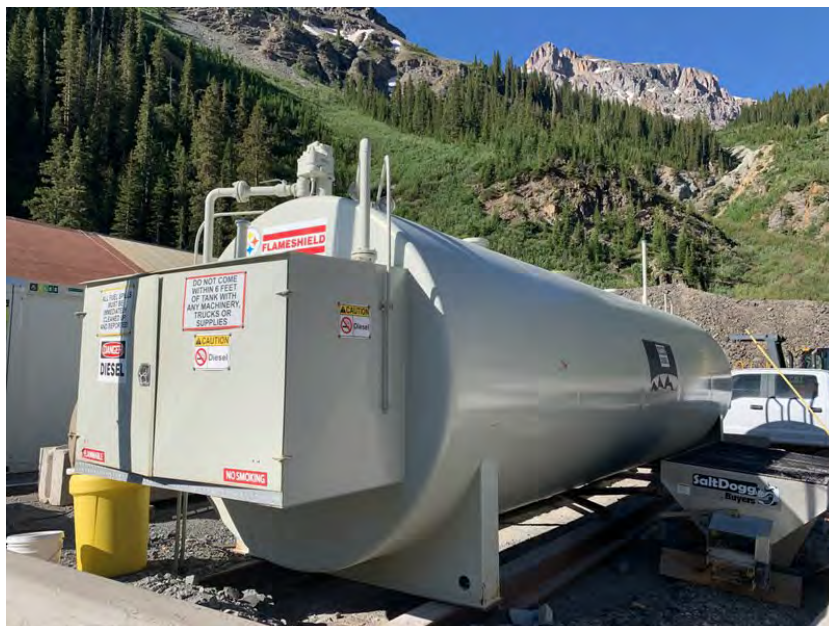
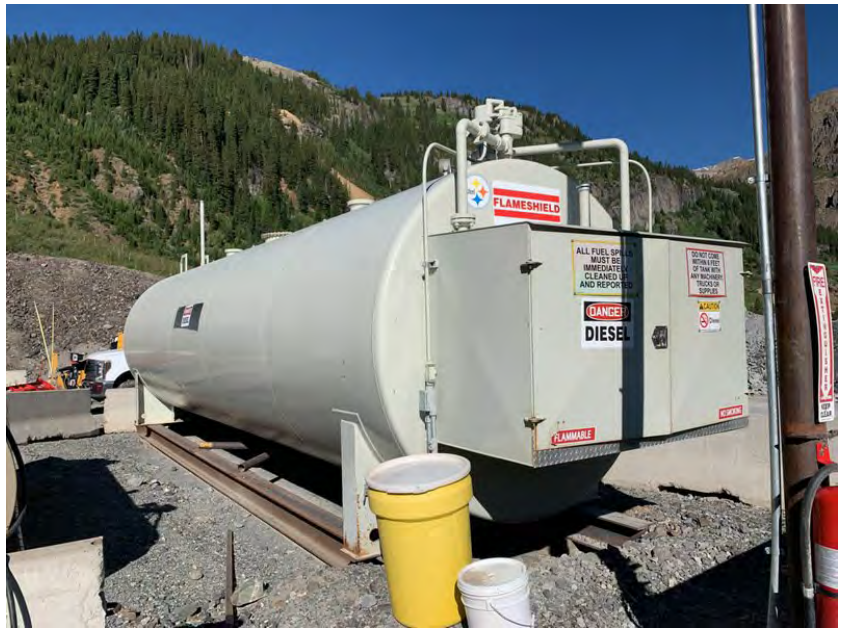
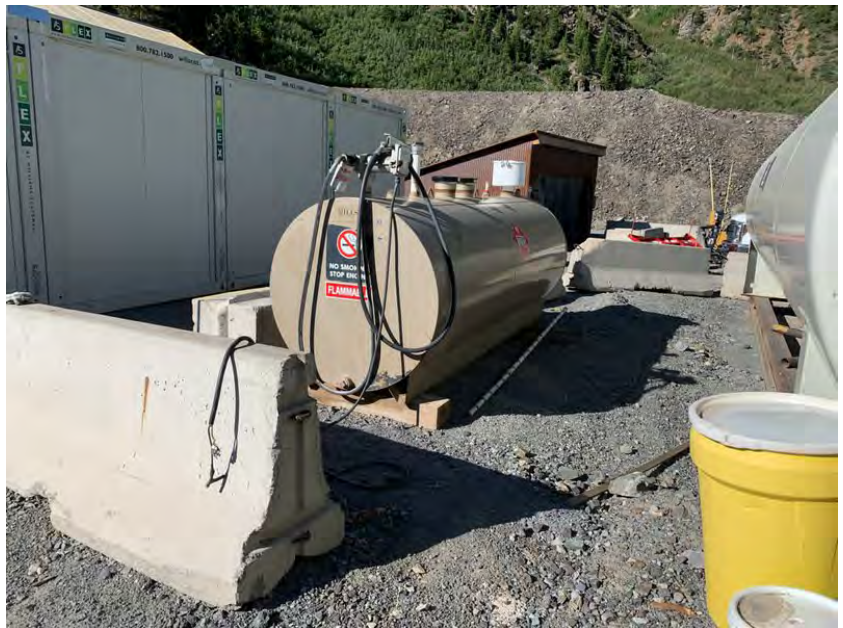
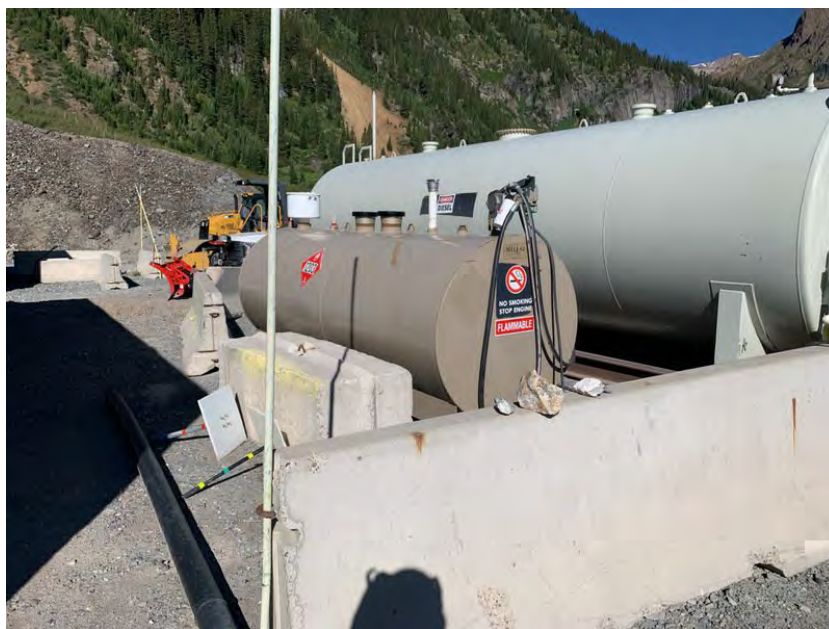
Tank photos (both tanks)

Do gas tank surfaces show signs of leakage?	No
Is gas tank damaged, rusted or otherwise deteriorating?	No
Are gas tank supports damaged, rusted or otherwise deteriorating?	No
Are gas tank foundations eroded or settled?	No
Gas tank fill level gauge functional?	Yes
Note gas fill level (inches)	33
Are gas vents free of obstruction?	Yes
Is gas secondary containment damaged?	No
Is any maintenance required for gas tank?	No
Note corrective action needed for gas tank	No corrective action needed
7/12/2021 - adjusted diesel fill level to the correct amount

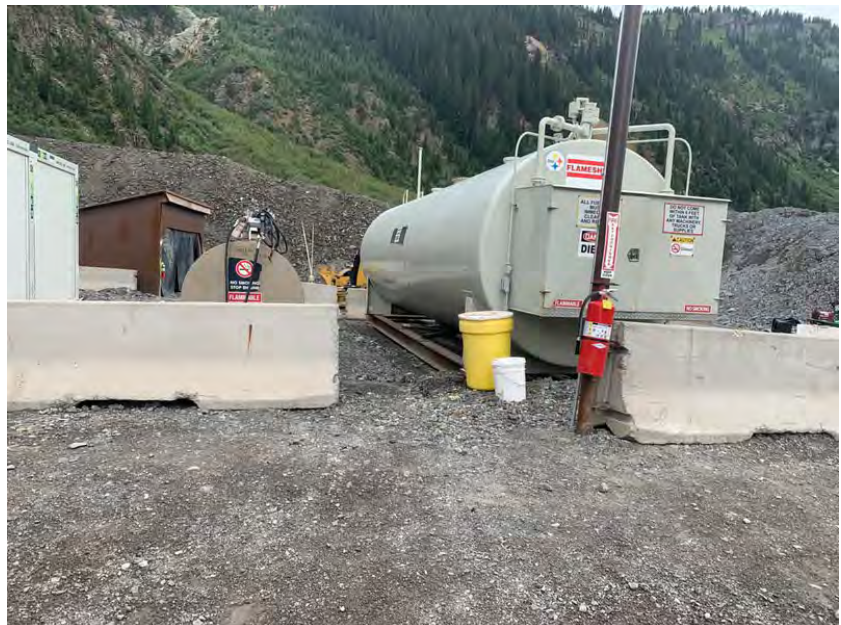
Tank photos (both tanks)

Is a spill kit present?	Yes
Is equipment inventory complete?	No
Is any maintenance required for response equipment?	Yes
Note corrective action needed for response equipment	Oil absorbency pads. Additional absorbent pads. Someone left used absorbent pads within the spill kit instead of disposing them Properly. Updated diesel quantity in inches 7/22/21 MR

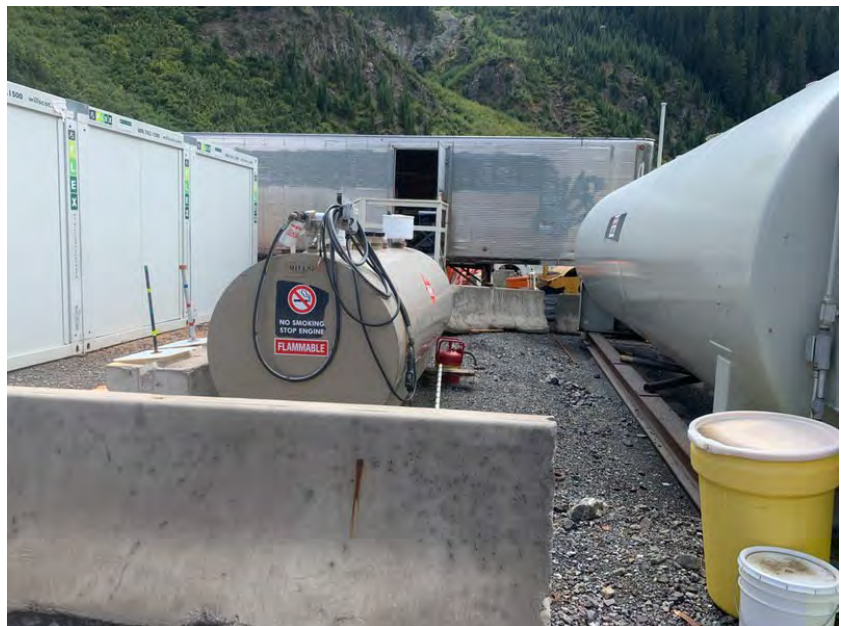
Tank photos (both tanks)

Is a spill kit present?	Yes
Is equipment inventory complete?	Yes
Is any maintenance required for response equipment?	Yes
Note corrective action needed for response equipment	Additional items needed/refill supply

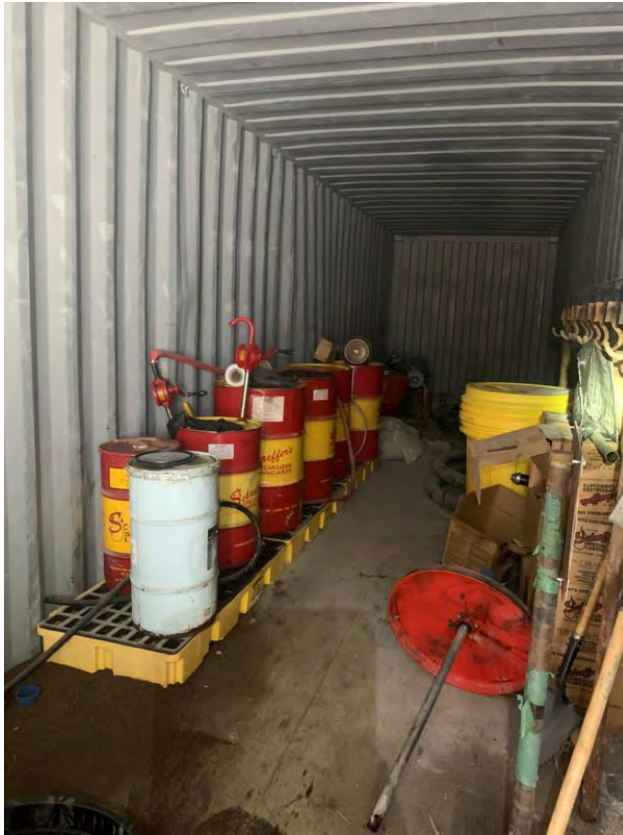
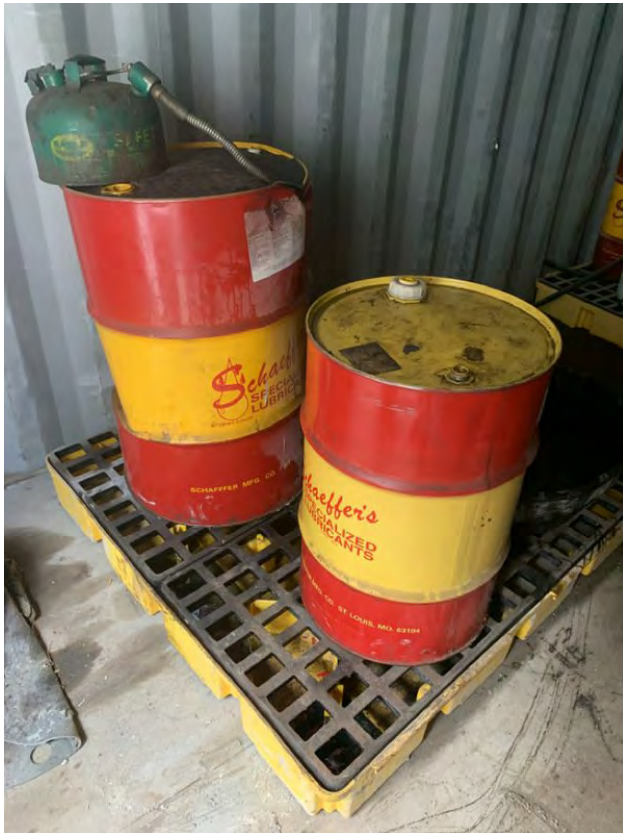
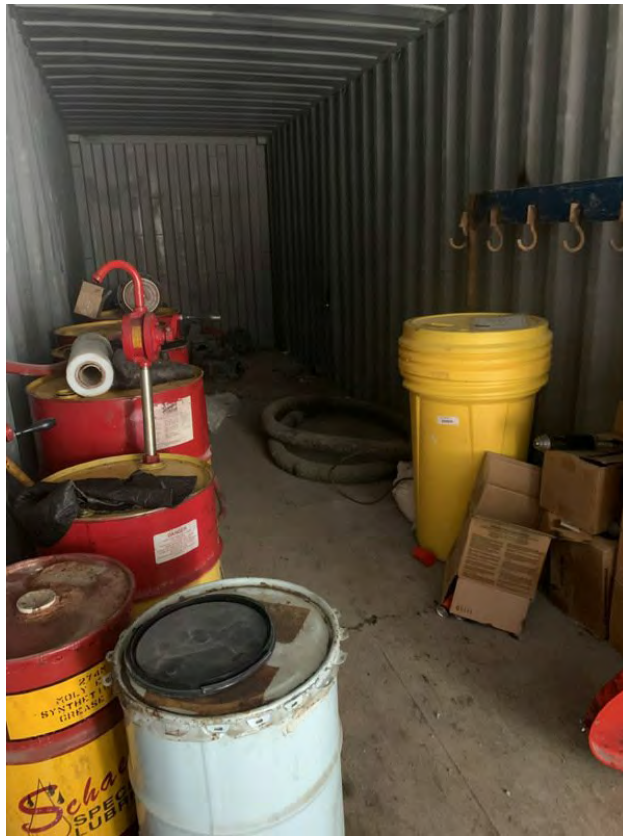
Is a spill kit present?	Yes
Is equipment inventory complete?	Yes
Is any maintenance for response equipment required?	Yes
Note corrective action needed for response equipment	Additional supplies needed
Oil storage photo

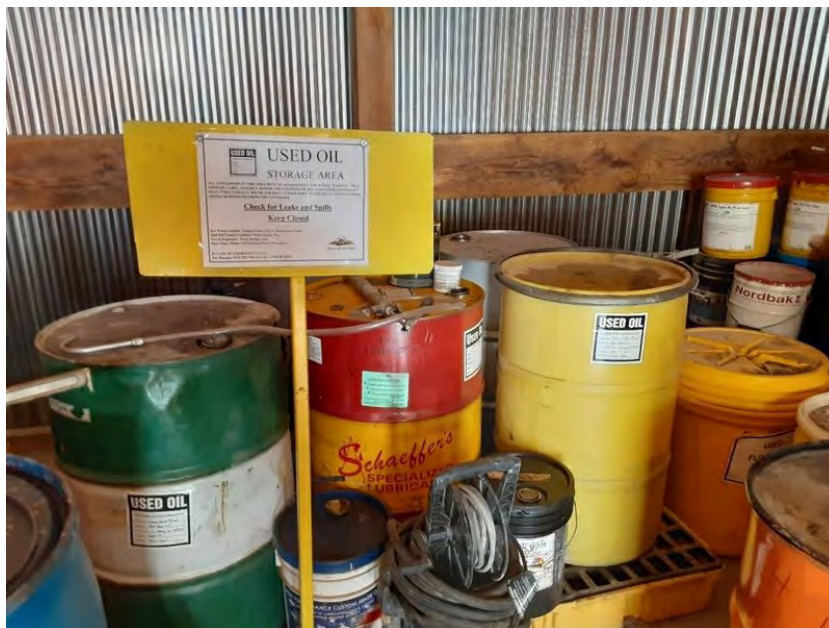
Waste storage photo

Are containers located within the designated storage area?	Yes
Is debris, spills or other fire hazards present in secondary containment?	No
Is water present in secondary containment?	No
Are drain valves functional?	Yes
Are drain valves in closed position?	Yes
Are gates/doors functional?	Yes
Is isle space adequate?	Yes
Are containers in good condition?	Yes
Are containers closed at time of inspection?	Yes
Are containers labeled correctly?	Yes
Are there any indications of leakage around containers or storage area?	No
Is any maintenance required?	No
Note corrective action needed	NA

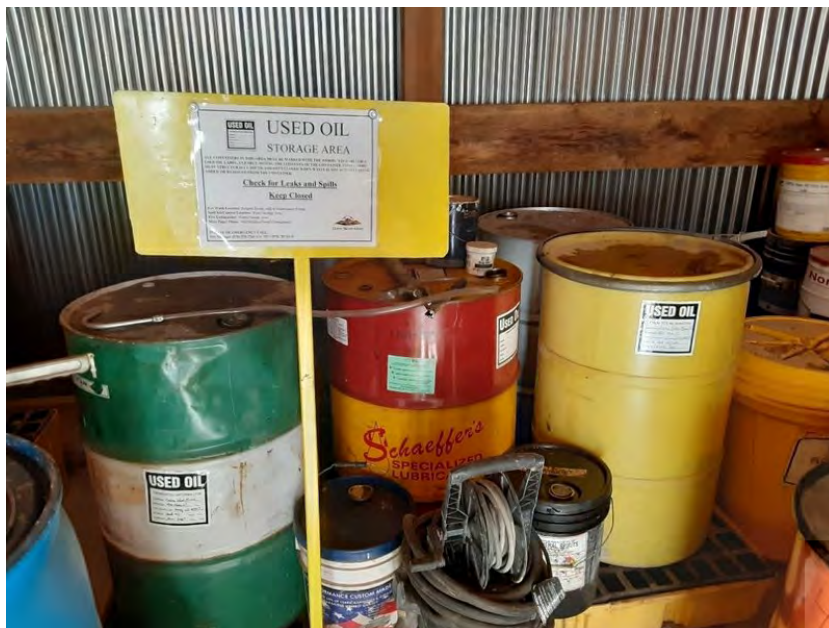
Waste storage photo

Are containers located within the designated storage area?	Yes
Is debris, spills or other fire hazards present in secondary containment?	No
Is water present in secondary containment?	Yes
Are drain valves functional?	Yes
Are drain valves in closed position?	Yes
Are gates/doors functional?	Yes
Is isle space adequate?	Yes
Are containers in good condition?	Yes
Are containers closed at time of inspection?	Yes
Are containers labeled correctly?	Yes
Are there any indications of leakage around containers or storage area?	No
Is any maintenance required?	No
Note corrective action needed	NA

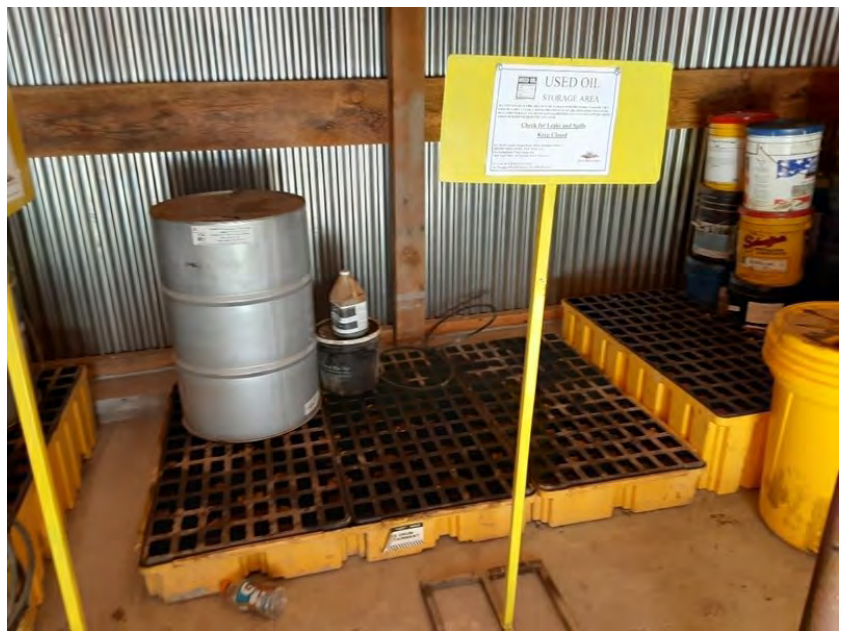
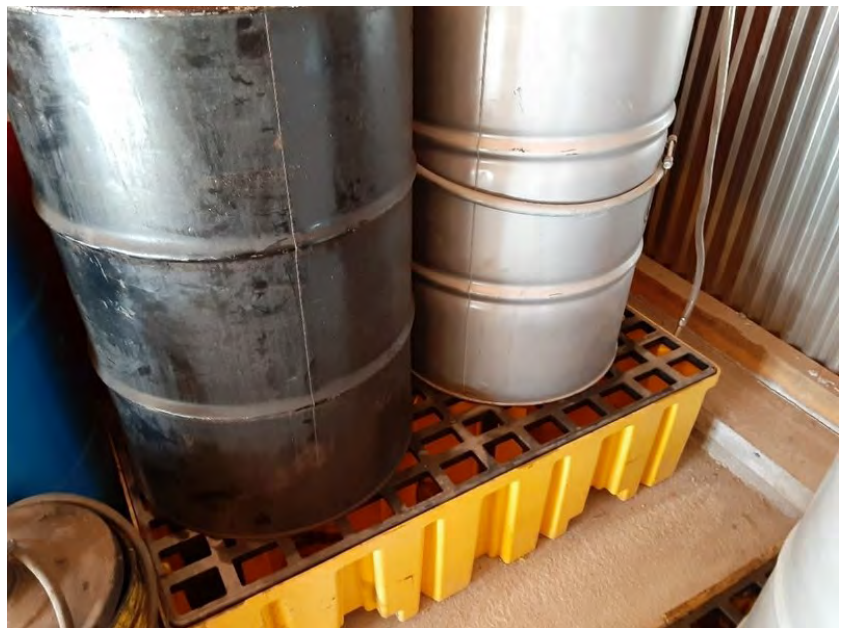
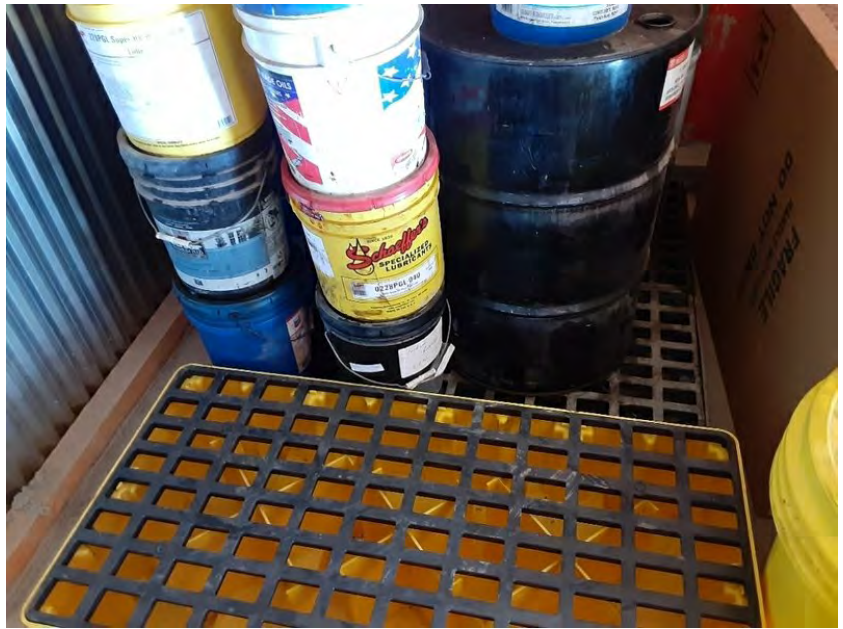
Waste storage photo

Are containers located within the designated storage area?	Yes
Is debris, spills or other fire hazards present in secondary containment?	No
Is water present in secondary containment?	No
Are drain valves functional?	Yes
Are drain valves in closed position?	Yes
Are gates/doors functional?	Yes
Is isle space adequate?	Yes
Are containers in good condition?	Yes
Are containers closed at time of inspection?	Yes
Are containers labeled correctly?	Yes
Are there any indications of leakage around containers or storage area?	No
Is any maintenance required?	No
Note corrective action needed	NA

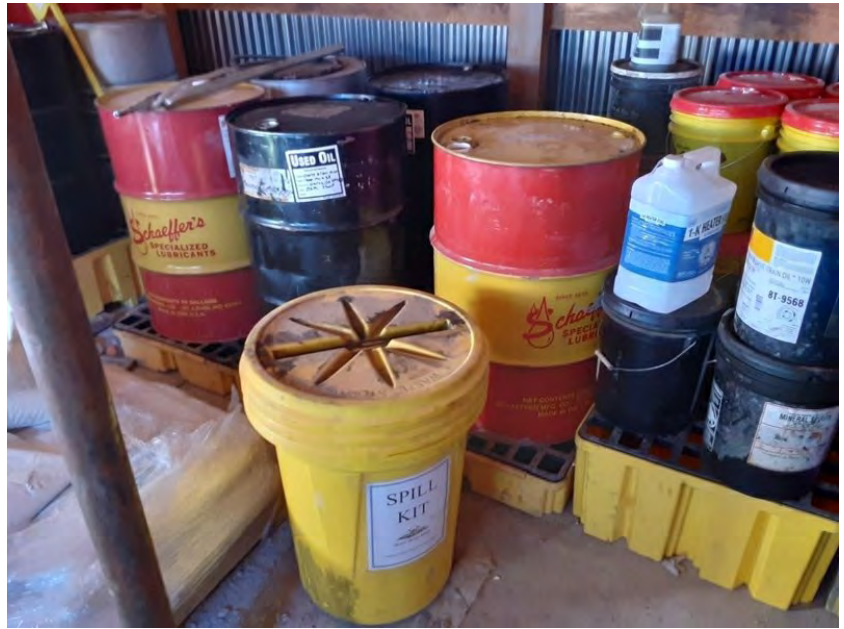
Waste storage photo

Are containers located within the designated storage area?	Yes
Is debris, spills or other fire hazards present in secondary containment?	No
Is water present in secondary containment?	No
Are drain valves functional?	Yes
Are drain valves in closed position?	Yes
Are gates/doors functional?	Yes
Is isle space adequate?	Yes
Are containers in good condition?	Yes
Are containers closed at time of inspection?	Yes
Are containers labeled correctly?	Yes
Are there any indications of leakage around containers or storage area?	No
Is any maintenance required?	No
Note corrective action needed	NA

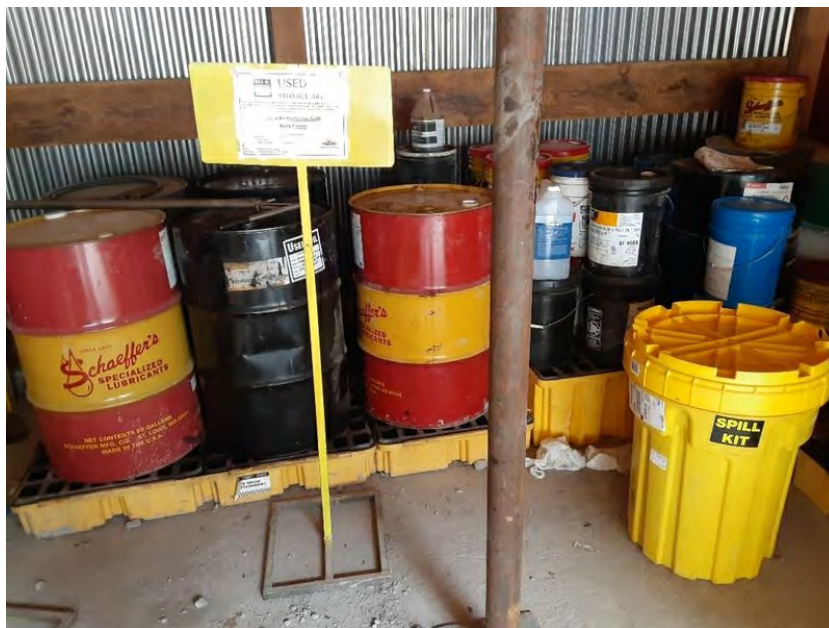
Waste storage photo

Are containers located within the designated storage area?	Yes
Is debris, spills or other fire hazards present in secondary containment?	No
Is water present in secondary containment?	Yes
Are drain valves functional?	Yes
Are drain valves in closed position?	Yes
Are gates/doors functional?	Yes
Is isle space adequate?	Yes
Are containers in good condition?	Yes
Are containers closed at time of inspection?	Yes
Are containers labeled correctly?	Yes
Are there any indications of leakage around containers or storage area?	No
Is any maintenance required?	No
Note corrective action needed	NA

Is a spill kit present?	Yes
Is equipment inventory complete?	No
Is any maintenance required for response equipment?	Yes
Note corrective action needed for response equipment	Need floor dry and check list for spill kit

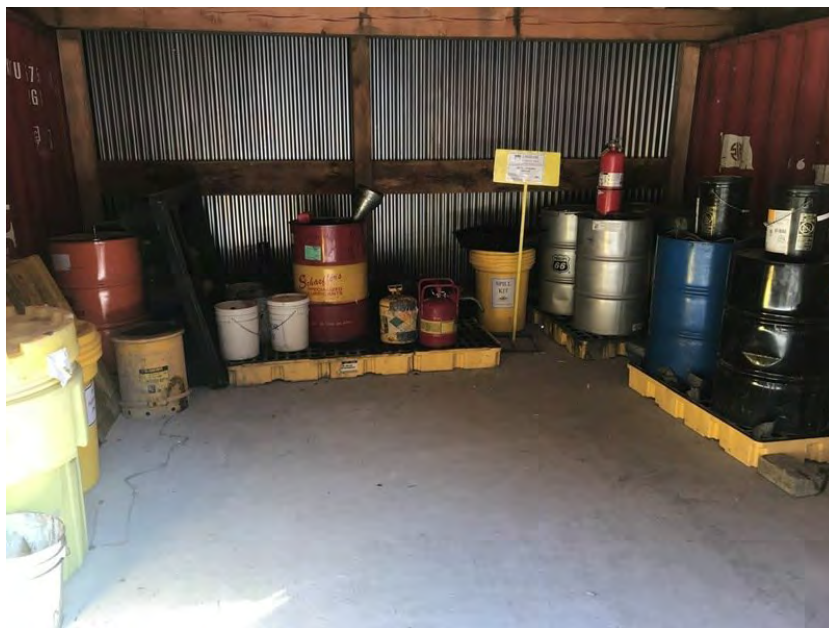
Waste storage photo

Are containers located within the designated storage area?	Yes
Is debris, spills or other fire hazards present in secondary containment?	No
Is water present in secondary containment?	No
Are drain valves functional?	Yes
Are drain valves in closed position?	Yes
Are gates/doors functional?	Yes
Is isle space adequate?	Yes
Are containers in good condition?	Yes
Are containers closed at time of inspection?	Yes
Are containers labeled correctly?	Yes
Are there any indications of leakage around containers or storage area?	No
Is any maintenance required?	No

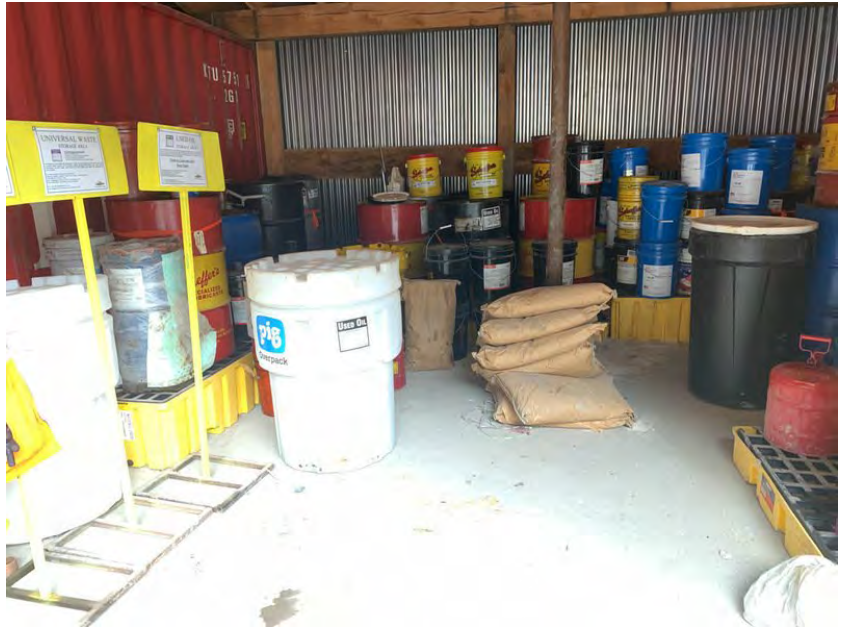
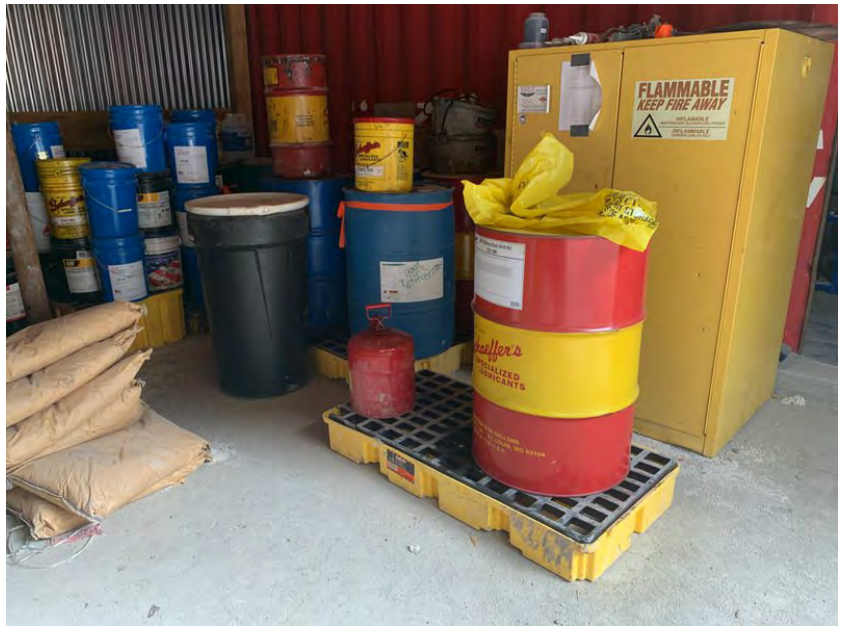
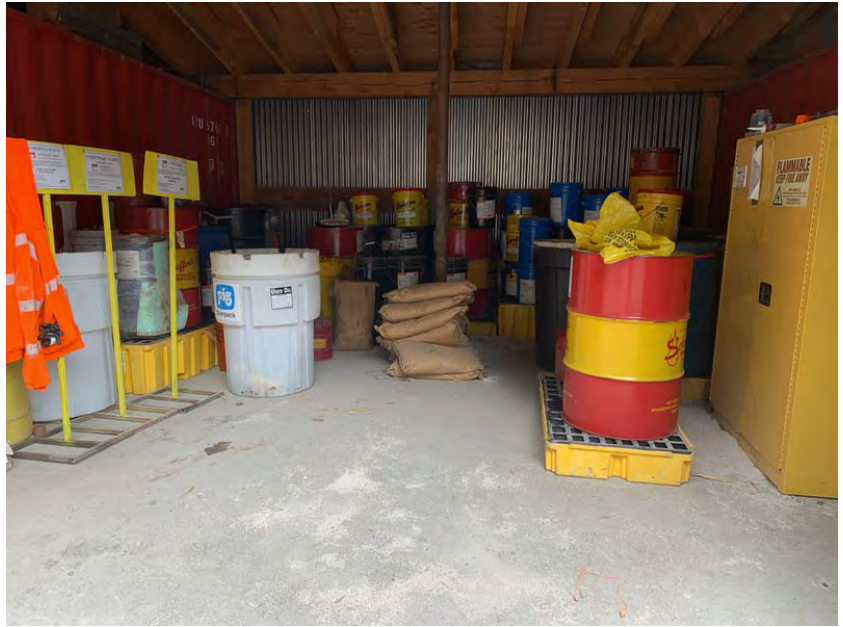
Waste storage photo

Are containers located within the designated storage area?	Yes
Is debris, spills or other fire hazards present in secondary containment?	No
Is water present in secondary containment?	No
Are drain valves functional?	Yes
Are drain valves in closed position?	Yes
Are gates/doors functional?	Yes
Is isle space adequate?	Yes
Are containers in good condition?	Yes
Are containers closed at time of inspection?	Yes
Are containers labeled correctly?	Yes
Are there any indications of leakage around containers or storage area?	No
Is any maintenance required?	No
Note corrective action needed	No corrective action needed

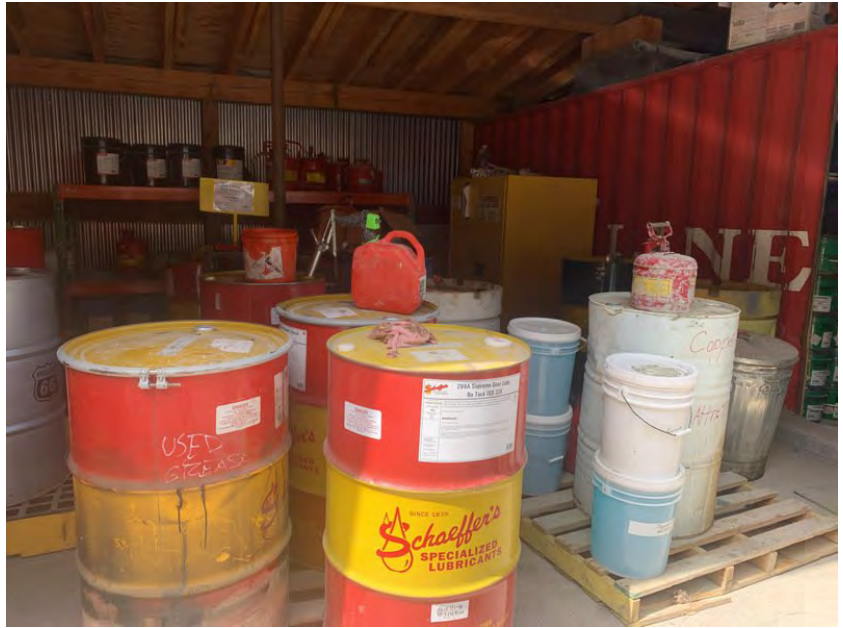
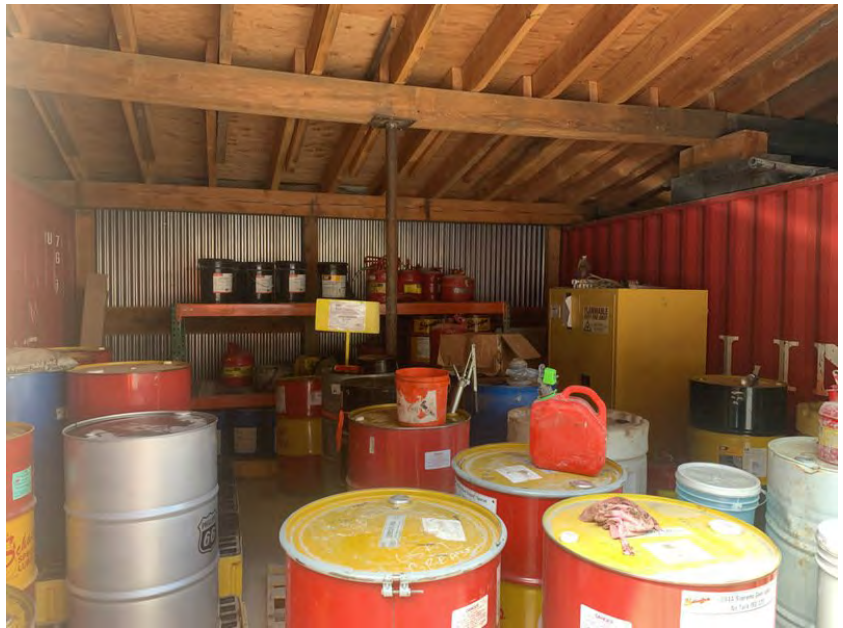
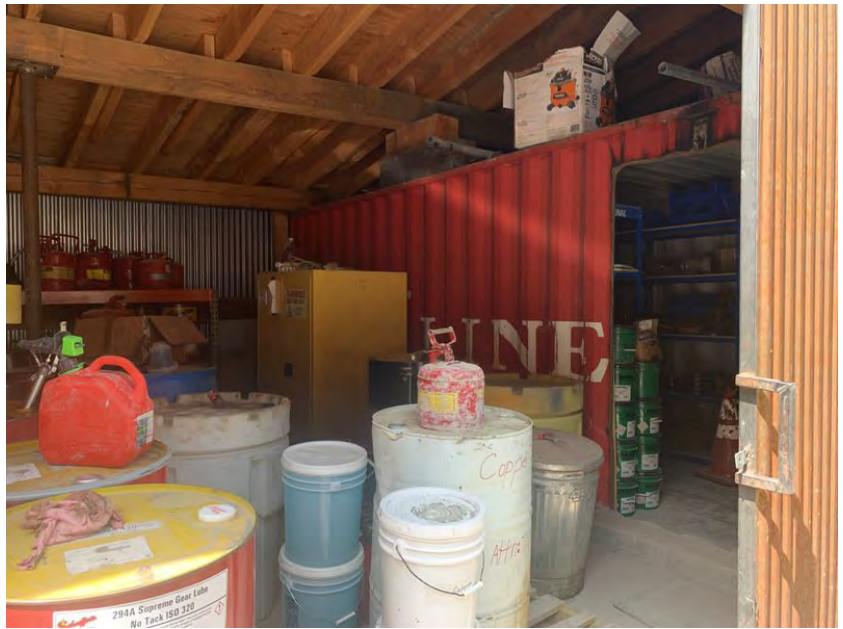
Waste storage photo

Are containers located within the designated storage area?	Yes
Is debris, spills or other fire hazards present in secondary containment?	No
Is water present in secondary containment?	No
Are drain valves functional?	Yes
Are drain valves in closed position?	Yes
Are gates/doors functional?	Yes
Is isle space adequate?	Yes
Are containers in good condition?	Yes
Are containers closed at time of inspection?	Yes
Are containers labeled correctly?	Yes
Are there any indications of leakage around containers or storage area?	No
Is any maintenance required?	Yes
Note corrective action needed	Secondary containment needed for oil drums

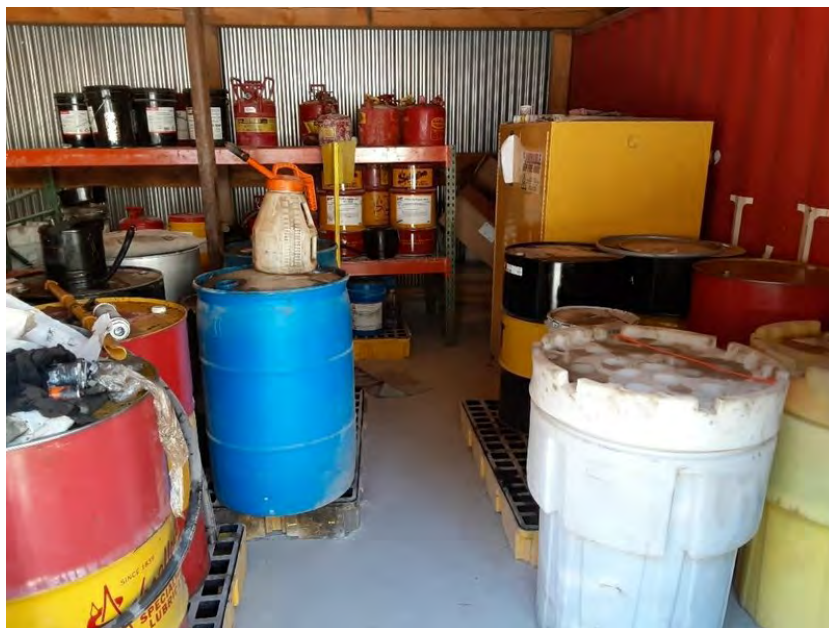
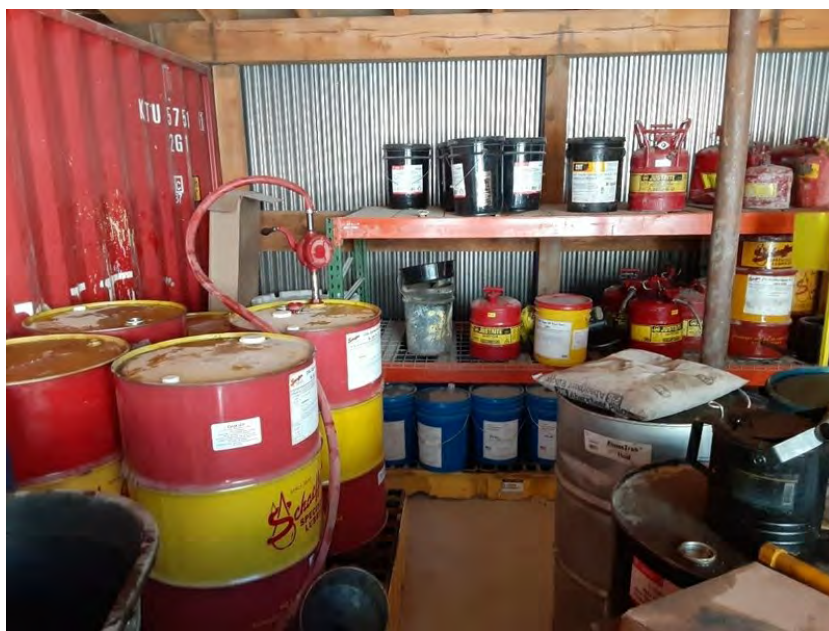
Waste storage photo

Are containers located within the designated storage area?	Yes
Is debris, spills or other fire hazards present in secondary containment?	No
Is water present in secondary containment?	No
Are drain valves functional?	Yes
Are drain valves in closed position?	Yes
Are gates/doors functional?	Yes
Is isle space adequate?	No
Are containers in good condition?	Yes
Are containers closed at time of inspection?	Yes
Are containers labeled correctly?	Yes
Are there any indications of leakage around containers or storage area?	No
Is any maintenance required?	Yes
Note corrective action needed	Housekeeping. Pad needs to be organized to make adequate isle space

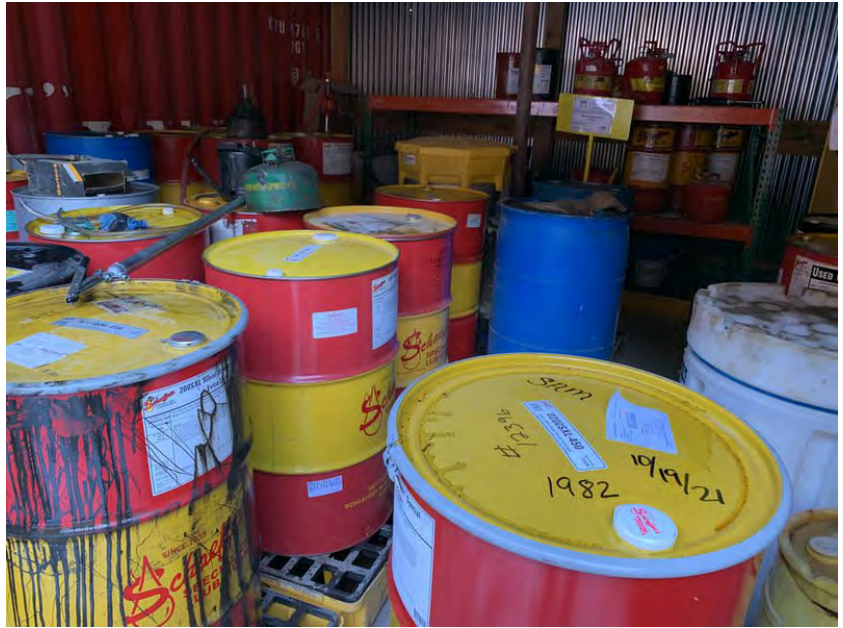
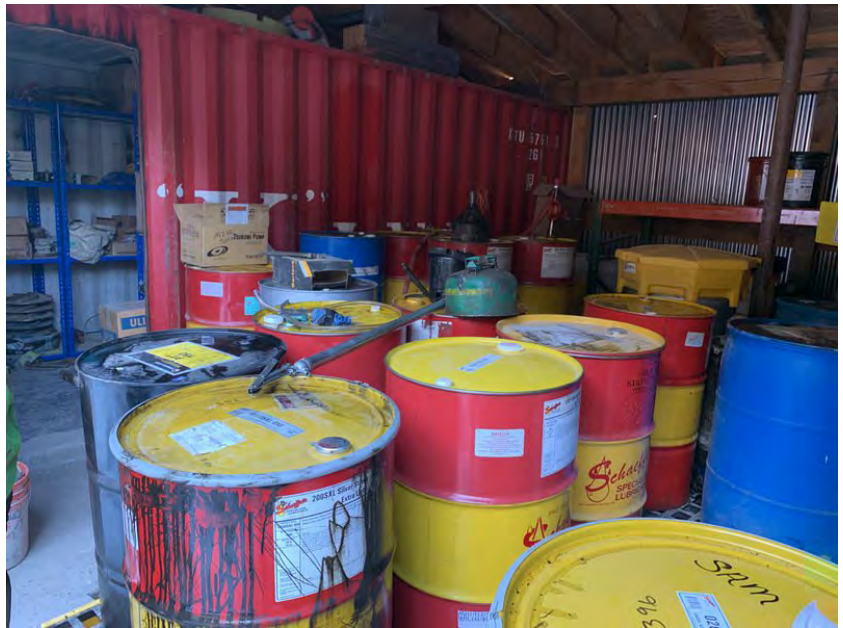
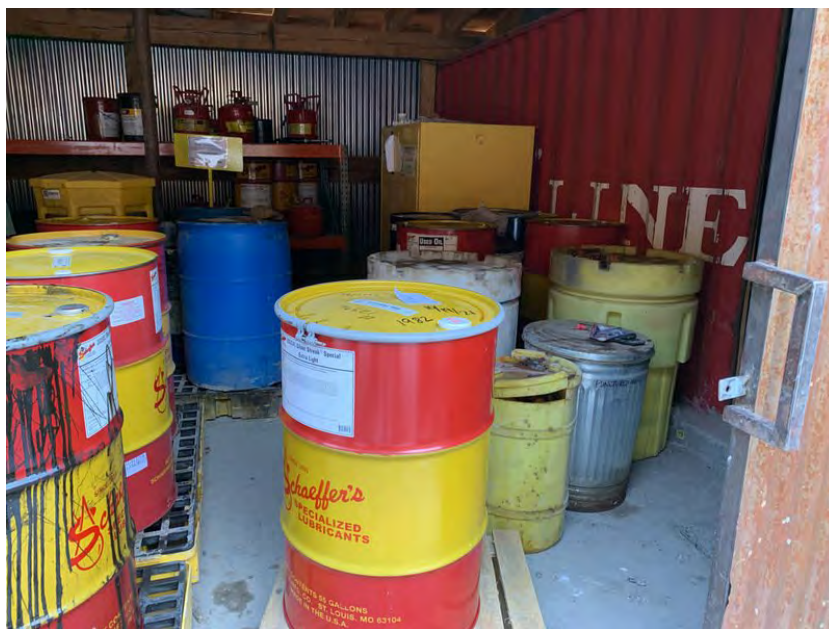
Are containers located within the designated storage area?	Yes
Is debris, spills or other fire hazards present in secondary containment?	No
Is water present in secondary containment?	No
Are drain valves functional?	Yes
Are drain valves in closed position?	Yes
Are gates/doors functional?	Yes
Is isle space adequate?	Yes
Are containers in good condition?	Yes
Are containers closed at time of inspection?	Yes
Are containers labeled correctly?	Yes
Are there any indications of leakage around containers or storage area?	No
Is any maintenance required?	No
Note corrective action needed	Lubricants need to be stored in secondary containment

Is a spill kit present?	Yes
Is equipment inventory complete?	No
Is any maintenance required for response equipment?	Yes
Note corrective action needed for response equipment	Additional supplies needed in spill kit. On order
Waste storage photo

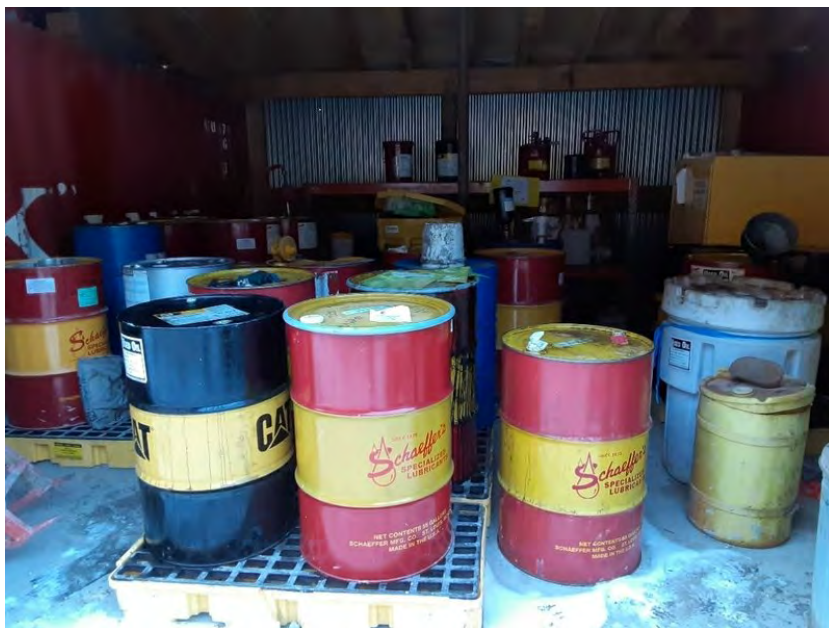
Waste storage photo

Are containers located within the designated storage area?	Yes
Is debris, spills or other fire hazards present in secondary containment?	Yes
Is water present in secondary containment?	No
Are drain valves functional?	Yes
Are drain valves in closed position?	Yes
Are gates/doors functional?	No
Is isle space adequate?	No
Are containers in good condition?	Yes
Are containers closed at time of inspection?	Yes
Are containers labeled correctly?	Yes
Are there any indications of leakage around containers or storage area?	No
Is any maintenance required?	Yes
Note corrective action needed	One barrel not on secondary containment. Concrete floor broken and needs to be replaced - door won't close. Crowded walkways. Need to move new products to storage warehouse. Spill pallets need to be cleaned.
