Attachment D

SPCC C-1 Diesel and Gas Storage & Filling Station

Date of Inspection	2021-01-28
Inspection Frequency	Monthly

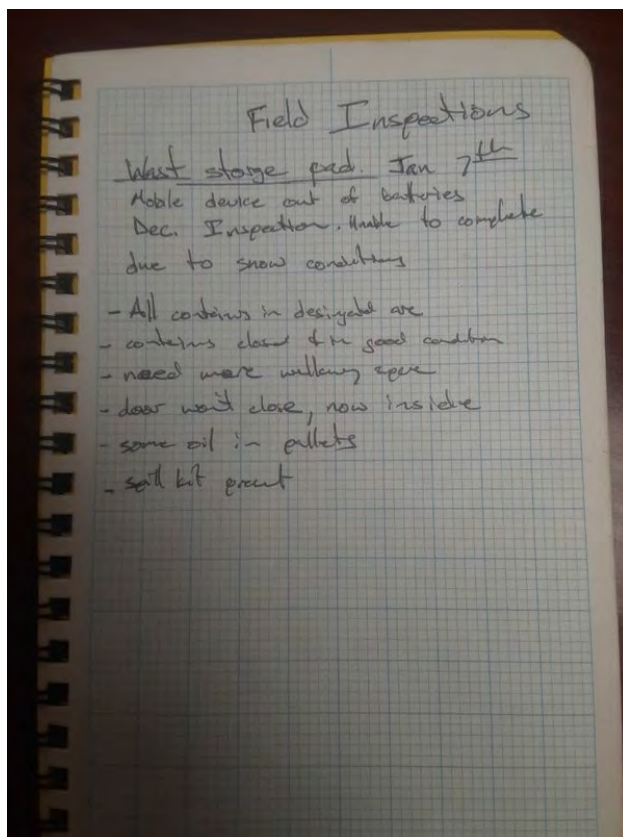
Are containers located within the designated storage area?	Yes
Is debris, spills or other fire hazards present in secondary containment?	No
Is water present in secondary containment?	Yes
Are drain valves functional?	Yes
Are drain valves in closed position?	Yes
Are gates/doors functional?	No
Is isle space adequate?	No
Are containers in good condition?	Yes
Are containers closed at time of inspection?	Yes
Are containers labeled correctly?	Yes
Are there any indications of leakage around containers or storage area?	No
Is any maintenance required?	Yes
Note corrective action needed	Inspection for december. Could not get to site sooner due to snow. Door won't close needs to be repaired. Snow inside the storage area that needs to be cleaned. New oil should be brought to the new warehouse to make storage space. Phone died. Took notes into field notebook and uploaded noted.

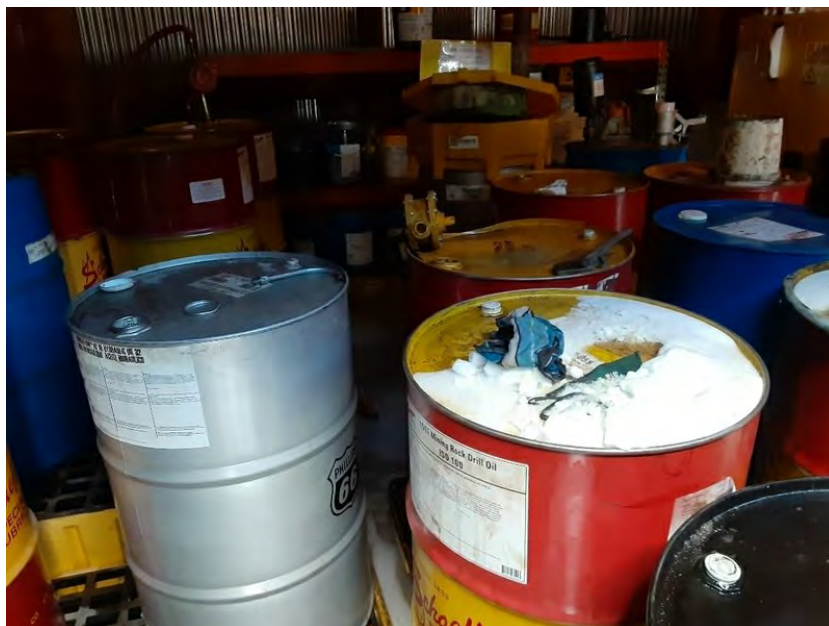
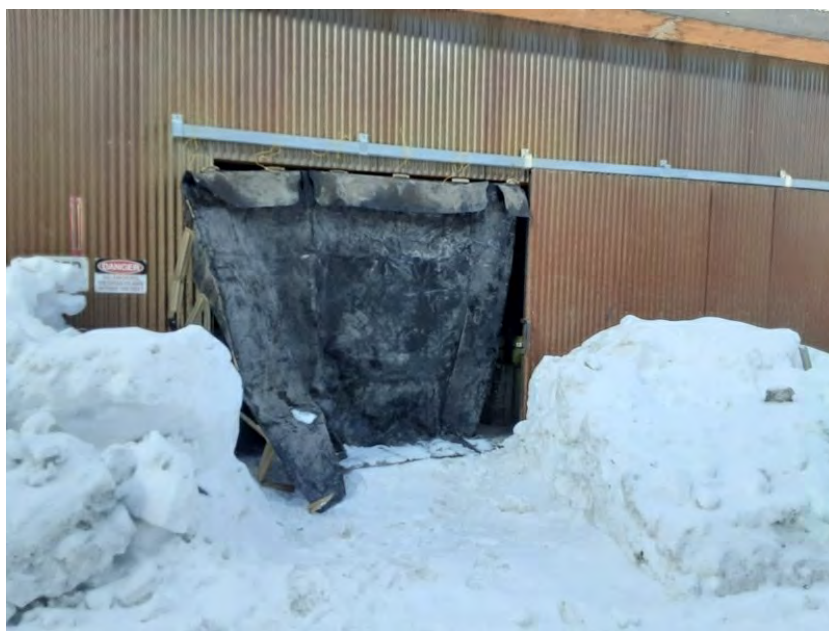
Waste storage photo

Are containers located within the designated storage area?	Yes
Is debris, spills or other fire hazards present in secondary containment?	Yes
Is water present in secondary containment?	Yes
Are drain valves functional?	Yes
Are drain valves in closed position?	Yes
Are gates/doors functional?	Yes
Is isle space adequate?	No
Are containers in good condition?	Yes
Are containers closed at time of inspection?	Yes
Are containers labeled correctly?	Yes
Are there any indications of leakage around containers or storage area?	No
Is any maintenance required?	Yes
Note corrective action needed	Temporary tarp over door. Will repair door once springs comes. Not enough aisle space. Need to move new product to new warehouse.

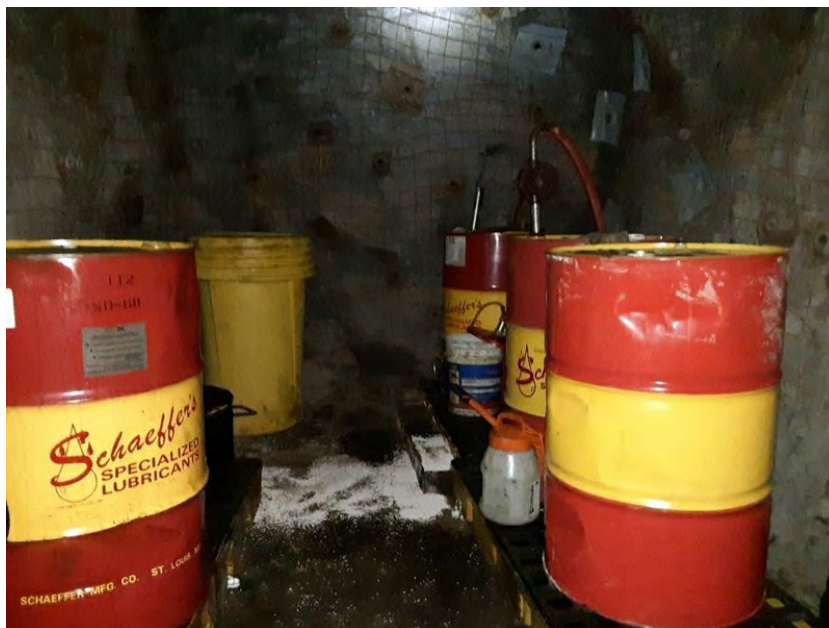
Location photo

Are containers located within the designated storage area?	Yes
Is debris, spills or other fire hazards present in secondary containment?	No
Is water present in secondary containment?	No
Are drain valves functional?	N/A
Are drain valves in closed position?	N/A
Are gates/doors functional?	Yes
Is isle space adequate?	Yes
Are containers in good condition?	Yes
Are containers closed at time of inspection?	Yes
Are containers labeled correctly?	Yes
Are there any indications of leakage around containers or storage area?	No
Is any maintenance required?	No
Note corrective action needed	Floor dry needs to be swept

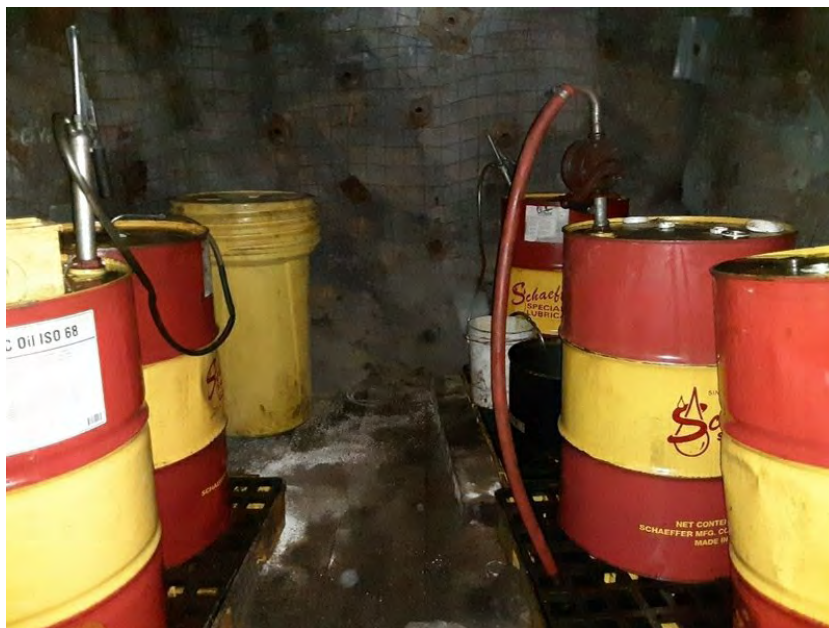
Location photo

Are containers located within the designated storage area?	Yes
Is debris, spills or other fire hazards present in secondary containment?	No
Is water present in secondary containment?	No
Are drain valves functional?	N/A
Are drain valves in closed position?	N/A
Are gates/doors functional?	Yes
Is isle space adequate?	Yes
Are containers in good condition?	Yes
Are containers closed at time of inspection?	Yes
Are containers labeled correctly?	Yes
Are there any indications of leakage around containers or storage area?	No
Is any maintenance required?	No
Note corrective action needed	Housekeeping. Floor dry needs to be cleaned

Is a spill kit present?	Yes
Is equipment inventory complete?	Yes
Is any maintenance required for response equipment?	No
Note corrective action needed for response equipment	Need more wattles. Only two left

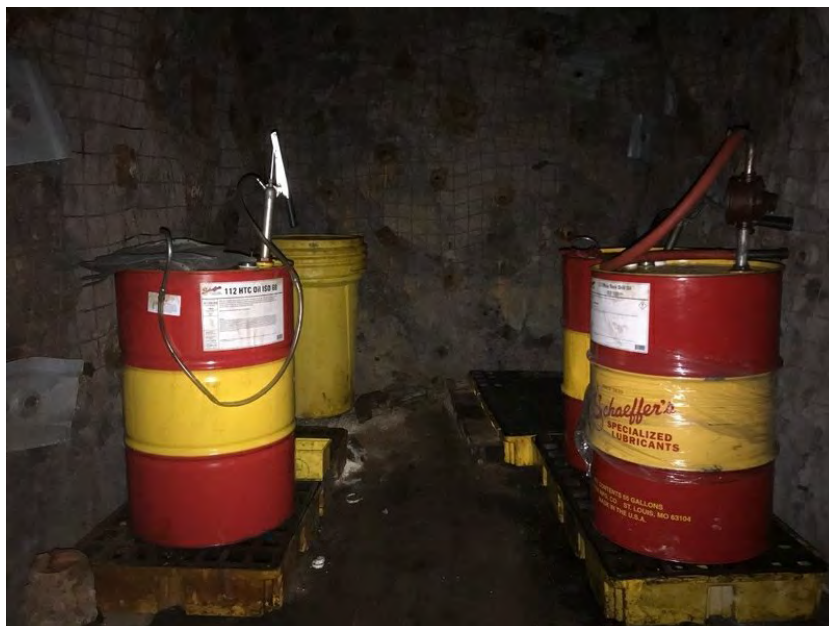
Location photo

Is a spill kit present?	Yes
Is equipment inventory complete?	Yes
Is any maintenance required for response equipment?	No
Note corrective action needed for response equipment	Running low on product absorption pads and floor dry.

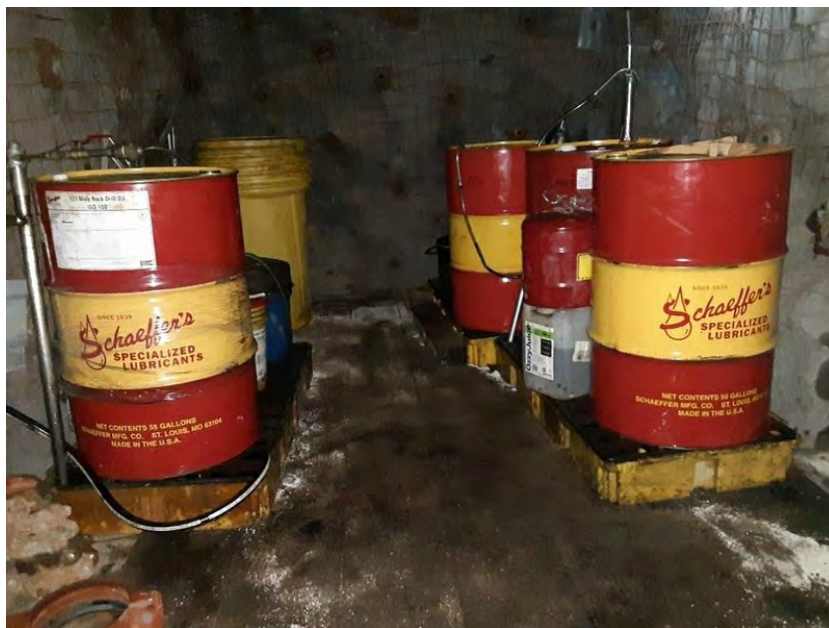
Location photo

Are containers located within the designated storage area?	Yes
Is debris, spills or other fire hazards present in secondary containment?	No
Is water present in secondary containment?	No
Are drain valves functional?	N/A
Are drain valves in closed position?	N/A
Are gates/doors functional?	Yes
Is isle space adequate?	Yes
Are containers in good condition?	Yes
Are containers closed at time of inspection?	Yes
Are containers labeled correctly?	Yes
Are there any indications of leakage around containers or storage area?	No
Is any maintenance required?	No
Note corrective action needed	NA

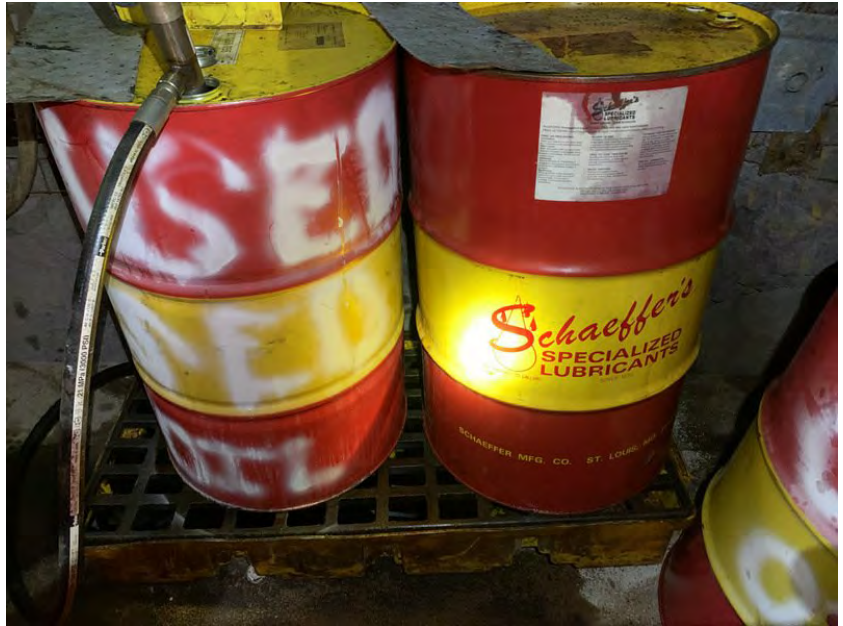
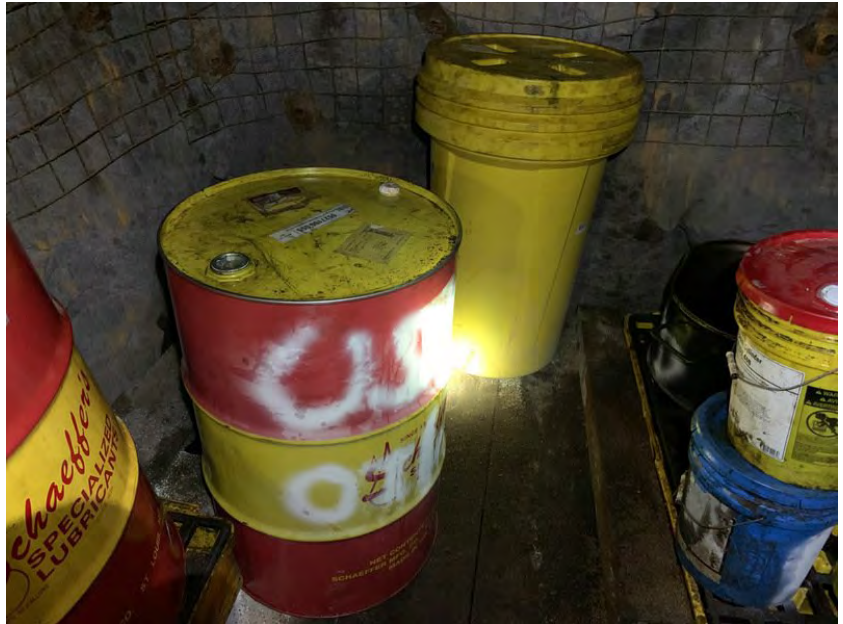
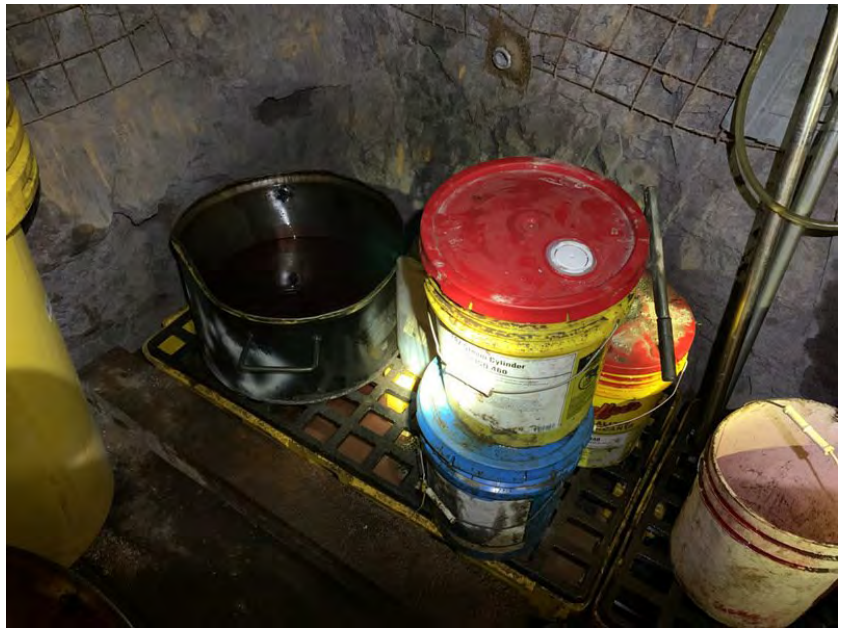
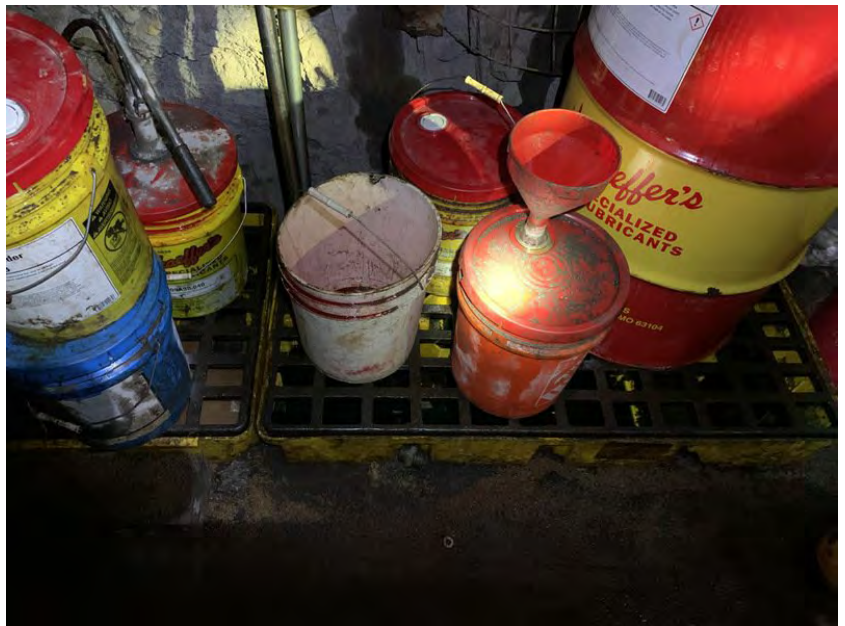
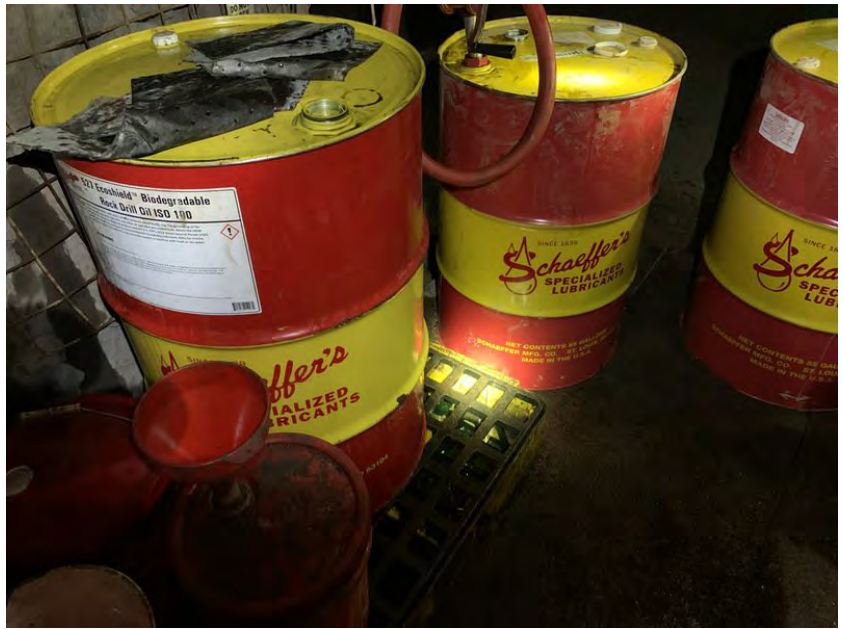
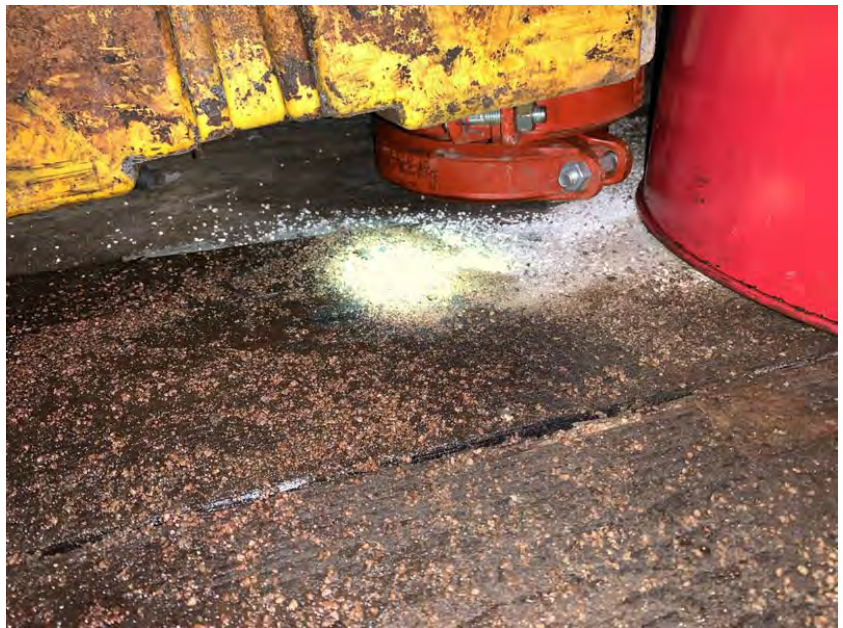
Are containers located within the designated storage area?	Yes
Is debris, spills or other fire hazards present in secondary containment?	No
Is water present in secondary containment?	Yes
Are drain valves functional?	N/A
Are drain valves in closed position?	N/A
Are gates/doors functional?	Yes
Is isle space adequate?	Yes
Are containers in good condition?	Yes
Are containers closed at time of inspection?	No
Are containers labeled correctly?	Yes
Are there any indications of leakage around containers or storage area?	No
Is any maintenance required?	Yes
Note corrective action needed	Debris and used oil needs to be moved into a used oil container. Black open container needs to be sealed or emptied, 5 gallon needs to be sealed or emptied. Secondary containment for two barrels. Trash bin/used oil rag bin.

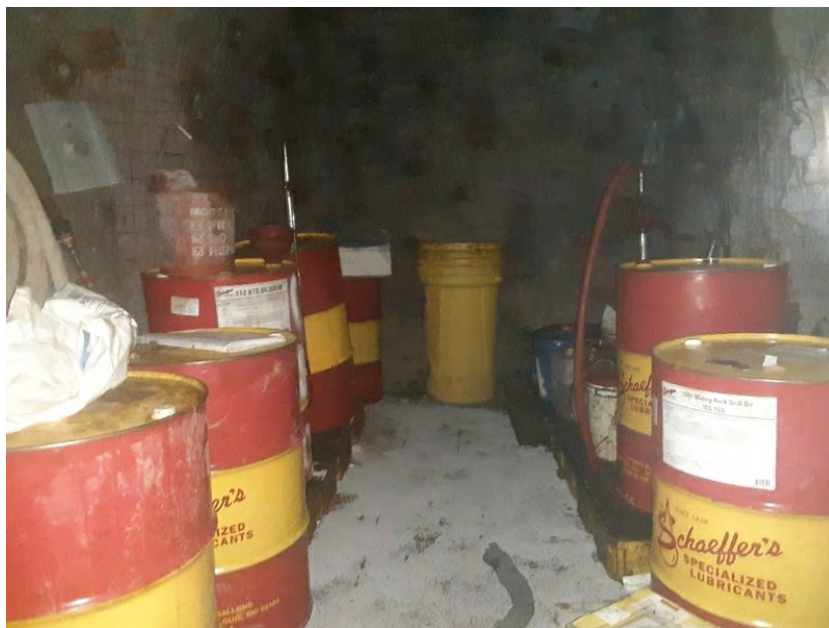
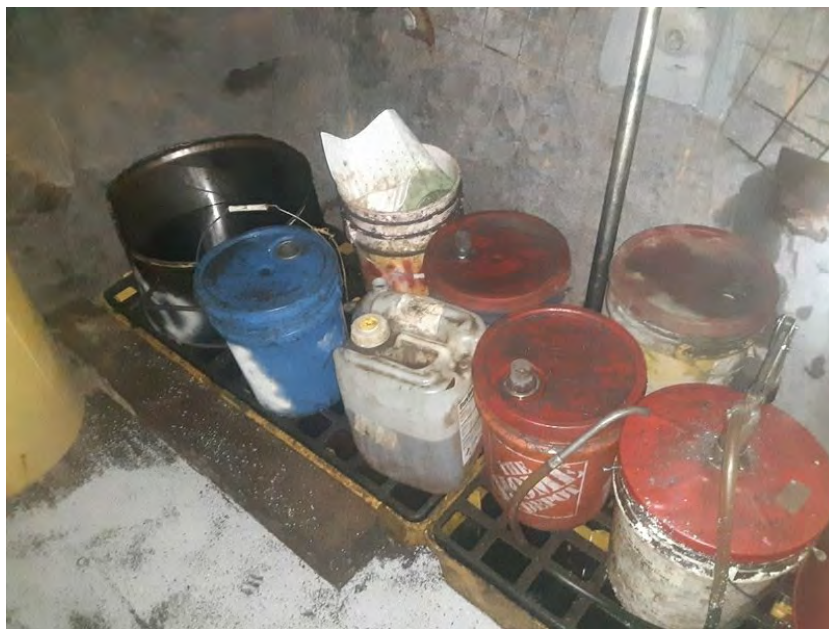
Location photo

Is a spill kit present?	Yes
Is equipment inventory complete?	No
Is any maintenance required for response equipment?	Yes
Note corrective action needed for response equipment	Need to replace dust pan.

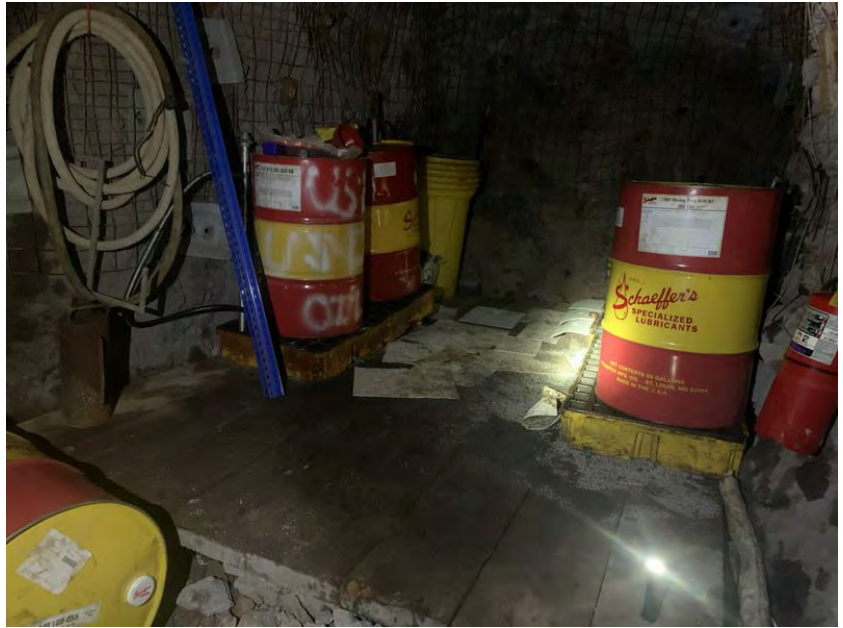
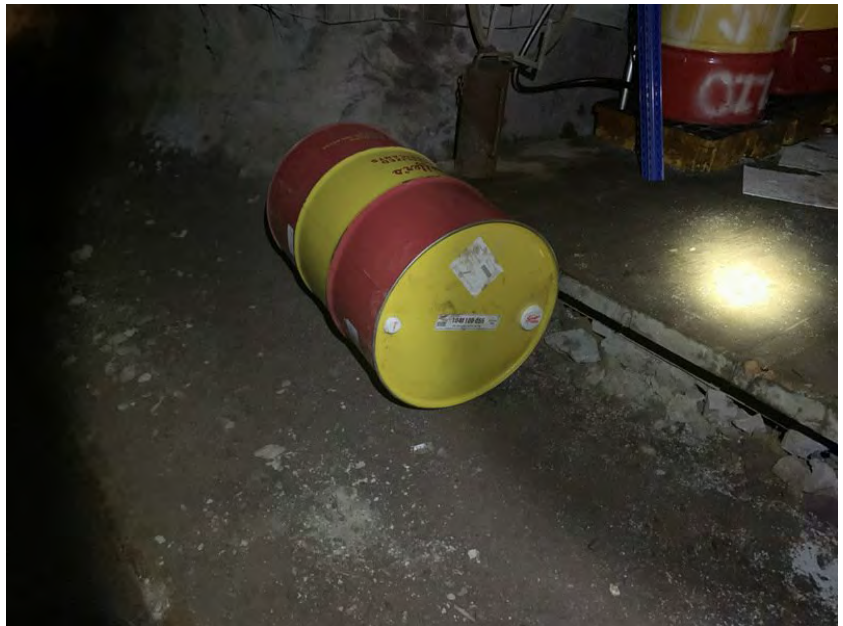
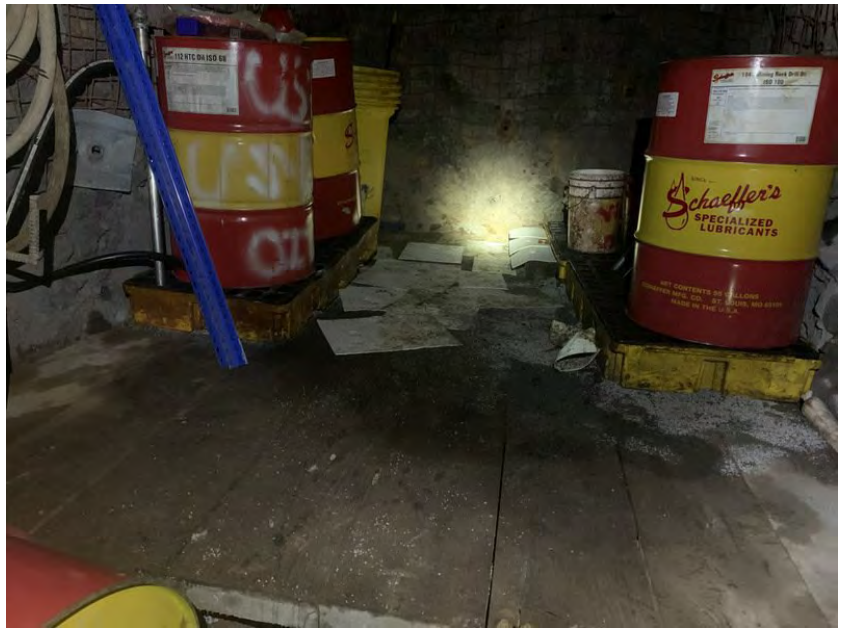
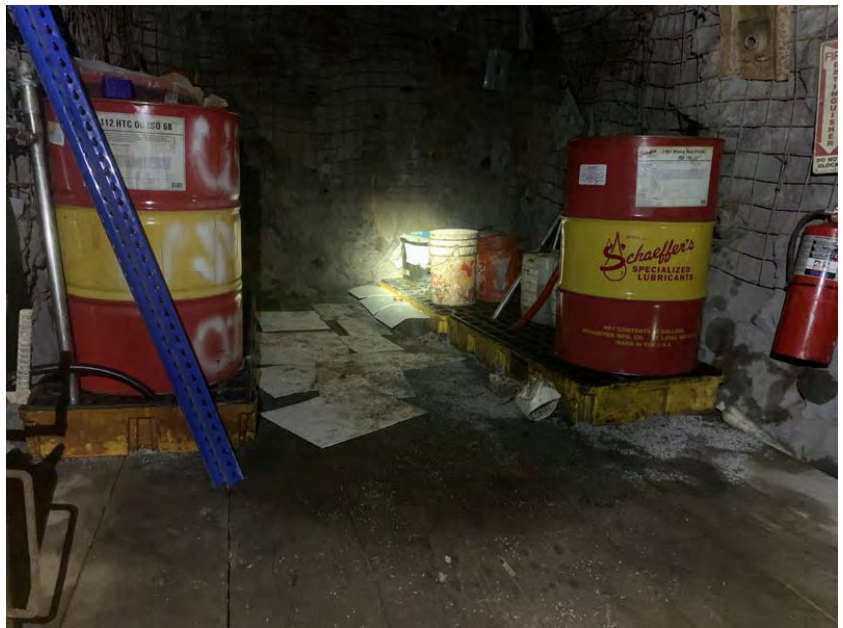
Are containers located within the designated storage area?	No
Is debris, spills or other fire hazards present in secondary containment?	Yes
Is water present in secondary containment?	No
Are drain valves functional?	Yes
Are drain valves in closed position?	Yes
Are gates/doors functional?	Yes
Is isle space adequate?	Yes
Are containers in good condition?	Yes
Are containers closed at time of inspection?	Yes
Are containers labeled correctly?	Yes
Are there any indications of leakage around containers or storage area?	No
Is any maintenance required?	Yes
Note corrective action needed	Oil barrel needs to be on secondary containment

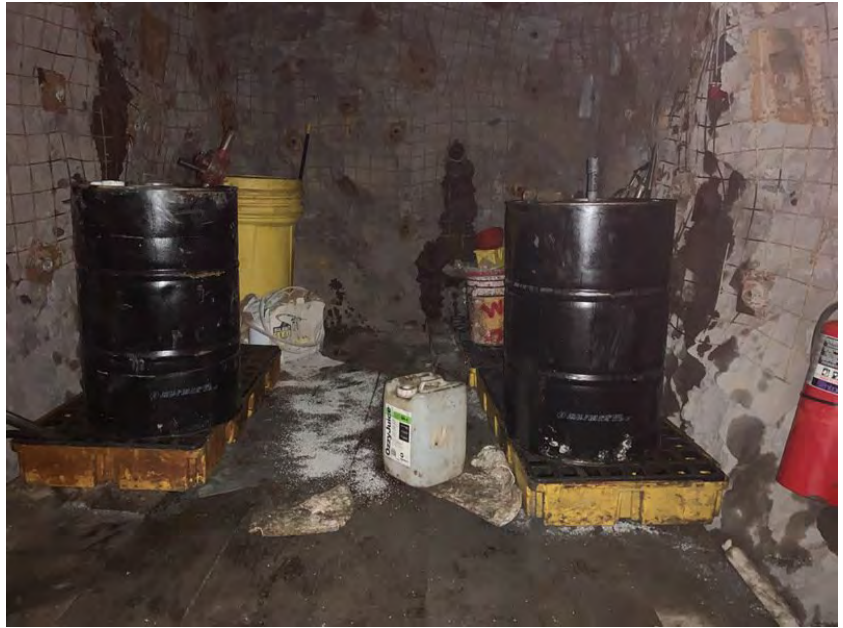
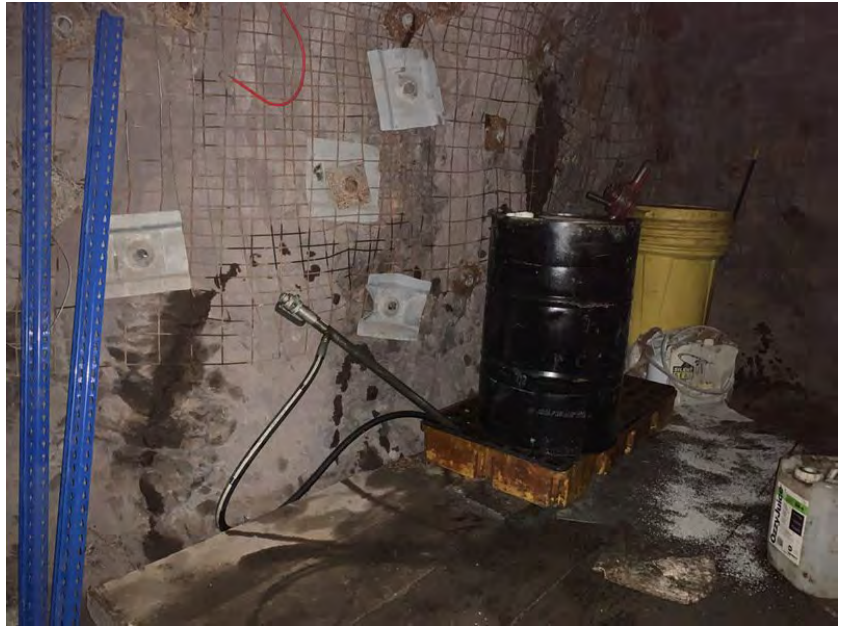
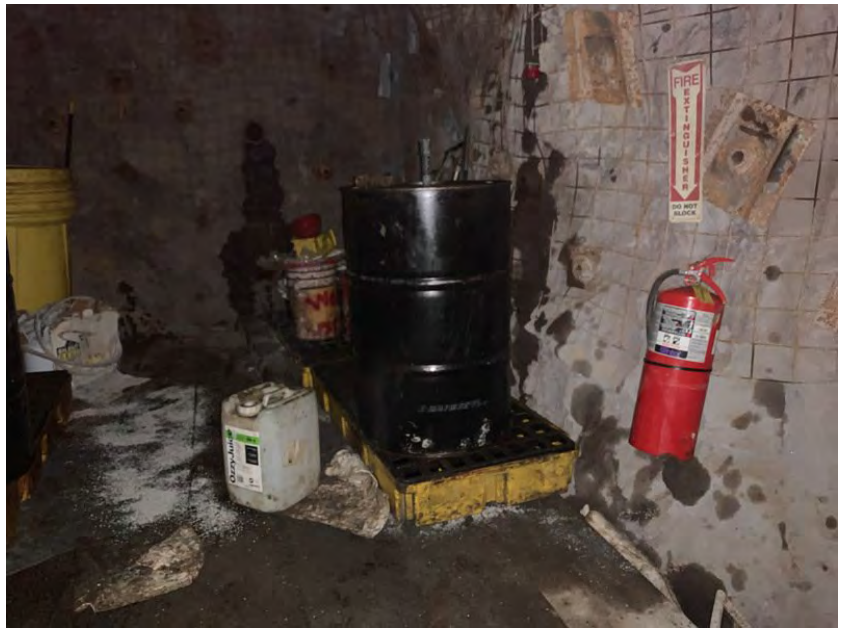
Are containers located within the designated storage area?	Yes
Is debris, spills or other fire hazards present in secondary containment?	No
Is water present in secondary containment?	No
Are drain valves functional?	Yes
Are drain valves in closed position?	Yes
Are gates/doors functional?	Yes
Is isle space adequate?	Yes
Are containers in good condition?	Yes
Are containers closed at time of inspection?	Yes
Are containers labeled correctly?	Yes
Are there any indications of leakage around containers or storage area?	No
Is any maintenance required?	Yes
Note corrective action needed	Floor dry needs to be applied and swept up. Dispose of properly.

Is a spill kit present?	Yes
Is equipment inventory complete?	No
Is any maintenance required for response equipment?	Yes
Note corrective action needed for response equipment	Add supplies to the spill kit. Socks, pads, floor dry needed. Items are on order
Location photo

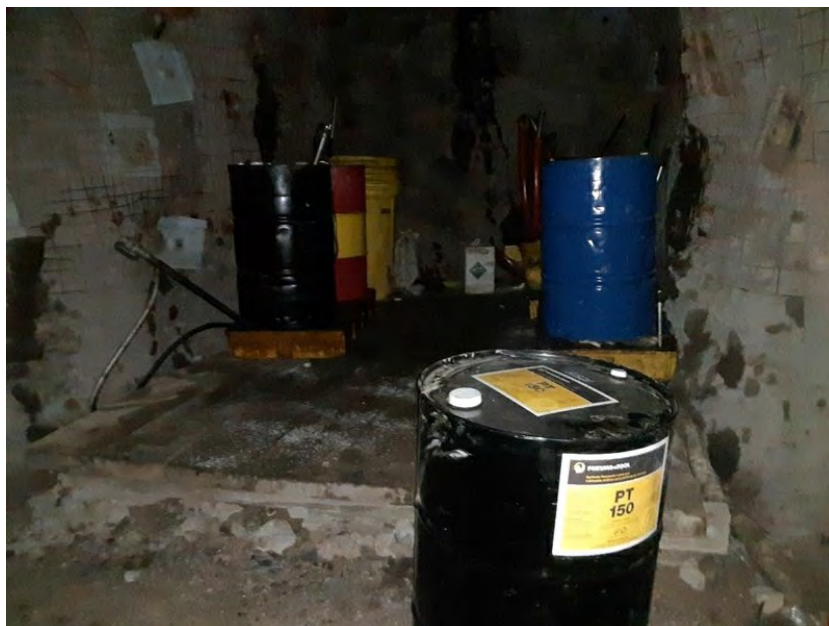
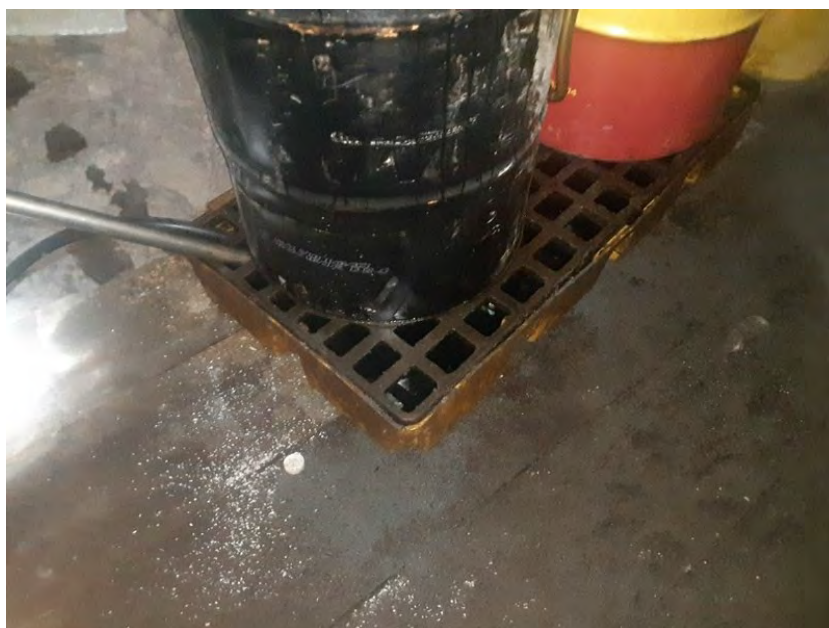
Are containers located within the designated storage area?	No
Is debris, spills or other fire hazards present in secondary containment?	Yes
Is water present in secondary containment?	No
Are drain valves functional?	N/A
Are drain valves in closed position?	N/A
Are gates/doors functional?	Yes
Is isle space adequate?	Yes
Are containers in good condition?	Yes
Are containers closed at time of inspection?	Yes
Are containers labeled correctly?	Yes
Are there any indications of leakage around containers or storage area?	No
Is any maintenance required?	Yes
Note corrective action needed	Secondary containment has rock drill oil. Needs to be cleaned. Two empty barrels need to be disposed of. One new barrel not placed on spill pallet.

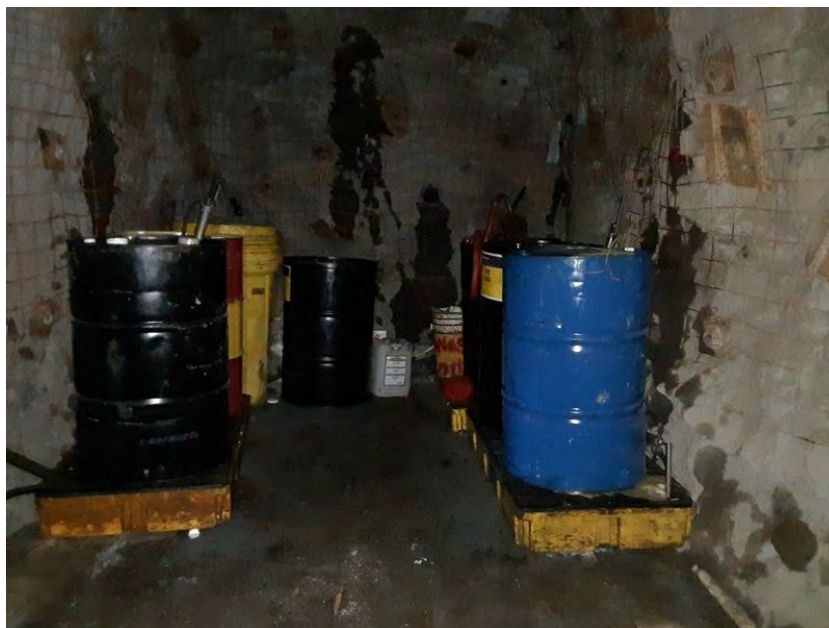
Are containers located within the designated storage area?	Yes
Is debris, spills or other fire hazards present in secondary containment?	Yes
Is water present in secondary containment?	No
Are drain valves functional?	N/A
Are drain valves in closed position?	N/A
Are gates/doors functional?	Yes
Is isle space adequate?	Yes
Are containers in good condition?	Yes
Are containers closed at time of inspection?	Yes
Are containers labeled correctly?	Yes
Are there any indications of leakage around containers or storage area?	No
Is any maintenance required?	Yes
Note corrective action needed	Small spill of rock oil in secondary containment. Empty barrel needs to be removed.

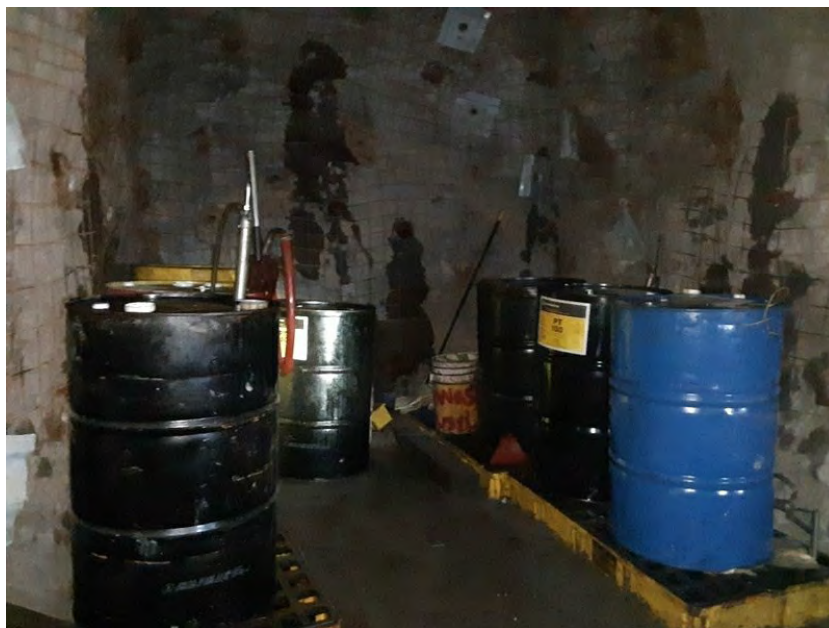
Are containers located within the designated storage area?	Yes
Is debris, spills or other fire hazards present in secondary containment?	Yes
Is water present in secondary containment?	No
Are drain valves functional?	N/A
Are drain valves in closed position?	N/A
Are gates/doors functional?	Yes
Is isle space adequate?	Yes
Are containers in good condition?	Yes
Are containers closed at time of inspection?	Yes
Are containers labeled correctly?	Yes
Are there any indications of leakage around containers or storage area?	No
Is any maintenance required?	Yes
Note corrective action needed	Empty barrel needs to be removed.

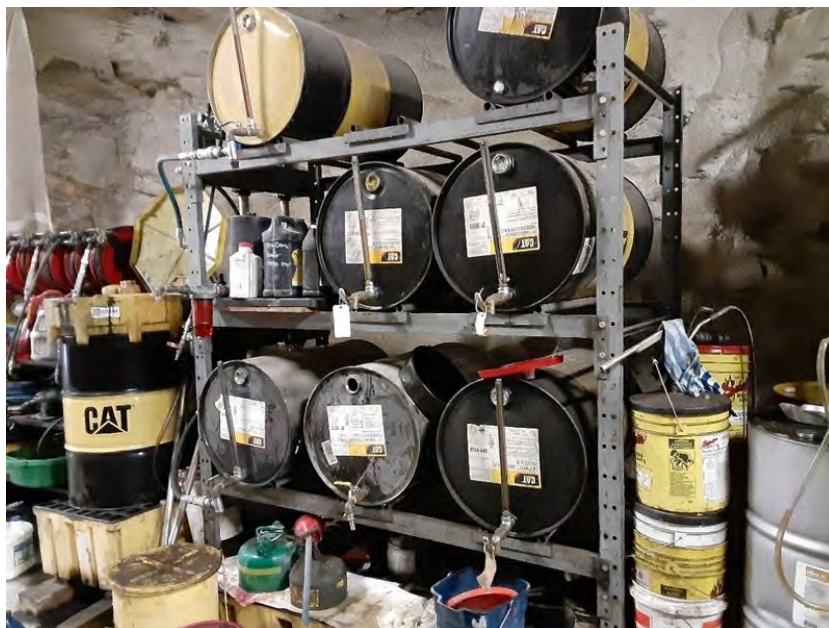
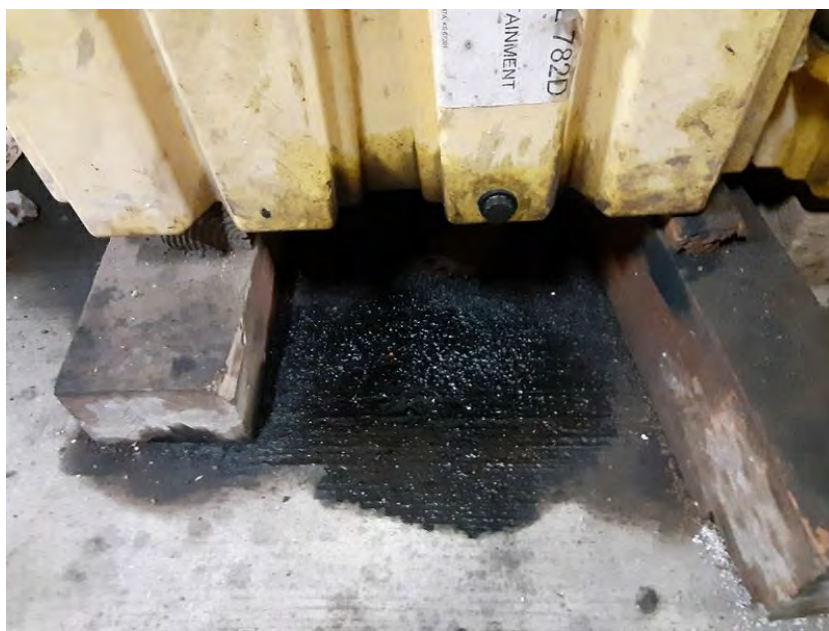
Are containers located within the designated storage area?	Yes
Is debris, spills or other fire hazards present in secondary containment?	No
Is water present in secondary containment?	No
Are drain valves functional?	No
Are drain valves in closed position?	Yes
Are gates/doors functional?	Yes
Is isle space adequate?	Yes
Are containers in good condition?	Yes
Are containers closed at time of inspection?	Yes
Are containers labeled correctly?	Yes
Are there any indications of leakage around containers or storage area?	Yes
Is any maintenance required?	Yes
Note corrective action needed	There is a small leak on one of the spill pallet drain valve. The pallet needs to be replaced to stop the leak.

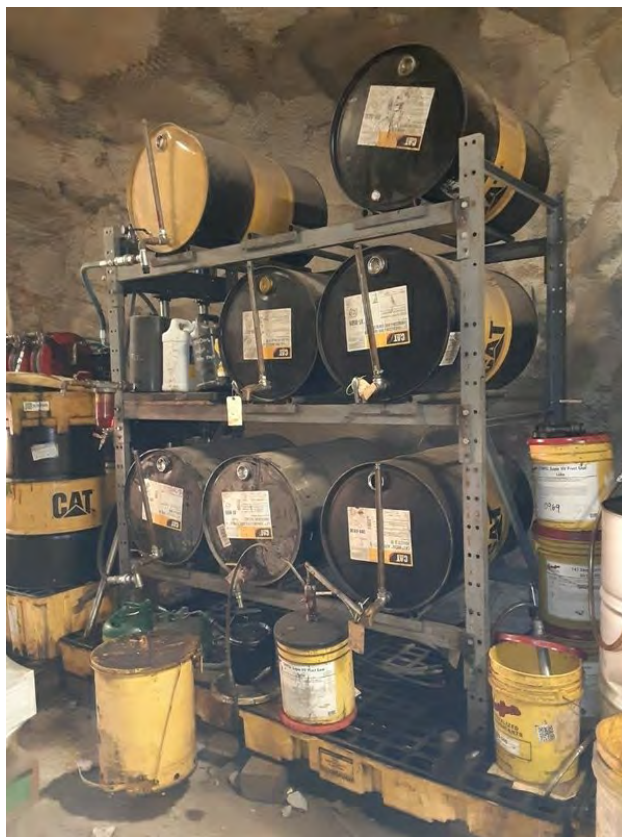
Are containers located within the designated storage area?	Yes
Is debris, spills or other fire hazards present in secondary containment?	Yes
Is water present in secondary containment?	No
Are drain valves functional?	Yes
Are drain valves in closed position?	Yes
Are gates/doors functional?	Yes
Is isle space adequate?	Yes
Are containers in good condition?	Yes
Are containers closed at time of inspection?	Yes
Are containers labeled correctly?	Yes
Are there any indications of leakage around containers or storage area?	No
Is any maintenance required?	Yes
Note corrective action needed	Pallet have spilled oil that needs to be pumped out.

Is a spill kit present?	Yes
Is equipment inventory complete?	No
Is any maintenance required for response equipment?	Yes
Note corrective action needed for response equipment	Need floor dry

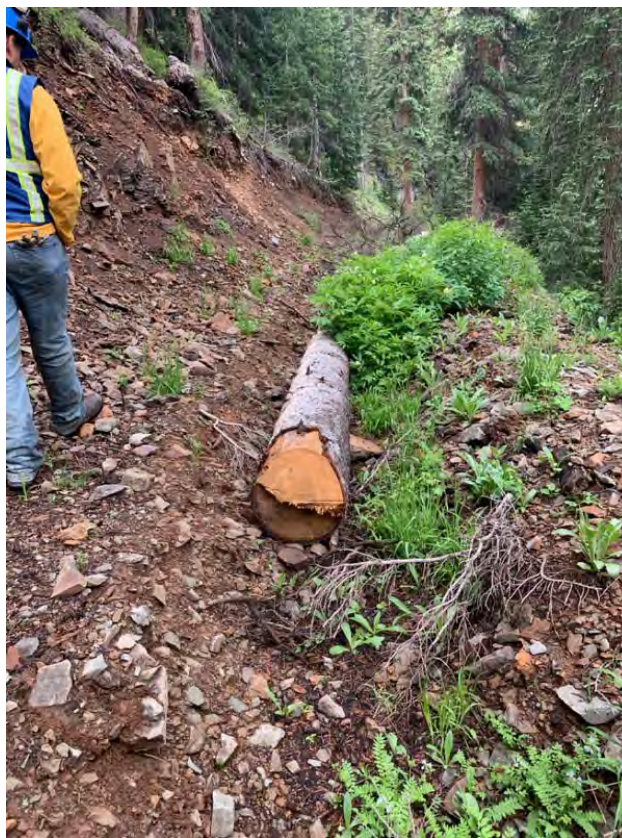
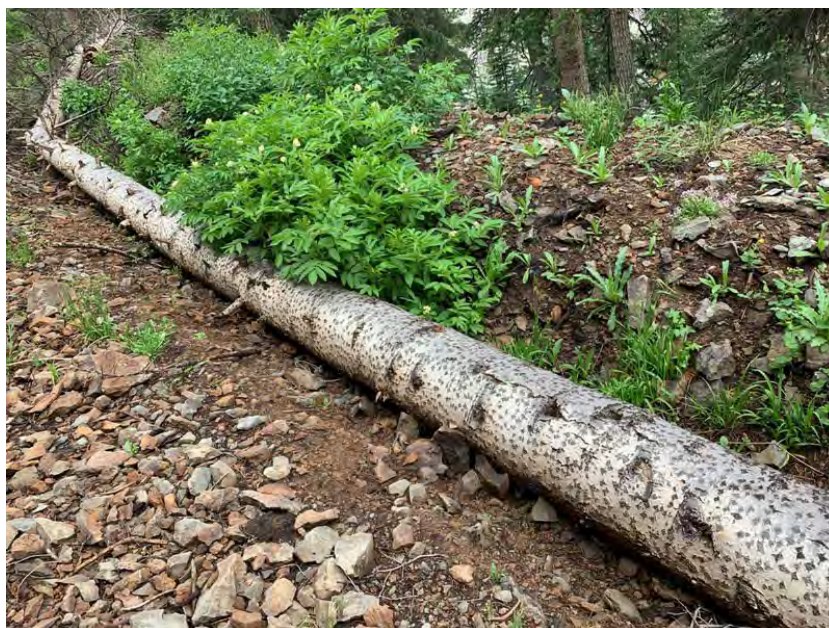
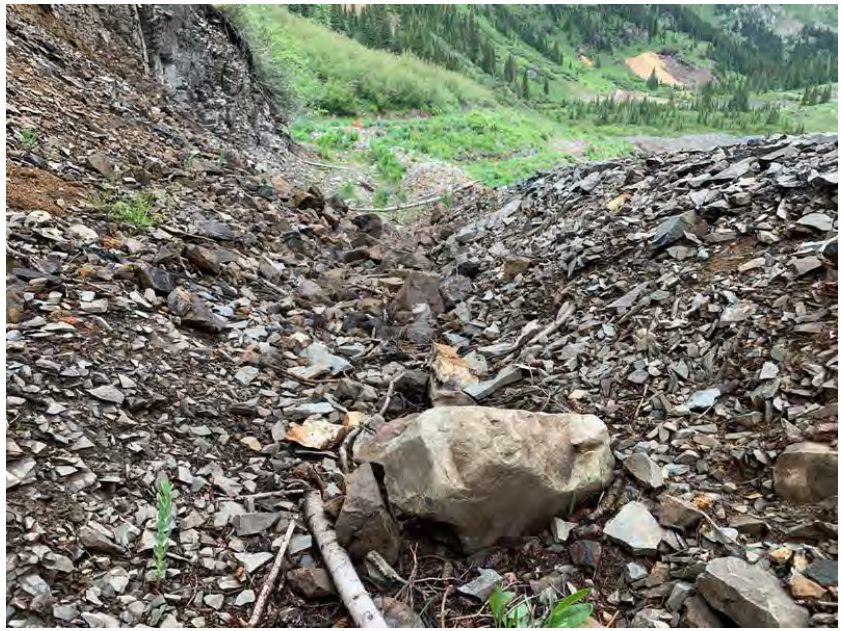
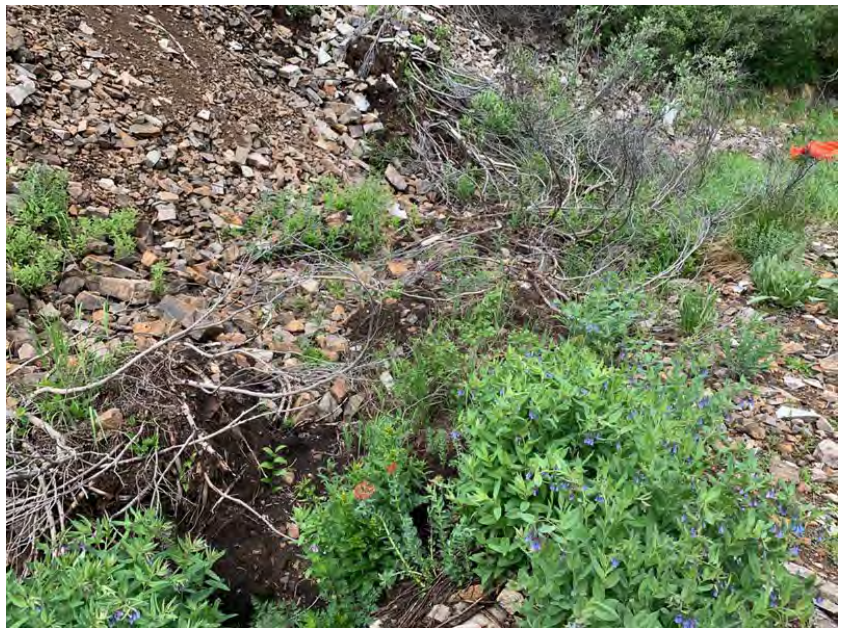
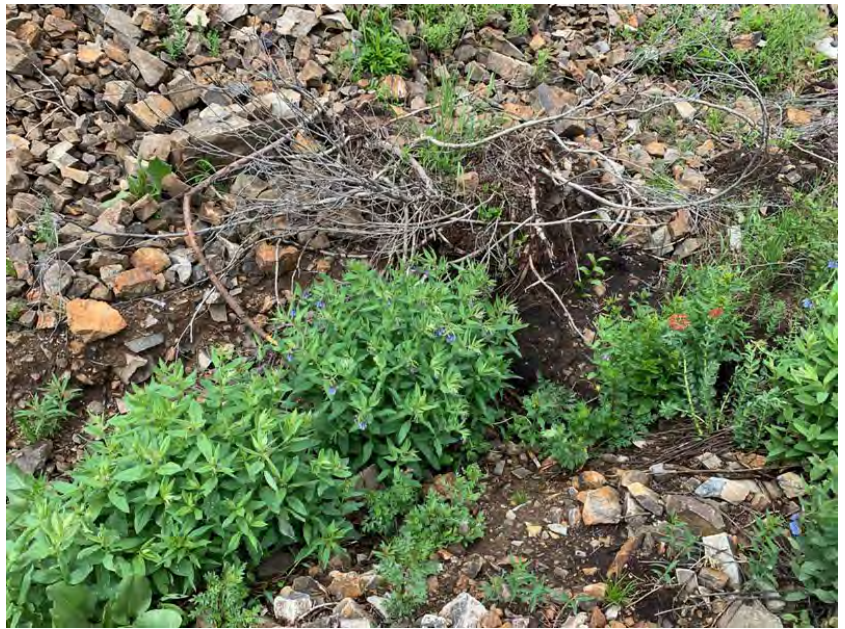
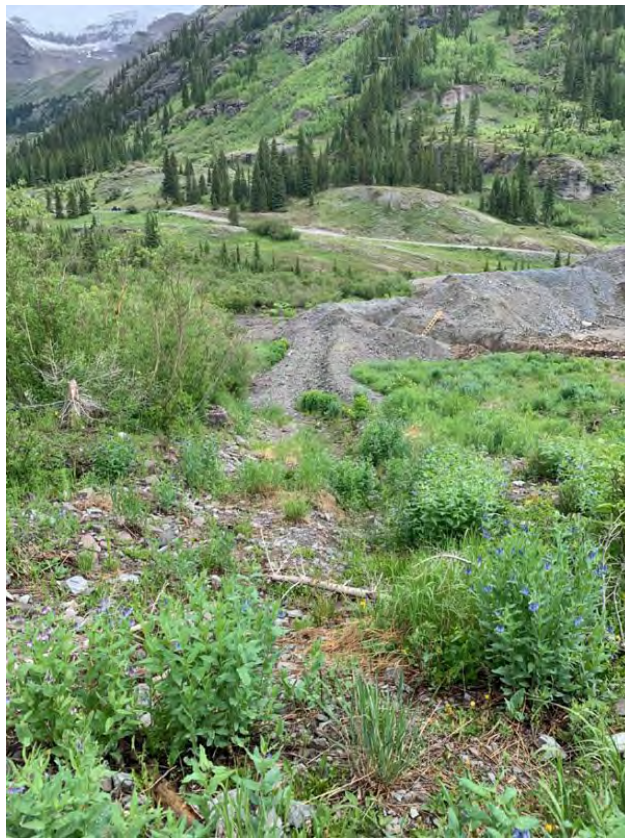
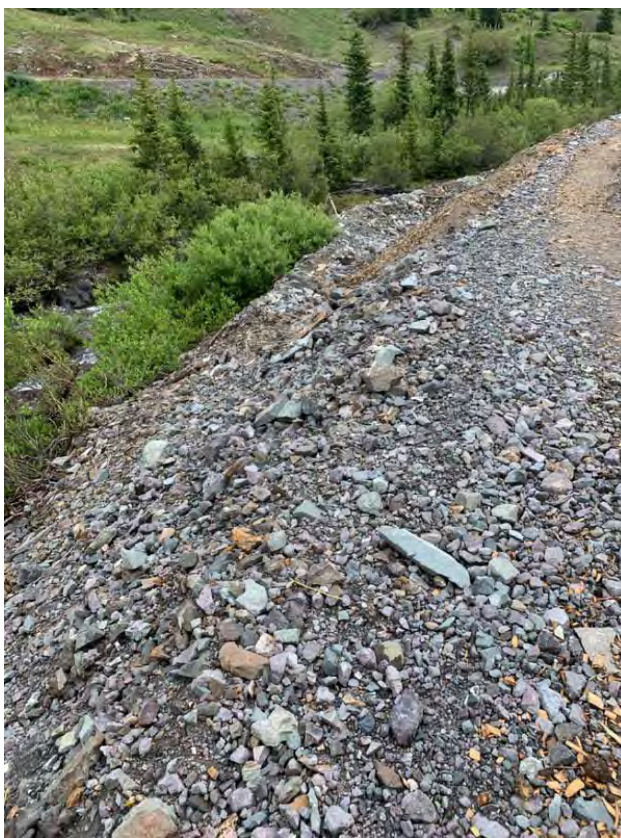
Collection Ditch #2: Is maintenance required?	Yes
Collection Ditch #2: note corrective action needed	Diversion ditch is blocked temporarily to repair water lines
Pond #2: Is maintenance required?	No
Pond #2: note corrective action needed	None
Pond #2 emergency spillway: Is maintenance required?	Yes
Pond #2 emergency spillway: note corrective action needed	Berm needs to be rebuilt after they're done putting down organic material Replace waddles north of the pond Keep waddles in the wetlands?

Collection Ditch #3: Is maintenance required?	Yes
Collection Ditch #3: note corrective action needed	Dig out the road base
Pond #3: Is maintenance required?	Yes
Pond #3: note corrective action needed	Waddles need to be replaced north of the pond
Pond #3 emergency spillway: Is maintenance required?	No
4" valve - Pond #3 spillway: Is it functional?	No
4" valve - Pond #3 spillway: Is there erosion or obstruction?	No
Pond #3 emergency spillway: note corrective action needed	4" valve doesn't exist
Hay bales: Is maintenance required?	Yes
Hay bales: note corrective action needed	Need to be replaced

Has there been a change in facility design, construction, operation or maintenance?	Yes
Note changes in facility design, construction, operation or maintenance.	Pond construction, passive water treatment construction. Will update changes reflected on living map
Effective date of SWMP	2018
Is current operator's certificate on file?	Yes
Is annual storm water training current?	Yes
