Attachment D

SPCC C-1 Diesel and Gas Storage & Filling Station

Date of Inspection	2021-01-28
Inspection Frequency	Monthly

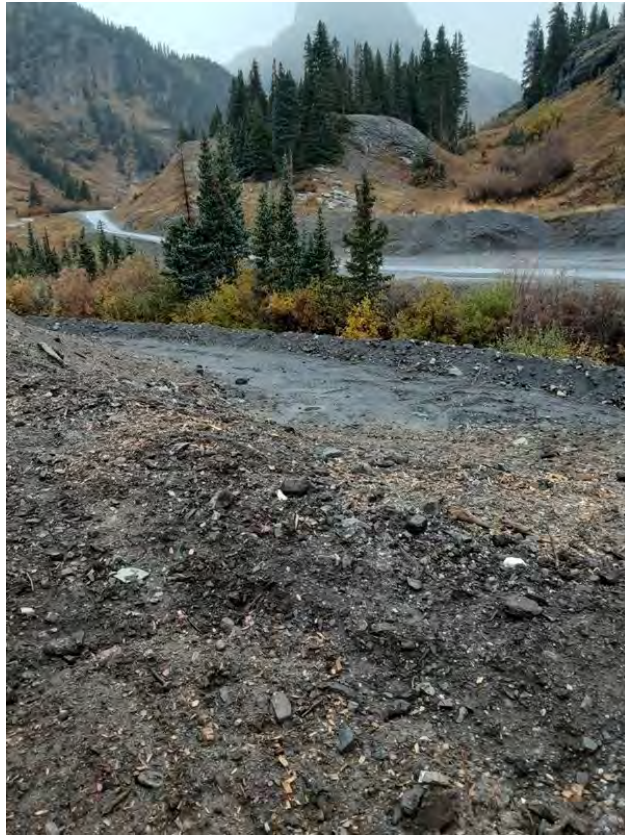
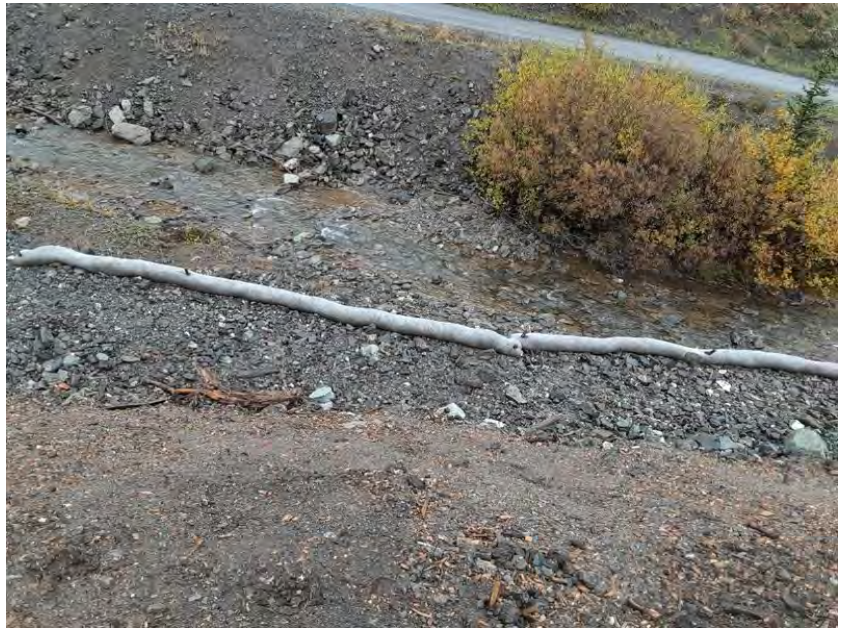
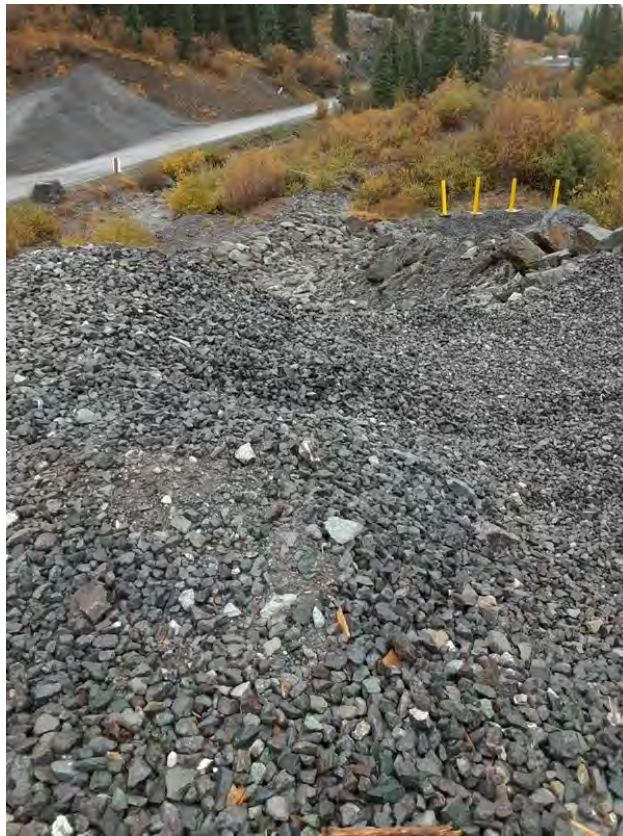
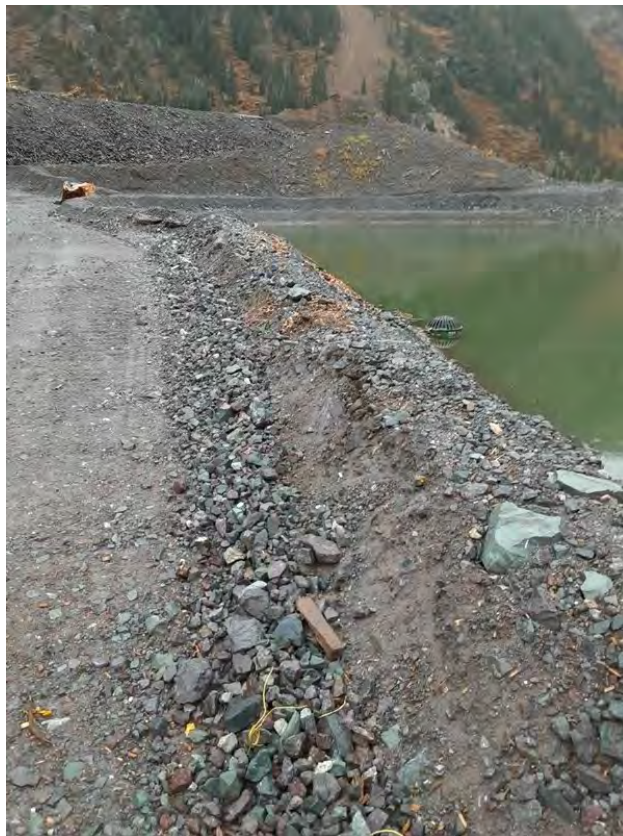
Pond #3 Berm: note corrective action needed	NA
Pond #3 Wattles: Is maintenance required?	Yes
Pond #3 Wattles: note corrective action needed	Rocks need to be pulled back
Pond #3: Is maintenance required?	No
Pond #3: note corrective action needed	NA
Pond #3 emergency spillway: Is maintenance required?	No
Pond #3 emergency spillway: note corrective action needed	NA
Hay bales: Is maintenance required?	No
Hay bales: note corrective action needed	Replaced after last inspection

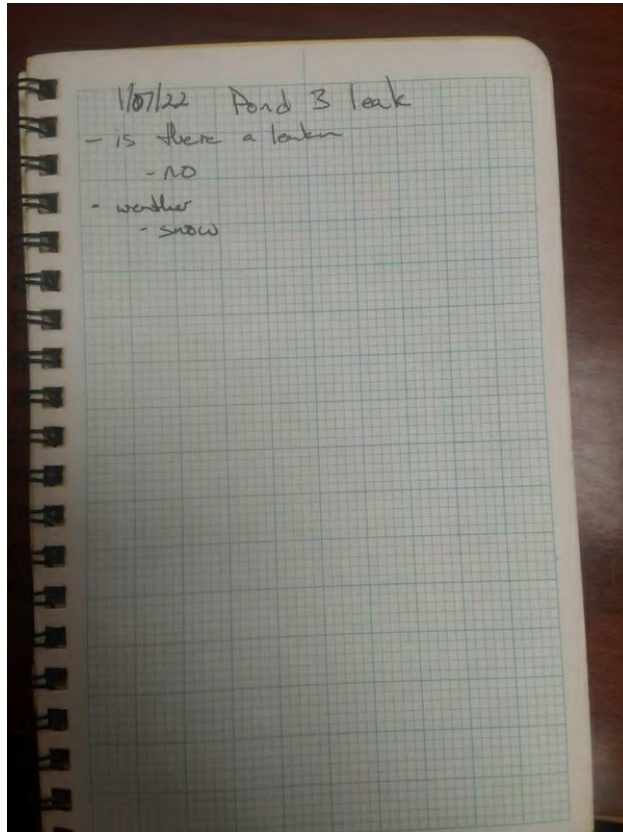
Created	2022-01-17 12:42:28 MST by Environmental Department
Updated	2022-01-17 12:44:14 MST by Environmental Department
Location	38.024155, -107.6718031
Date	2022-01-07
Time	12:42
Weather Conditions	Snow
Water Present?	No
Notes	Part of december inspection. Couldn't get to site sooner due to snow conditions. Phone died during inspection. Photo of notes uploaded
