To: Jerald Schnabel From: Paul Kos
Continental Materials Corp. Denver, CO 80222
File: January 2022 Monitoring Summary Date: February 28, 2022

Reference: January 2022 Geotechnical Monitoring Summary Pikeview Quarry

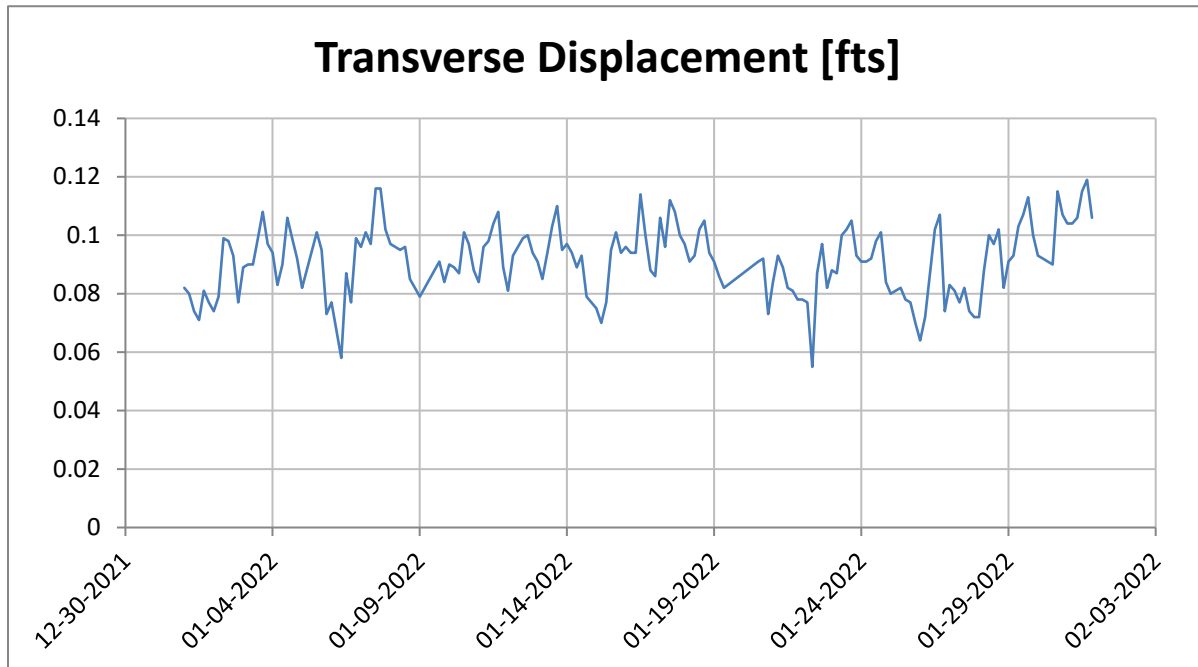
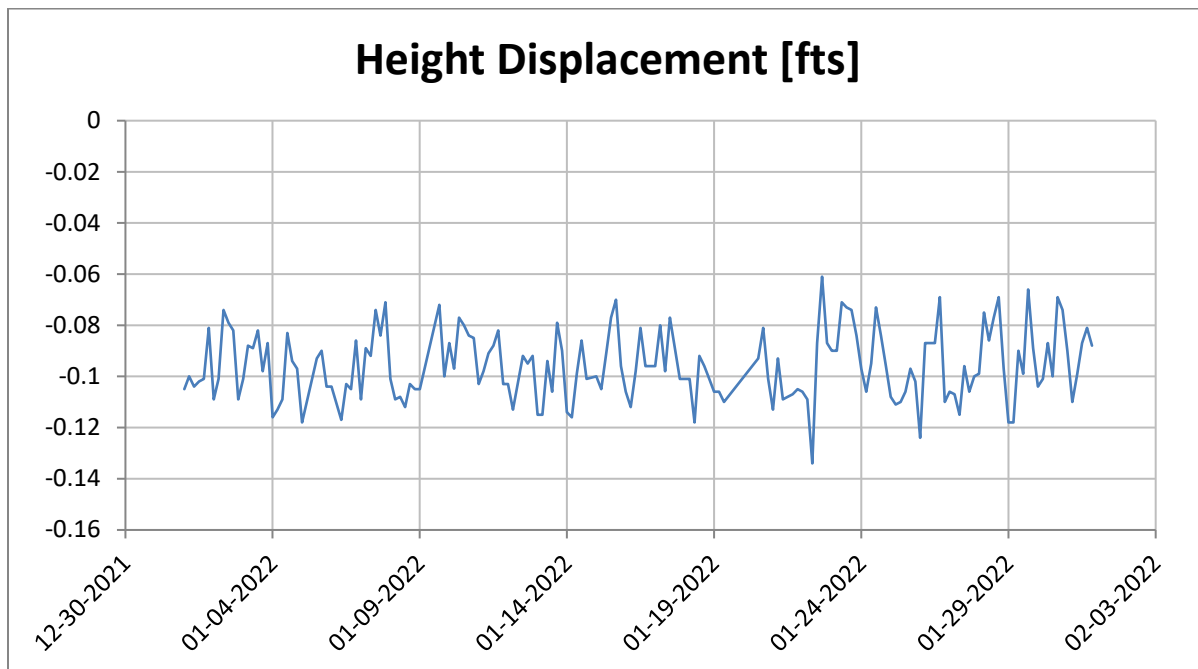
Prism NP2

1. Survey accuracy is ± 0.016 feet.
2. Alarm threshold is ± 0.35 feet.
3. Transverse displacement is in the horizontal direction. Positive direction means closer to the robotic station.
4. Height displacement is in the vertical direction. Positive direction means higher in elevation.
5. Prism records slope creep movements with slow velocity.

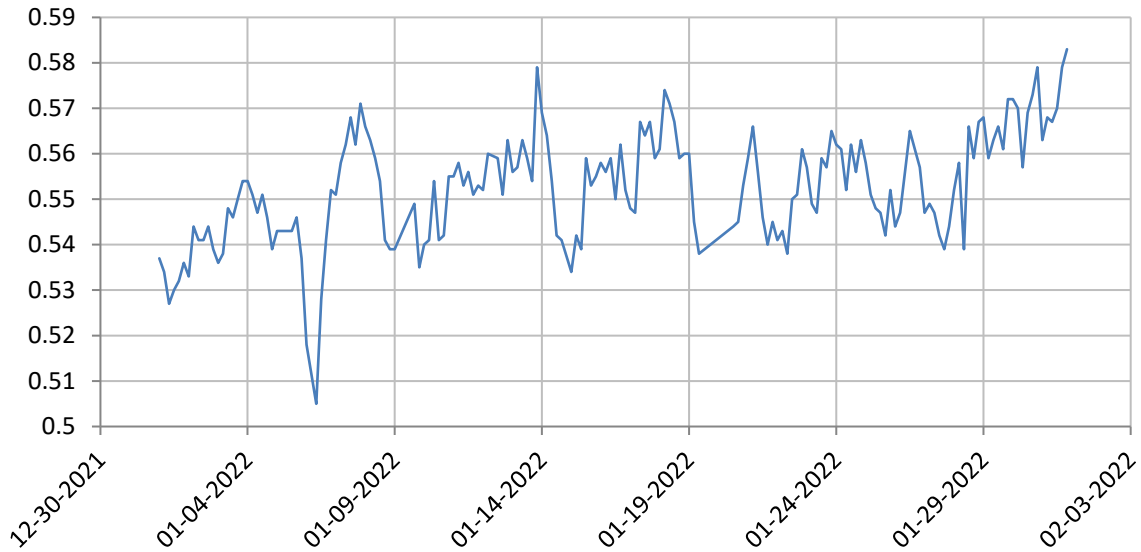
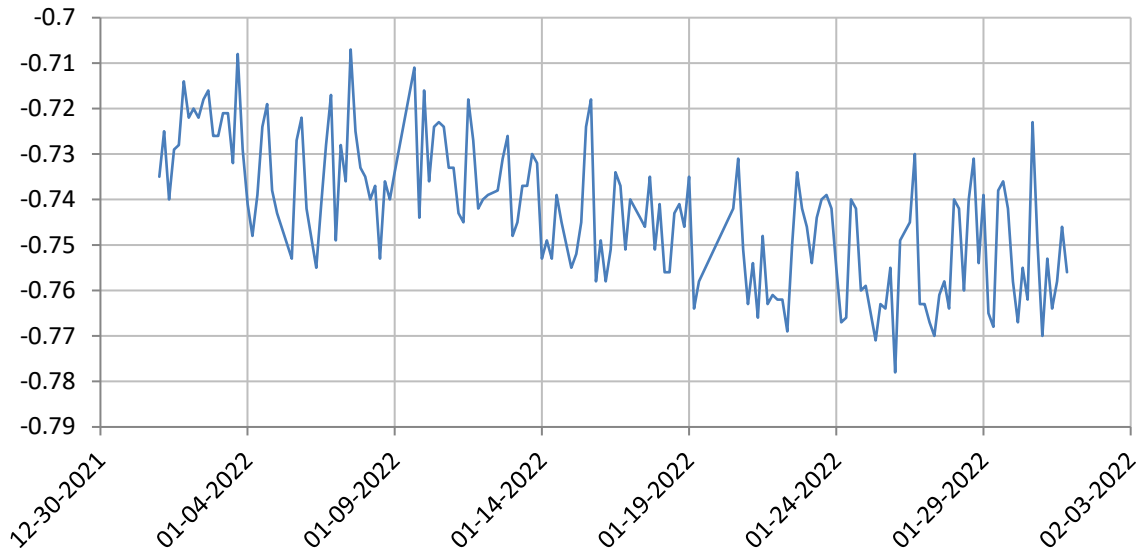
Prism NP66

1. Survey accuracy is ± 0.016 feet.
2. Alarm threshold is ± 0.35 feet.
3. Transverse displacement is in the horizontal direction. Positive direction means closer to the robotic station.
4. Height displacement is in the vertical direction. Positive direction means higher in elevation.
5. Prism records slope creep movements with slow velocity.

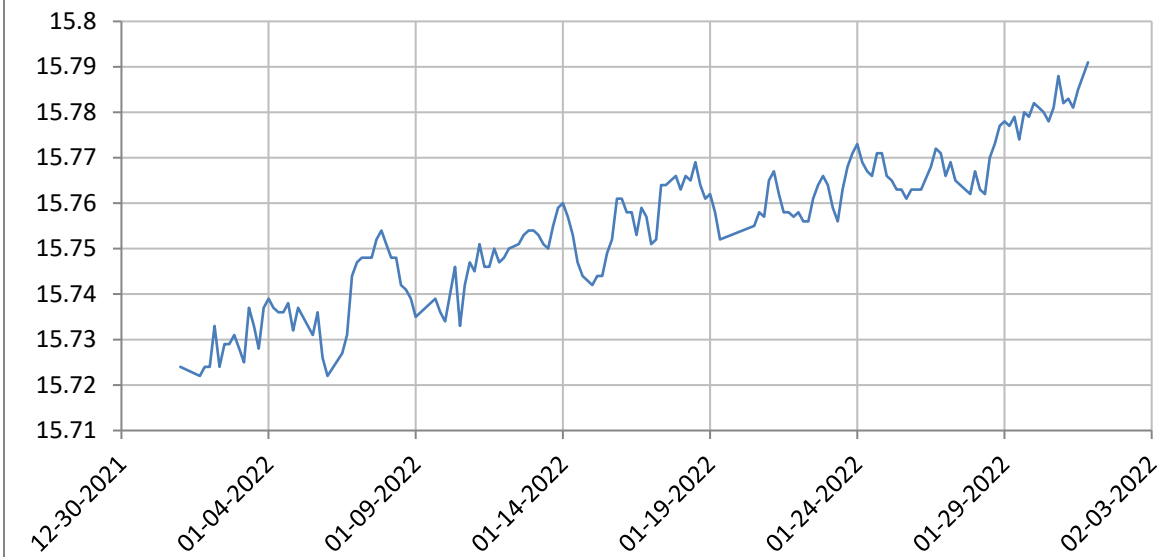
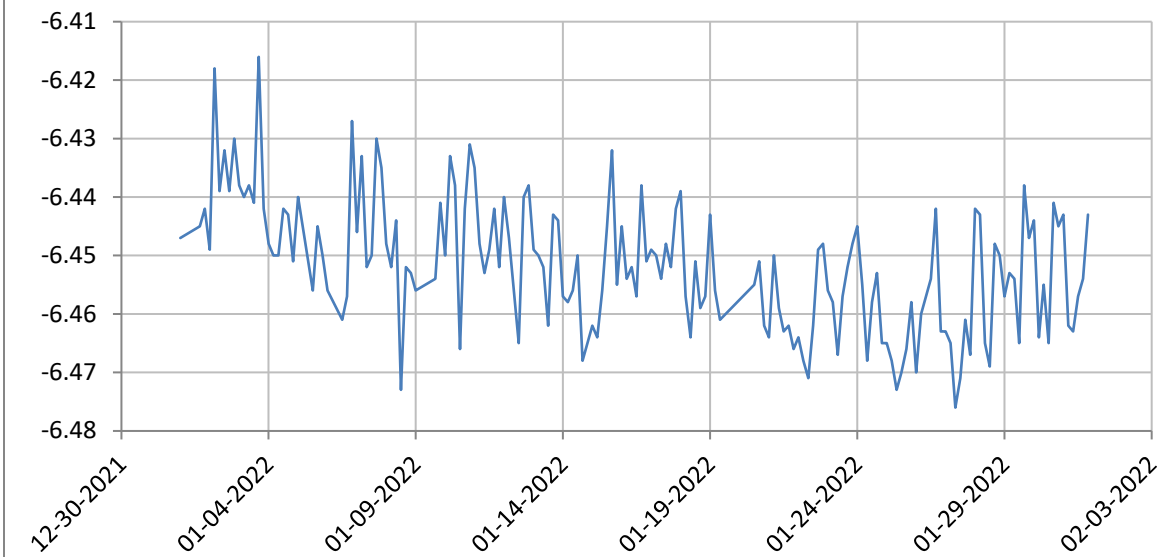
Prism P63

1. Survey accuracy is ± 0.016 feet.
2. Alarm threshold is ± 0.35 feet.
3. Transverse displacement is in the horizontal direction. Positive direction means closer to the robotic station.
4. Height displacement is in the vertical direction. Positive direction means higher in elevation.
5. Prism records slope creep movements with slow velocity.
