RE: 2021 Annual Report, Henderson Mine and Mill, Permit No M-1977-342

Re: **#1333.0 - Henderson Mill
TSF Flood Storage**

Subject: Annual (Year 2021) Tailings Storage Facility Evaluation, Henderson Tailings Storage Facility, Permit No. M-1977-342, Henderson Mill, Colorado

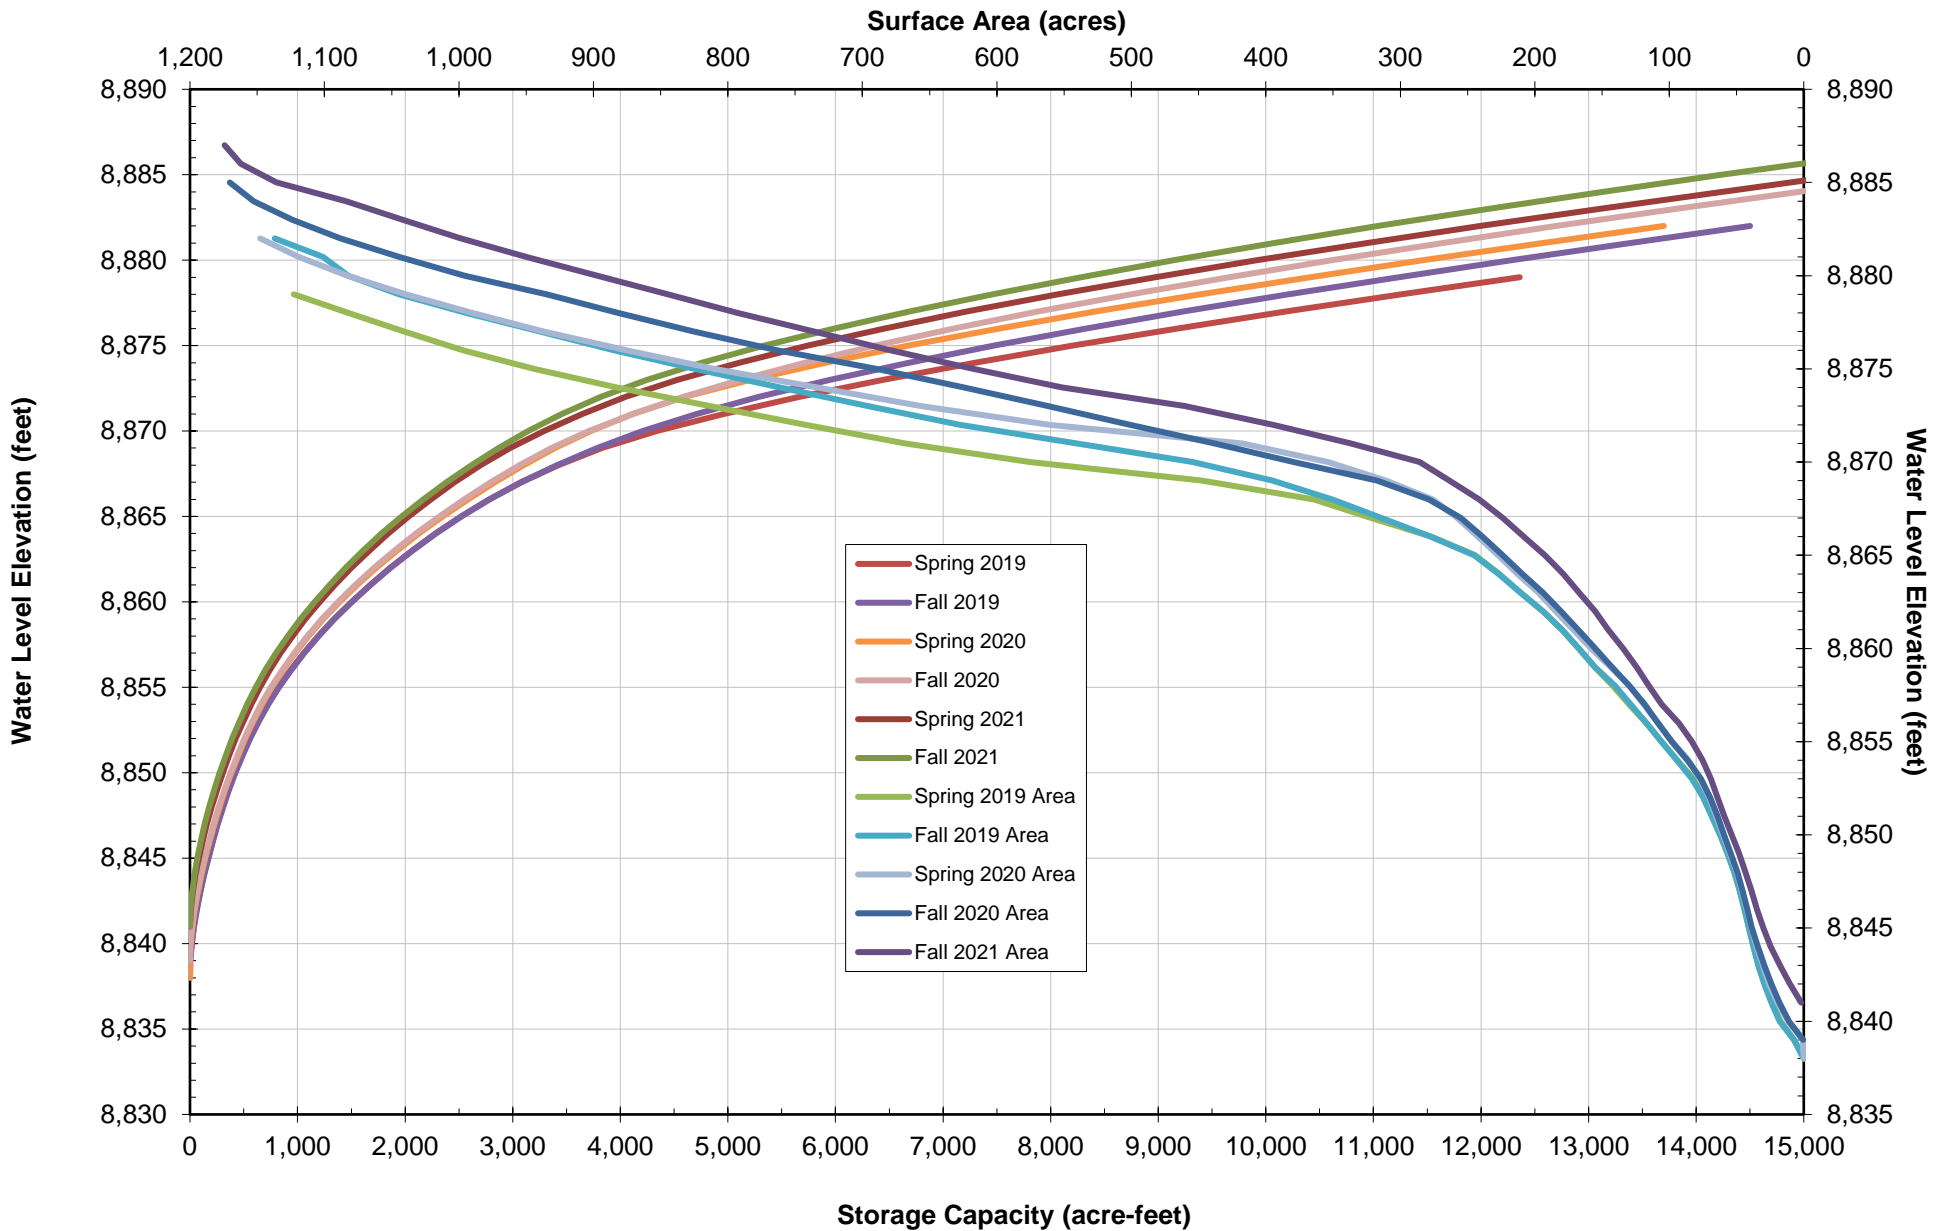
Figure 2 - Henderson TSF Elevation Area Capacity

One of the primary uses of the survey data is to evaluate the flood storage capacity conditions in the water system. As summarized on Figure 1, at the approximate time of the fall survey there was a total system surcharge storage capacity of about **10,574 acre-feet** in the system. This capacity includes both the TSF and East Branch Reservoir and is based on 0.5 feet of residual freeboard below the minimum dam crest elevation of 8,885.0' and a October 31st water level of 8,870.0 feet. The flood storage requirement for the system is **3,582 acre-feet**. This requirement is based on hydrologic modeling of the probable maximum precipitation (PMP) event. The available flood storage capacity in the system at

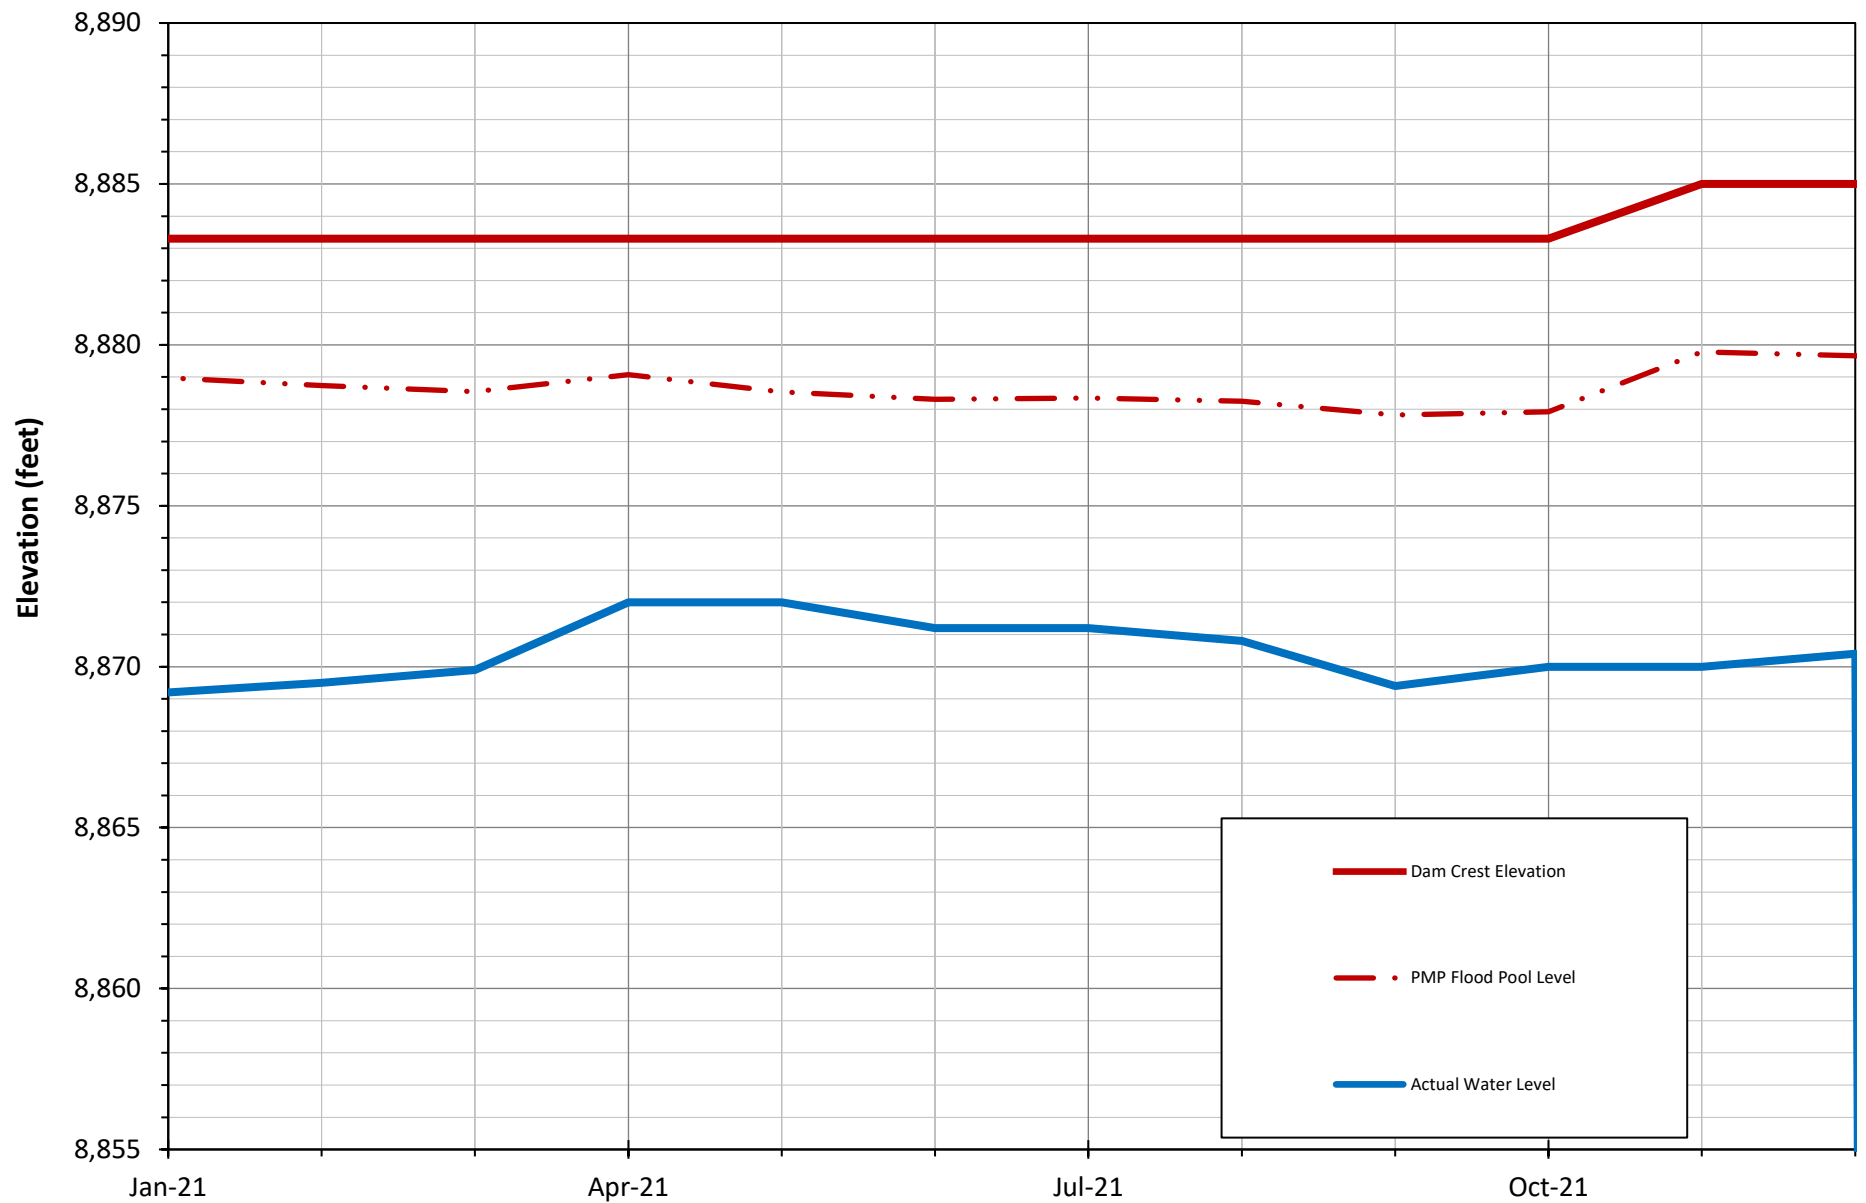
**Figure 3 Henderson TSF
Water Pool Level Tracking**

A relatively accurate determination of the flood storage capacity in the impoundment can be made at the time of the spring and fall pond surveys. An operations model has been developed to track water levels and estimate the flood storage availability in the system between surveys. This model is updated by Wheeler on a monthly basis. One of the reports generated by this model is the attached TSF Water Level Report (Figure 3). This graph shows the actual water level in the TSF as compared to the flood pool level in the pond, which is defined as the level corresponding to 3,582 acre-feet of available capacity. Note that the actual water level did not exceed the flood pool level at any time in 2021. This shows that the required flood storage space was maintained in the system throughout the 2021 calendar year.
