MINERALS PROGRAM INSPECTION REPORT PHONE: (303) 866-3567

MINE NAME:	MINE	/PROSPECTING ID#:	MINERAL:	COUNTY:	
Speer Mining Resource	M-198	33-176	Gravel	Adams	
INSPECTION TYPE:	INSPI	ECTOR(S):	INSP. DATE:	INSP. TIME:	
Monitoring	Patricl	k Lennberg	March 3, 2022	10:00	
OPERATOR:		RATOR REPRESENTATIVE:	TYPE OF OPERA	TYPE OF OPERATION:	
Asphalt Specialties Co., Inc.		Geras and Miles Buescher	112c - Construction	112c - Construction Regular Operation	
REASON FOR INSPECTION:		O CALCULATION TYPE:		BOND AMOUNT:	
Normal I&E Program	Partial	Bond	\$678,169.00		
DATE OF COMPLAINT:		INSP. CONTACTS:	JOINT INSP. AGE	JOINT INSP. AGENCY:	
NA	None		County		
WEATHER:	INSPECTOR'S SIGNATURE:		SIGNATURE DATE:		
Clear	Patrick Stor		March 11, 2022

PERMIT #: M-1983-176 INSPECTOR'S INITIALS: JPL INSPECTION DATE: March 3, 2022

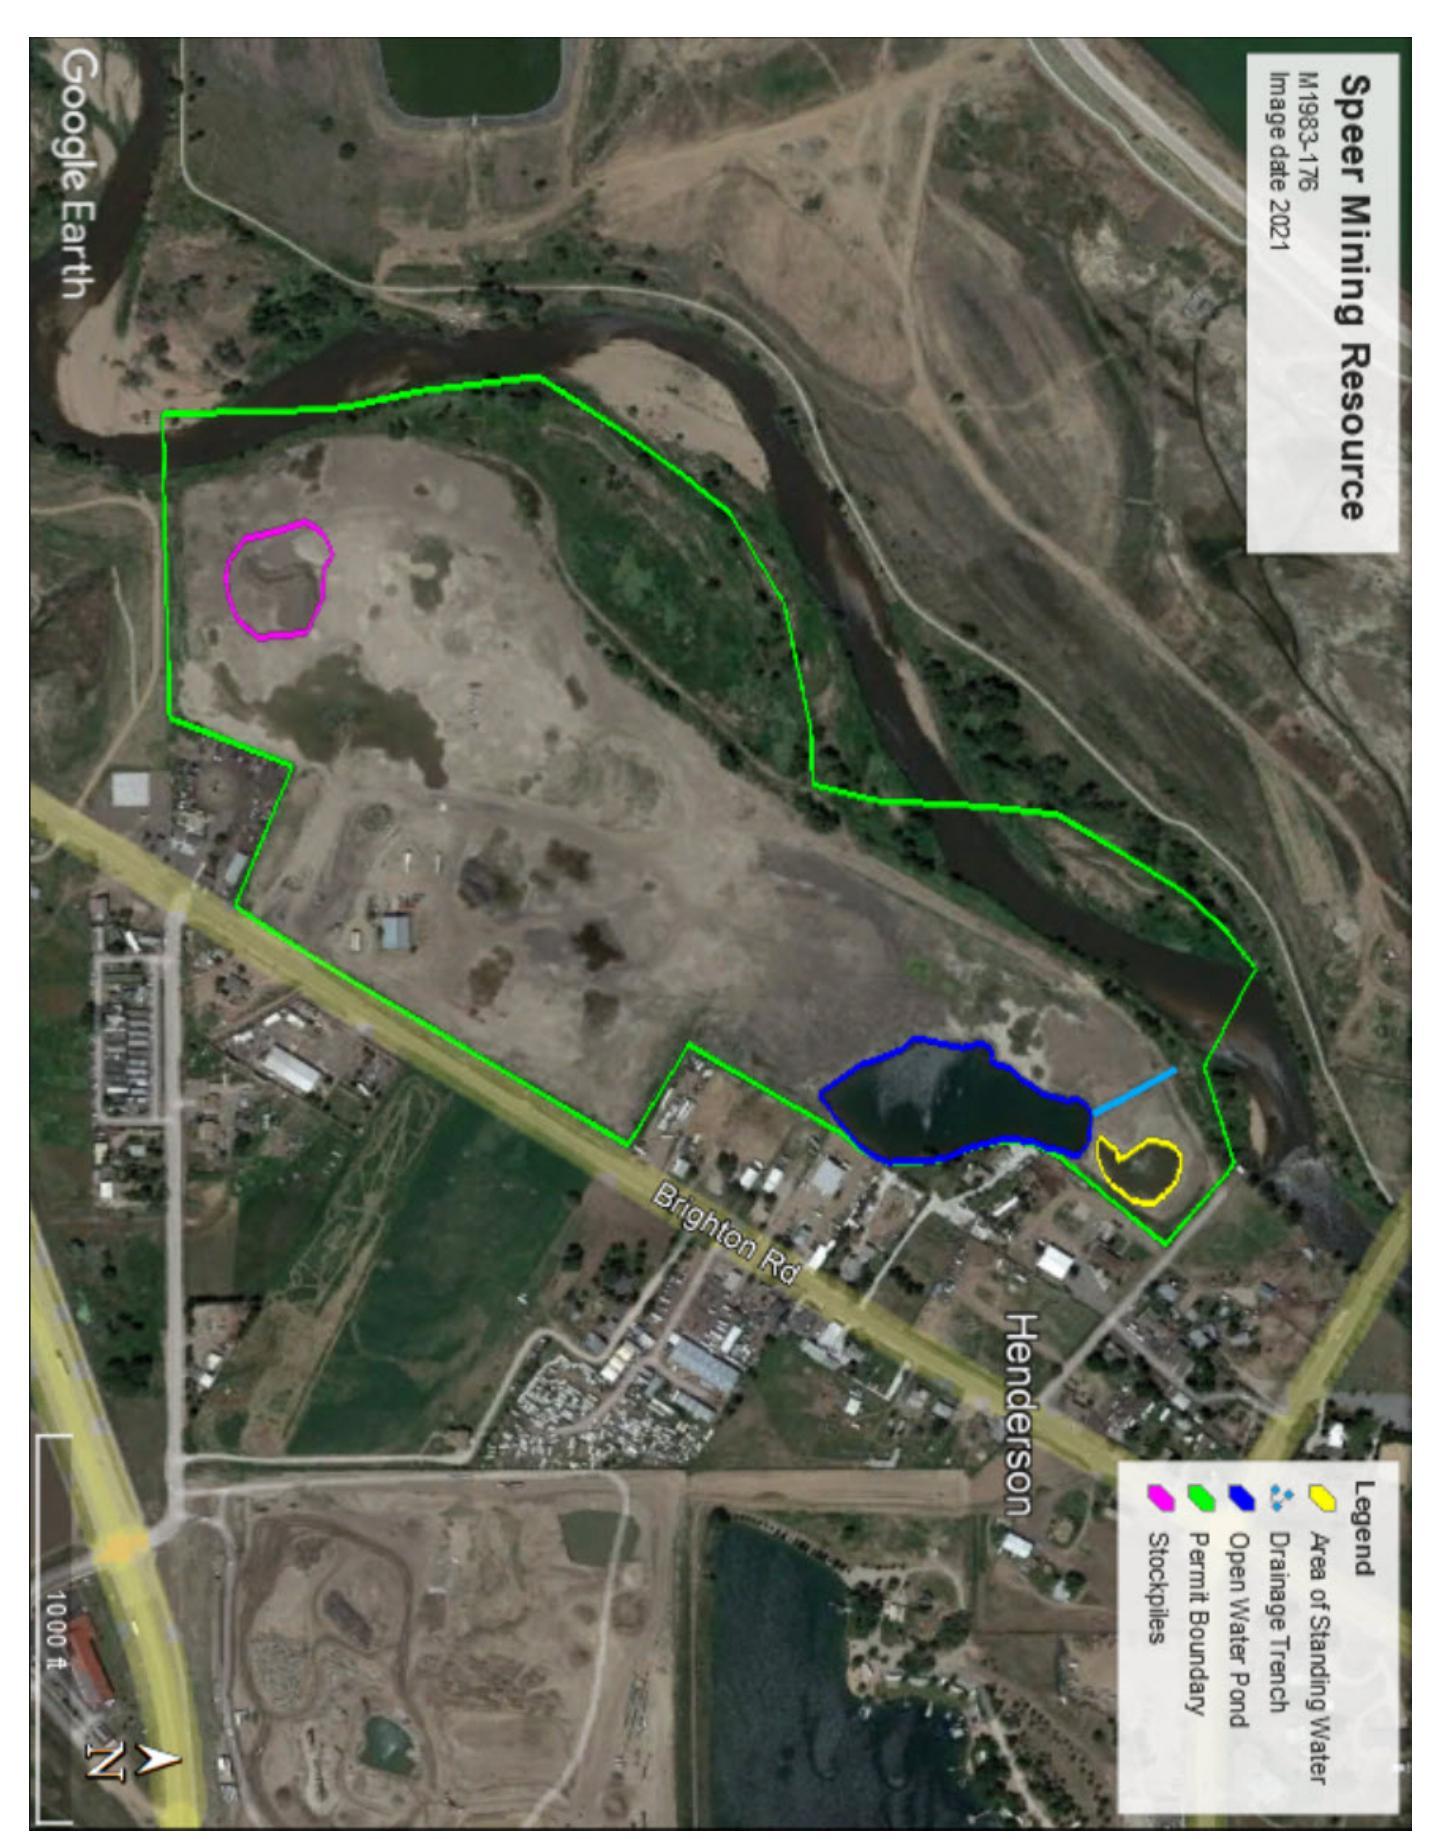
Photo 8: Looking north to south across the unlined pond

Drain, lining the 2.5 acre pond, filling the area where storm water was collecting, submitting a Technical Revision(s) to update the permit to be consistent with field conditions and when topsoil and seeding would occur. The Operator committed in the field to providing a tentative schedule when these activities are to be initiated. The Division is concerned the Operator will not achieve reclamation in the five year period pursuant to Rule 3.1.3.
