Battle Mountain Resources, Inc.
San Luis Project
P.O. Box 310
San Luis, Colorado 81152-0310
(719) 379-0798

Re: Battle Mountain Resources, Inc.
San Luis Project - San Luis, Colorado
Annual Report and Fee 2021
CMLRB Permit No. M-1988-112

ATTACHMENT 2
SAN LUIS TAILINGS STORAGE FACILITY
2021 ANNUAL DAM SAFETY INSPECTION
JUNE 8, 2021
INSPECTION PHOTOS

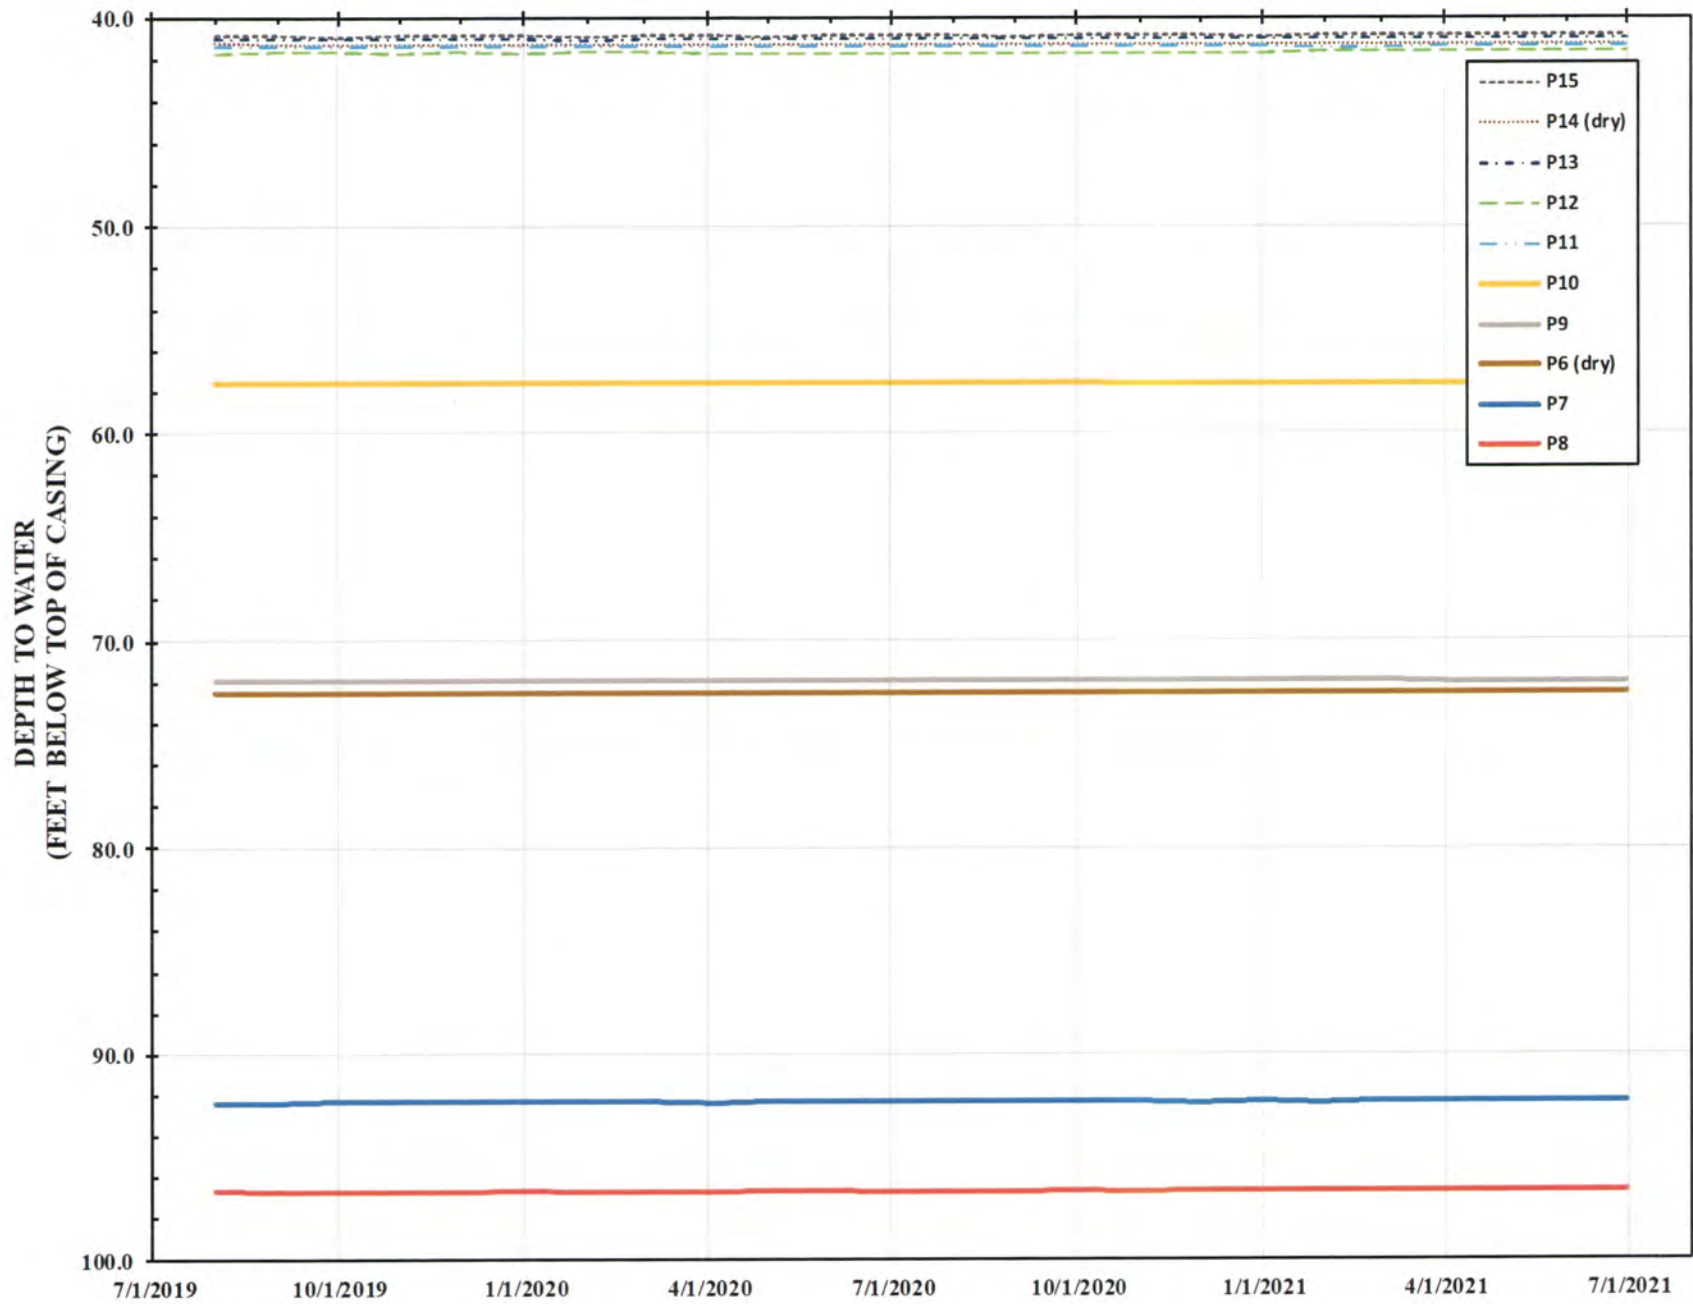
FIGURE 3
PIEZOMETER LEVELS
2021 ANNUAL DAM SAFETY INSPECTION
SAN LUIS TAILINGS STORAGE FACILITY

Piezometers: Piezometer readings from June 2020 to June 2021 are shown in Table 1, and readings from July 2019 through June 2021 are presented graphically on Figure 3. The piezometers all indicate dry conditions or minor amounts of water present at the bottom of the casings due to moisture condensation. This behavior is consistent with historic observations and indicates that the sub-drains are functioning. Low phreatic conditions are maintained within the dam embankment. No abnormalities are indicated in the measurements.

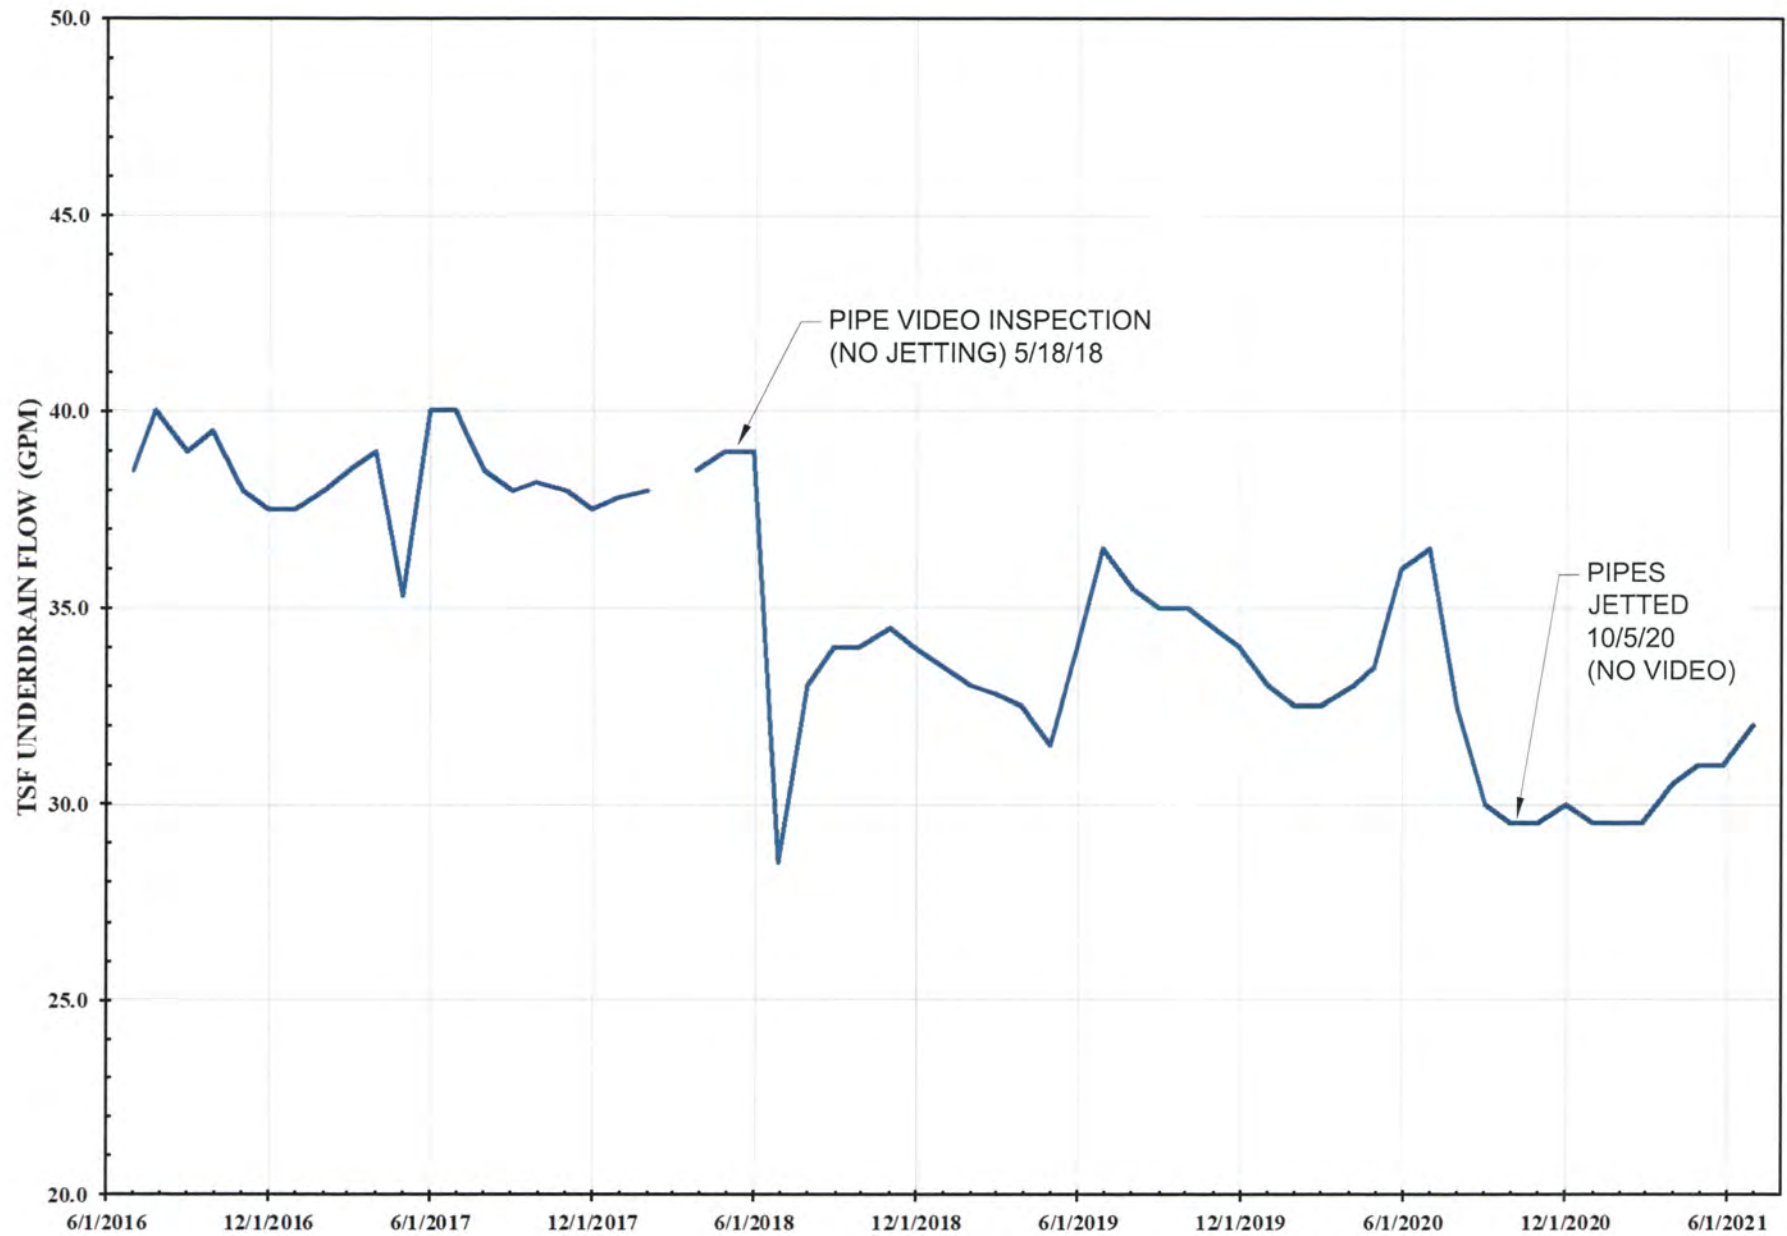
FIGURE 4
UNDERDRAIN FLOW
2021 ANNUAL DAM SAFETY INSPECTION
SAN LUIS TAILINGS STORAGE FACILITY

Underdrain: Underdrain flow rates discharging to the seepage collection pond from June 2020 through June 2021 are shown in Table 2, and flow rates from 2016 to 2021 are presented graphically on Figure 4. Average underdrain flow measurements from 2019-21 (32.5 gpm) are slightly lower than from 2016-2021 (34.8 gpm).

The underdrain pipes were jet-cleaned in 2014 in conjunction with the first camera inspection of the accessible downstream ends of the pipes. A second video inspection of the pipe ends was done without jet cleaning in 2018. The 2018 videos showed some accumulation of sediment and precipitates in the pipes compared to the 2014 videos, but the pipes were all still flowing (not clogged). Thus, the observed slight reduction in underdrain flow in recent years is likely due to ongoing severe regional drought. The pipes were jet-cleaned again on October 5, 2020, with no video inspection. It is recommended that jetting of the pipes and video inspections be conducted at least every 3 years unless a change in measured drainage flow rates warrants more frequent cleaning and inspection.

Seepage Underdrain Collection System: Continue the jetting and video inspection program to ensure the drain pipes do not become clogged. Consider installing a concrete structure for collecting underdrain flows from the toe drains to facilitate maintenance in the toe drain area, improve conditions for monitoring and inspecting the drain system, and to prevent the attraction of animals to the area by pooling of leakage from the drain pipes.
