Fall 2021 Subsidence and Geologic Field Observations

Southern Panels and Sunset Trail Mining Areas

Gary D. Witt, P.G., Hydrogeologist/Geological Engineer
Jonathan M. Kelly, P.E., Project Manager
Wright Water Engineers, Inc.

March 2022

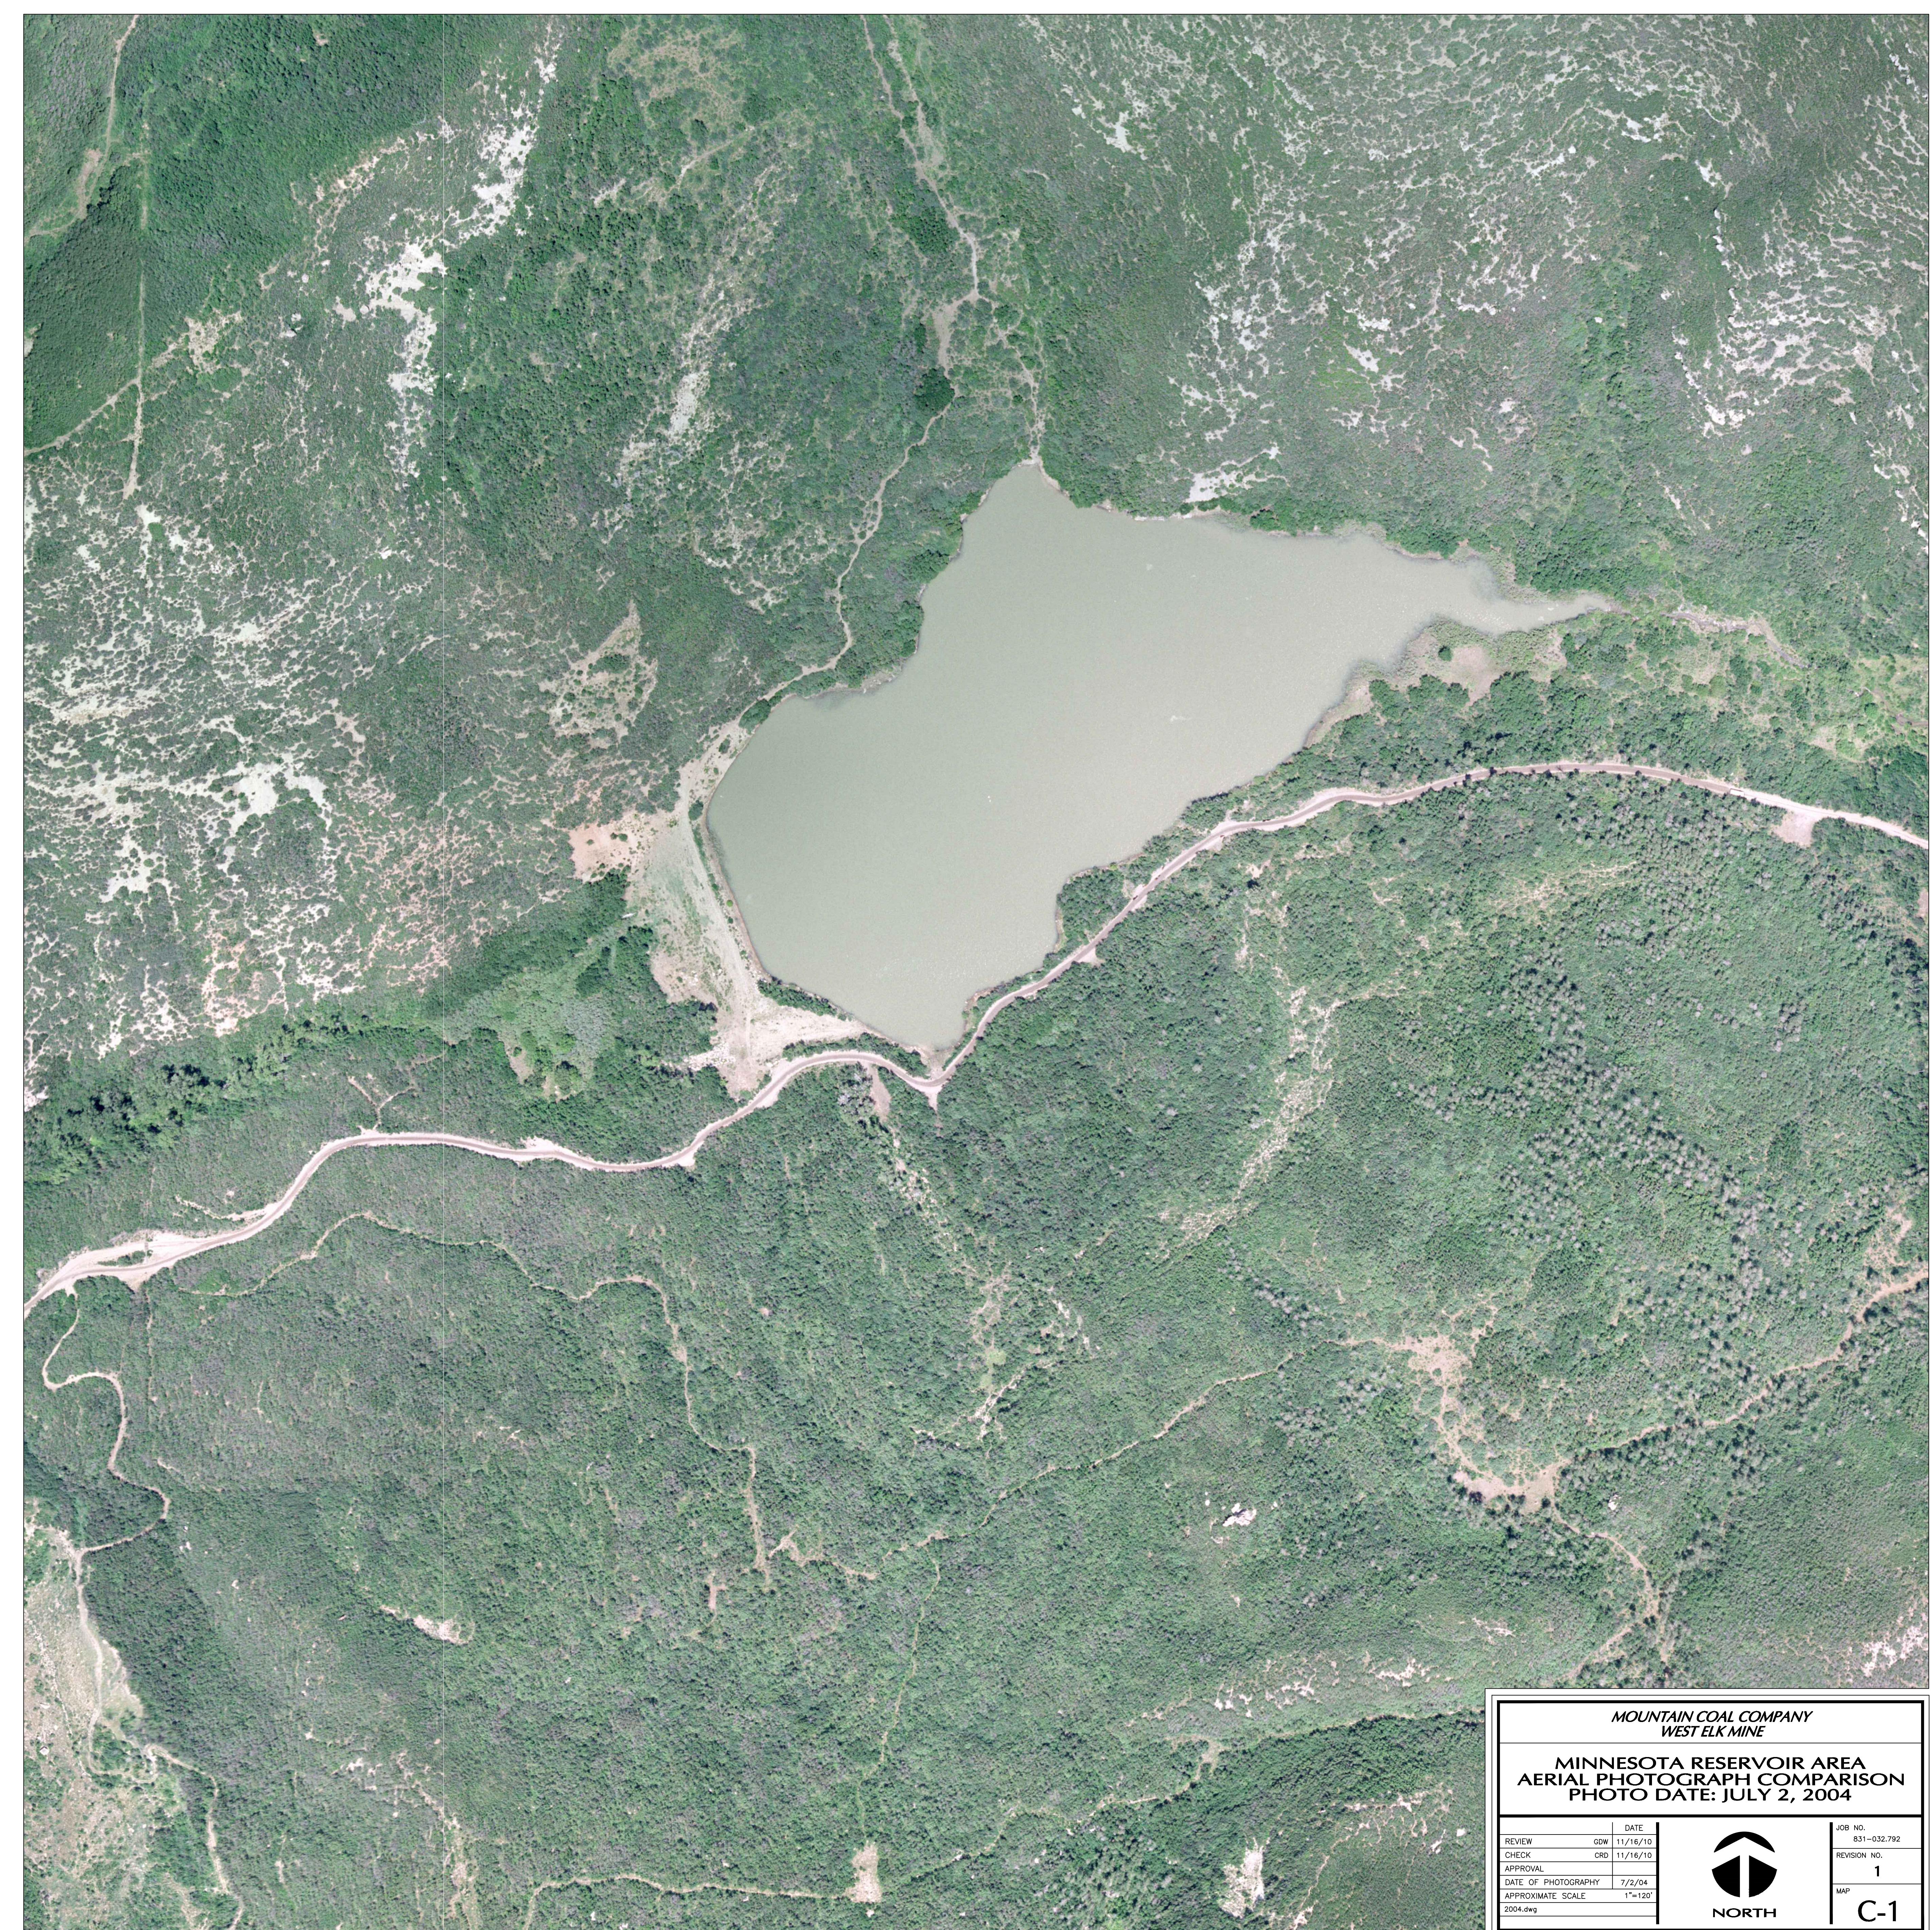
MOUNTAIN COAL COMPANY WEST ELK MINE	
MINNESOTA RESERVOIR AREA AERIAL PHOTOGRAPH COMPARISON PHOTO DATE: JULY 2, 2004	
REVIEW CHECK APPROVAL DATE OF PHOTOGRAPHY APPROXIMATE SCALE	DATE CRD 7/2/04 1'=120' 2004.dwg
JOB NO. 631-032.792 REVISION NO. 1 MAP NORTH C-1

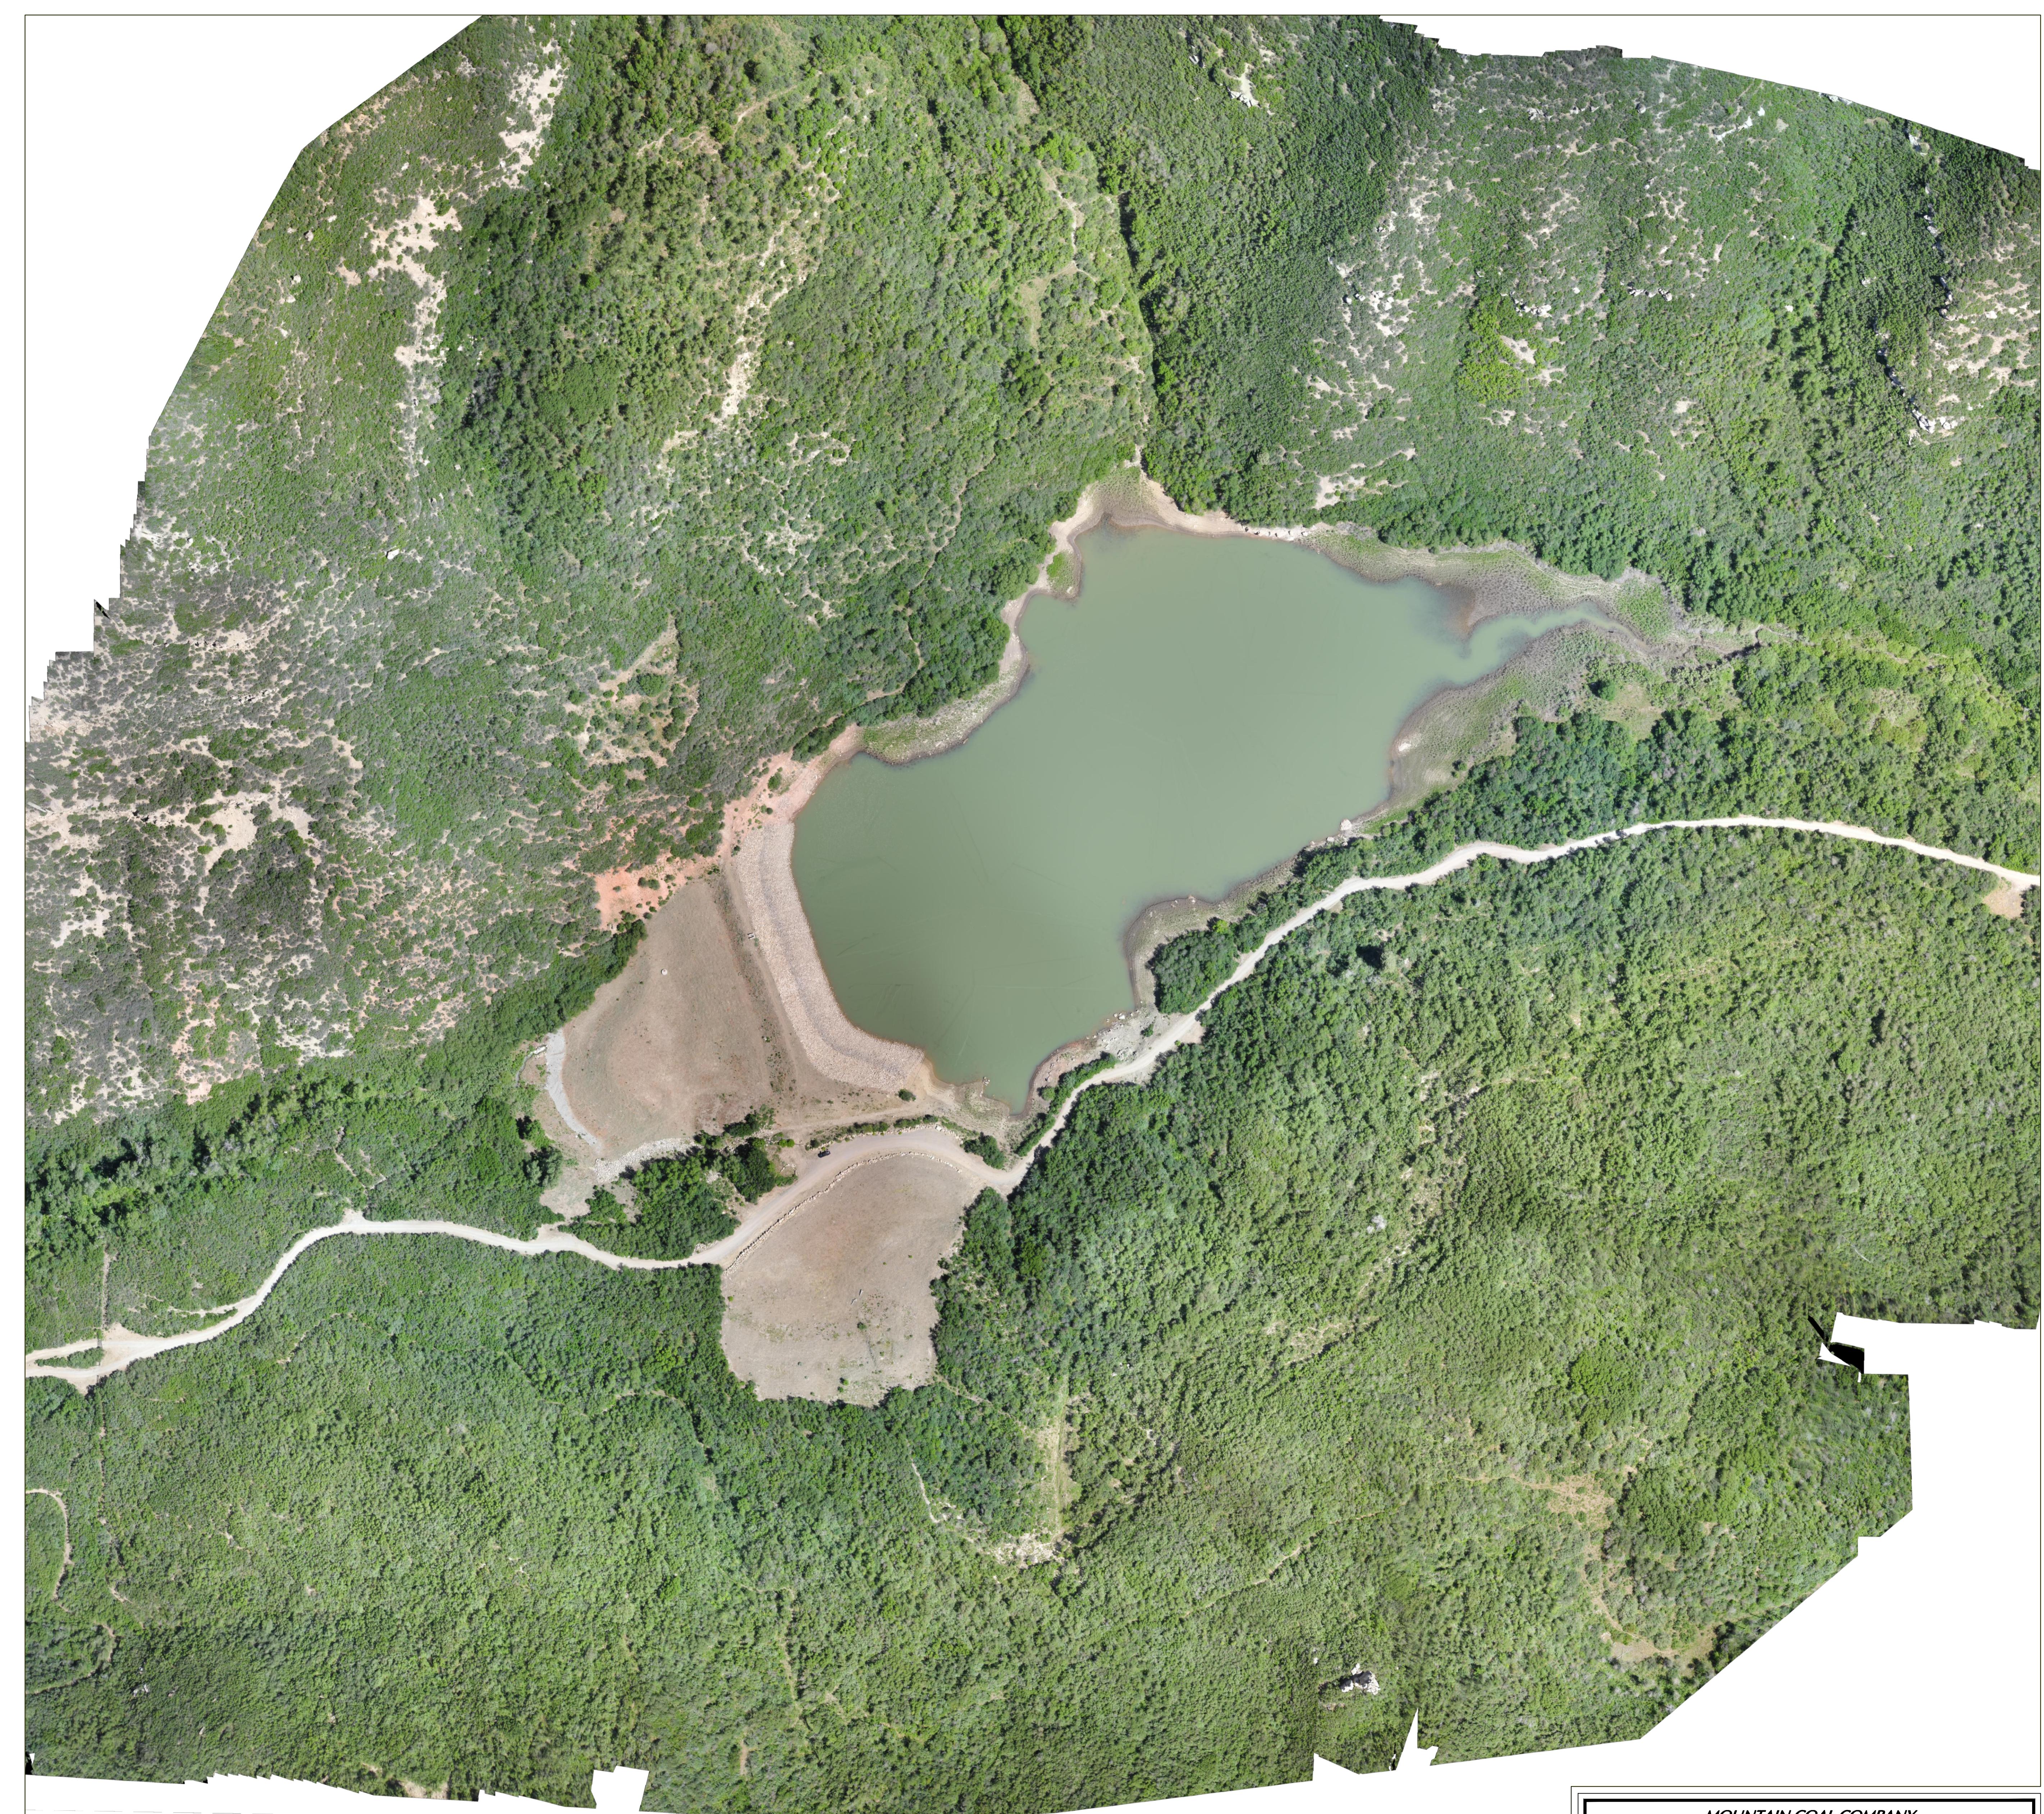
MOUNTAIN COAL COMPANY WEST ELK MINE	
MINNESOTA RESERVOIR AREA AERIAL PHOTOGRAPH COMPARISON PHOTO DATE: JUNE 24TH, 2020	
REVIEW	DATE
GDW	12/21/20
CHECK	
APPROVAL	
DATE OF PHOTOGRAPHY	06/24/20
APPROXIMATE SCALE	1"=120'
2020.dwg	
JOE NO.	631-032.911
REVISION NO.	0
NORTH	MAP
C-14

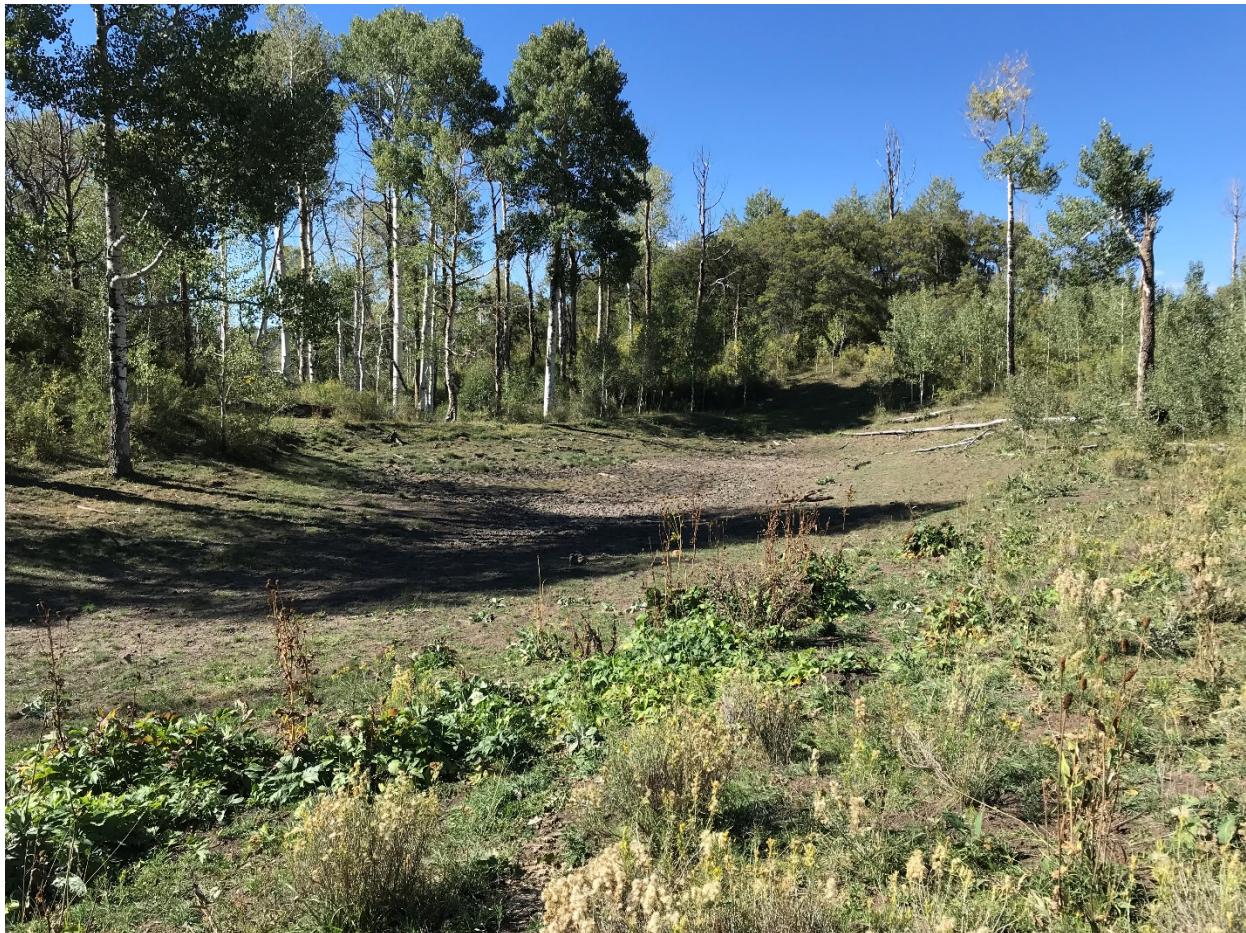
DF-35

This pond is located in the upper reaches of Lick Creek. The coordinates are N 38°50'55.0939", W 107°25'29.0538" and the elevation is approximately 8,500'. The pond is located above longwall panel LWSS1 that will be longwall mined during 2021.
