MINERALS PROGRAM INSPECTION REPORT

MINE NAME: Miller Gravel Pit	MINE/PROSPECTING ID#: M-1982-112	MINERAL: Sand and gravel	COUNTY: Elbert
INSPECTION TYPE: Monitoring	INSPECTOR(S): Amy Eschberger	INSP. DATE: March 24, 2022	INSP. TIME: 10:00
OPERATOR: Schmidt Construction Company	OPERATOR REPRESENTATIVE: Mark Heifner	TYPE OF OPERATION: 112c - Construction Regular Operation	
REASON FOR INSPECTION: Normal I&E Program	BOND CALCULATION TYPE: Partial Bond	BOND AMOUNT: \$146,646.00	
DATE OF COMPLAINT: NA	POST INSP. CONTACTS: None	JOINT INSP. AGENCY: None	
WEATHER: Clear	INSPECTOR'S SIGNATURE:

M-1982-112 / Miller Gravel Pit / Schmidt Construction Company / 112c

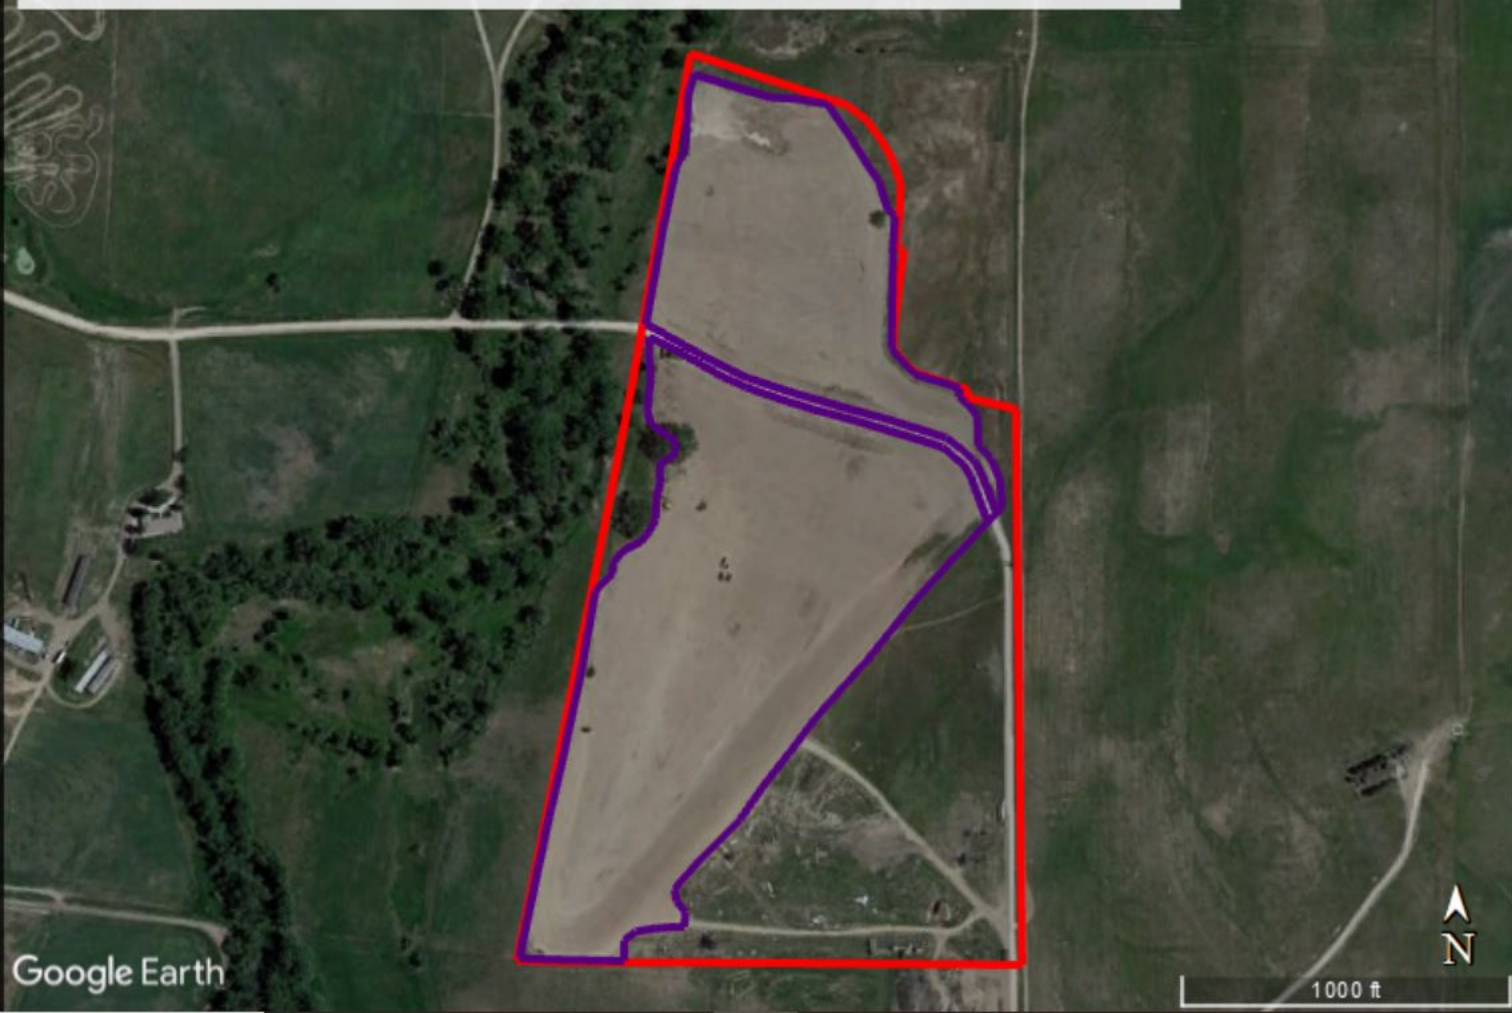
Red outline = 69.2 acres = Approved permit area (location approximated based on permit maps)
Purple outline = 43.7 acres = Approximate disturbed area (after reclamation earthwork completed)
(Image data from 6/10/2021)
