April 19, 2022  
Project#01349-0001

Subject: Summary of Instrumentation Monitoring  
1<sup>st</sup> Quarter 2022  
Bowie Coal Waste Disposal Area No. 2  
Paonia, Colorado

**SUBJECT: Summary Report, 1<sup>st</sup> Quarter 2022, Inclinator and Active Vibrating Wire Piezometer Data January – March 2022, Bowie Mine #2 Coal Waste Disposal Area (CWDA) #2**

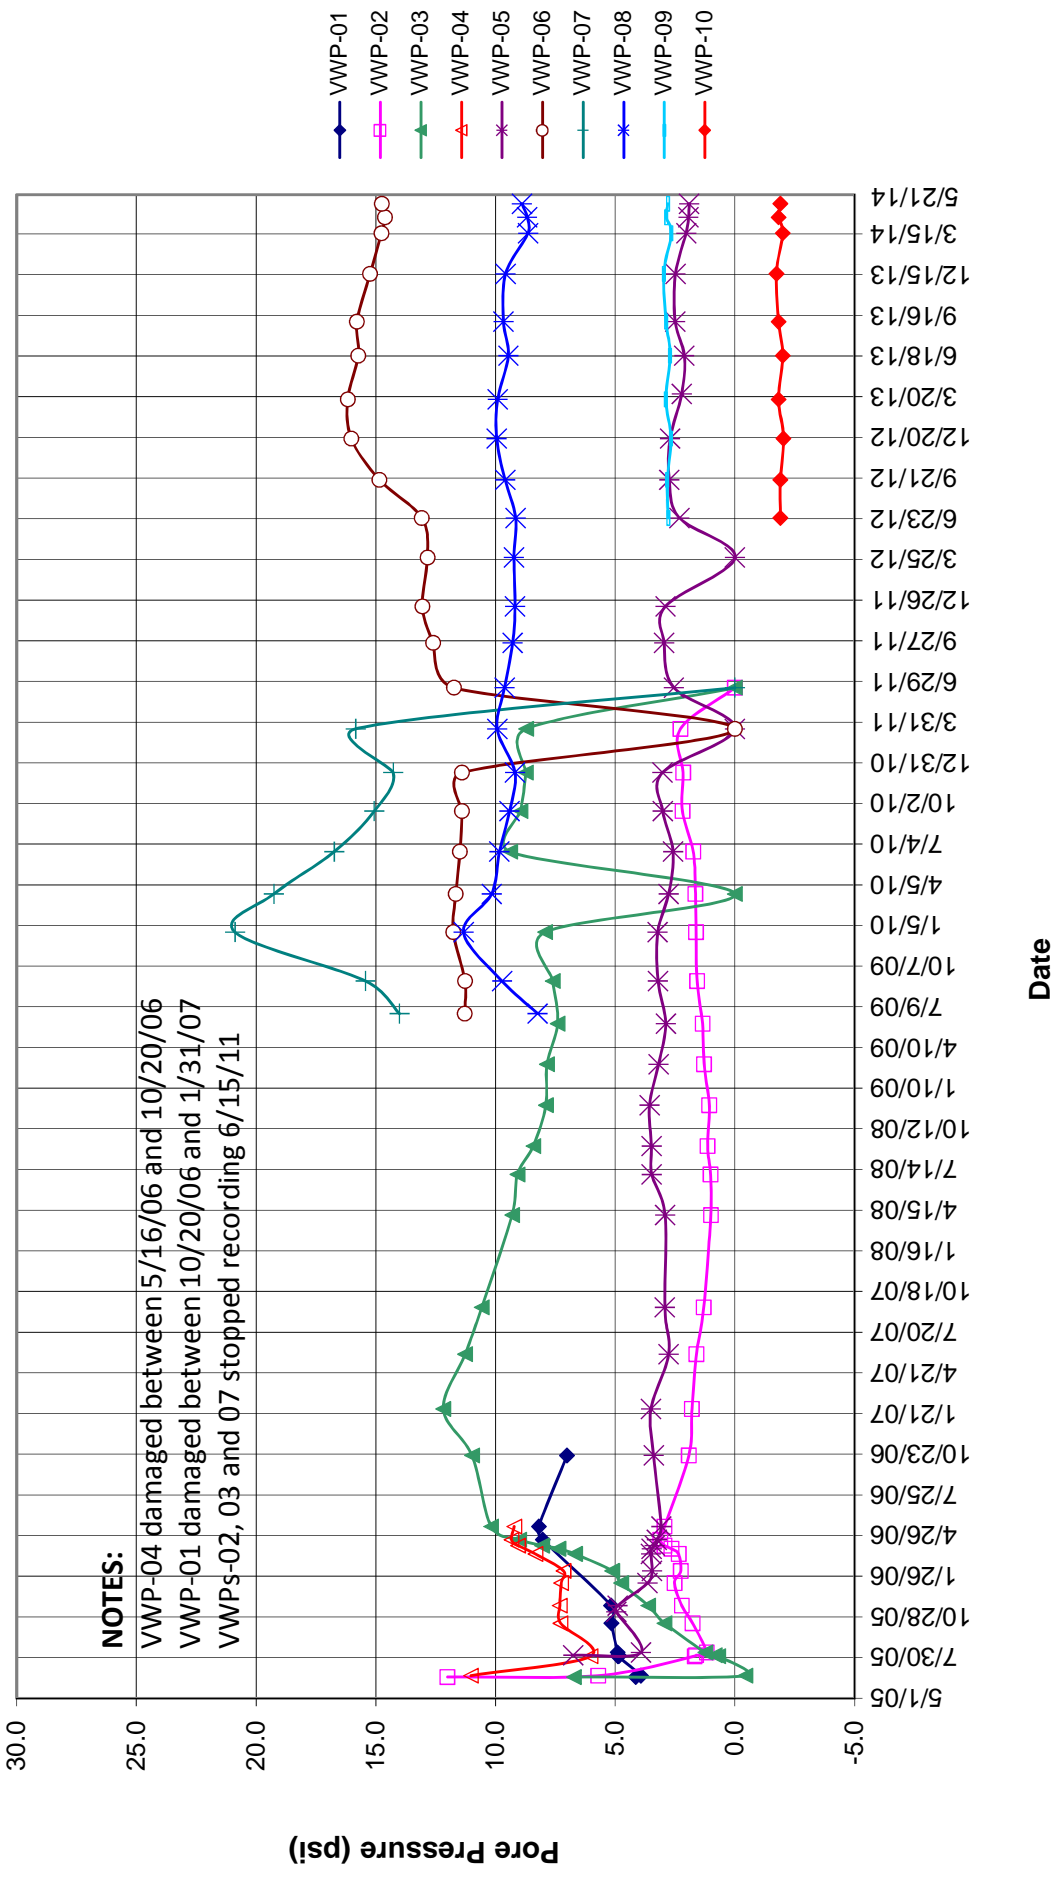
## Figure 1 - Bowie Mine #2 - CWDA #2

The physical locations of the piezometers are shown on the attached Instrumentation Site Plan (Map 1). As seen on this map, five of the original piezometers were damaged, and some were replaced. Currently, there are five active VWP's, and three of them are adjacent to inclinometers. The graph of historical VWP data from May 16, 2005 through May 21, 2014 is presented in Figure 1. A graph of measured pore pressures of active piezometers is presented on the attached Figure 2 and is presented numerically in Table 1 below.
