Pikeview monitoring report

Reference: March 2022 Geotechnical Monitoring Summary Pikeview Quarry

CONTINENTAL MATERIALS
CORP.
PIKEVIEW QUARRY SLOPE
MONITORING

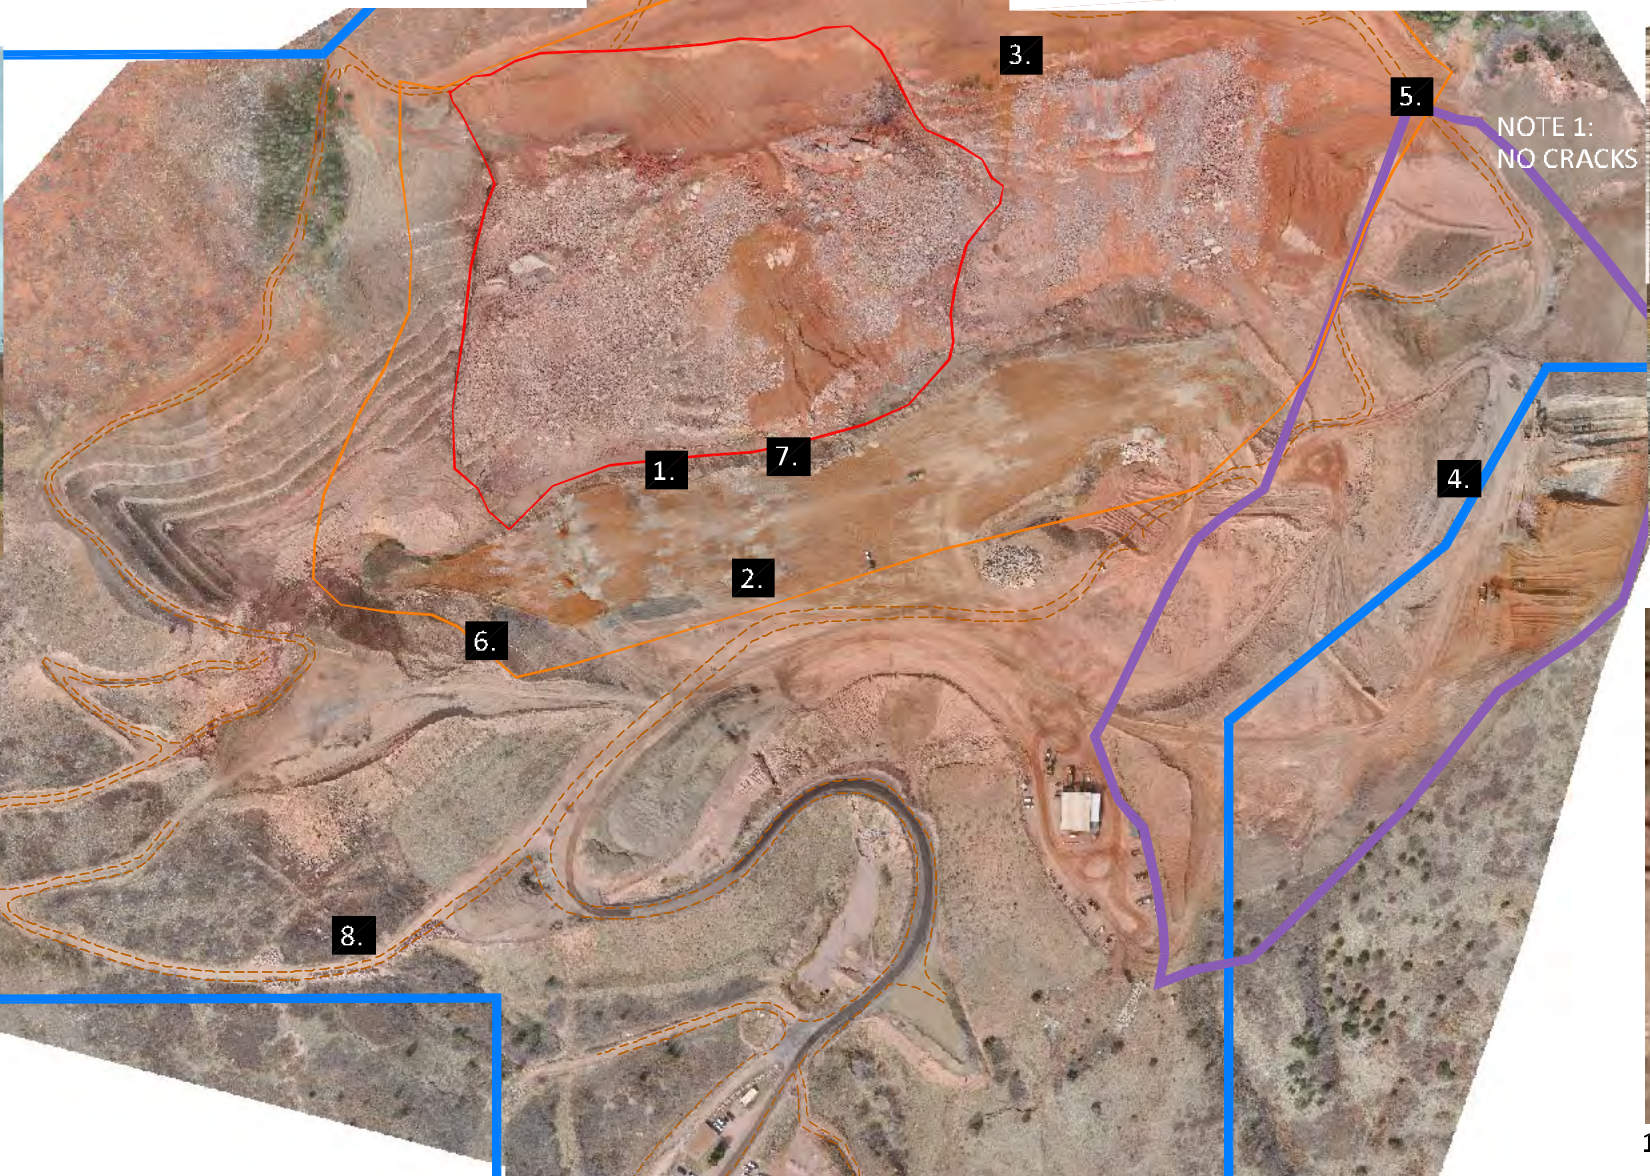
2. Sheep's foot compactor in the pit area.

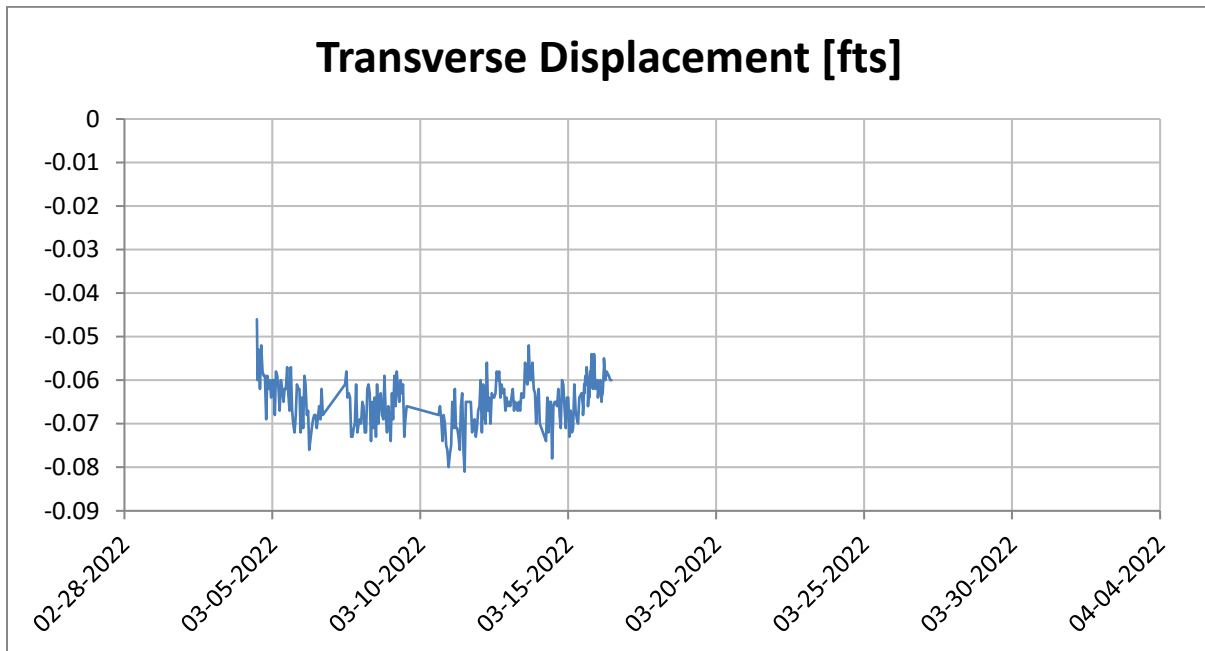
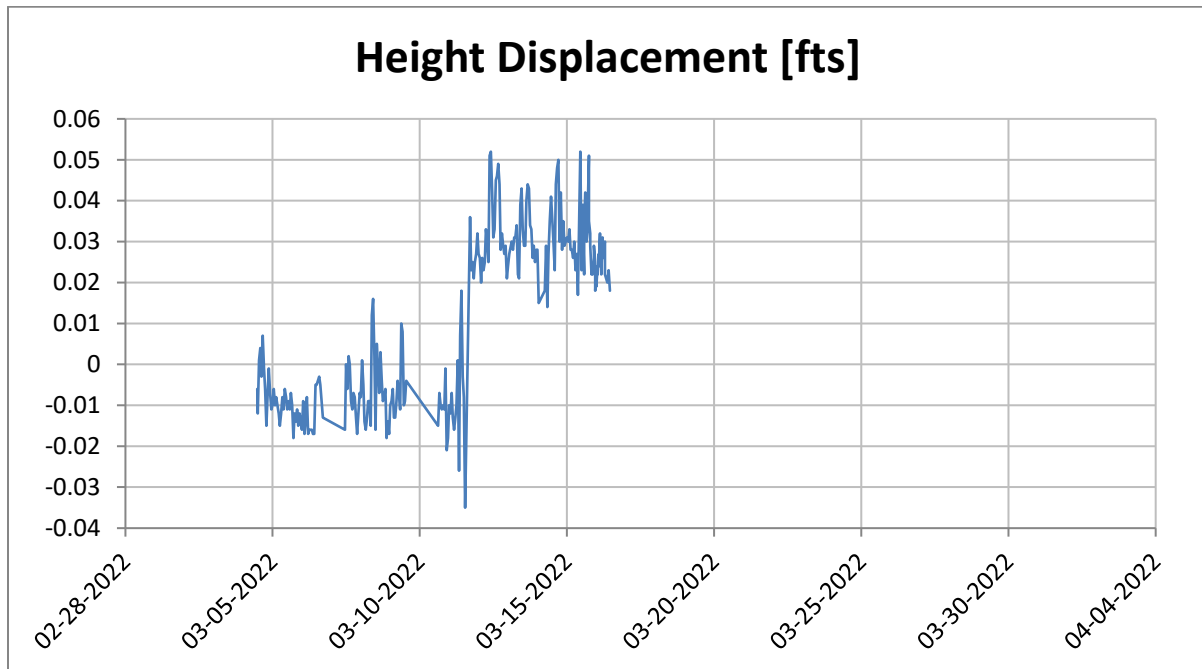
Prism CP2

1. Survey accuracy is ± 0.016 feet.
2. Alarm threshold is ± 0.35 feet.
3. Transverse displacement is in the horizontal direction. Positive direction means closer to the robotic station.
4. Height displacement is in the vertical direction. Positive direction means higher in elevation.
5. Prism removed March 11, 2022 but reinstalled until March 16 when CP4 and CP5 could replace the control prism. The height displacement recorded is the result of the prism being removed and then replaced.

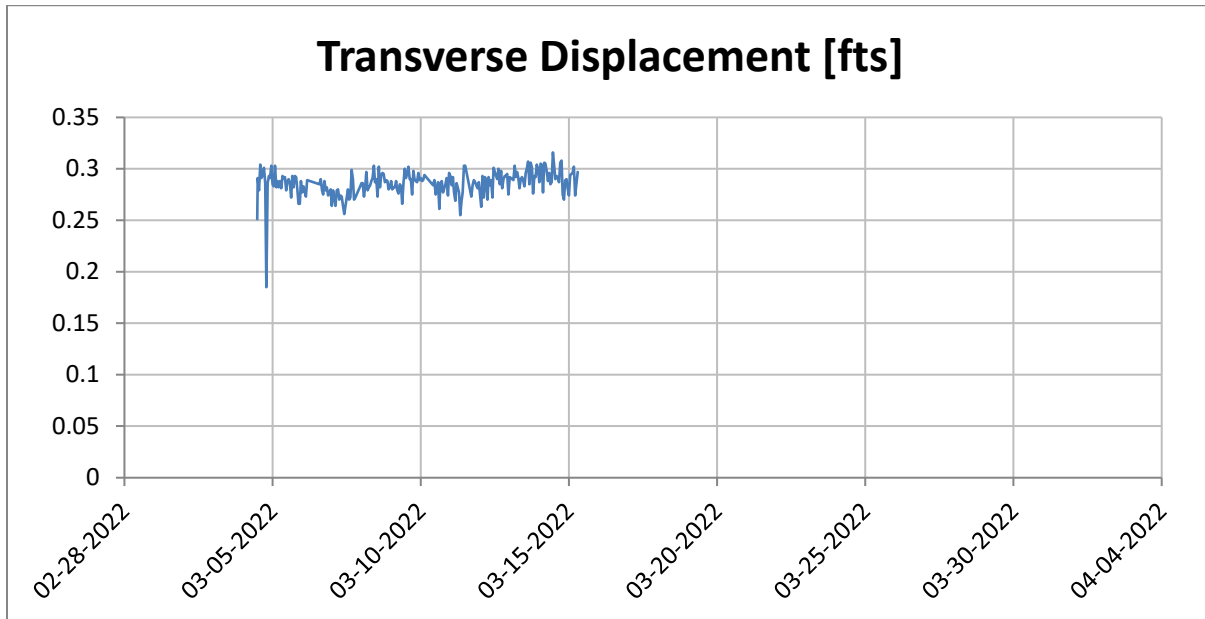
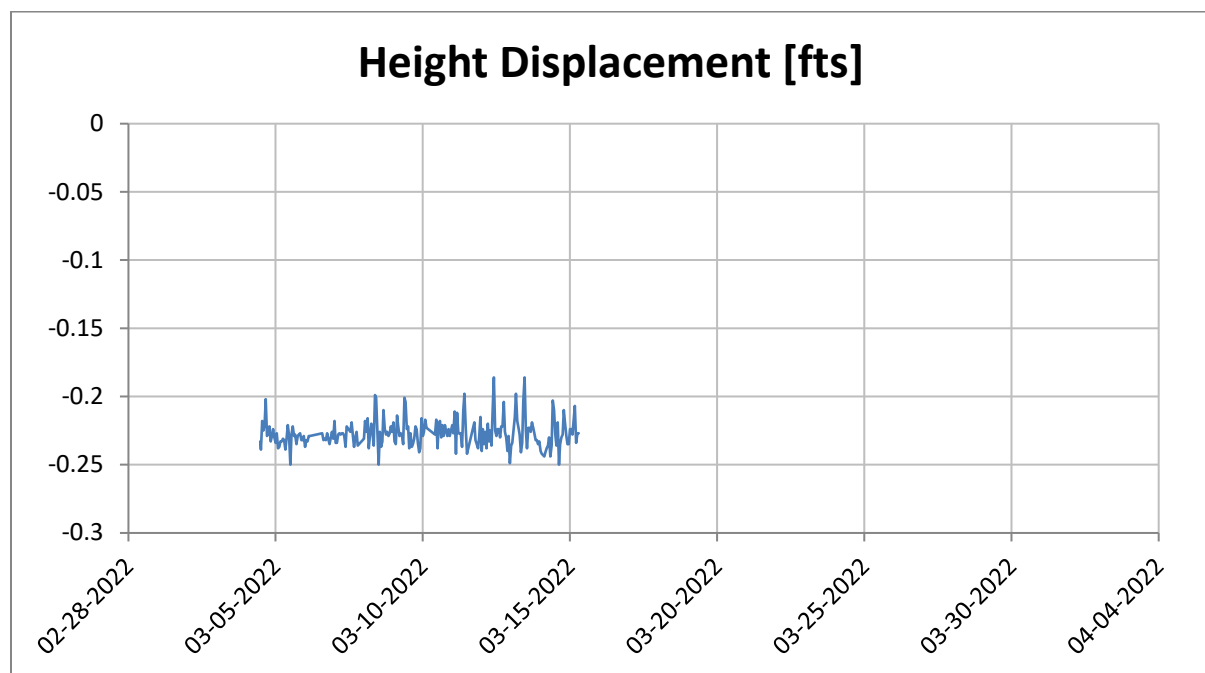
Prism CP3

1. Survey accuracy is +/-0.016 feet.
2. Alarm threshold is +/-0.35 feet.
3. Transverse displacement is in the horizontal direction. Positive direction means closer to the robotic station.
4. Height displacement is in the vertical direction. Positive direction means higher in elevation.
5. Prism removed March 11, 2022.

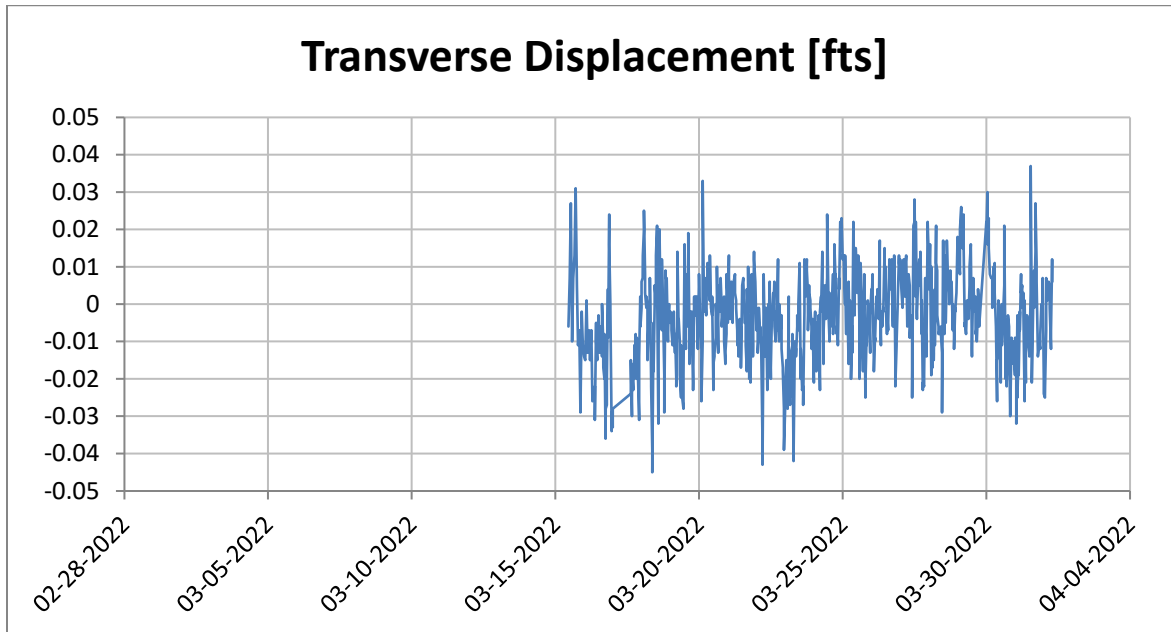
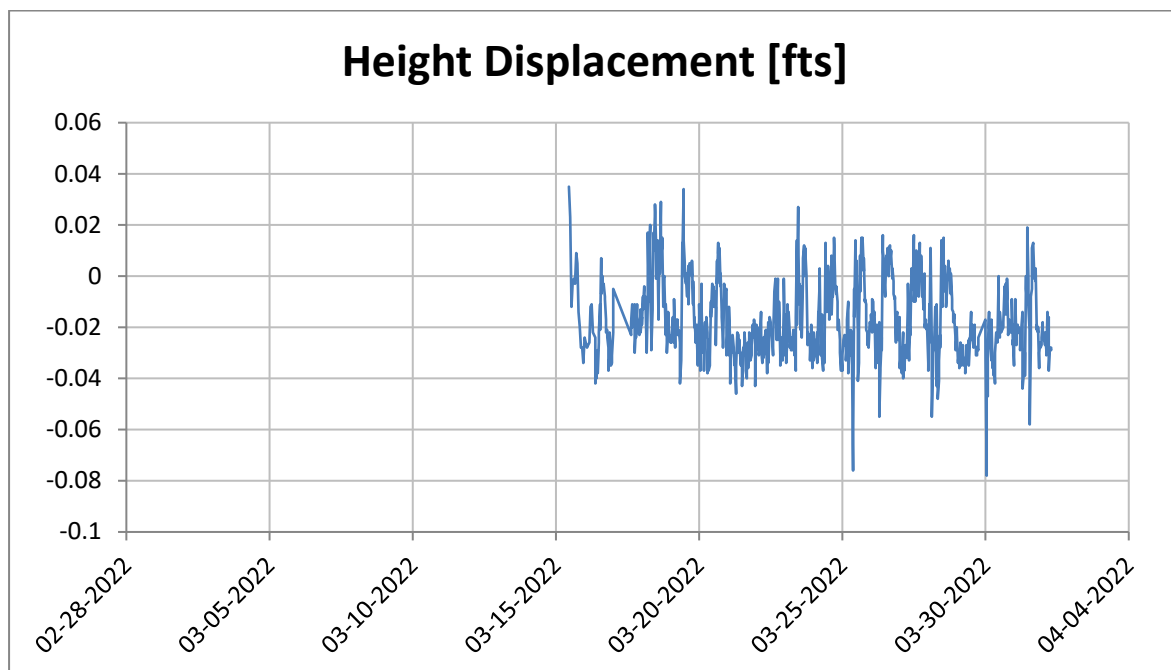
Prism CP4

1. Survey accuracy is ± 0.016 feet.
2. Alarm threshold is ± 0.35 feet.
3. Transverse displacement is in the horizontal direction. Positive direction means closer to the robotic station.
4. Height displacement is in the vertical direction. Positive direction means higher in elevation.
5. Prism installed March 11, 2022.

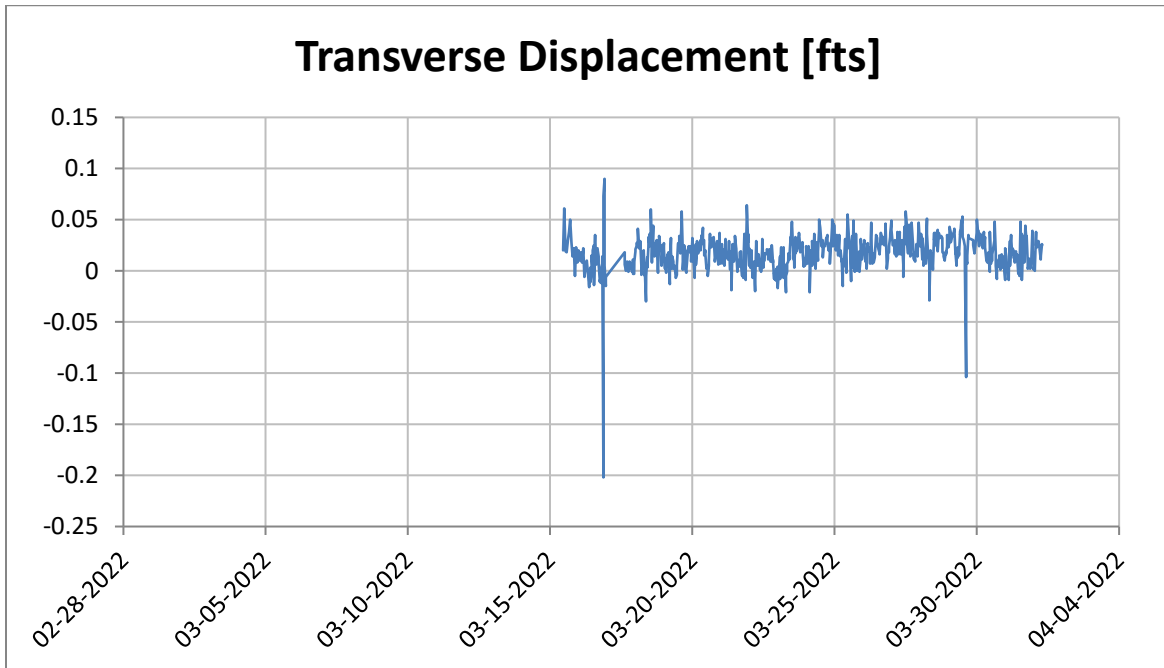
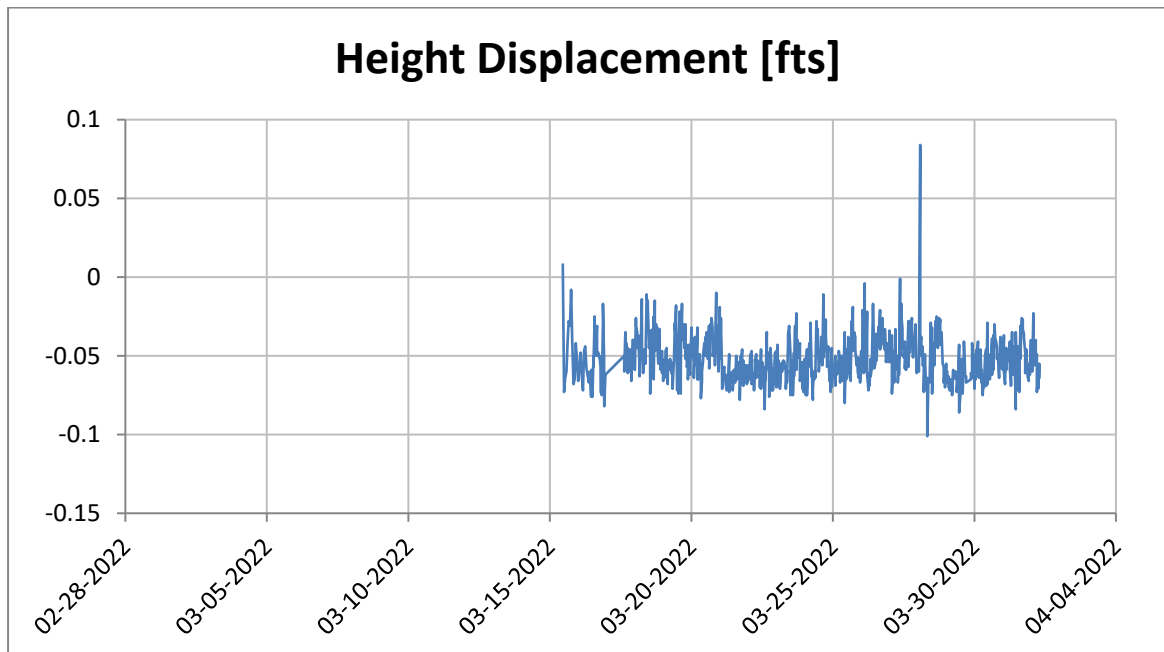
Prism CP5

1. Survey accuracy is +/-0.016 feet.
2. Alarm threshold is +/-0.35 feet.
3. Transverse displacement is in the horizontal direction. Positive direction means closer to the robotic station.
4. Height displacement is in the vertical direction. Positive direction means higher in elevation.
5. Prism installed March 11, 2022.

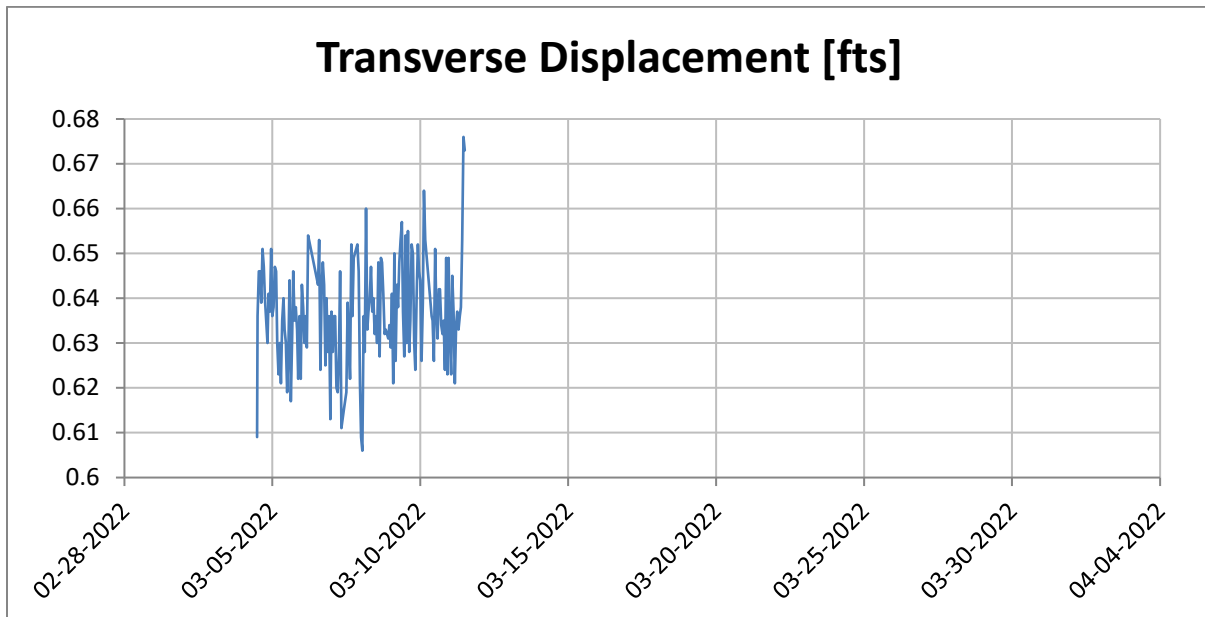
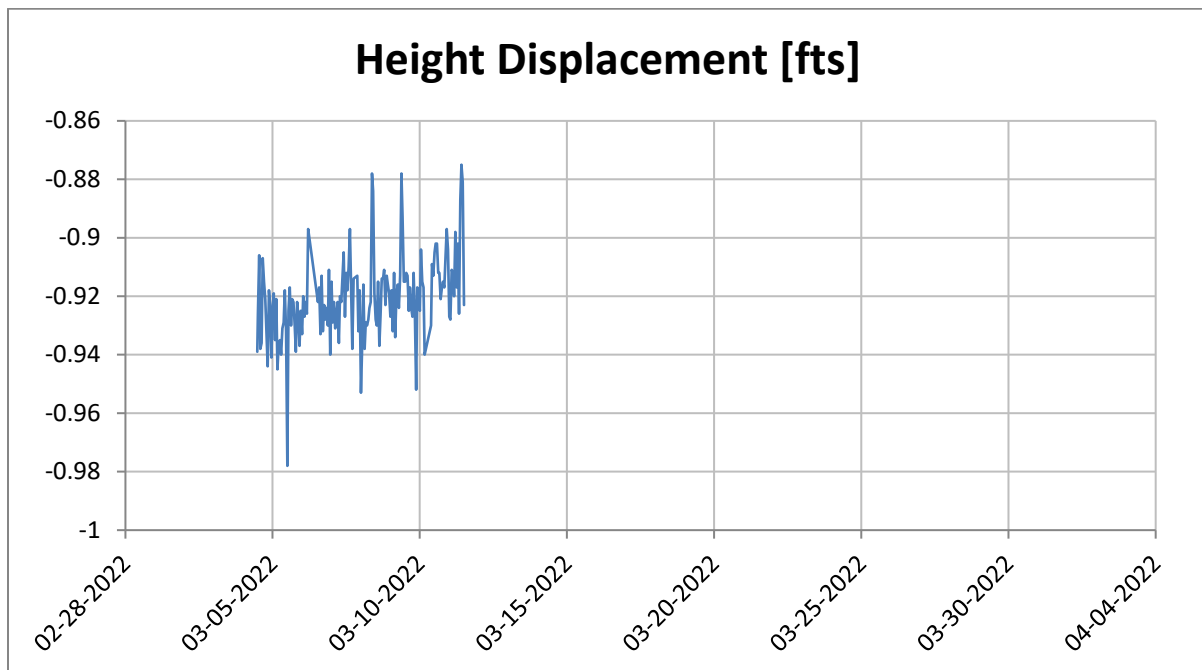
Prism NP1

1. Survey accuracy is ± 0.016 feet.
2. Alarm threshold is ± 0.35 feet.
3. Transverse displacement is in the horizontal direction. Positive direction means closer to the robotic station.
4. Height displacement is in the vertical direction. Positive direction means higher in elevation.
5. Prism removed March 11, 2022.

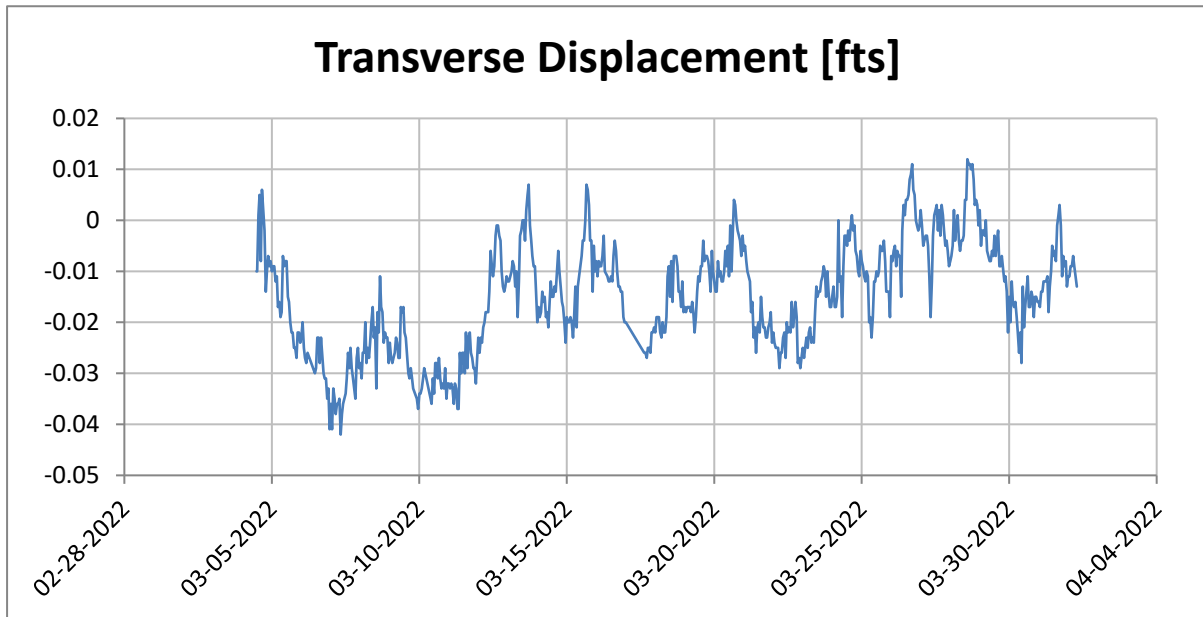
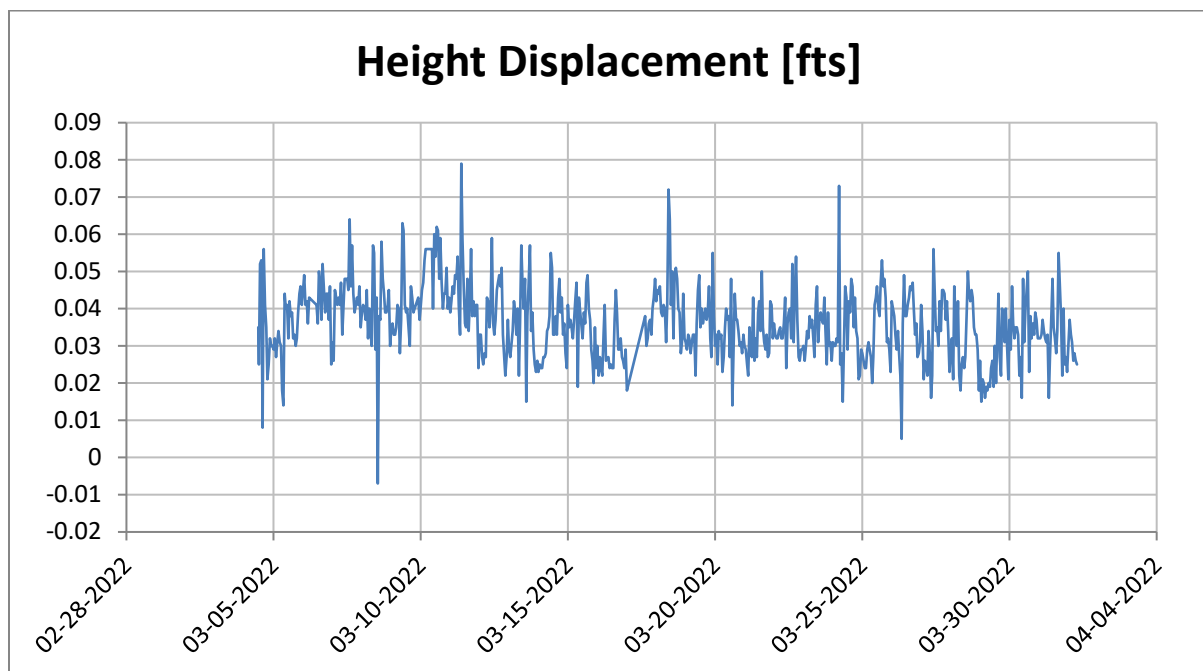
Prism P25

1. Survey accuracy is ± 0.016 feet.
2. Alarm threshold is ± 0.35 feet.
3. Transverse displacement is in the horizontal direction. Positive direction means closer to the robotic station.
4. Height displacement is in the vertical direction. Positive direction means higher in elevation.
5. Alarm recorded on February 13, 2022. Attributed to wildlife in the area.

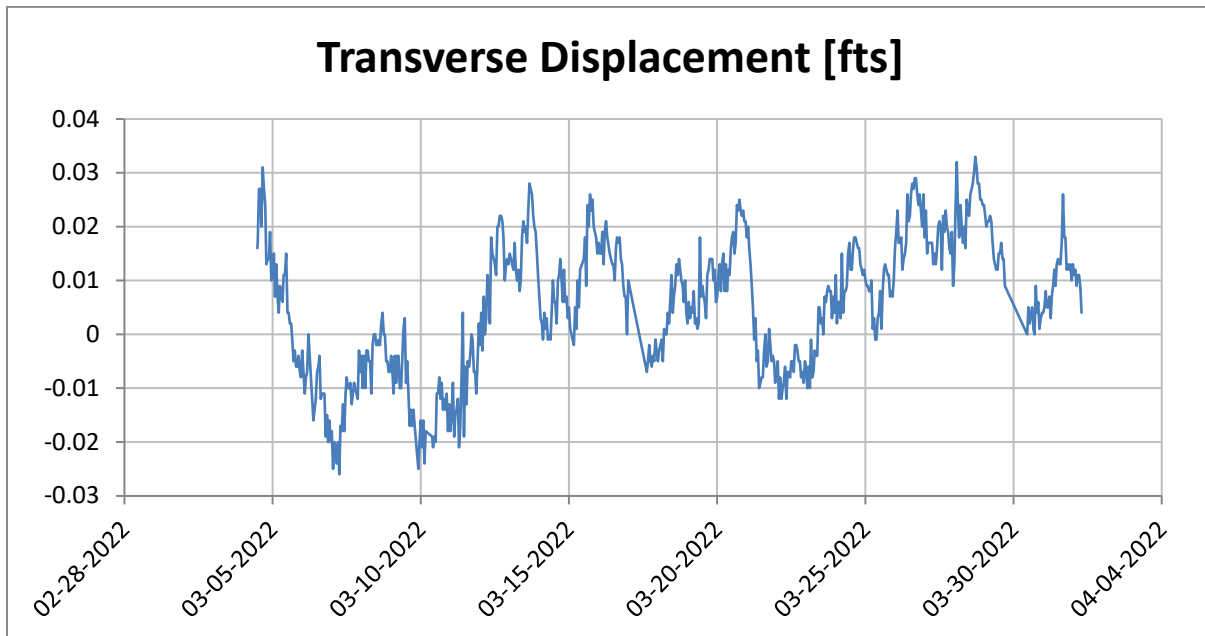
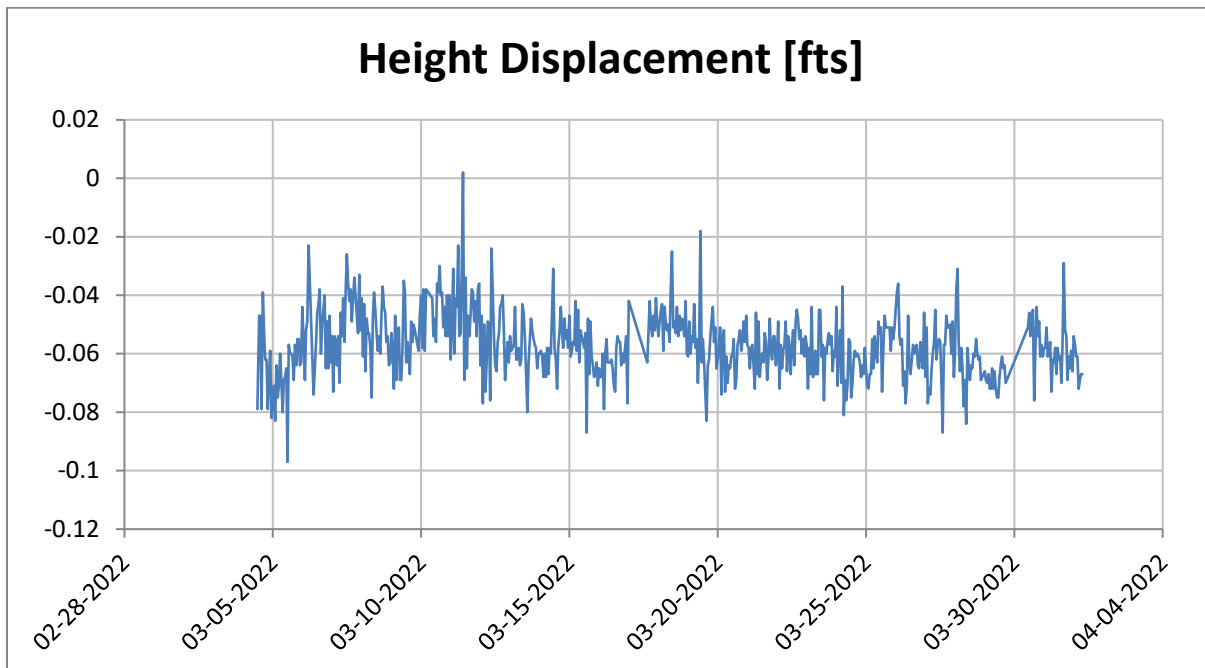
Prism P69

| 03/25/2022 | P69 not found | Unknown cause. Single reading after work hours | 03/25/2022 |

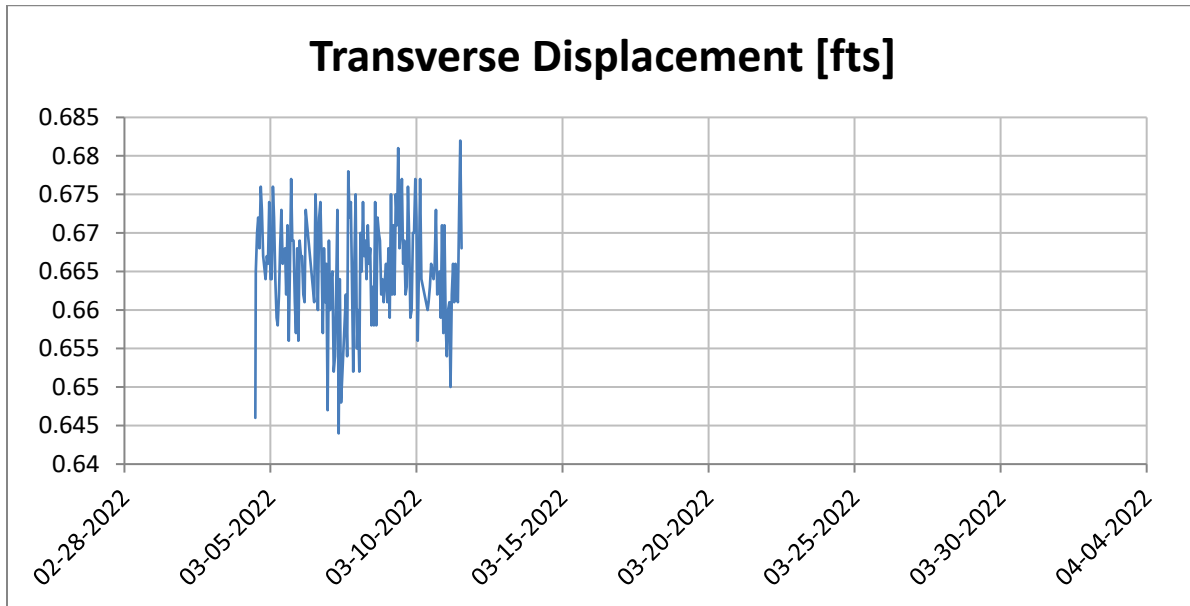
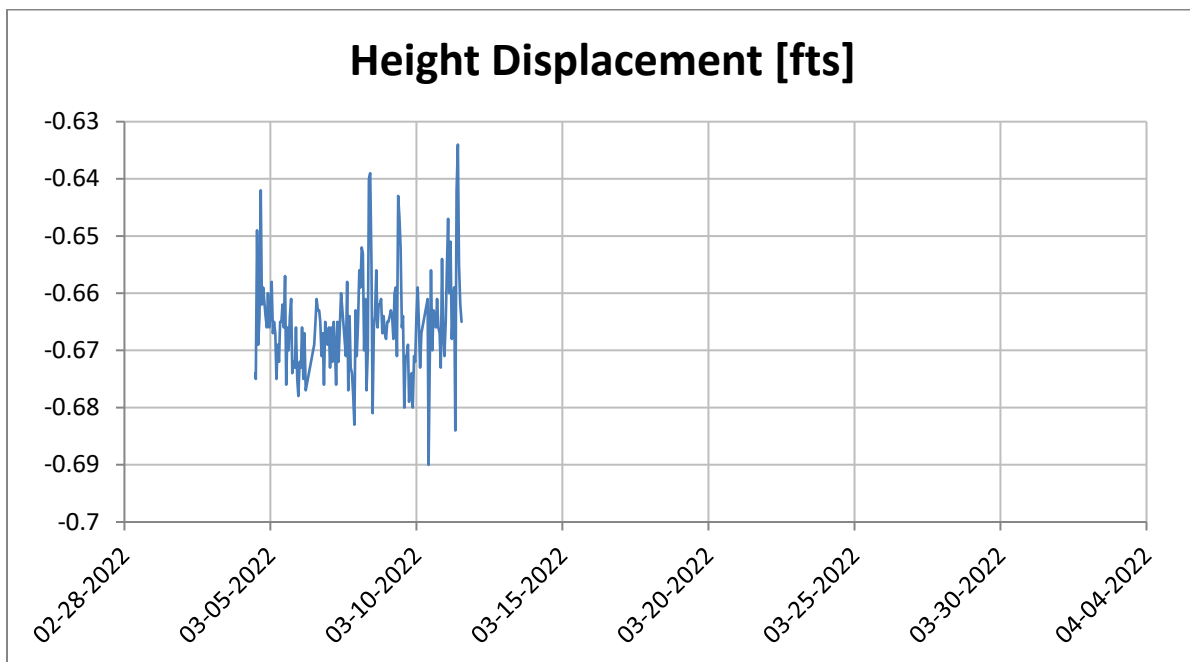
Prism TOE2

1. Survey accuracy is ± 0.016 feet.
2. Alarm threshold is ± 0.35 feet.
3. Transverse displacement is in the horizontal direction. Positive direction means closer to the robotic station.
4. Height displacement is in the vertical direction. Positive direction means higher in elevation.
5. Prism removed March 11, 2022.

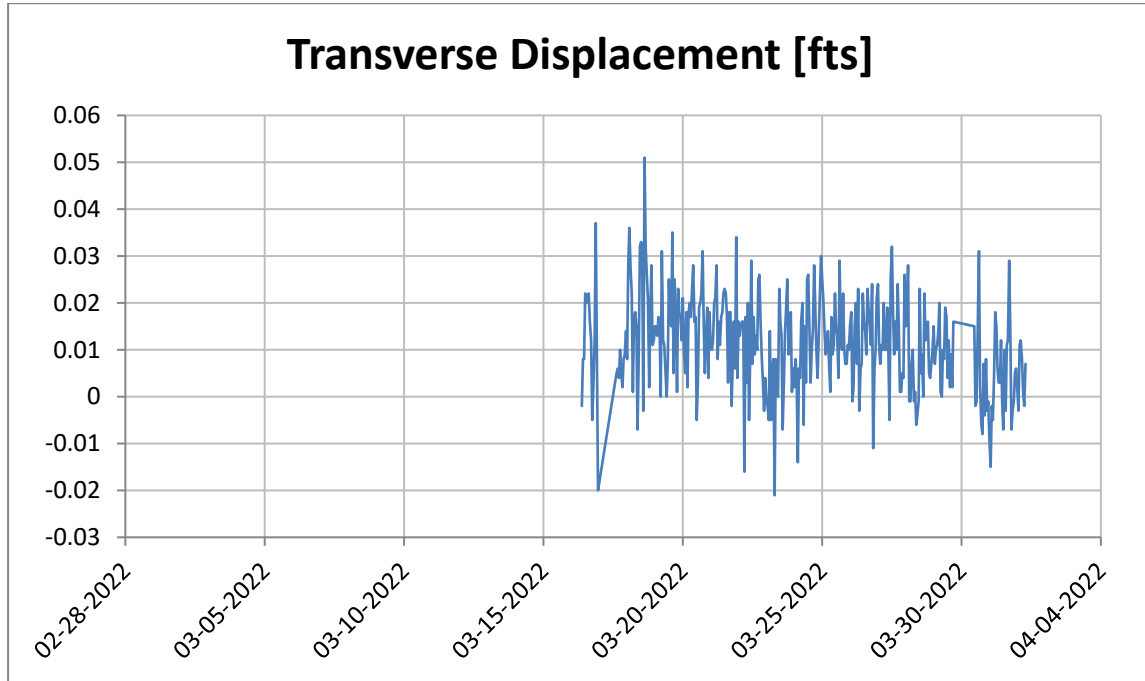
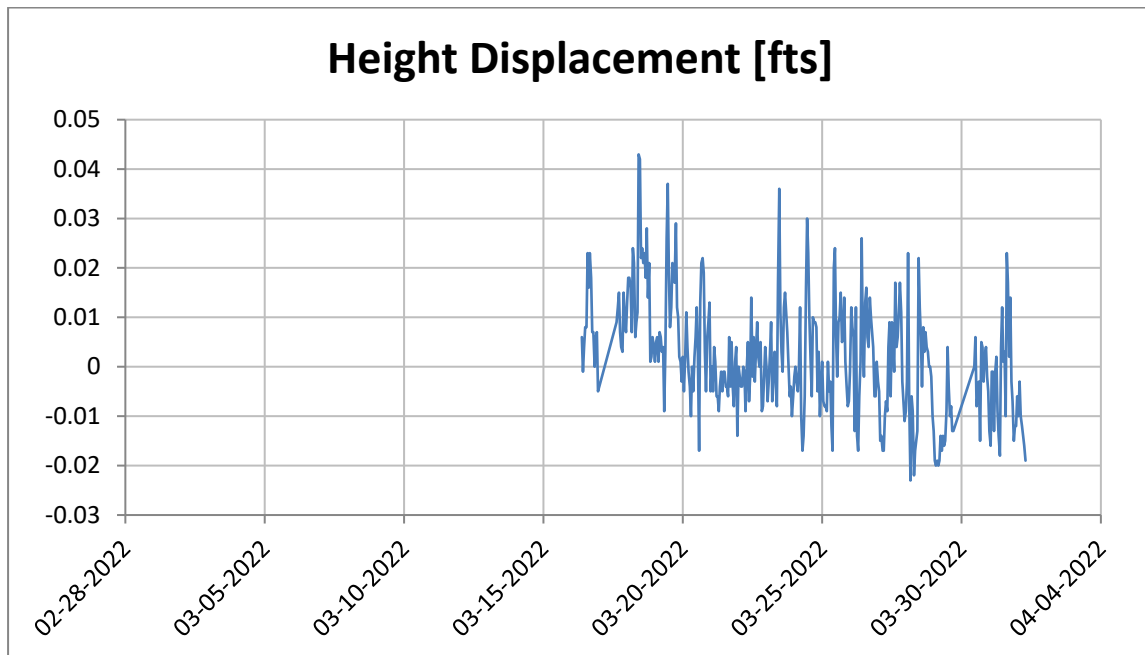
Prism TS1

1. Survey accuracy is ± 0.016 feet.
2. Alarm threshold is ± 0.35 feet.
3. Transverse displacement is in the horizontal direction. Positive direction means closer to the robotic station.
4. Height displacement is in the vertical direction. Positive direction means higher in elevation.
5. Prism installed March 12, 2022.
