To: Jerald Schnabel From: Paul Kos  
Continental Materials Corp. Denver, CO 80222  
File: April 2022 Monitoring Summary Date: May 31, 2022

**Reference: April 2022 Geotechnical Monitoring Summary Pikeview Quarry**

Client/Project  
CONTINENTAL MATERIALS  
CORP.  
PIKEVIEW QUARRY SLOPE  
MONITORING

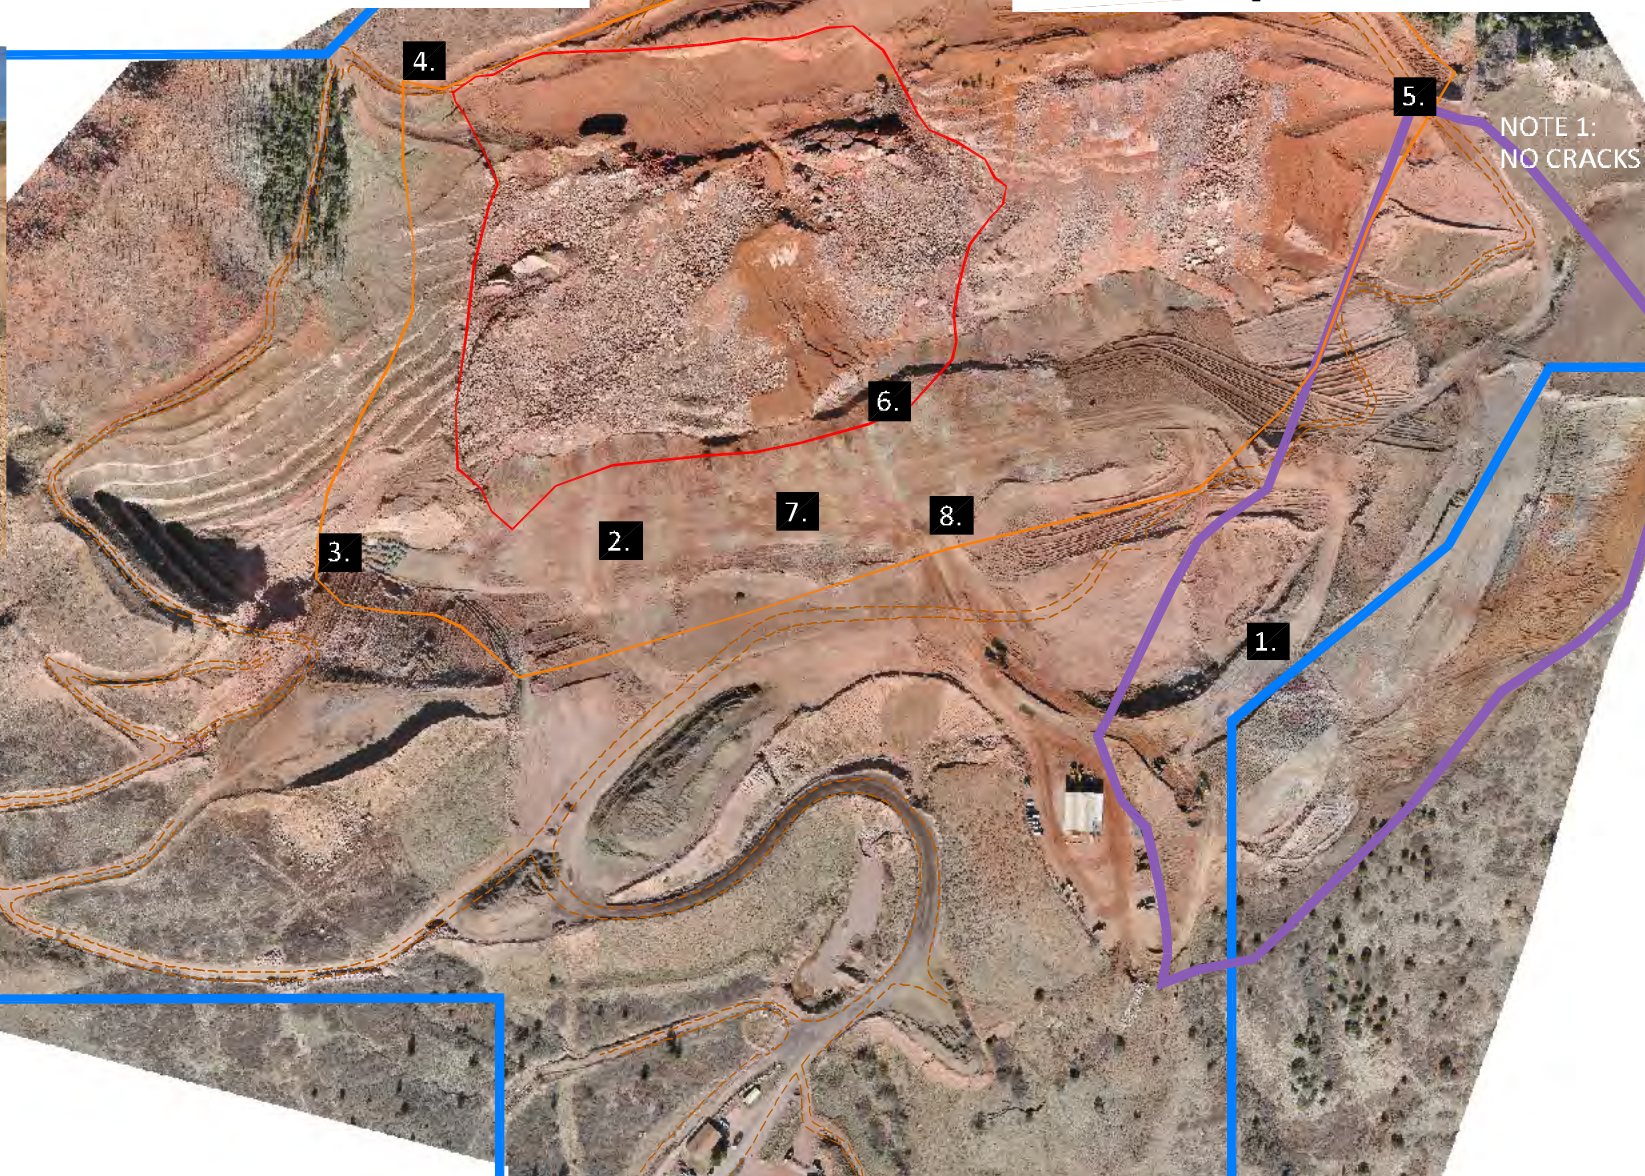
2. Compaction zone in the pit as seen from the south.

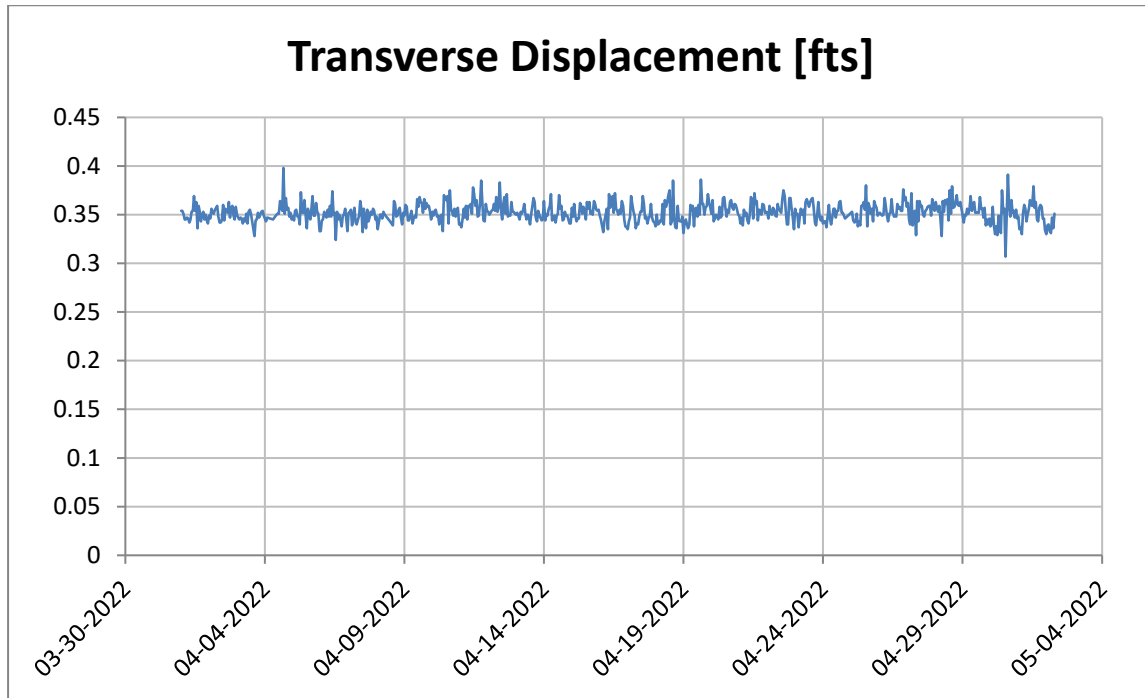
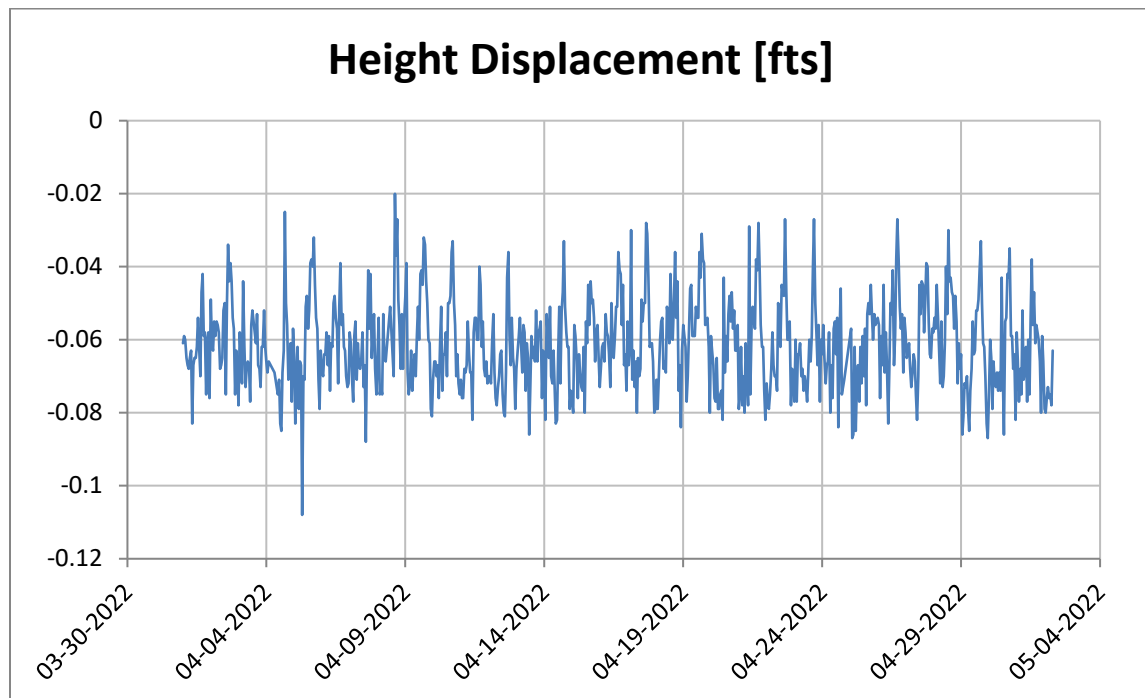
## Prism P1

1. Survey accuracy is +/-0.016 feet.
2. Alarm threshold is +/-0.35 feet.
3. Transverse displacement is in the horizontal direction. Positive direction means closer to the robotic station.
4. Height displacement is in the vertical direction. Positive direction means higher in elevation.
5. Regression limit alarms were received on April 30.

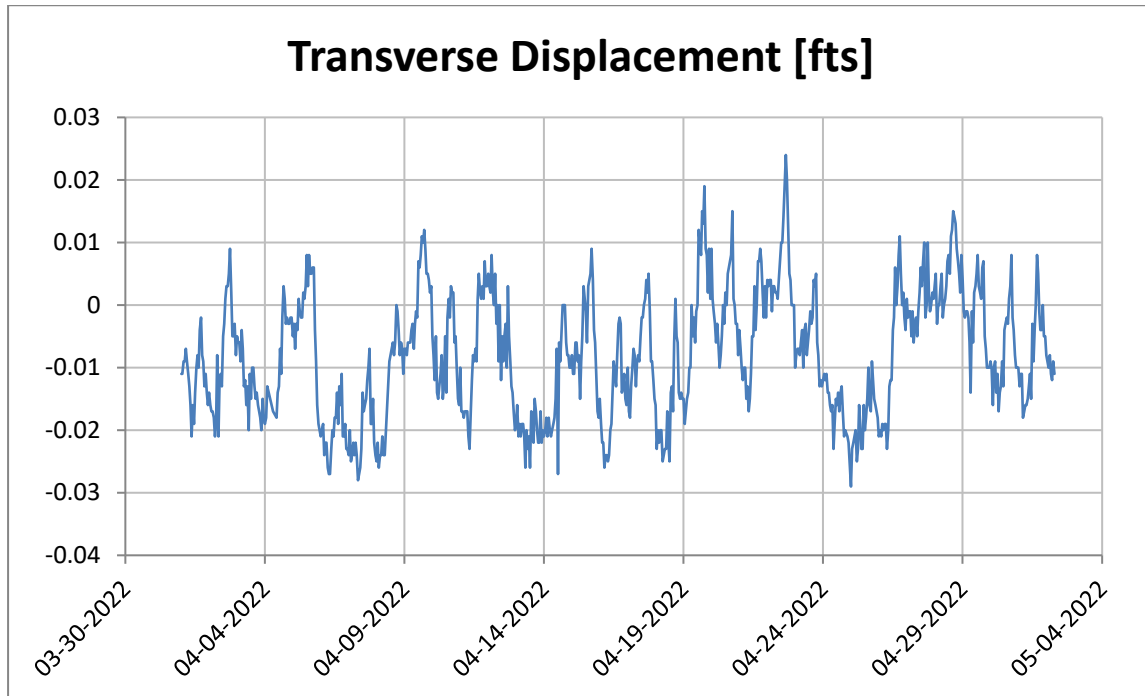
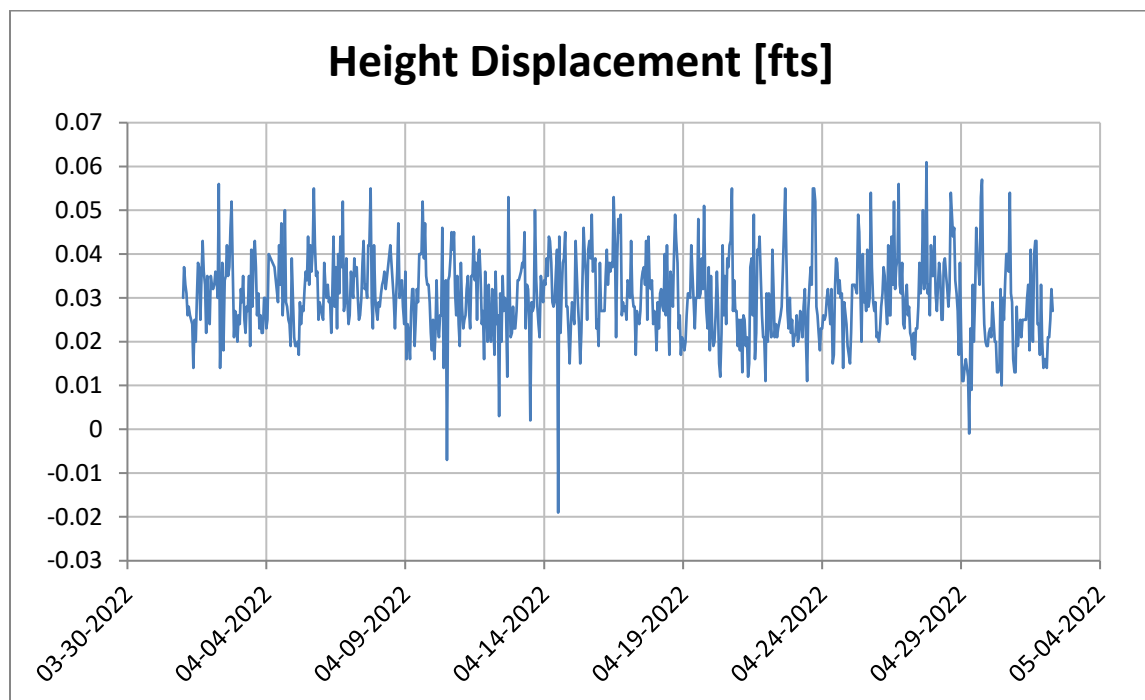
## Prism P25

1. Survey accuracy is  $\pm 0.016$  feet.
2. Alarm threshold is  $\pm 0.35$  feet.
3. Transverse displacement is in the horizontal direction. Positive direction means closer to the robotic station.
4. Height displacement is in the vertical direction. Positive direction means higher in elevation.
5. Regression limit alarms were received on April 3.

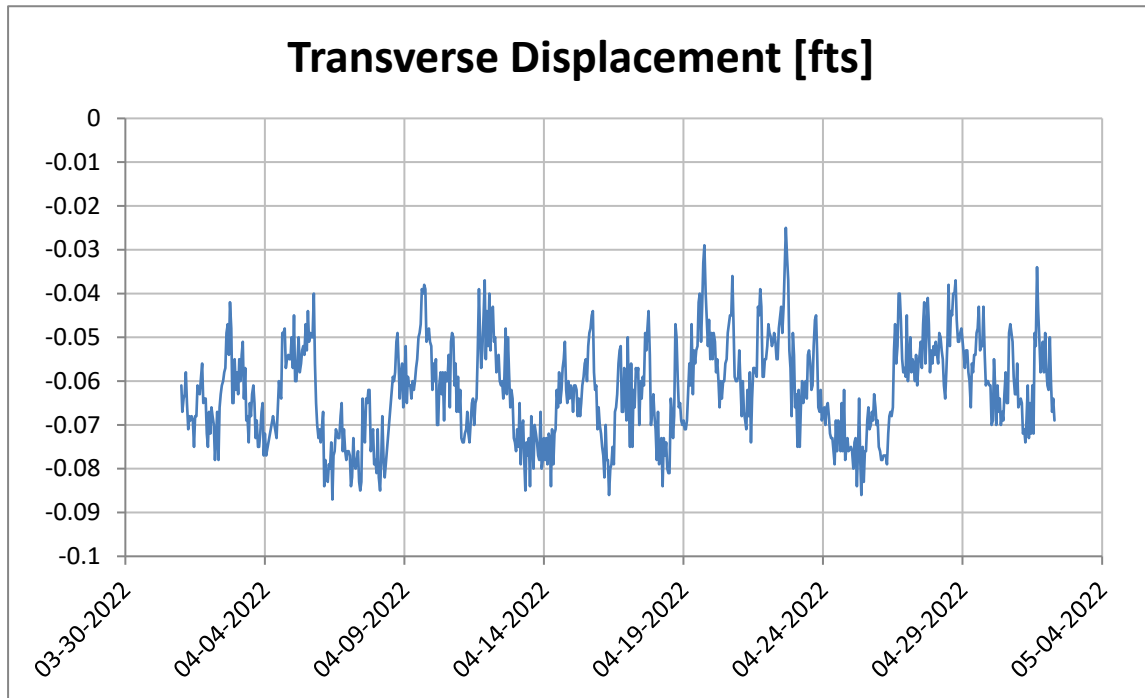
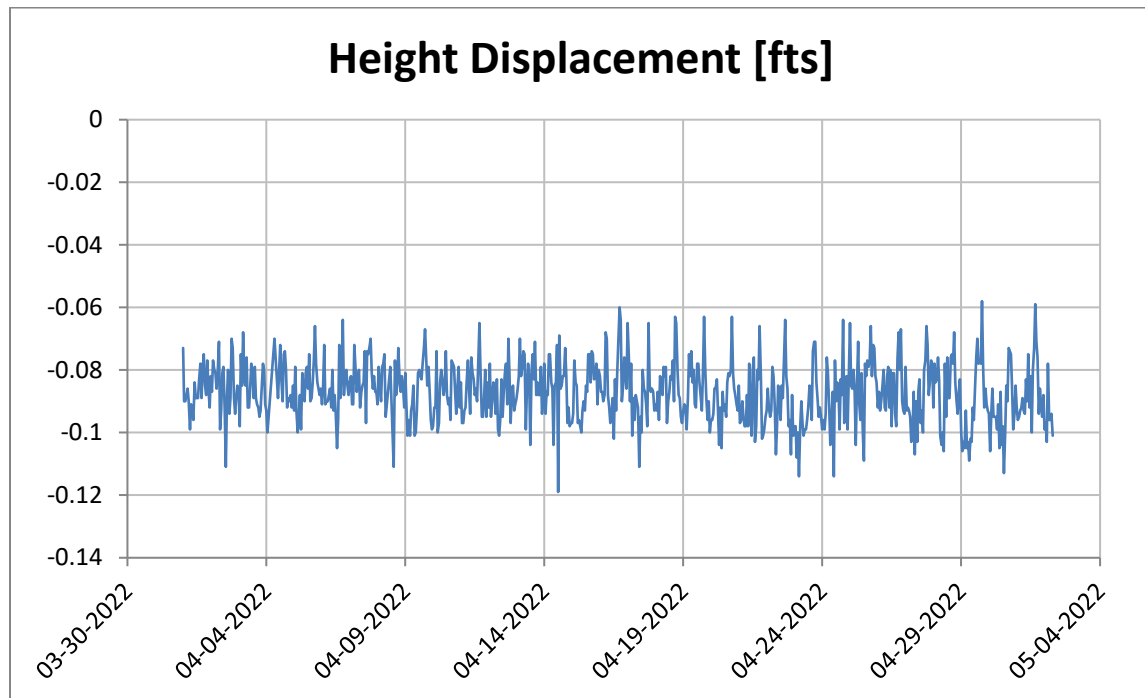
## Prism P32

1. Survey accuracy is  $\pm 0.016$  feet.
2. Alarm threshold is  $\pm 0.35$  feet.
3. Transverse displacement is in the horizontal direction. Positive direction means closer to the robotic station.
4. Height displacement is in the vertical direction. Positive direction means higher in elevation.
5. Regression limit alarm was received on April 28.

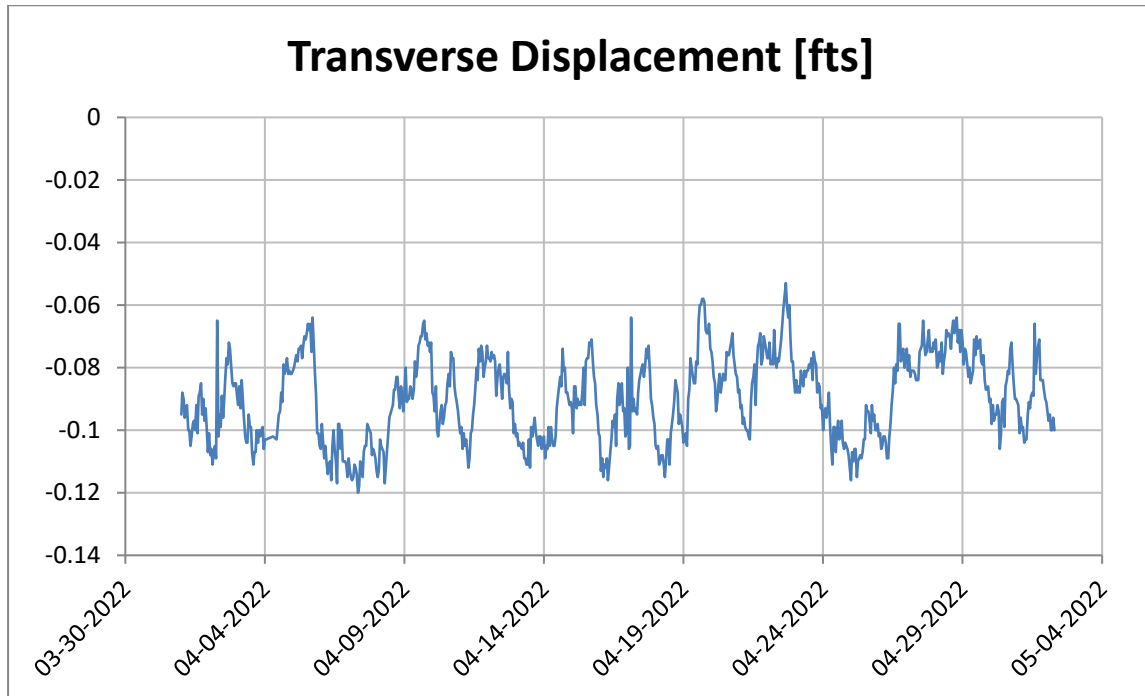
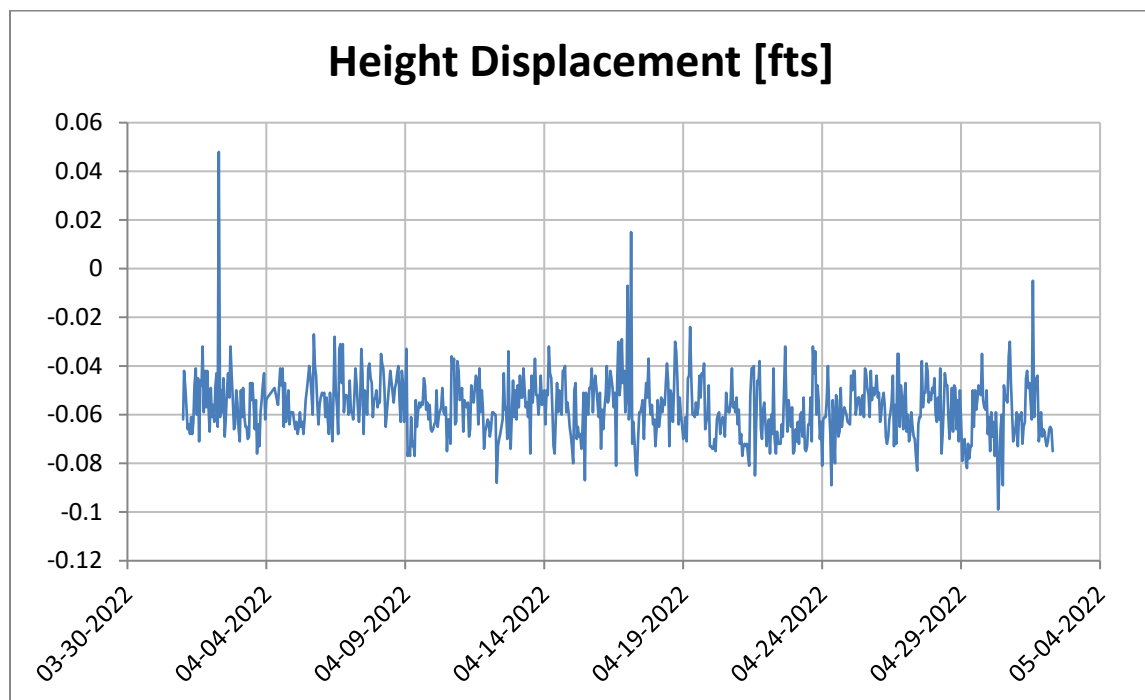
## Prism P33

1. Survey accuracy is  $\pm 0.016$  feet.
2. Alarm threshold is  $\pm 0.35$  feet.
3. Transverse displacement is in the horizontal direction. Positive direction means closer to the robotic station.
4. Height displacement is in the vertical direction. Positive direction means higher in elevation.
5. Regression limit alarms were received on April 3.
