MINERALS PROGRAM INSPECTION REPORT
PHONE: (303) 866-3567

MINE NAME: Henderson Mine	MINE/PROSPECTING ID#: M-1977-342	MINERAL: Molybdenum	COUNTY: Clear Creek, Grand
INSPECTION TYPE: Monitoring	INSPECTOR(S): Brock Bowles	INSP. DATE: May 27, 2022	INSP. TIME: 09:00
OPERATOR: Climax Molybdenum Company	OPERATOR REPRESENTATIVE: Geoffrey Niggeler and Miguel Hamarat	TYPE OF OPERATION: 112d-3 - Designated Mining Operation	
REASON FOR INSPECTION: Citizen Complaint	BOND CALCULATION TYPE: None	BOND AMOUNT: \$135,204,778.00	
DATE OF COMPLAINT: NA	POST INSP. CONTACTS: None	JOINT INSP. AGENCY: None	
WEATHER: Clear	INSPECTOR'S SIGNATURE:

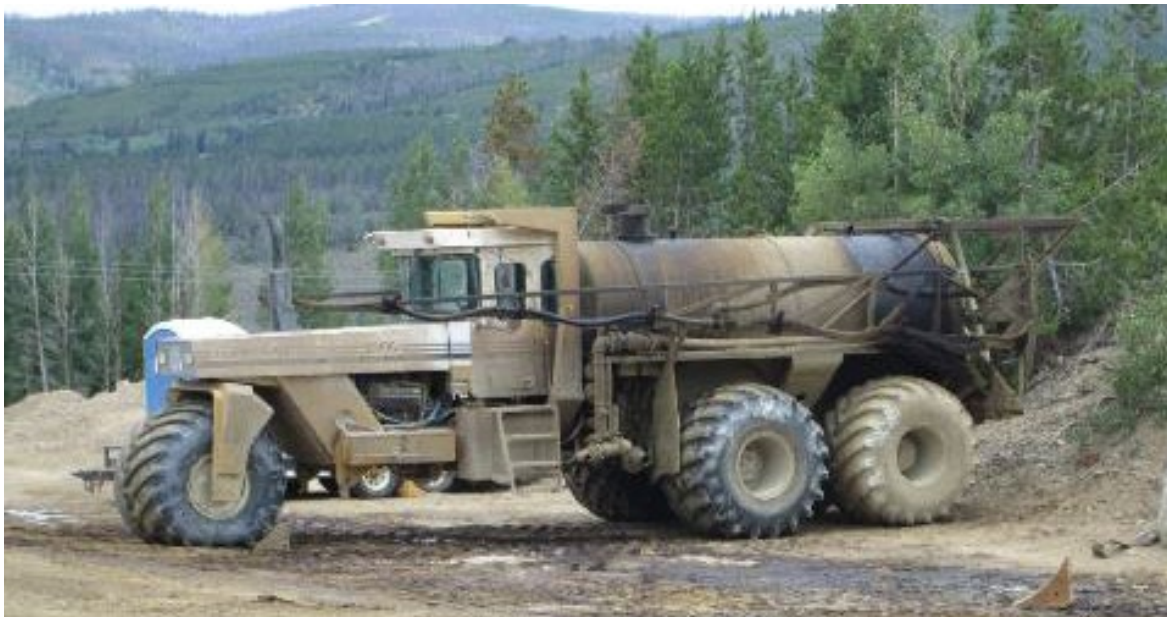
Figure 1. Typical Coherex spray truck. Henderson owns and operates 4 spray vehicles.

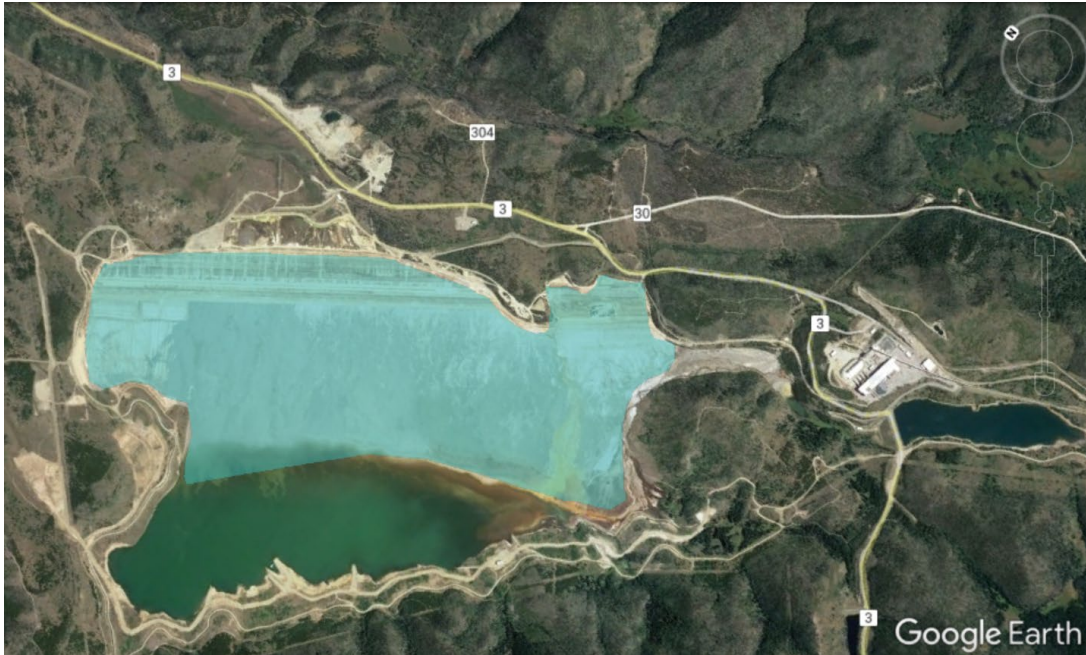
Figure 2. The Henderson Tailings Storage Facility consists of dry tailings impoundment (shaded light green) and reclaim pond (dark green). The dry beach and embankment are treated with Coherex to suppress dust mobilization.
