MINERALS PROGRAM INSPECTION REPORT

MINE NAME: Perdue	MINE/PROSPECTING ID#: M-2000-089	MINERAL: Sandstone (silica, st quartzite)	COUNTY: Boulder
INSPECTION TYPE: Monitoring	INSPECTOR(S): Patrick Lennberg	INSP. DATE: June 9, 2022	INSP. TIME: 11:00
OPERATOR: Mary Vasquez	OPERATOR REPRESENTATIVE: None	TYPE OF OPERATION: 110c - Construction Limited Impact	
REASON FOR INSPECTION: Normal I&E Program	BOND CALCULATION TYPE: Complete Bond	BOND AMOUNT: \$12,500.00	
DATE OF COMPLAINT: NA	POST INSP. CONTACTS: None	JOINT INSP. AGENCY: None	
WEATHER: Clear	INSPECTOR'S SIGNATURE:

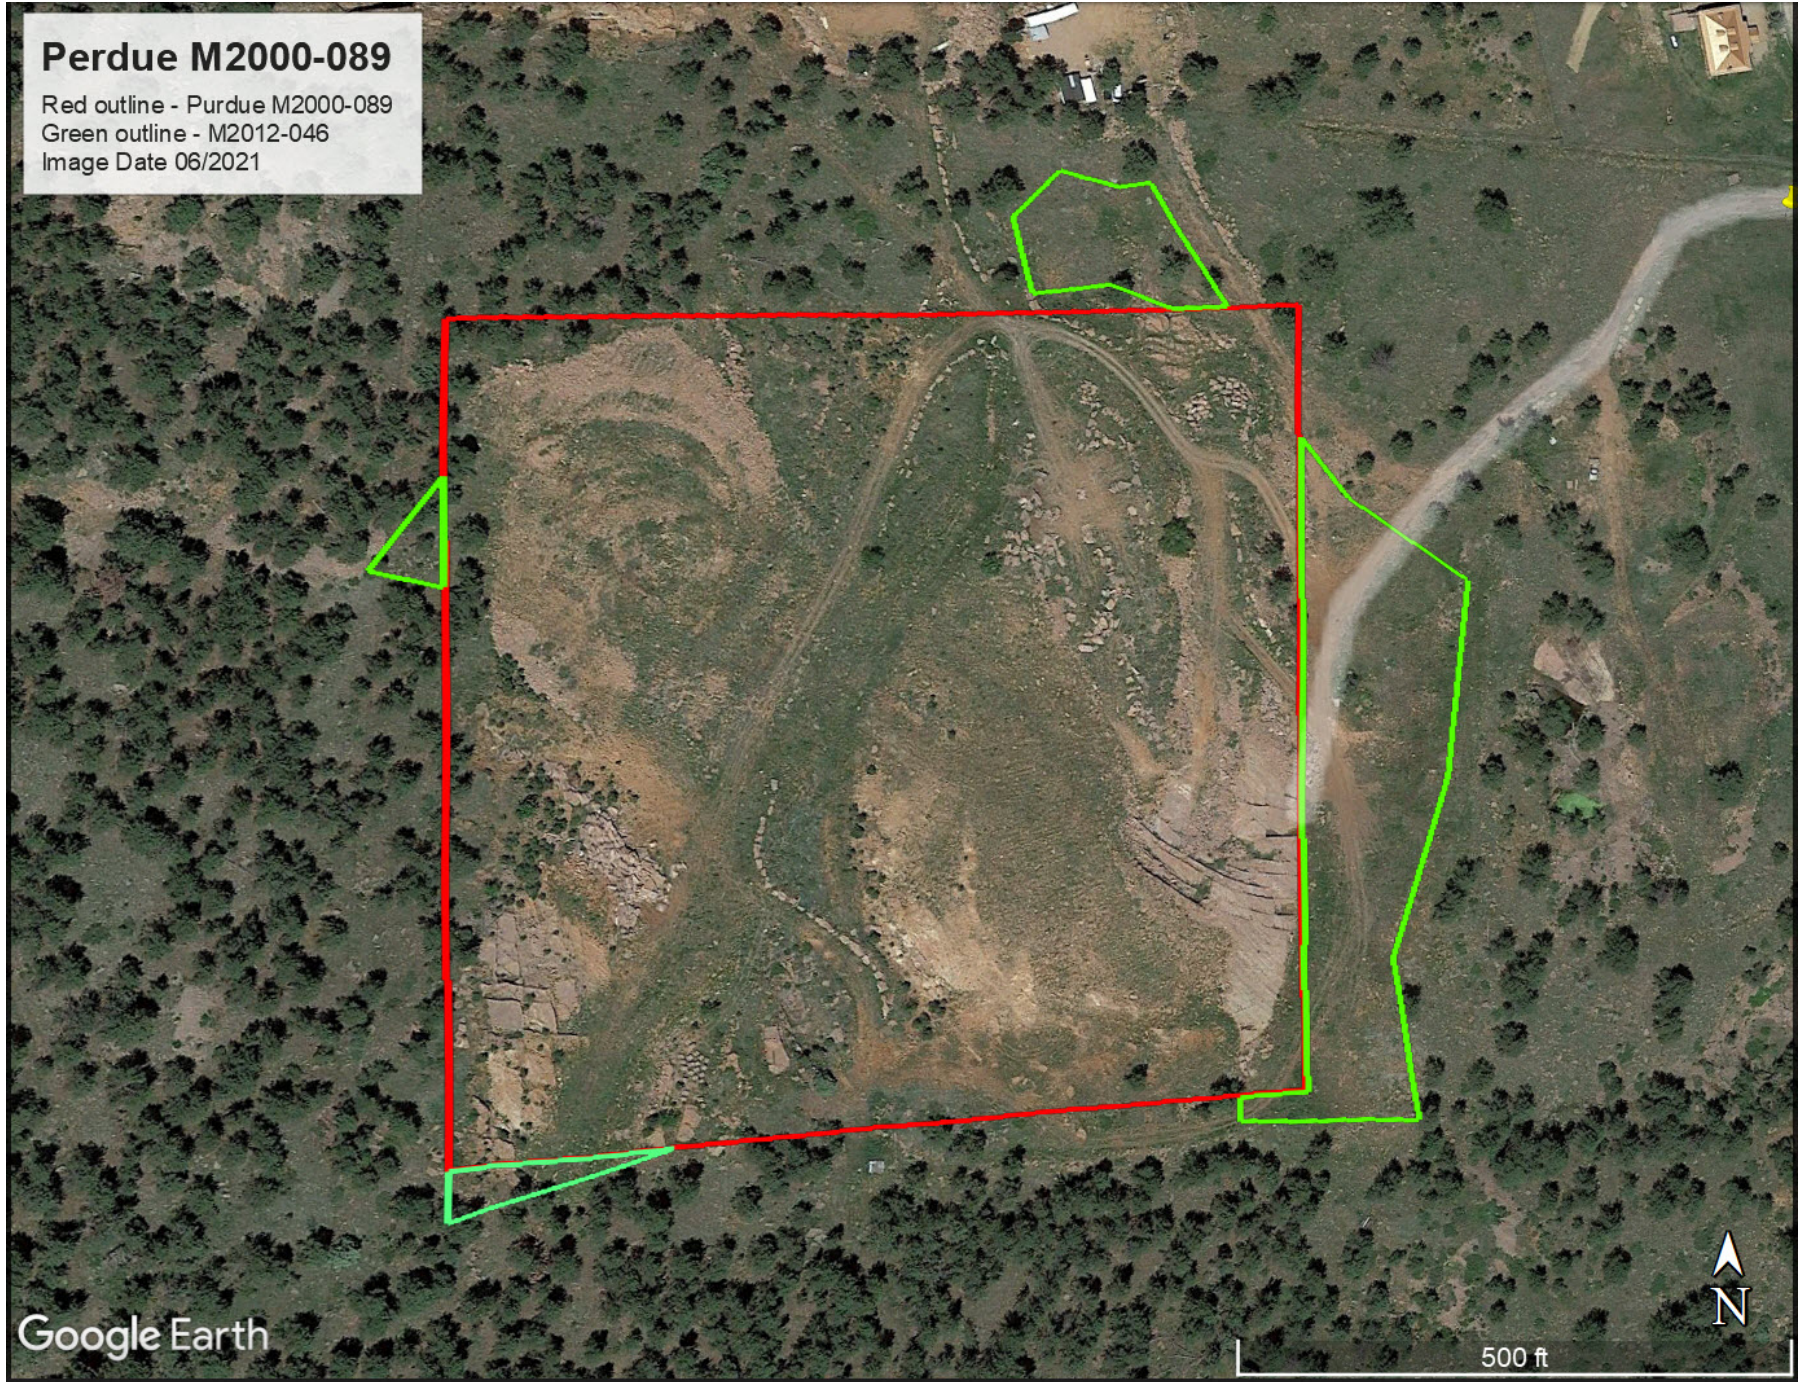
Photo 10: Looking towards the southwestern pit area, note stacked material in the center and the right of center of picture
