MINERALS PROGRAM INSPECTION REPORT

MINE NAME: Leadville Complaint	MINE/PROSPECTING ID#: M-2022-026	MINERAL: UNK	COUNTY: Lake
INSPECTION TYPE: Illegal(Unpermitted Operation)	INSPECTOR(S): Lucas West	INSP. DATE: June 1, 2022	INSP. TIME: 12:56
OPERATOR: Carol Bellhouse	OPERATOR REPRESENTATIVE: Carol Bellhouse	TYPE OF OPERATION: ILL - Illegal	
REASON FOR INSPECTION: Citizen Complaint	BOND CALCULATION TYPE: None	BOND AMOUNT: No Bond Held	
DATE OF COMPLAINT: NA	POST INSP. CONTACTS: None	JOINT INSP. AGENCY: None	
WEATHER: Clear	INSPECTOR'S SIGNATURE:

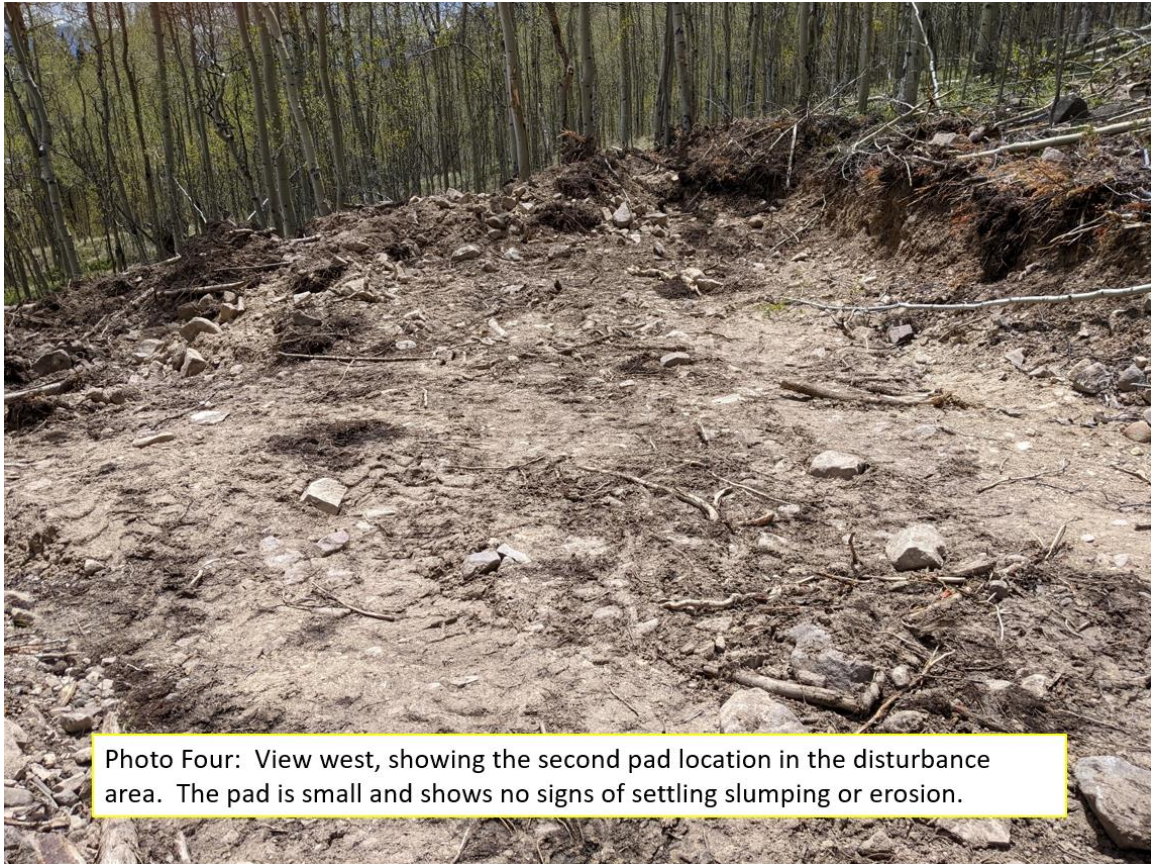
Photo Four: View west, showing the second pad location in the disturbance area. The pad is small and shows no signs of settling slumping or erosion.
