**MINERALS PROGRAM INSPECTION REPORT**  
**PHONE: (303) 866-3567**

| <b>MINE NAME:</b><br>Climax Mine | <b>MINE/PROSPECTING ID#:</b><br>M-1977-493 | <b>MINERAL:</b><br>Molybdenum | <b>COUNTY:</b><br>Lake, Summit |
| <b>INSPECTION TYPE:</b><br>Multi Person Inspection | <b>INSPECTOR(S):</b><br>Amy Yeldell | <b>INSP. DATE:</b><br>June 16, 2022 | <b>INSP. TIME:</b><br>10:30 |

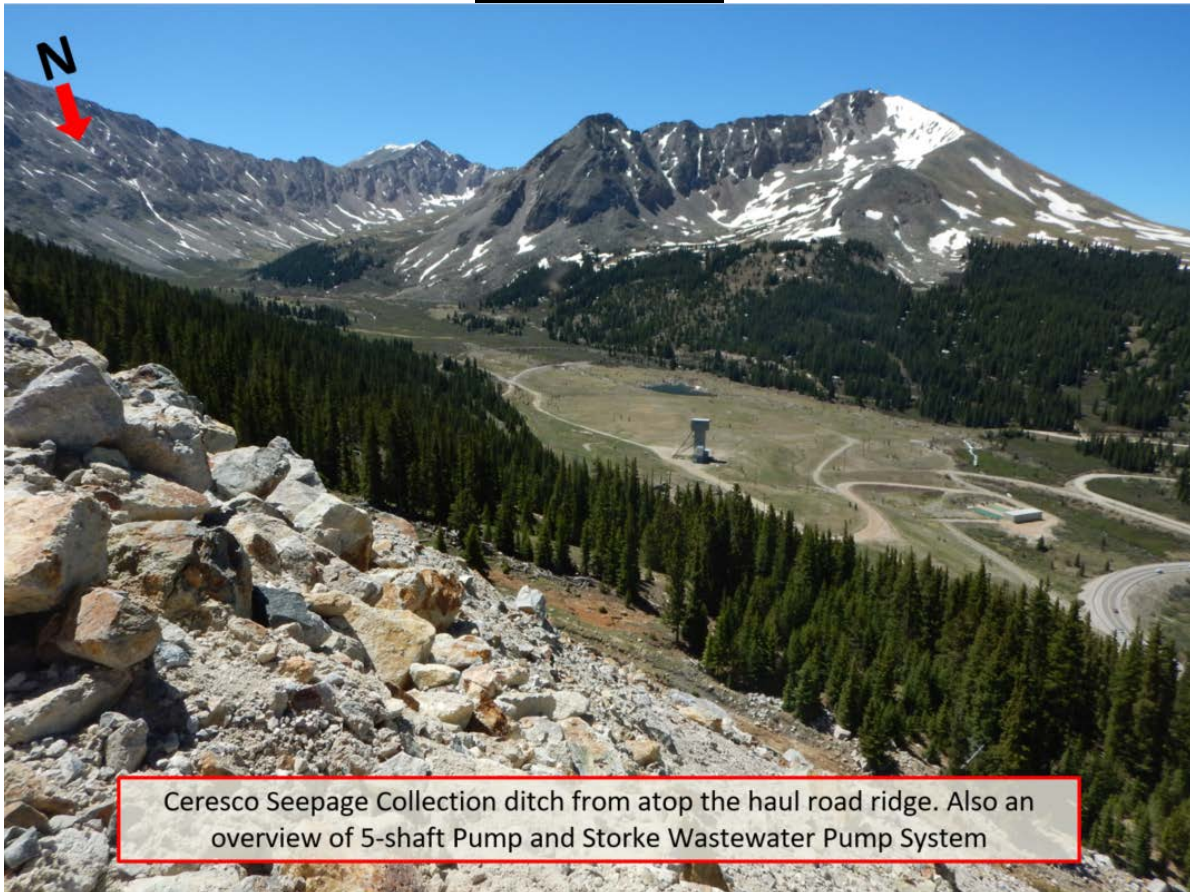
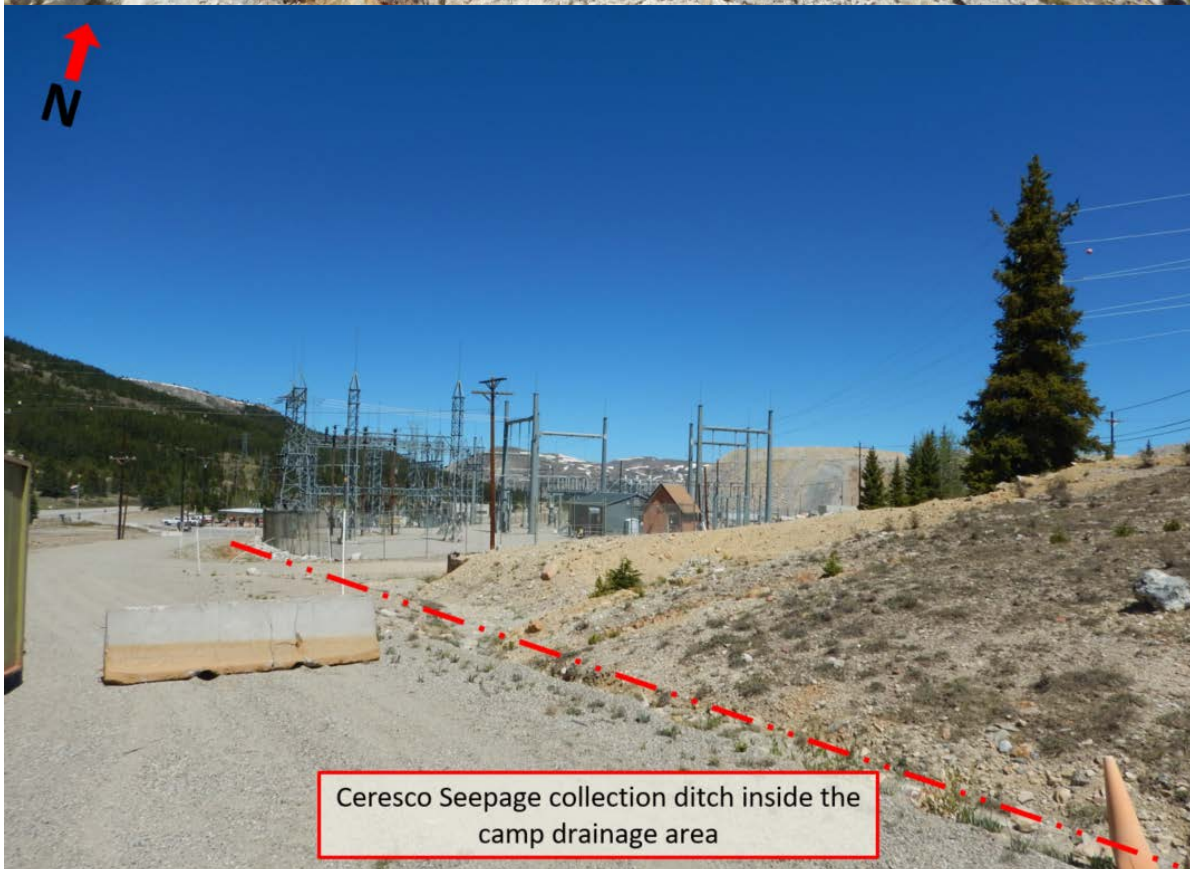
The Ceresco Seepage Collection System was first observed from atop the Ceresco Ridge haul road then the length of the collection ditch was followed. The purpose of this EPF is to intercept potentially impacted runoff and route it to the camp drainage which passes through water treatment as a means of protecting the Arkansas watershed. No water was observed in the ditch as the majority of snowmelt is gone. The ditch appeared free of debris or obstructions.

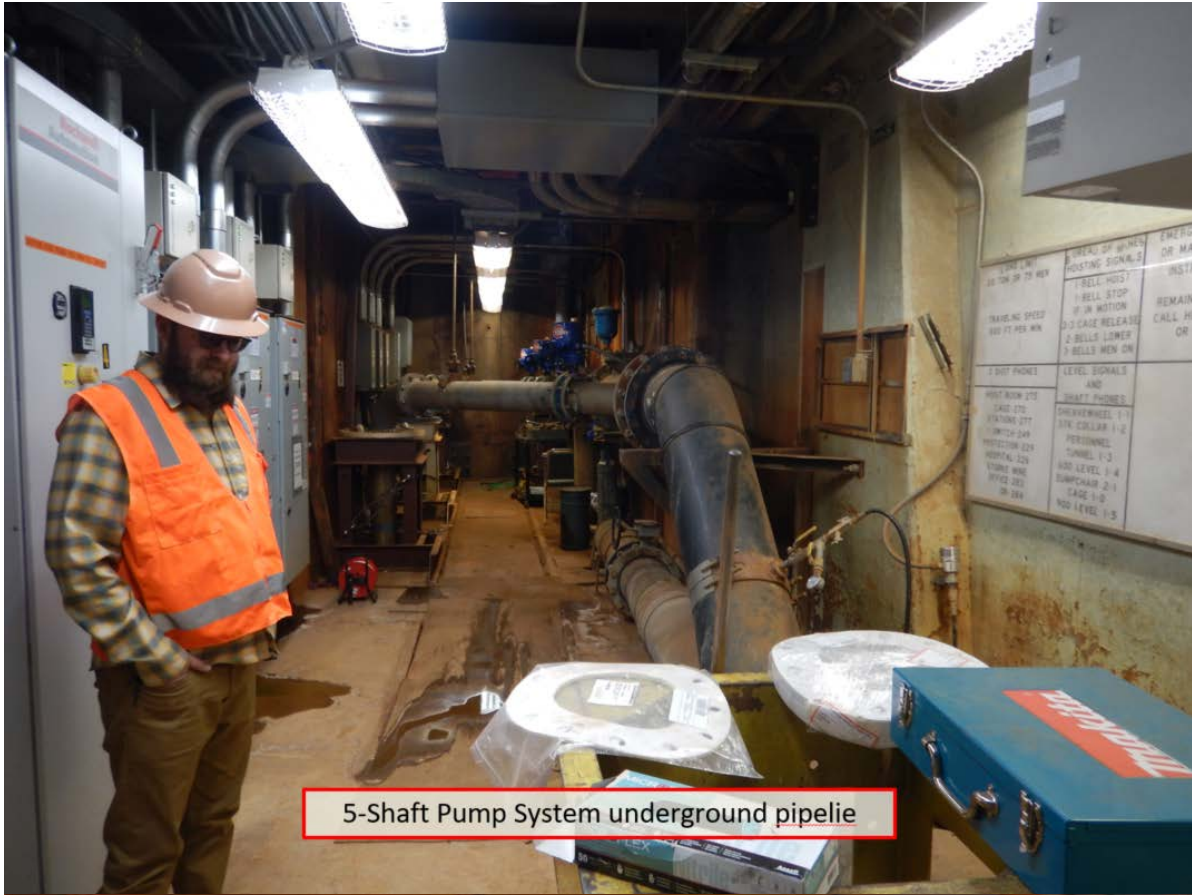
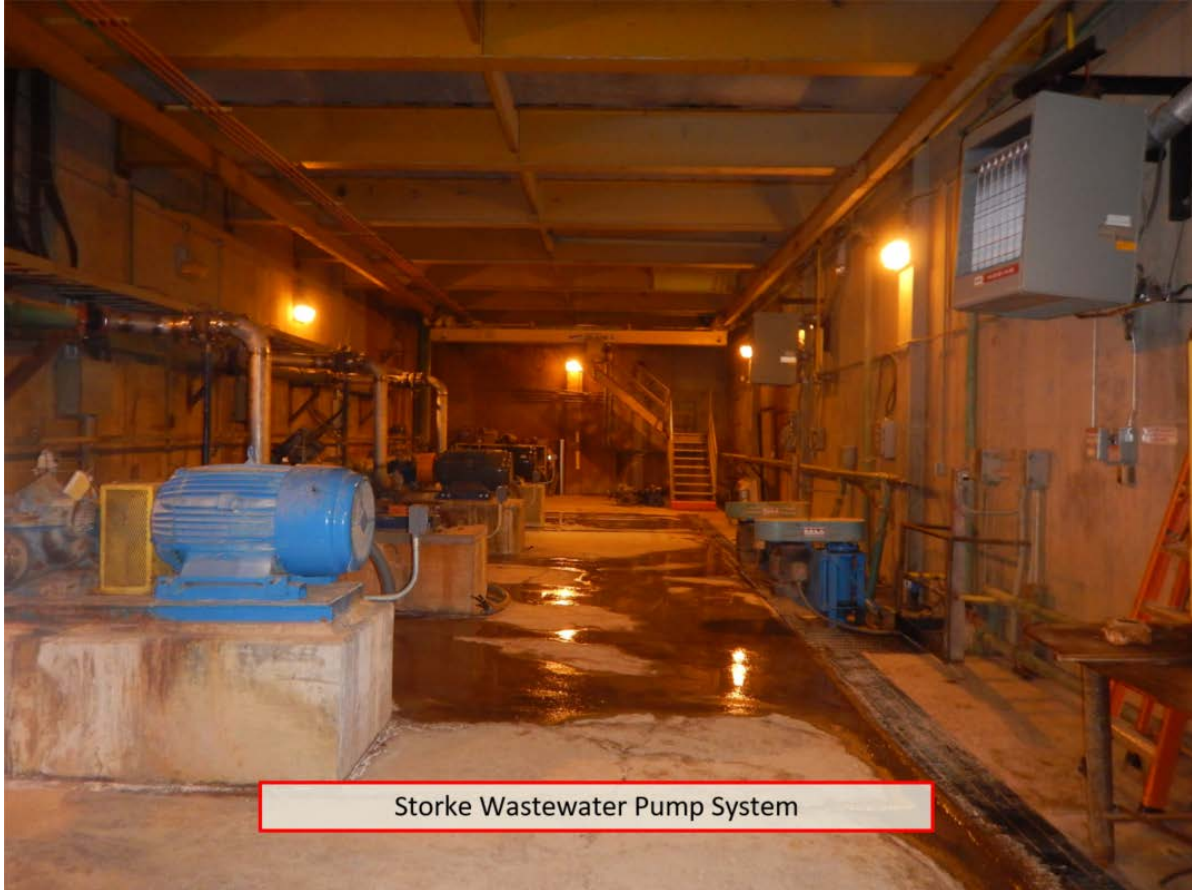
Next the 5-Shaft Pump System was observed. The 5-Shaft Pump System is a dual purpose EPF. First, in order to protect the Arkansas watershed quality it collects potentially impacted water and pumps it over to the Tenmile basin for treatment prior to discharge. This is stormwater that becomes impacted as it goes through the open pit and collects in the underground workings. Secondly, it also works to maintain the water level in underground workings below the apex of the Mosquito Fault, a level in which the Arkansas Basin could be impacted. All water collected from the 5-Shaft is pumped through the Storke Pipeline to the ETDL and where it is treated in the Tenmile process circuit. Overall the 5-shaft Pump System appeared to be in good working order. No apparent leaks were observed and generally the building was well maintained. Backup pumps and parts were on site to ensure uninterrupted functionality.

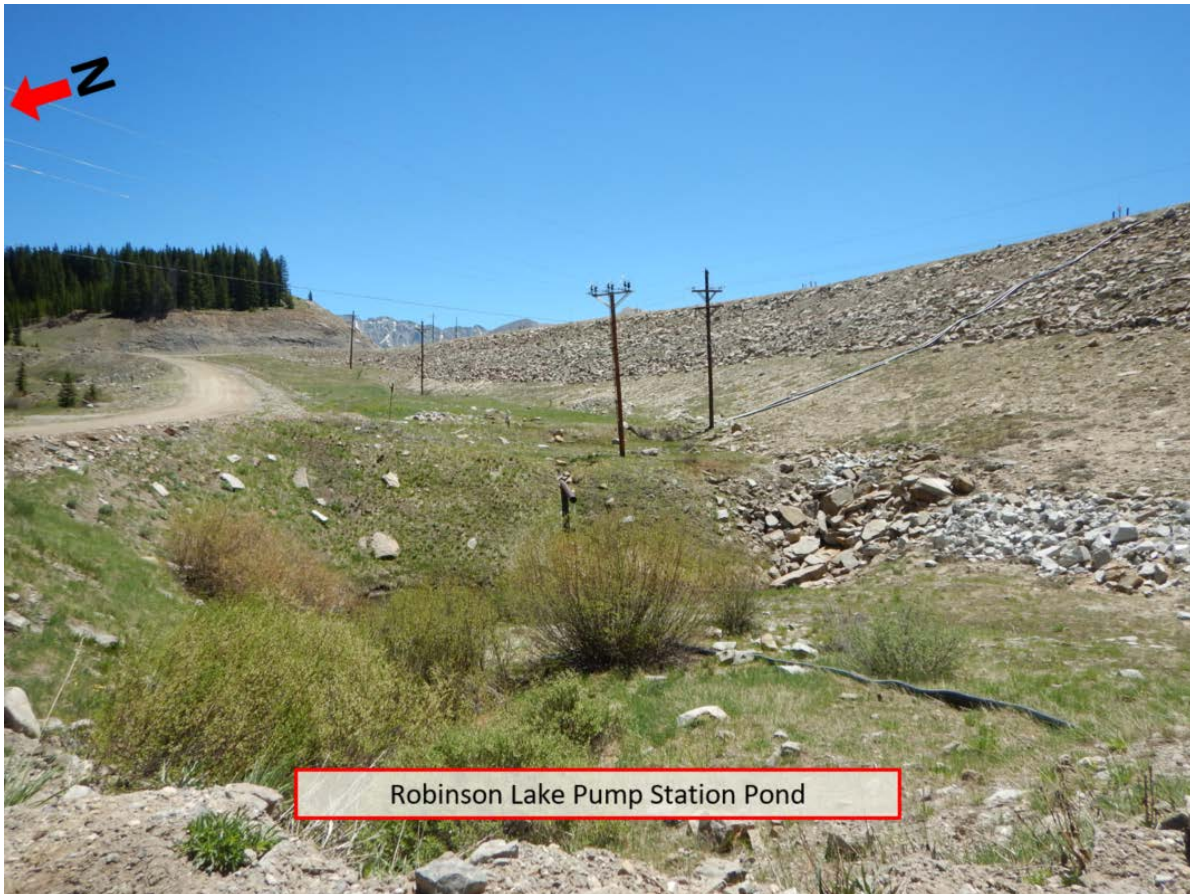
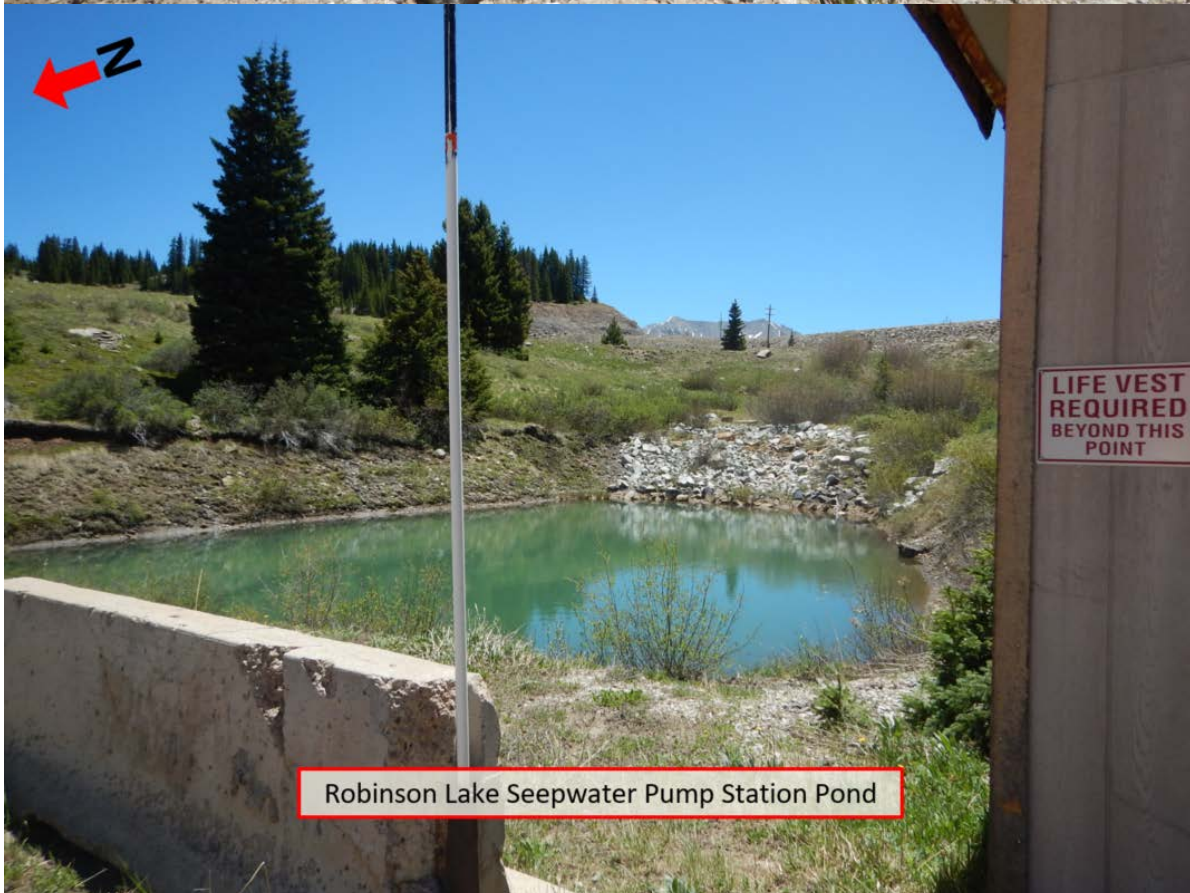
At the base of Robinson Dam is a seepage collection system. The dam face appeared to be in good shape with no evidence of settling, slumping or erosion. Any water is collected in the small pond at the base of the dam then pumped back into Robinson Lake for future use. The pump station pond was dry, well vegetated and stable. The pump station building itself was only briefly inspected due to noise inside the buildings. Pumps were actively operating providing water to the mill. No leaks were identified and good housekeeping practices were in place.
