MINERALS PROGRAM INSPECTION REPORT

MINE NAME: Reclamation Pit No 1	MINE/PROSPECTING ID#: M-1977-153 & M-1979-195	MINERAL: Sand and gravel	COUNTY: Adams
INSPECTION TYPE: Monitoring	INSPECTOR(S): Nikie Gagnon	INSP. DATE: June 15, 2022	INSP. TIME: 09:00
OPERATOR: Denver Water Department	OPERATOR REPRESENTATIVE: Brad Piede	TYPE OF OPERATION: 112c - Construction Regular Operation

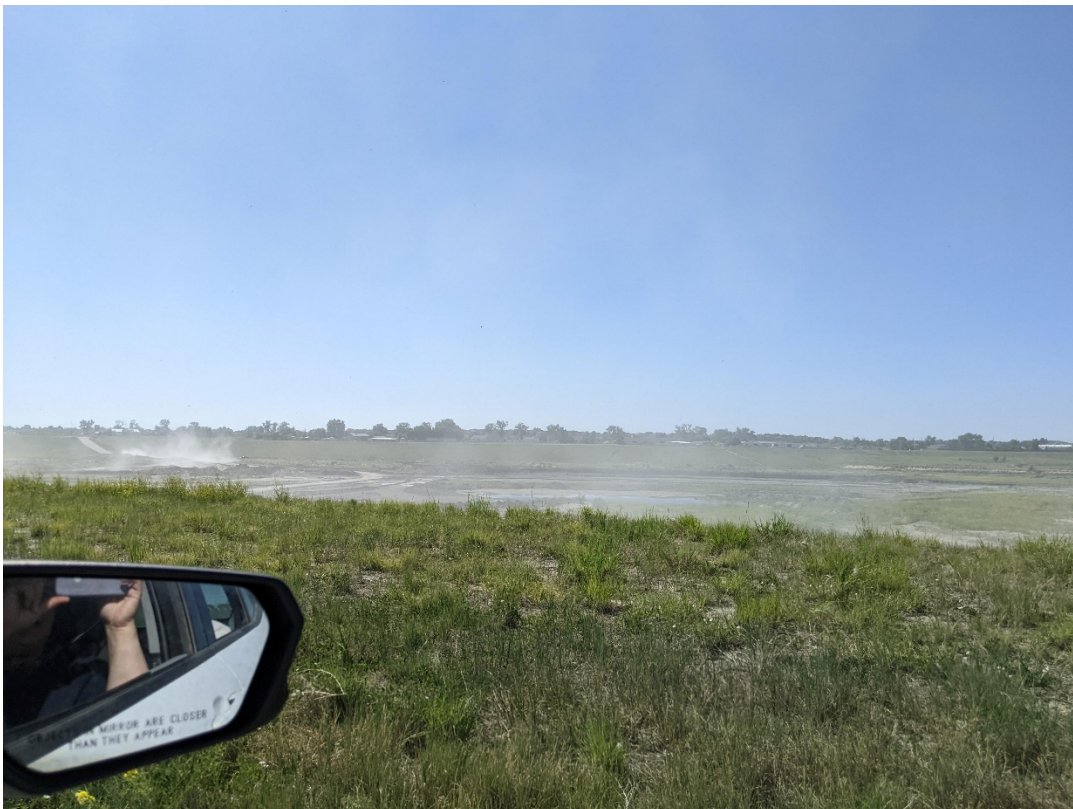
Fugitive dust was observed in the area of active mining during the inspection. The Division recommends applying water to reduce the dust during mining operations.

Fugitive dust in area of active mining.
