Reference: May 2022 Geotechnical Monitoring Summary Pikeview Quarry

CONTINENTAL MATERIALS
CORP.
PIKEVIEW QUARRY SLOPE
MONITORING

SITE MAP

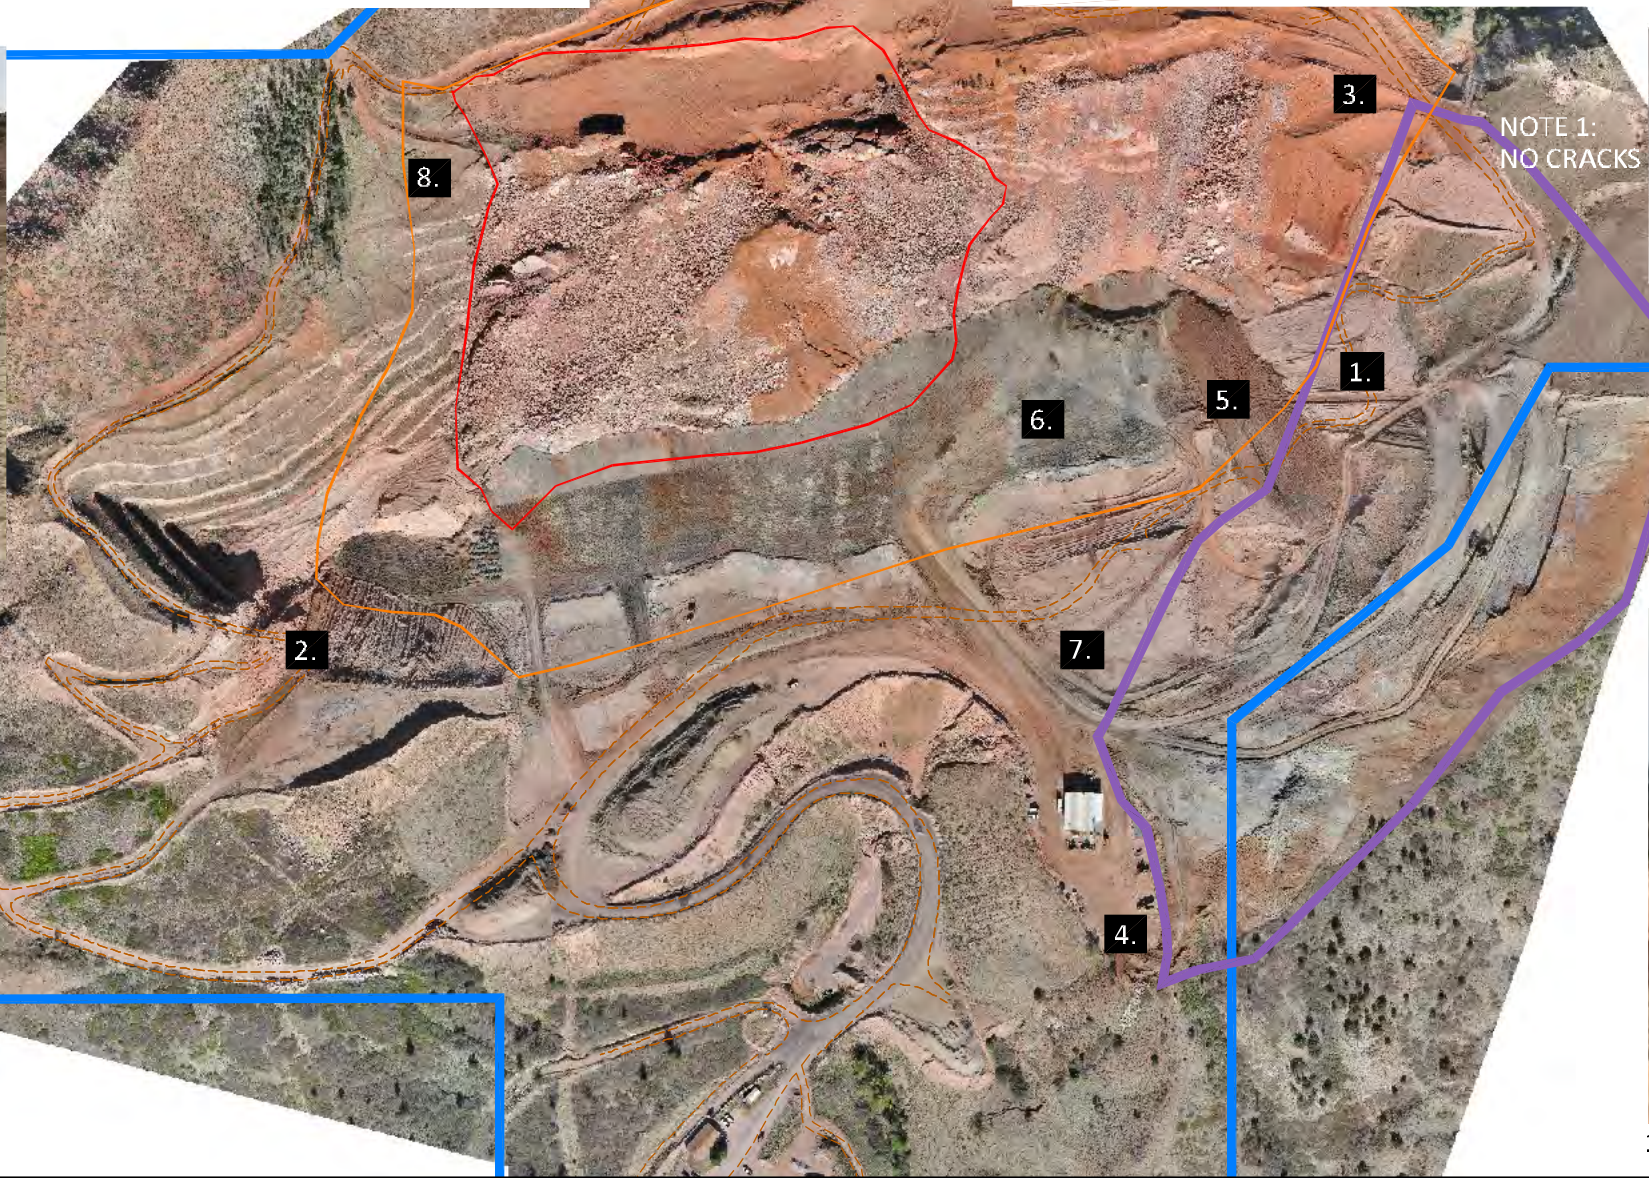
2. View to the north of the pit area.

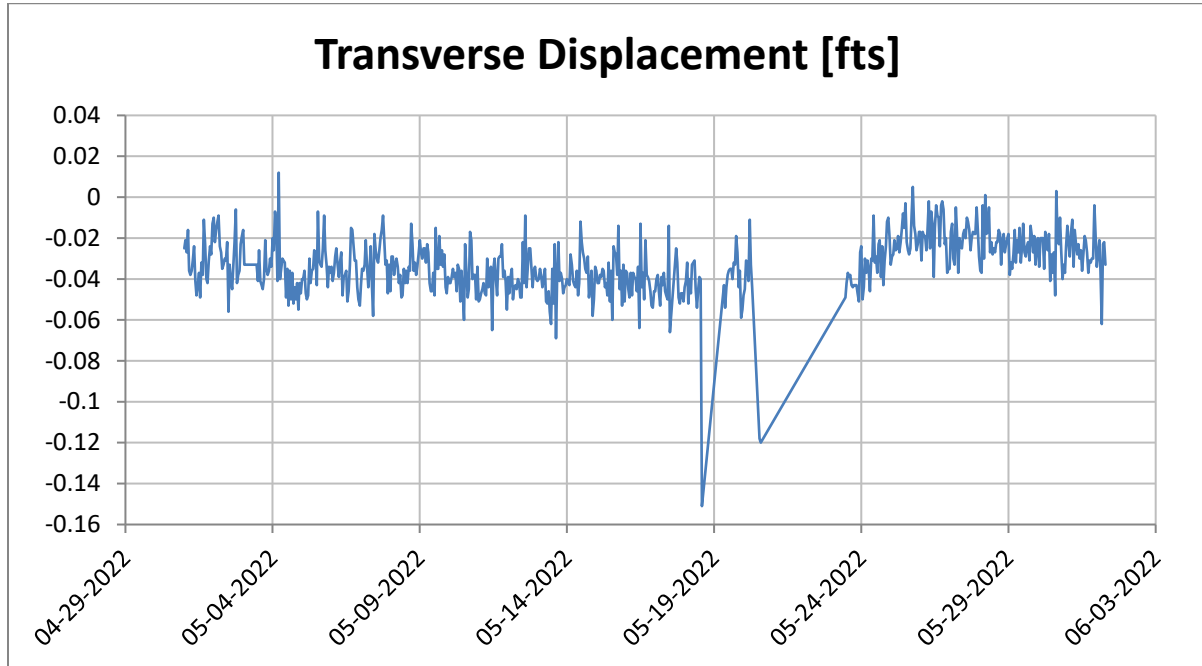
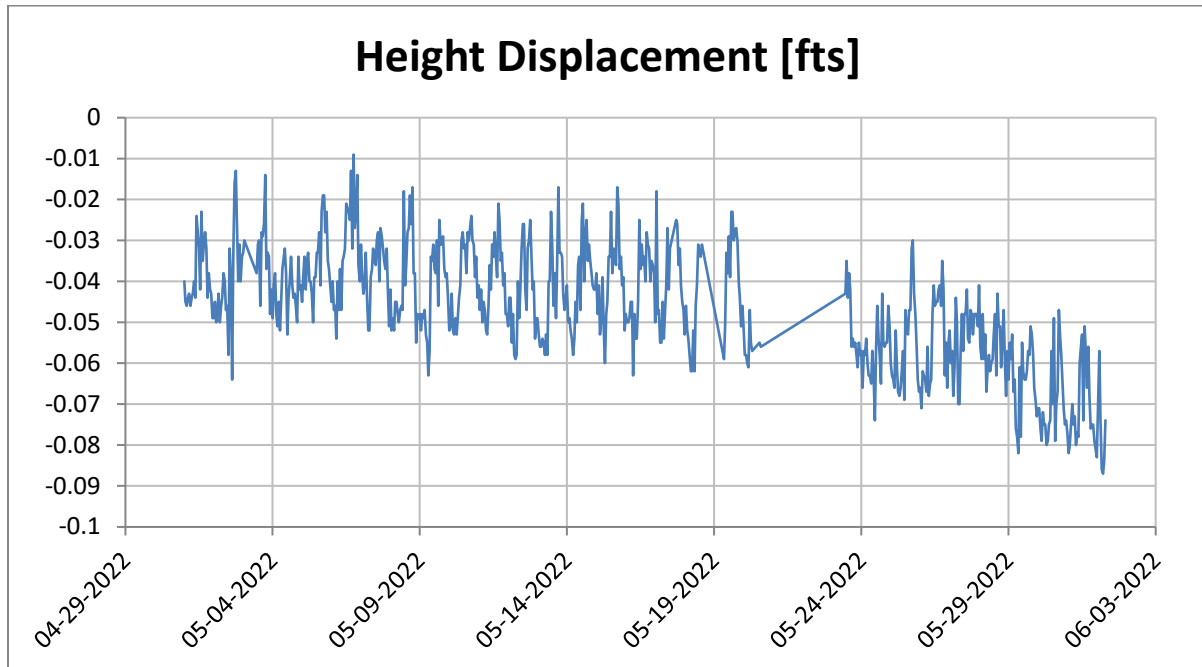
Prism BR1

1. Survey accuracy is ± 0.016 feet.
2. Alarm threshold is ± 0.35 feet.
3. Transverse displacement is in the horizontal direction. Positive direction means closer to the robotic station.
4. Height displacement is in the vertical direction. Positive direction means higher in elevation.
5. Prism records slope creep movements with slow velocity.

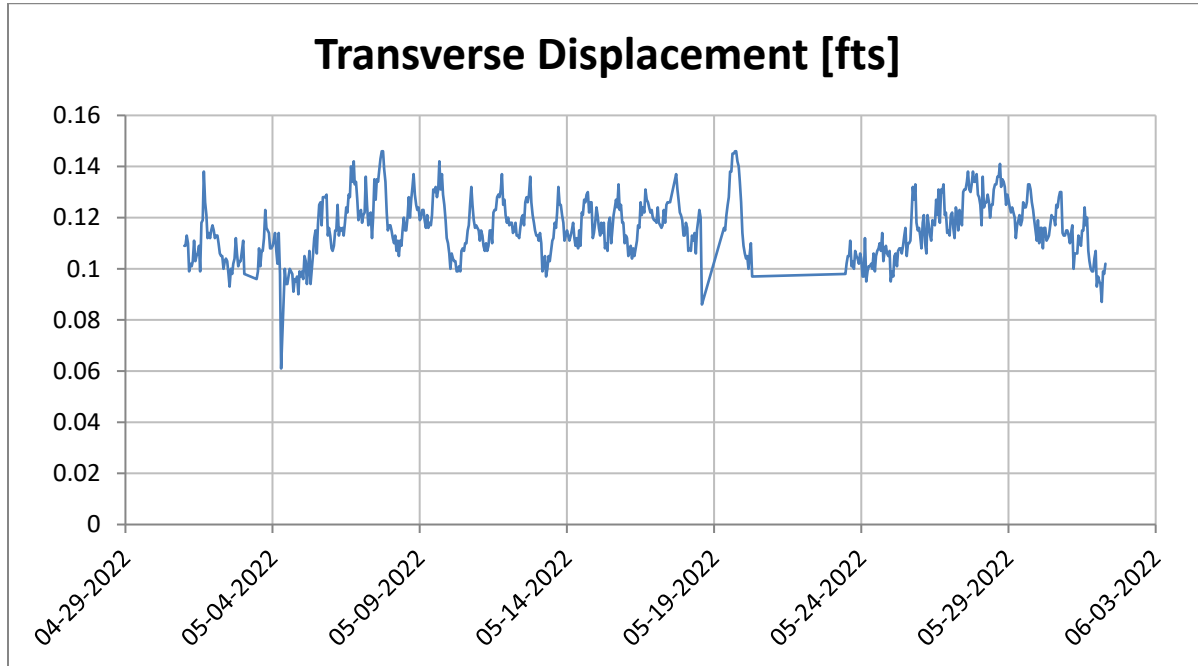
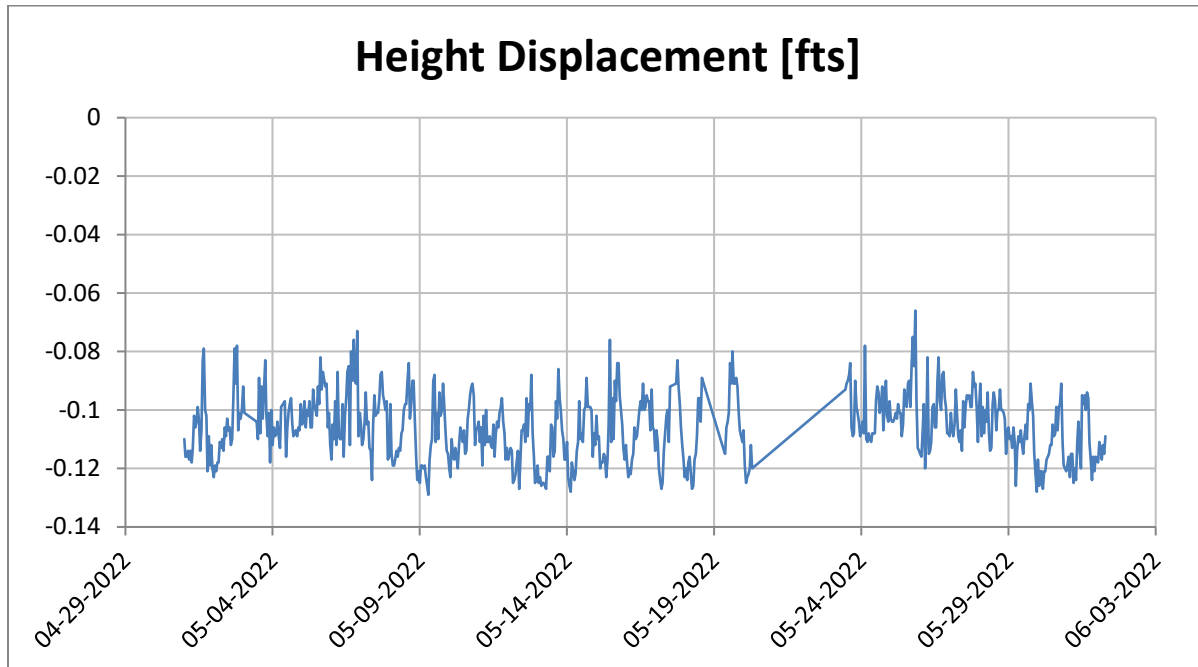
Prism NP2

1. Survey accuracy is ± 0.016 feet.
2. Alarm threshold is ± 0.35 feet.
3. Transverse displacement is in the horizontal direction. Positive direction means closer to the robotic station.
4. Height displacement is in the vertical direction. Positive direction means higher in elevation.
5. Regression limit alarms were received on May 4. One was in positive direction and the other was in the negative direction.

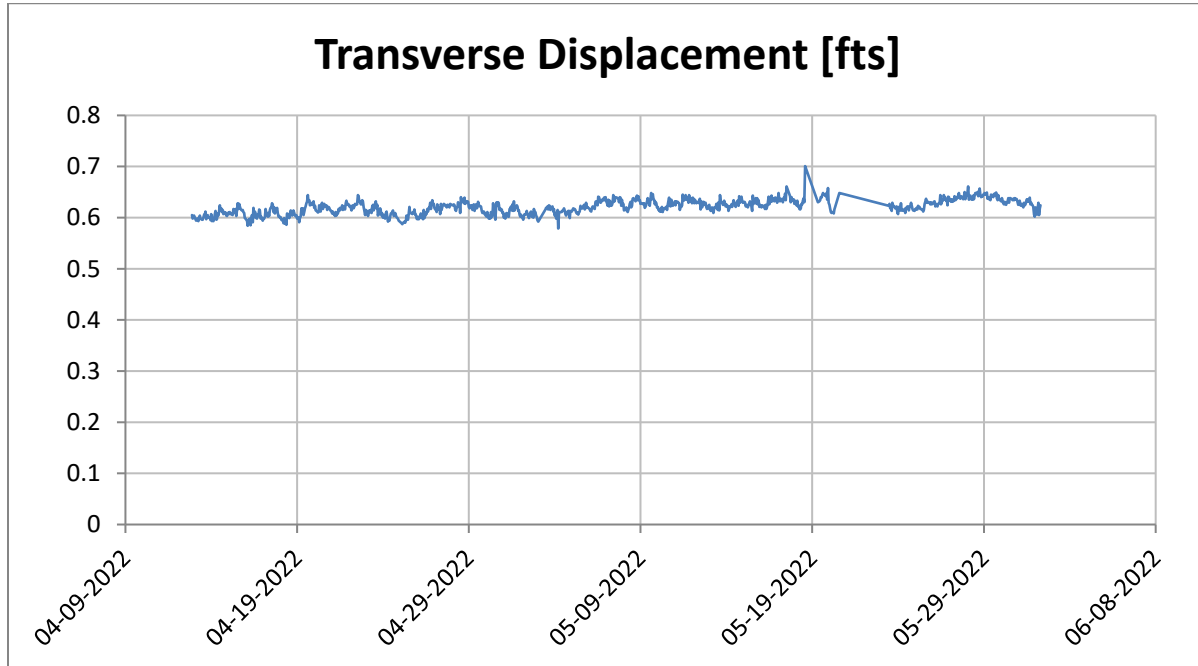
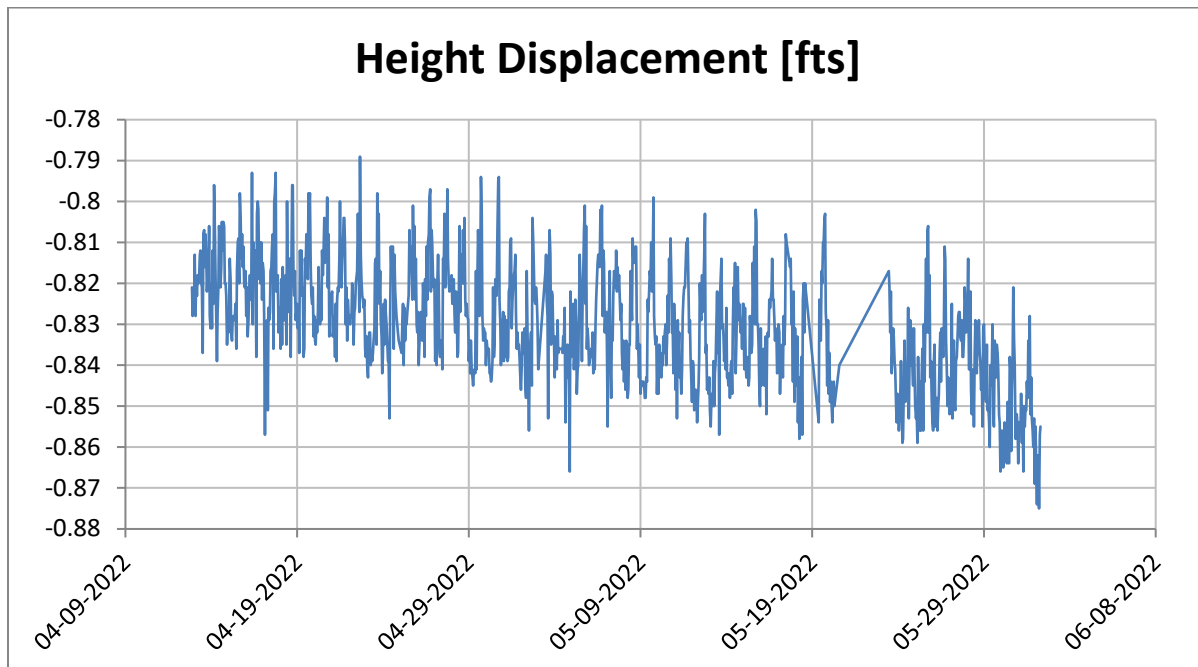
Prism NP66

1. Survey accuracy is ± 0.016 feet.
2. Alarm threshold is ± 0.35 feet.
3. Transverse displacement is in the horizontal direction. Positive direction means closer to the robotic station.
4. Height displacement is in the vertical direction. Positive direction means higher in elevation.
5. Prism records slope creep movements with slow velocity.

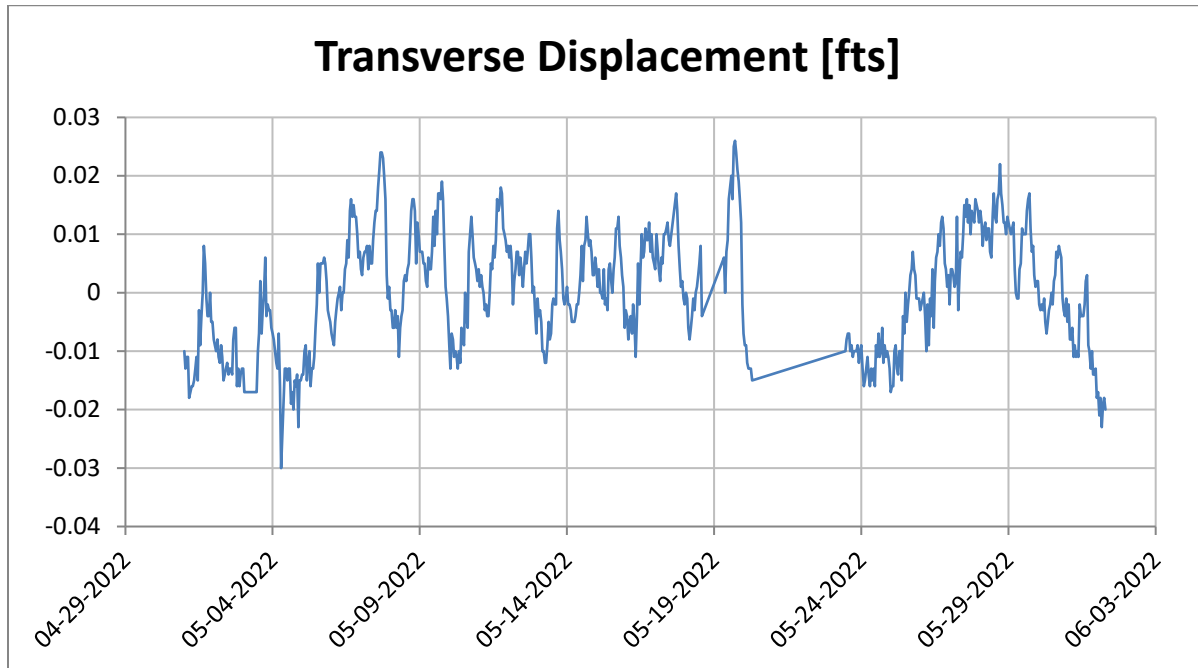
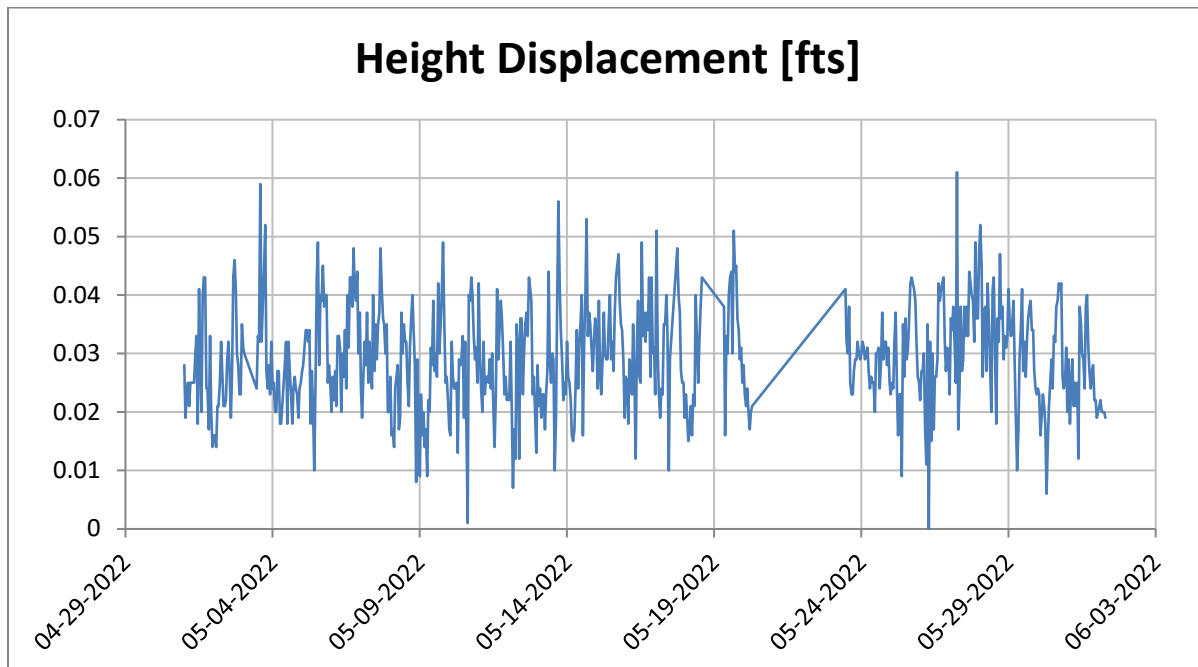
Prism P25

1. Survey accuracy is ± 0.016 feet.
2. Alarm threshold is ± 0.35 feet.
3. Transverse displacement is in the horizontal direction. Positive direction means closer to the robotic station.
4. Height displacement is in the vertical direction. Positive direction means higher in elevation.
5. Regression limit alarms were received on May 4 and 18.

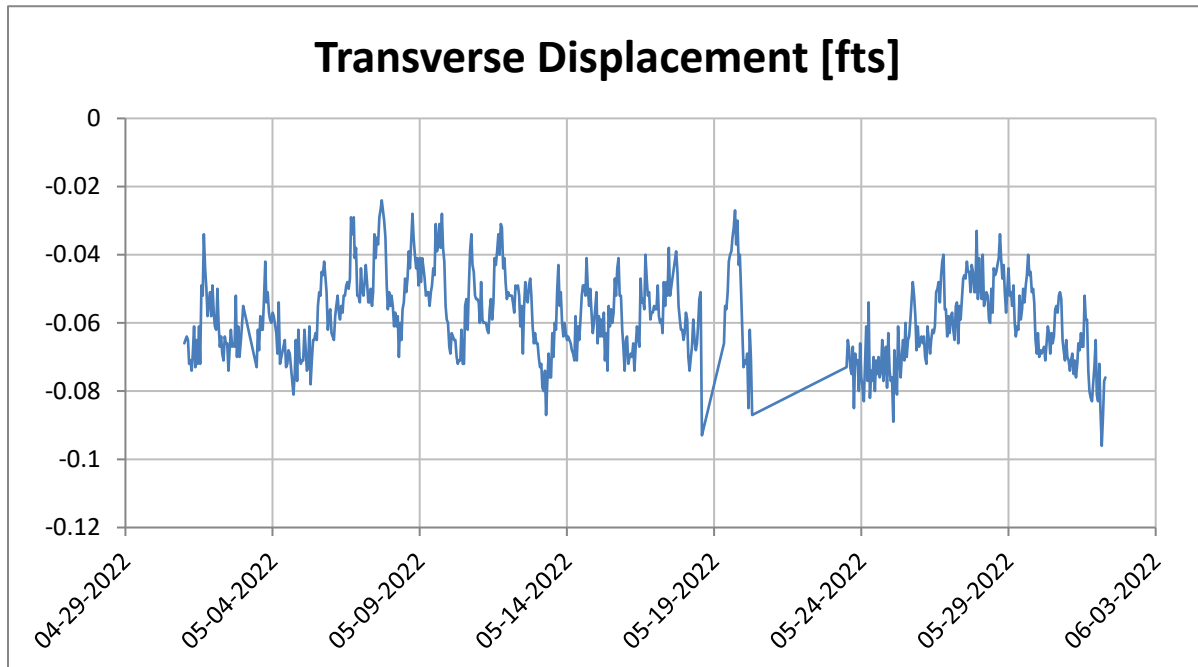
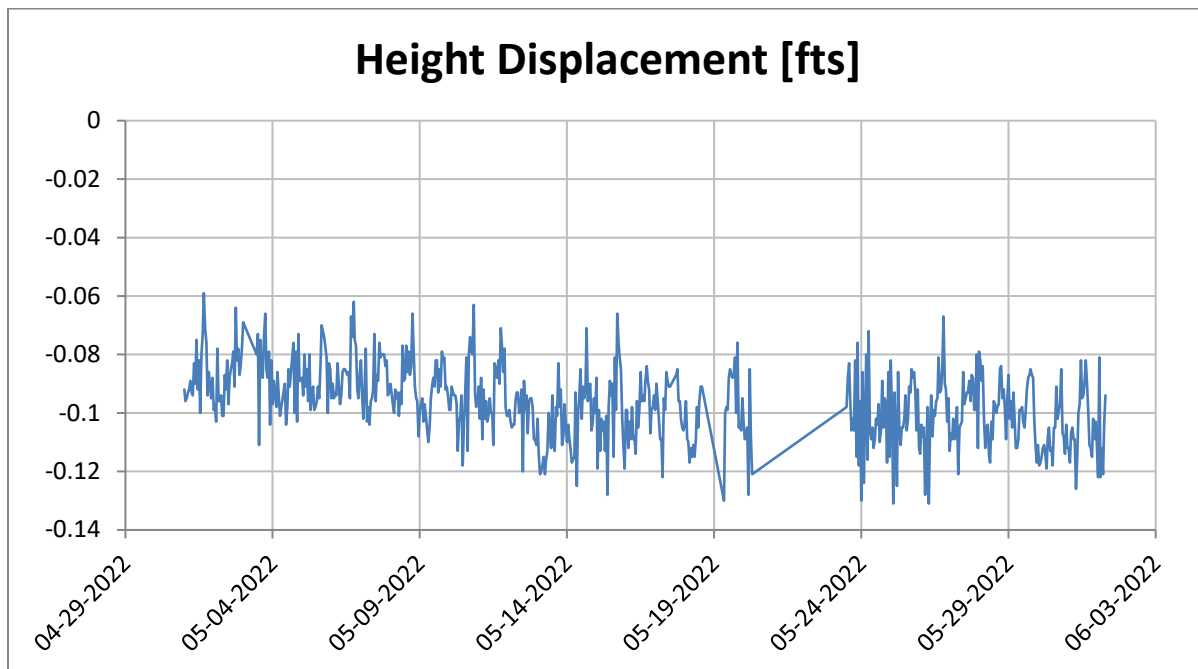
Prism P32

05/18/2022	P32 Regression limit level 1 exceeded	Data error during rain. No sign of movement after inspection. Reading of -0.429'	05/18/2022
05/18/2022-05/19/2022	No communication with sensors	Rain and lightning caused GFI to trip. No work due to afternoon thunderstorm.	05/19/2022
05/20/2022	Points not found	Fog, rain, snow, work halted for day (Fri, Mon, Tues)	05/20/22
05/20/2022-05/21/2022	No communication with sensors	GFI tripped due to weather over weekend. Reset on Monday	05/21/2022
05/23/2022-05/24/2022	Points not found	Fog, rain, snow, work halted for day (Mon, Tues)	05/24/2022
05/31/2022	Points not found	Fog and rain	05/31/2022

1. Survey accuracy is ± 0.016 feet.
2. Alarm threshold is ± 0.35 feet.
3. Transverse displacement is in the horizontal direction. Positive direction means closer to the robotic station.
4. Height displacement is in the vertical direction. Positive direction means higher in elevation.
5. Regression limit alarms were received on May 4 and 18.

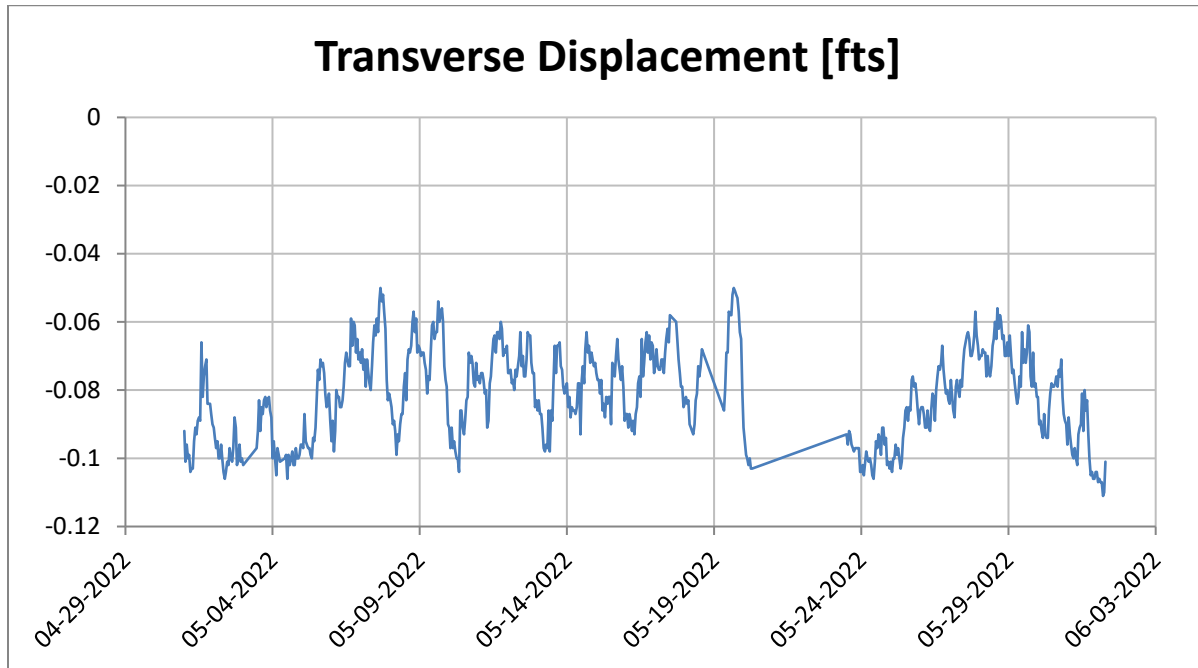
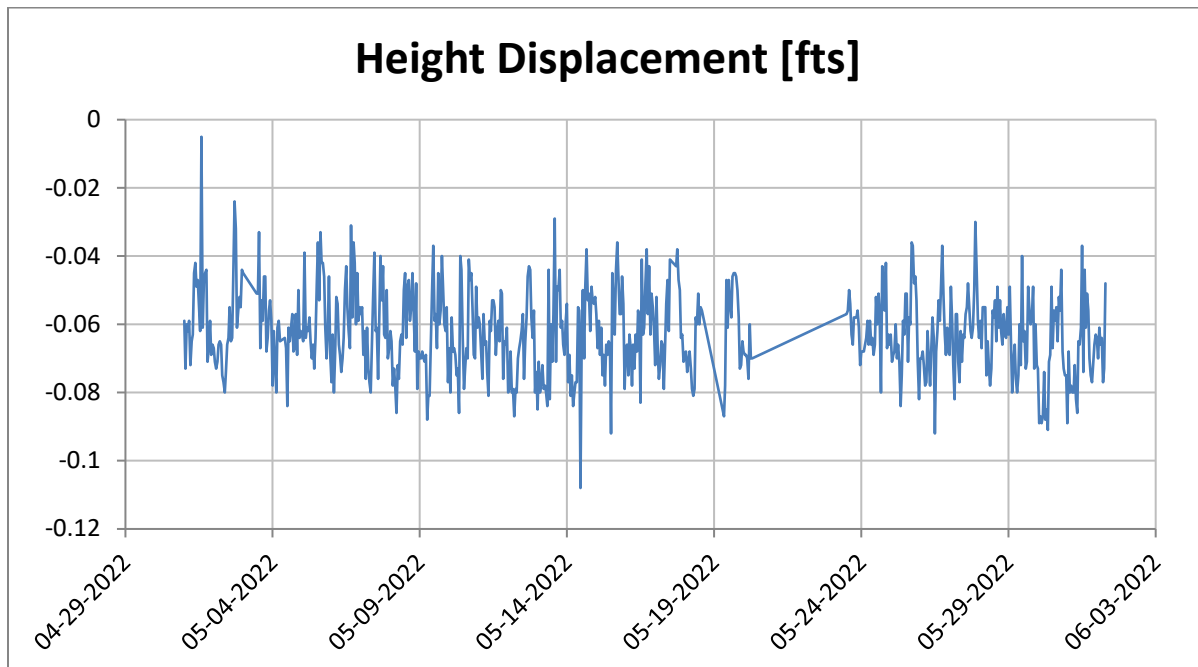
Prism P33

1. Survey accuracy is ± 0.016 feet.
2. Alarm threshold is ± 0.35 feet.
3. Transverse displacement is in the horizontal direction. Positive direction means closer to the robotic station.
4. Height displacement is in the vertical direction. Positive direction means higher in elevation.
5. Regression limit alarms were received on May 4 and 18.

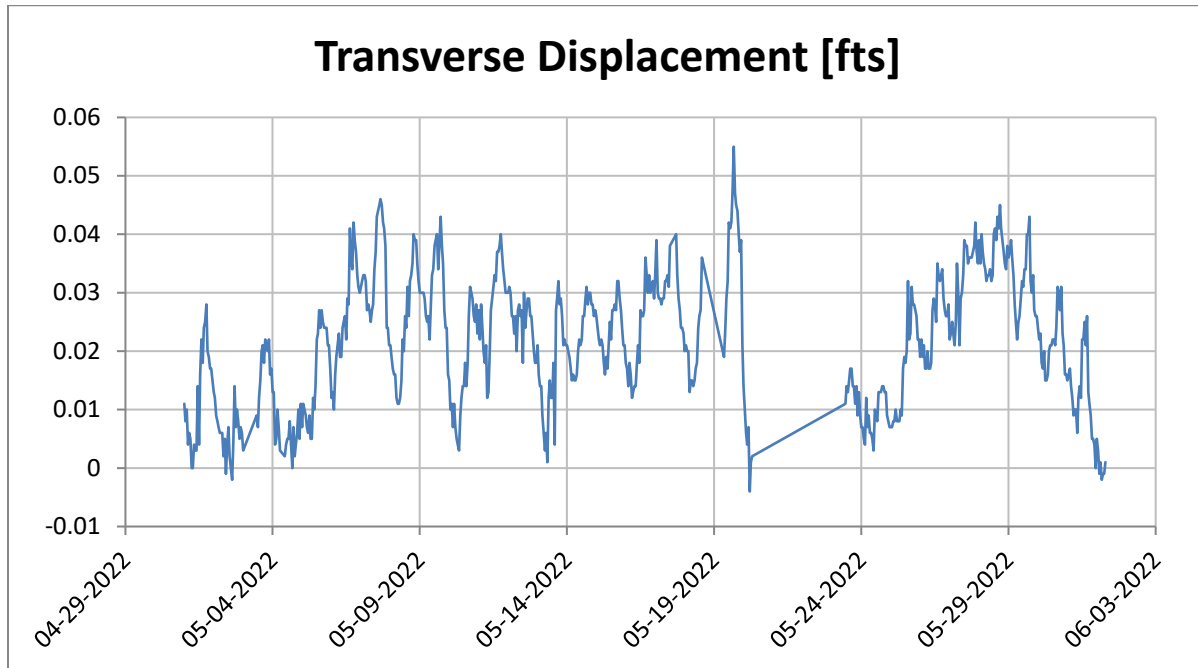
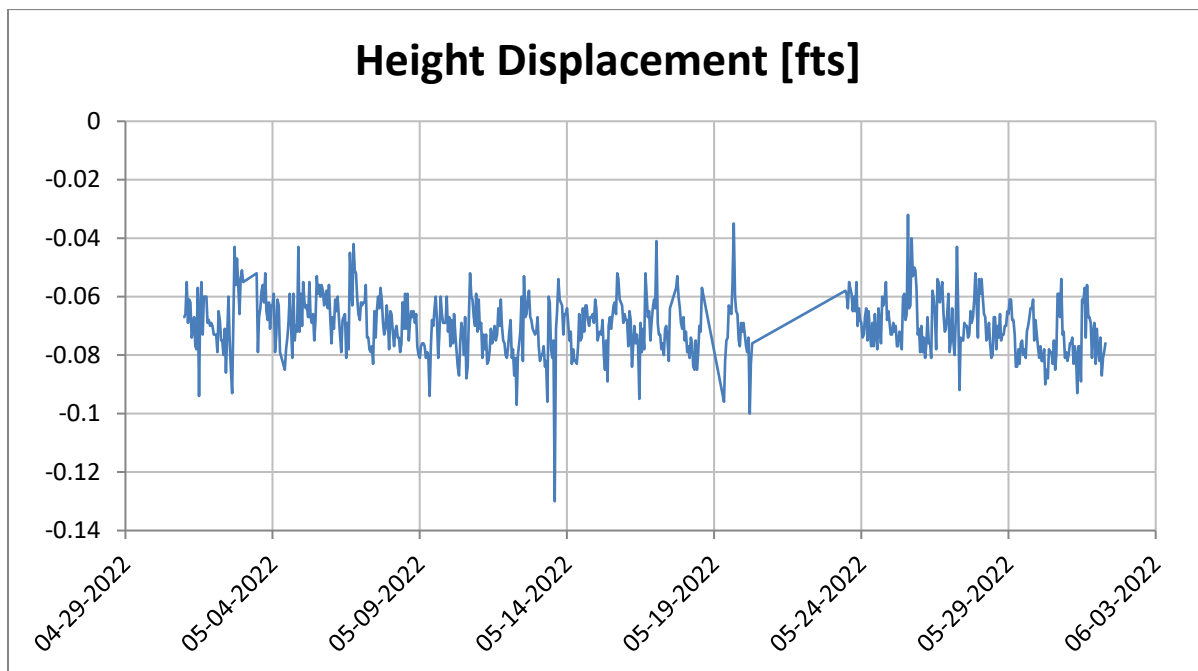
Prism P69

1. Survey accuracy is ± 0.016 feet.
2. Alarm threshold is ± 0.35 feet.
3. Transverse displacement is in the horizontal direction. Positive direction means closer to the robotic station.
4. Height displacement is in the vertical direction. Positive direction means higher in elevation.
5. Prism records slope creep movements with slow velocity.

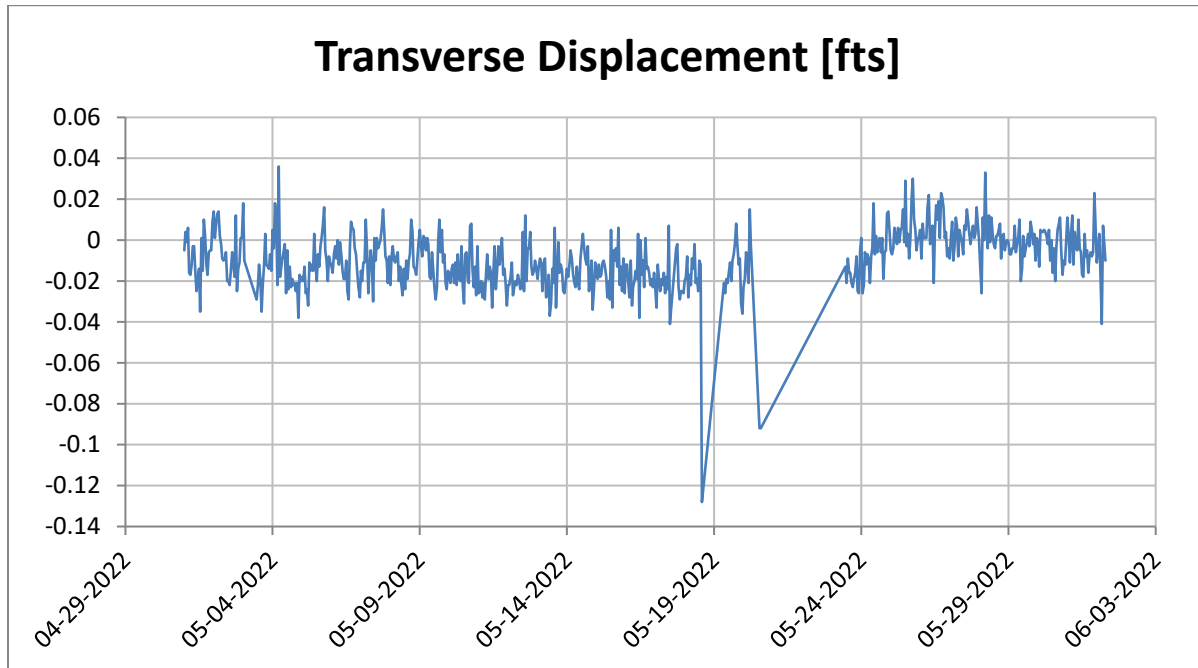
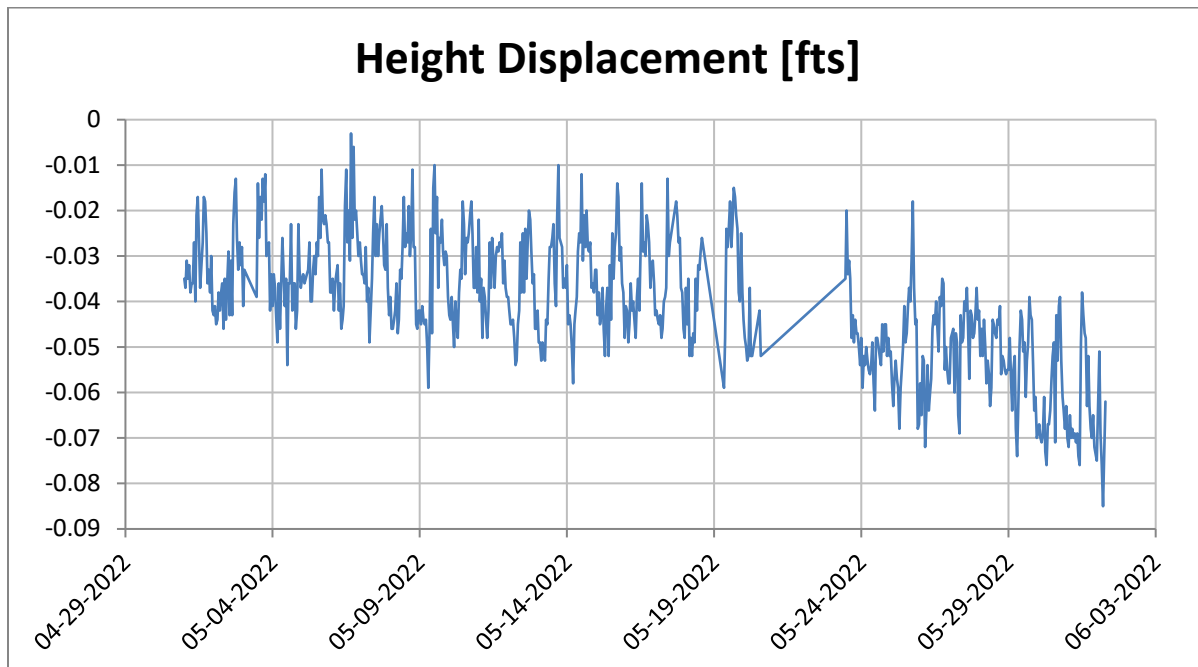
Prism TS1

1. Survey accuracy is ± 0.016 feet.
2. Alarm threshold is ± 0.35 feet.
3. Transverse displacement is in the horizontal direction. Positive direction means closer to the robotic station.
4. Height displacement is in the vertical direction. Positive direction means higher in elevation.
5. Prism records slope creep movements with slow velocity.

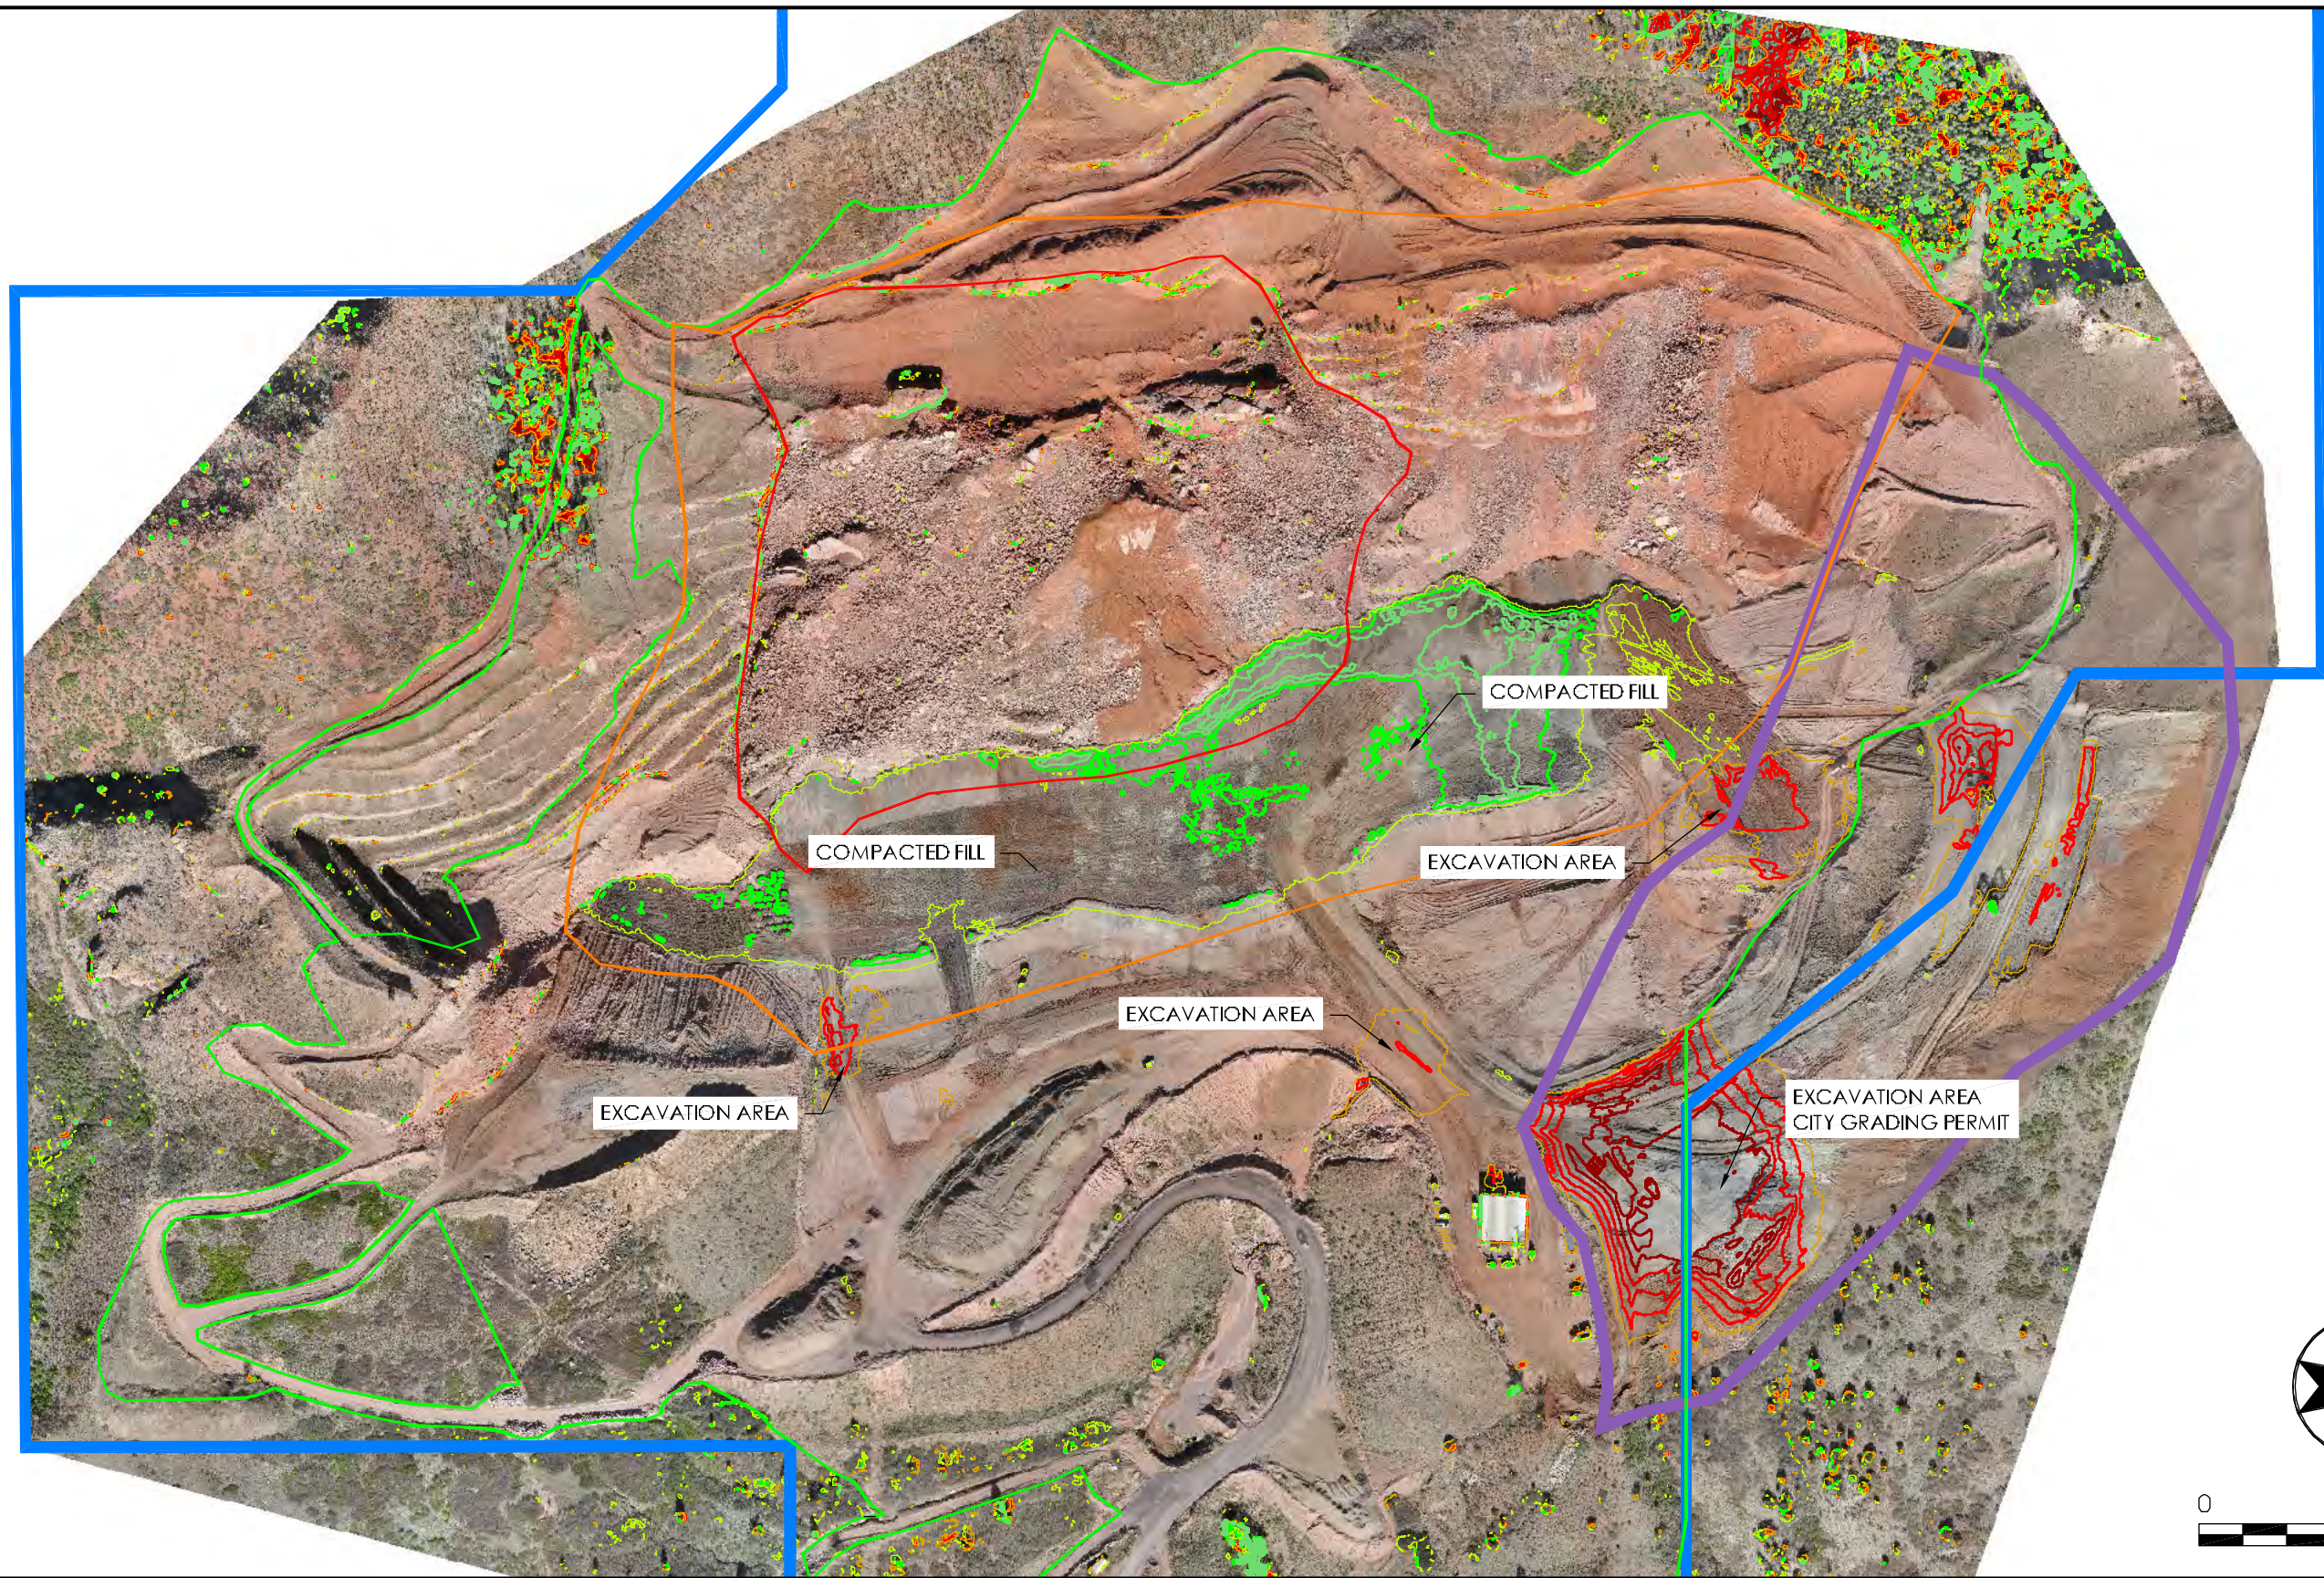
1. COMPARISON OF DRONE FLIGHTS FROM 04/28/2022 and 05/31/2022.
