MINERALS PROGRAM INSPECTION REPORT

MINE NAME: San Luis Project	MINE/PROSPECTING ID#: M-1988-112	MINERAL: Gold and silver	COUNTY: Costilla
INSPECTION TYPE: Monitoring	INSPECTOR(S): Lucas West	INSP. DATE: June 14, 2022	INSP. TIME: 09:50
OPERATOR: Battle Mountain Resources, Inc.	OPERATOR REPRESENTATIVE: Julio Madrid, Karen DeAgüero	TYPE OF OPERATION: 112d-3 - Designated Mining Operation	
REASON FOR INSPECTION: Normal I&E Program	BOND CALCULATION TYPE: None	BOND AMOUNT: \$7,400,000.00	
DATE OF COMPLAINT: NA	POST INSP. CONTACTS: None	JOINT INSP. AGENCY: None	
WEATHER: Clear	INSPECTOR'S SIGNATURE:

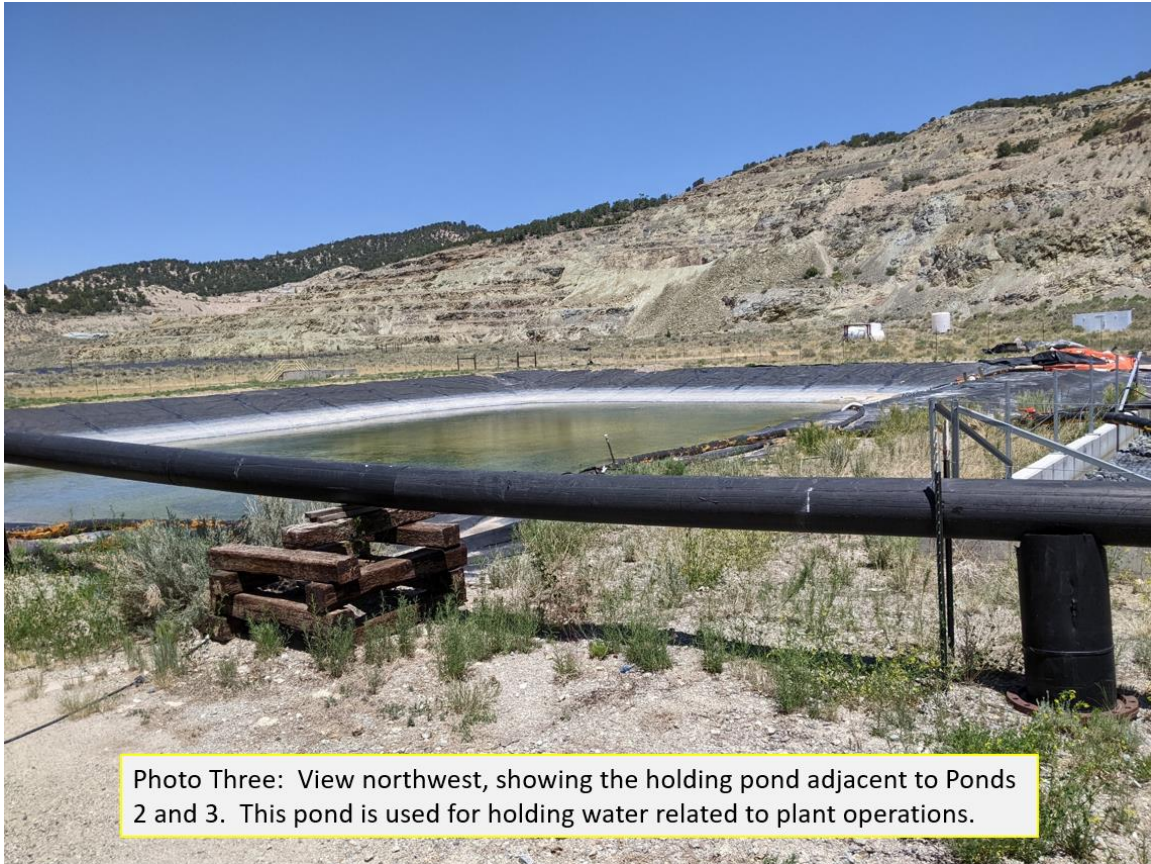
The main purpose of this inspection was to conduct a complete inspection of the site with Division Staff as well as the Operator and their representatives. The site was not active but the water treatment facility was operating during this inspection. The water treatment facilities utilizes a series of holding ponds, tanks, media filters and a reverse osmosis (RO) system to treat ground water prior to discharge. The interior of the plant can be seen in Photo One, the plant is in excellent condition, neat and well-kept and operating during the inspection. At the time of the inspection the RO system was treating and discharging water at approximately 580gpm at their discharge point. The holding ponds are all fenced in facilities. Pond 1 consists of raw water pumped from a series of wells and feeds the treatment system. Ponds 2, 3 and 4 are used to store water at various stages of the treatment procedure. The areas around the water treatment facility include access roads, equipment storage areas and parking areas are all in good condition. Recently, Pond 3 had been converted from an HDPE lined facility, to a concrete contained holding pond to make for easier maintenance and life of the pond. On site discussions indicate that Pond 2 is scheduled for similar upgrades in the coming weeks. To document the change, a Technical Revision was discussed in which the Operator should provide construction details and drawings of the ponds as well as an engineer certified as-built. The Division will continue to coordinate with the Operator on the details of the revision. The two ponds can be seen in Photos Two and Three.

Photo Two: View north, showing Ponds 2 and 3. Pond 3 has already been converted to a concrete structure for ease of operations and Pond 2 is scheduled for the same improvements later in the season.
