**MINERALS PROGRAM INSPECTION REPORT**  
**PHONE: (303) 866-3567**

<b>MINE NAME:</b> Ross Pit	<b>MINE/PROSPECTING ID#:</b> M-1990-134	<b>MINERAL:</b> Gravel	<b>COUNTY:</b> Moffat
<b>INSPECTION TYPE:</b> Monitoring	<b>INSPECTOR(S):</b> Zach Trujillo	<b>INSP. DATE:</b> July 27, 2022	<b>INSP. TIME:</b> 08:30
<b>OPERATOR:</b> James H & Kathleen H Ross	<b>OPERATOR REPRESENTATIVE:</b> Bud Bower	<b>TYPE OF OPERATION:</b> 110c - Construction Limited Impact	
<b>REASON FOR INSPECTION:</b> Normal I&E Program	<b>BOND CALCULATION TYPE:</b> None	<b>BOND AMOUNT:</b> \$20,545.00	
<b>DATE OF COMPLAINT:</b> NA	<b>POST INSP. CONTACTS:</b> None	<b>JOINT INSP. AGENCY:</b> None	
<b>WEATHER:</b> Clear	<b>INSPECTOR'S SIGNATURE:</b>

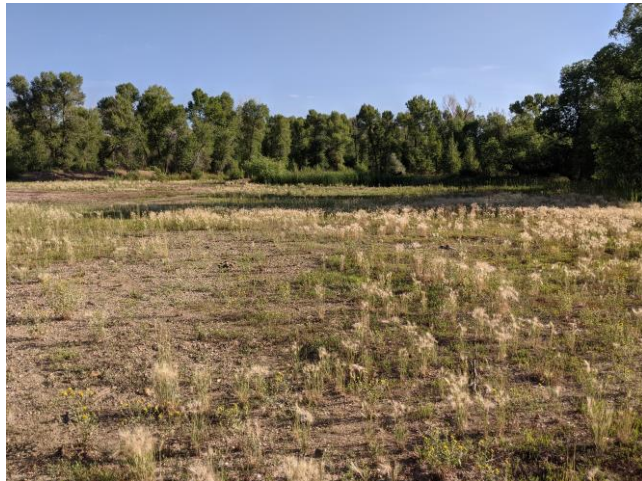
Area 2.

During the inspection two patches of thistles were observed, both within 'Area 2'. The first patch was small and sparse located near the downed tree along the access road. The second patch was larger and more concentrated and was long the northern perimeter of the permit boundary. The operator stated that a crew would chop and treat the two patches of thistle.
