MINERALS PROGRAM INSPECTION REPORT
PHONE: (303) 866-3567

MINE NAME: Cresson Project	MINE/PROSPECTING ID#: M-1980-244	MINERAL: Gold	COUNTY: Teller
INSPECTION TYPE: Monitoring	INSPECTOR(S): Amy Eschberger	INSP. DATE: July 26, 2022	INSP. TIME: 09:30
OPERATOR: Cripple Creek & Victor Gold Mining Company	OPERATOR REPRESENTATIVE: Johnna Gonzalez, Brian Doering	TYPE OF OPERATION: 112d-3 - Designated Mining Operation

This was a normal monthly monitoring inspection of the Cresson Project (Permit No. M-1980-244) conducted by Amy Eschberger of the Division of Reclamation, Mining and Safety (Division). The operator was represented by Johnna Gonzalez and Brian Doering during the inspection. This is a 112d-3 Designated Mining Operation (DMO) permitted for 6,007 acres to mine and process gold ore. The site is located between the towns of Cripple Creek and Victor in Teller County. The approved post-mining land use is a combination of rangeland and wildlife habitat. **Photos 1-83** taken during the inspection are included with this report.

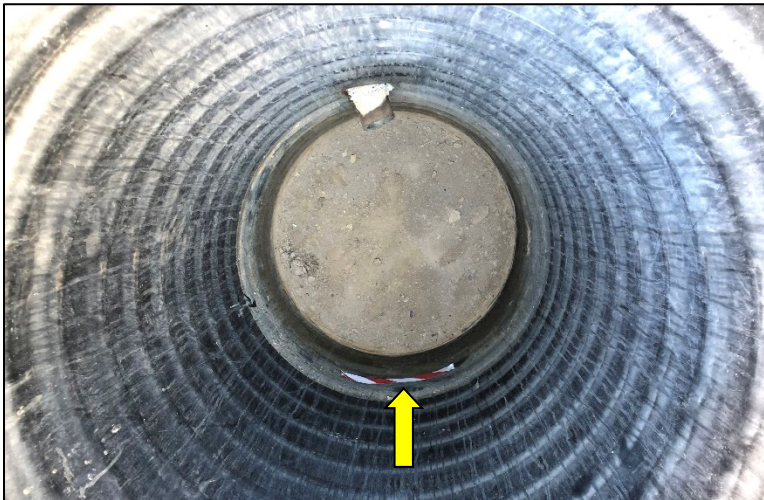
Photo 2. View looking inside VLF-1 LDS-9, showing sump dry. Note visual indicator (red and white tape; indicated) placed 1 foot above bottom of sump.

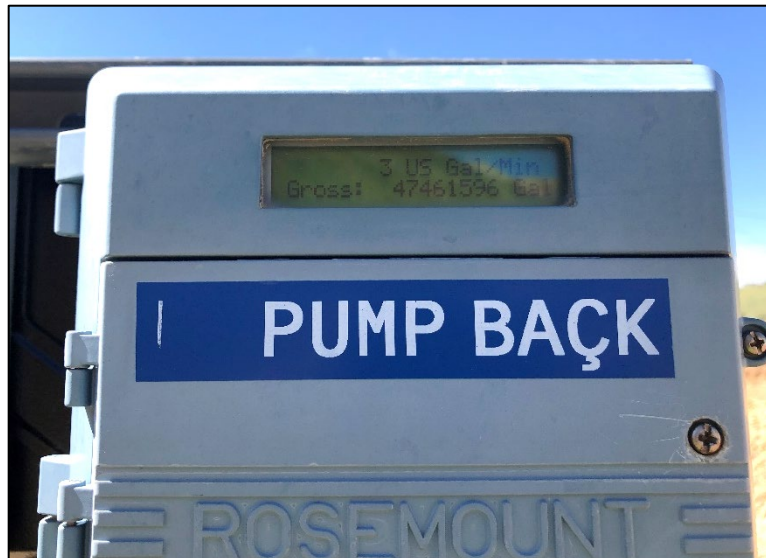
Photo 8. View of display for VLF-1 Arequa pumpback system, showing a pump rate of 3 gallons per minute.

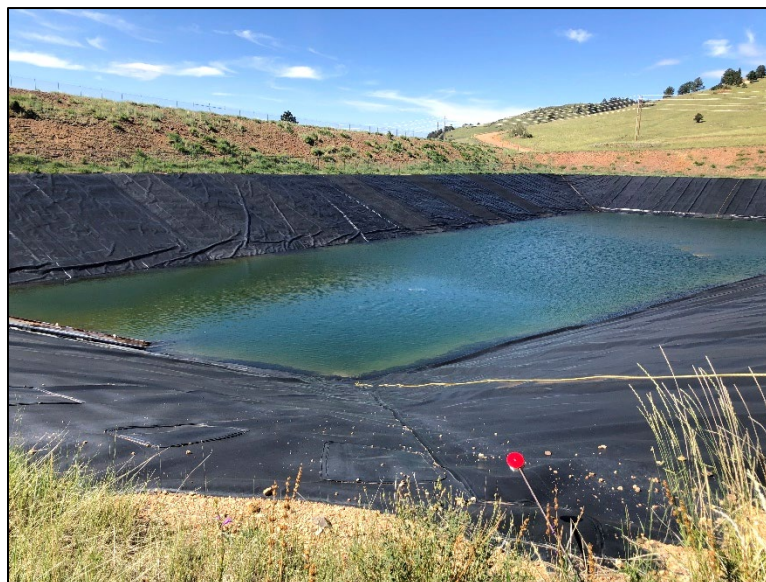
Photo 9. View looking southwest across VLF-1 External Storage Pond (ESP) LVSCS. Pond level was reported at 14.3% of capacity during inspection.

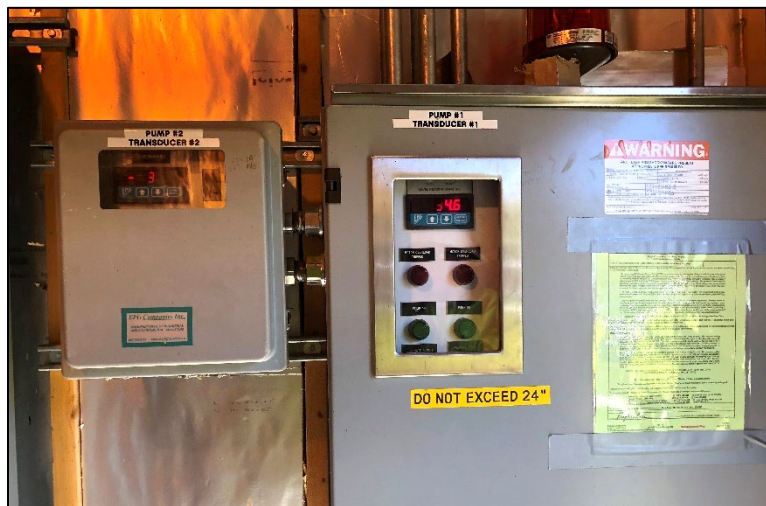
Photo 11. View of displays inside shed at VLF-1 ESP LVSCS, which were not functional at the time of the inspection.

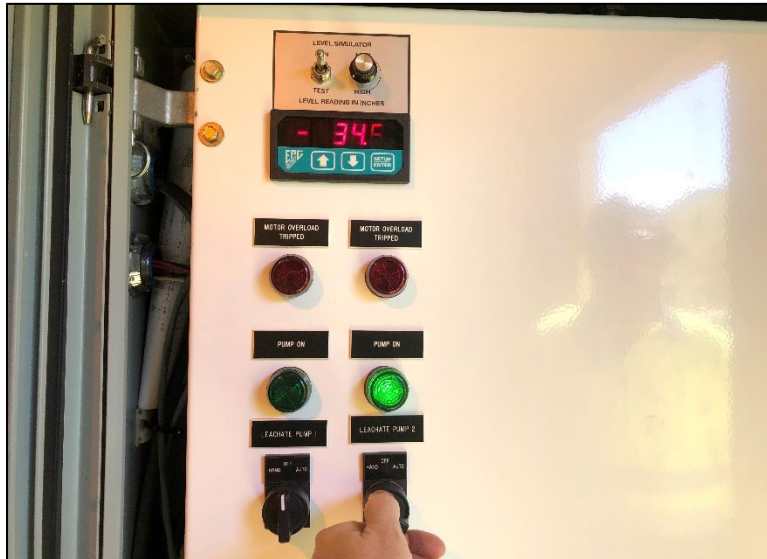
Photo 13. View of displays inside shed at VLF-1 ESP LVSCS, showing pump #2 operable per manual test (despite issue with displays).

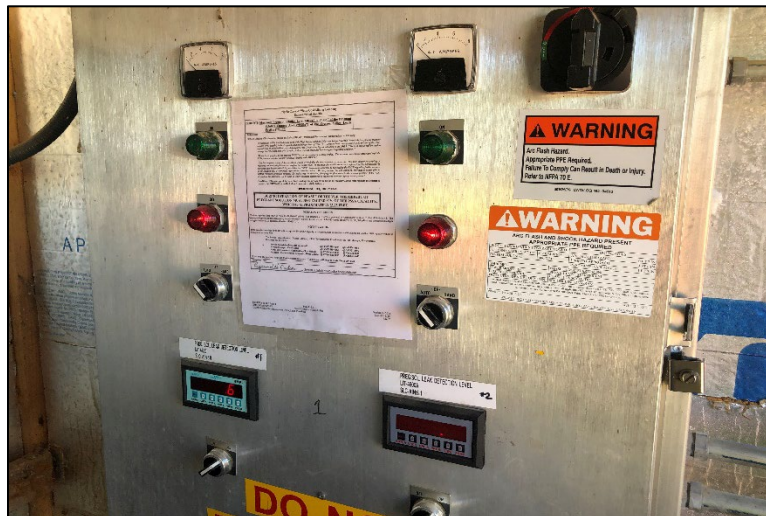
Photo 15. View of displays inside VLF-1 Phase 1 LVSCS shed, which were not functional at the time of the inspection.

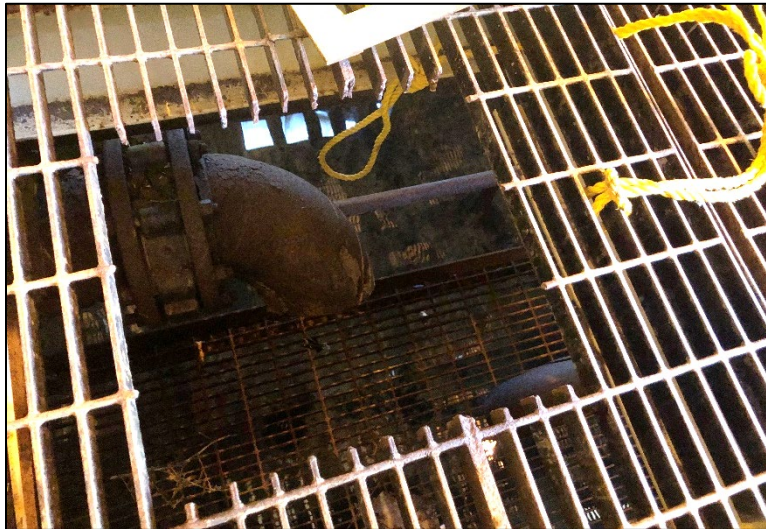
Photo 20. View inside VLF-1 underdrain shed, showing no flows from underdrain pipe #1 during inspection.

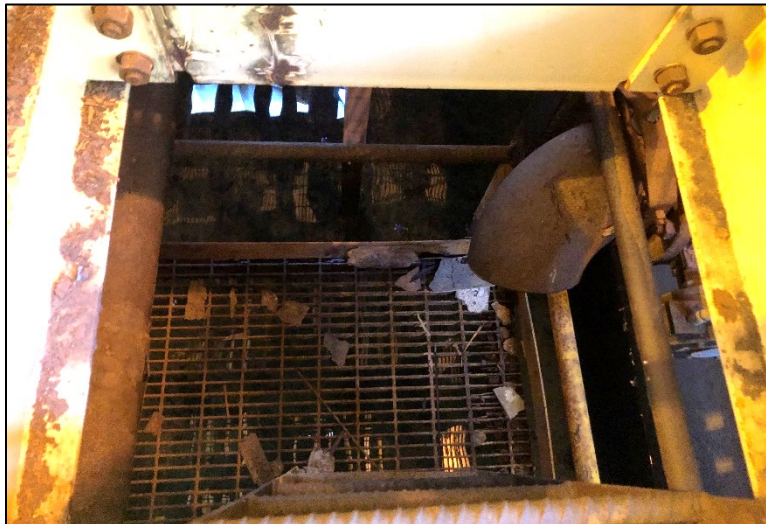
Photo 21. View inside VLF-1 underdrain shed, showing no flows from underdrain pipe #2 during inspection.

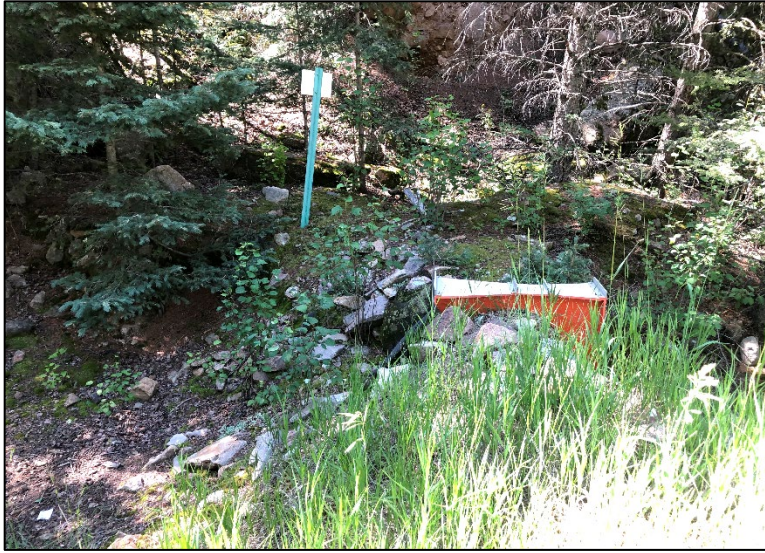
Photo 25. View looking south at discharge monitoring station AG 1.5 (weir in drainage), located approx. 650 feet downgradient from VLF-1 underdrain shed. No flows were observed during the inspection.

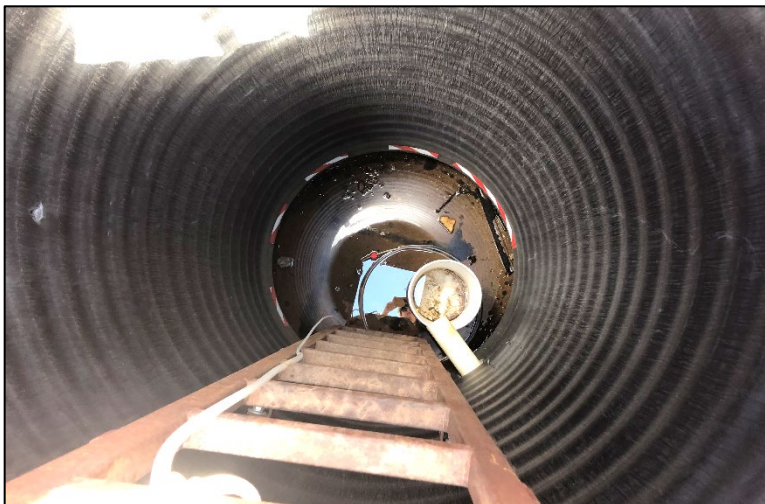
Additionally, the Division noticed that four of the sumps (for VLF-1), including LDS-3, LDS-5, LDS-10, and LDS-11, still had a bucket hanging from the inlet pipe. This practice was utilized prior to TR-127 approval, as a means for determining if the water observed in the sump came from the inlet or from meteoric infiltration. However, in TR-127, the operator committed to placing a visual indicator one foot above the bottom of each sump, and to collecting samples from the water if it is observed to be at or above the marker during the weekly inspection. Keeping the buckets in the sumps interferes with the monitoring and sampling plan approved in TR-127.

Photo 27. View looking inside VLF-1 LDS-3, showing < 1 inch of water present in sump. Note visual indicator (red/white tape) placed 1 foot above bottom of sump. Bucket hanging from inlet needs to be removed.

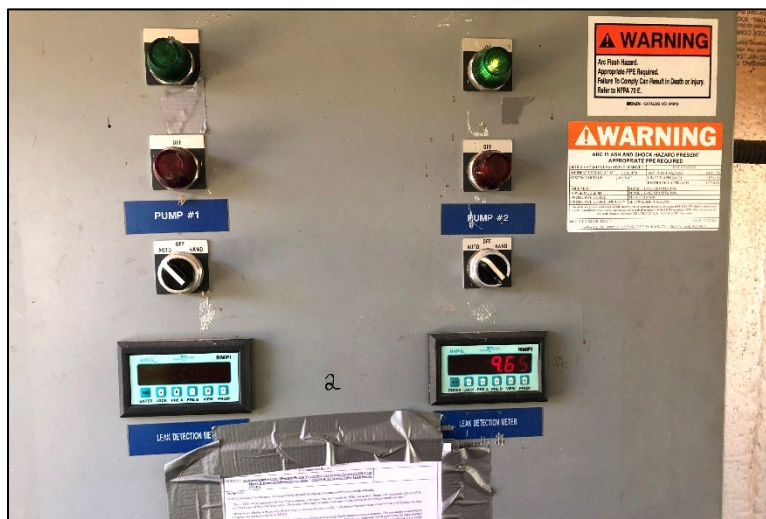
Photo 30. View of displays inside VLF-1 Phase 2 LVSCS shed, which were not functional at the time of the inspection. However, pump #2 was running (indicated by green light).

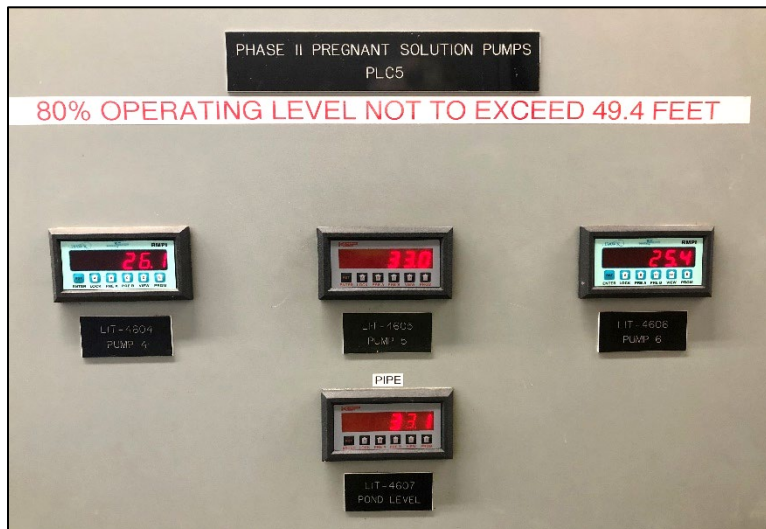
Photo 32. View of displays inside VLF-1 Phase 2 HVSCS shed, showing readouts for pumps #4, 5, and 6, all below the 80% operating level (49.4 feet).

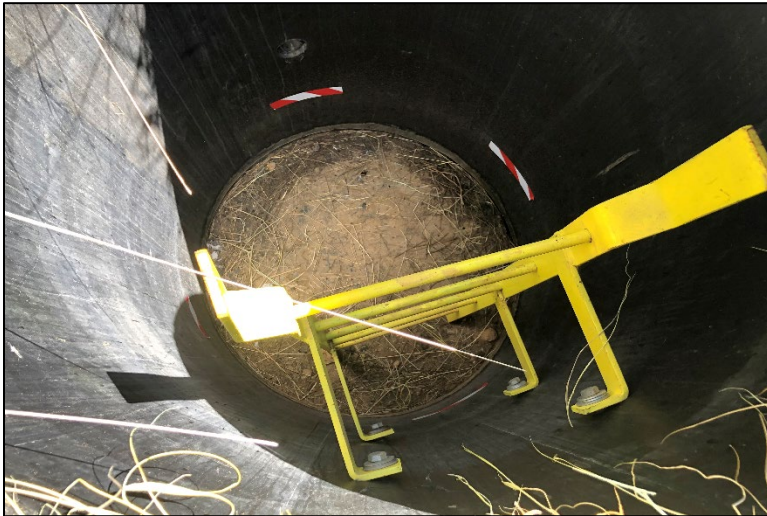
Photo 38. View looking inside VLF-1 LDS-8, showing sump dry. Note visual indicator (red/white tape) marking 1 foot above bottom of sump.

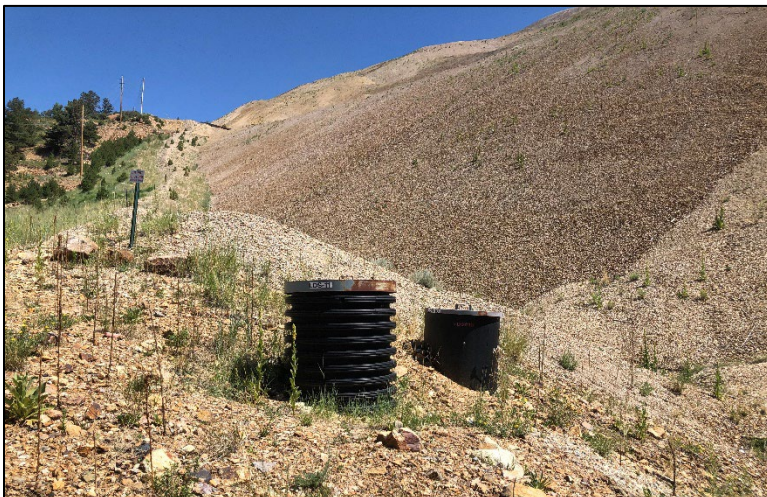
Photo 39. View looking north at VLF-1 LDS-10 (background) and LDS-11 (foreground).

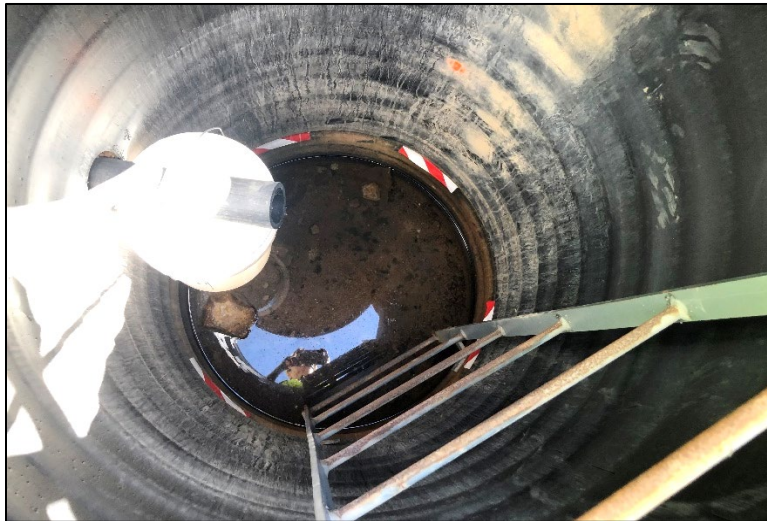
Photo 41. View looking inside VLF-1 LDS-11, showing <1 inch of water present in sump. Note visual indicator (red/white tape) marking 1 foot from bottom of sump. Bucket hanging from sump inlet needs to be removed.

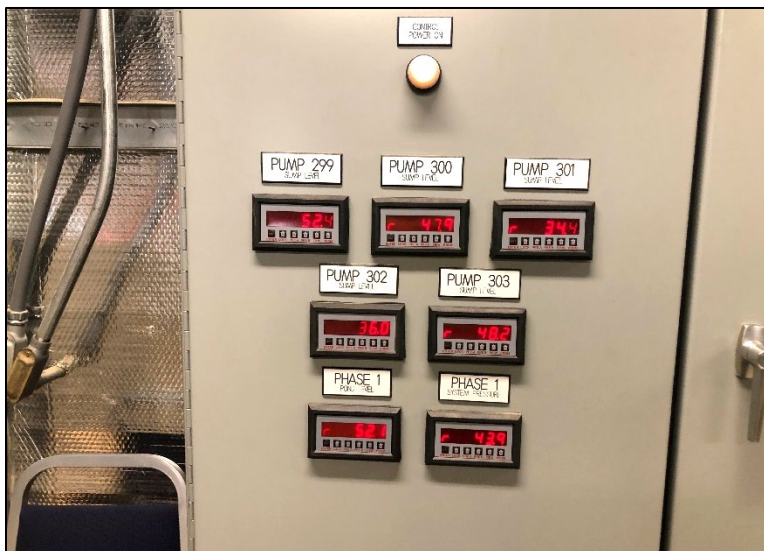
Photo 45. View of displays inside VLF-1 Phase 1 HVSCS shed, showing readouts for pumps #299-303, all below the 80% operating level (63.75 feet).

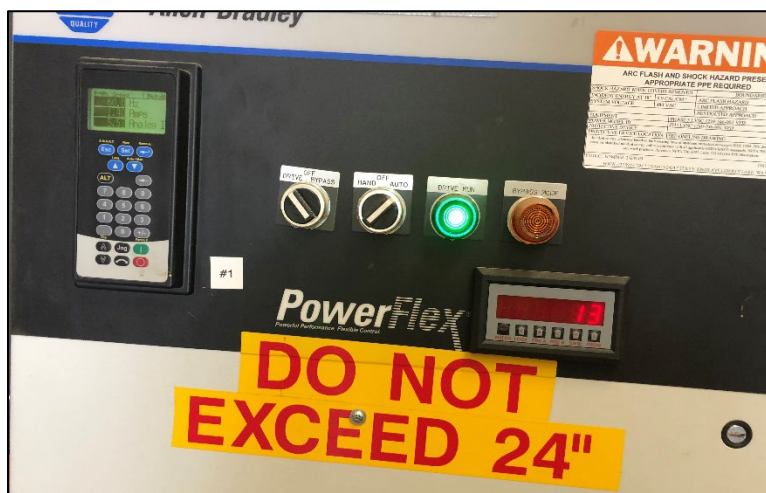
Photo 48. View of display inside VLF-1 Phase 5 LVSCS shed, showing readout for pump #1 below cap of 24 inches.

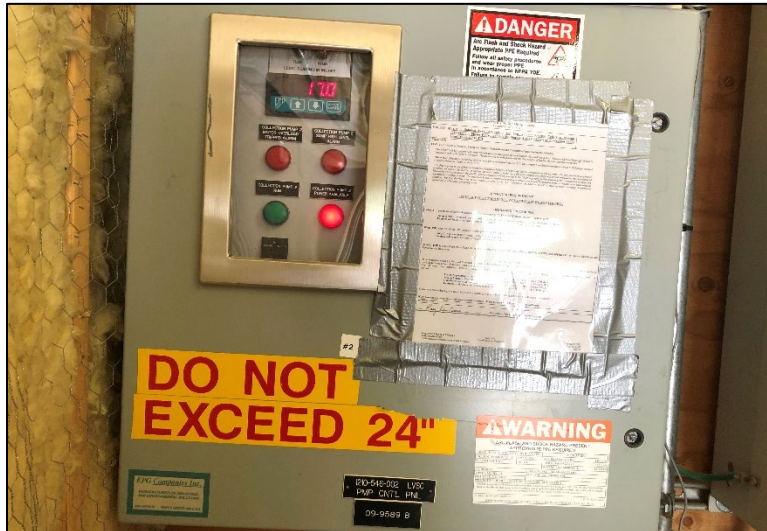
Photo 49. View of display inside VLF-1 Phase 5 LVSCS shed, showing readout for pump #2 below cap of 24 inches.

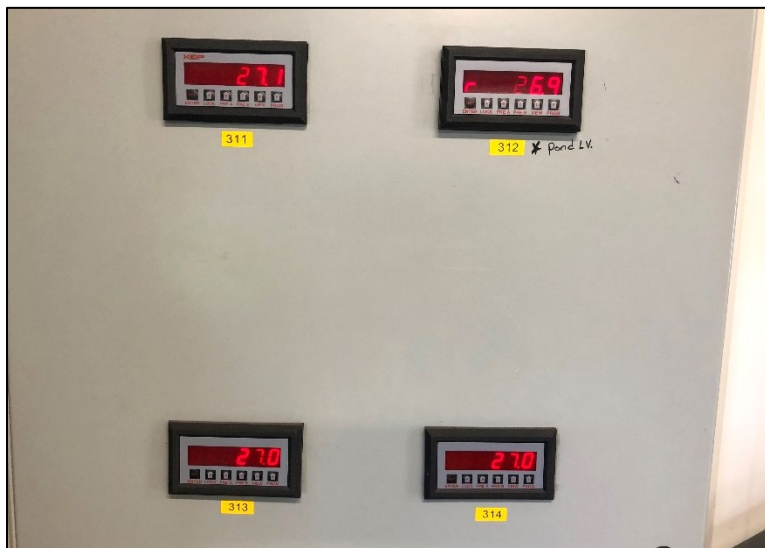
Photo 51. View of displays inside VLF-1 Phase 5 HVSCS shed, showing readouts for pumps #311-314, all below the 80% operating level (36.5 feet).

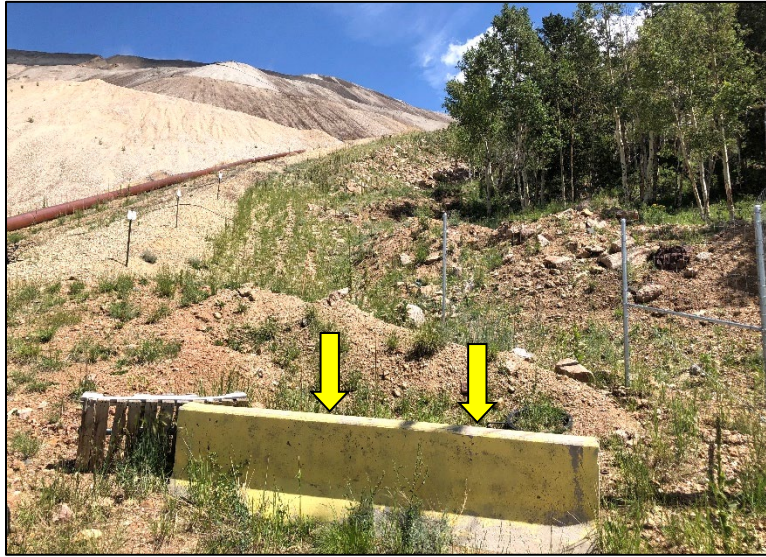
Photo 52. View looking north at area where VLF-1 LDS-14 and LDS-15 are located (behind concrete barrier; indicated).

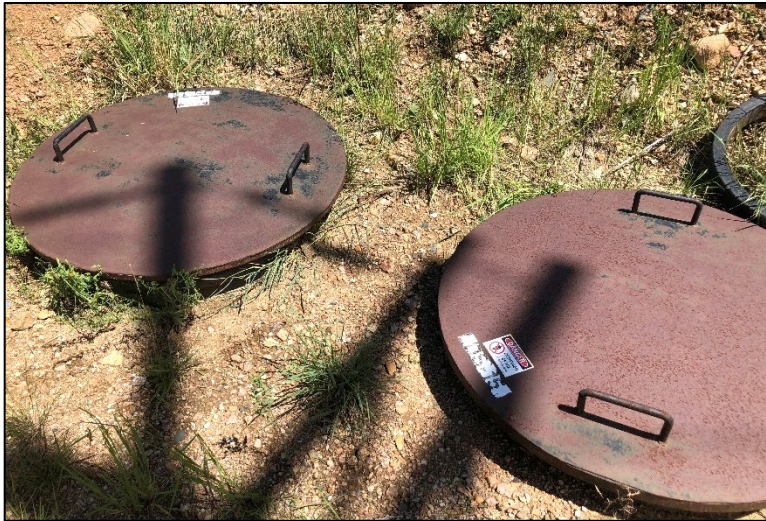
Photo 53. Close up view of VLF-1 LDS-14 (at left) and LDS-15 (at right).

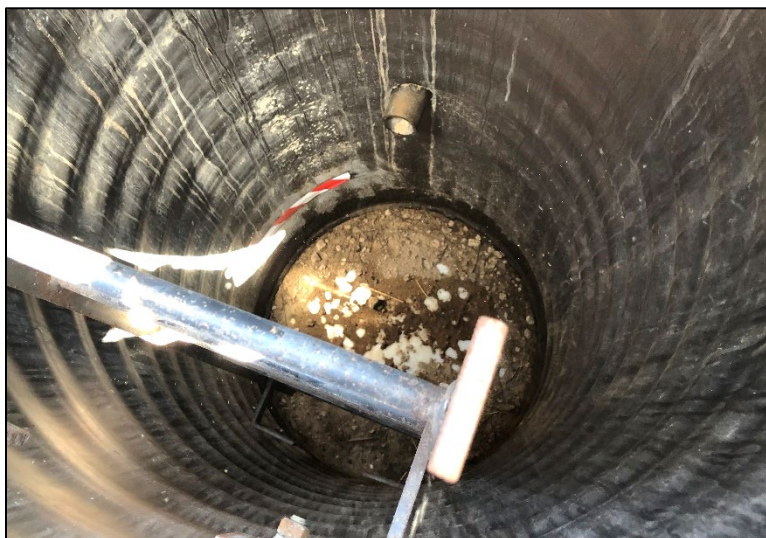
Photo 54. View looking inside VLF-1 LDS-14, showing sump dry. Note visual indicator (red/white tape) marking 1 foot from bottom of sump.

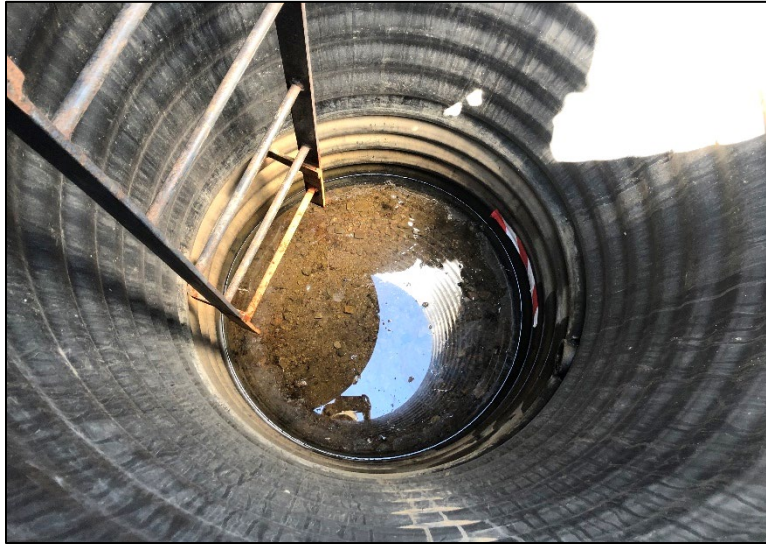
Photo 55. View looking inside VLF-1 LDS-15, showing approx. 6 inches of water in sump. Note visual indicator (red/white tape) marking 1 foot from bottom of sump.

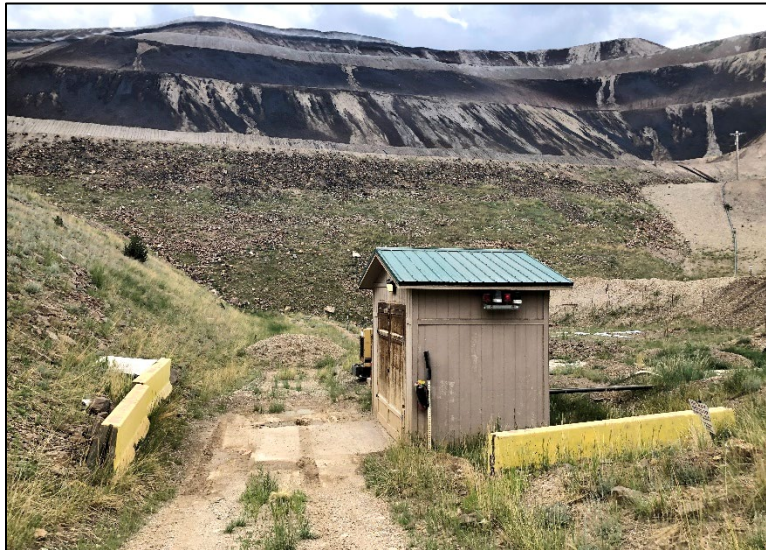
Photo 56. View looking south at VLF-1 Phase 4 LVSCS shed.

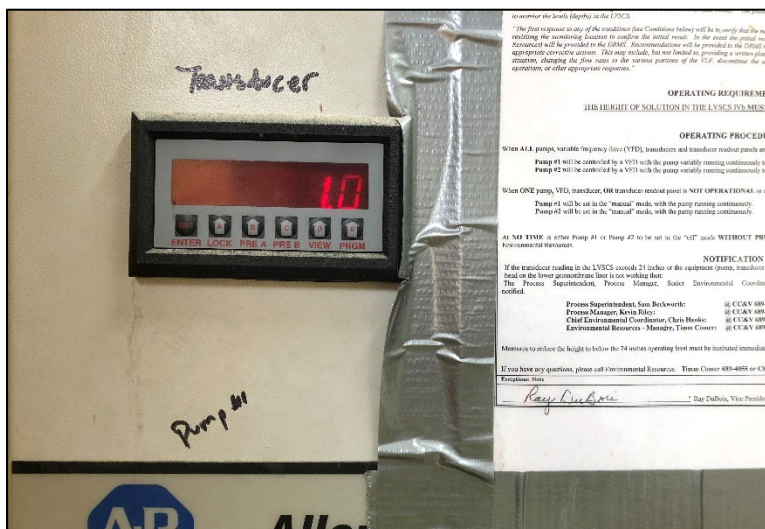
Per TR-127, if the transducer monitoring data in the LVSCS or the Leak Detection, Collection, and Recovery System for the External Storage Pond (LDCRS) exceed 24 inches in a sustained manner for 72 hours, the operator must report this exceedance to the Division after confirmation of the initial monitoring results.

Photo 57. View of display inside VLF-1 Phase 4 LVSCS shed, showing readout for pump #1 (11.0 inches; not fully visible in photo) below cap of 24 inches.

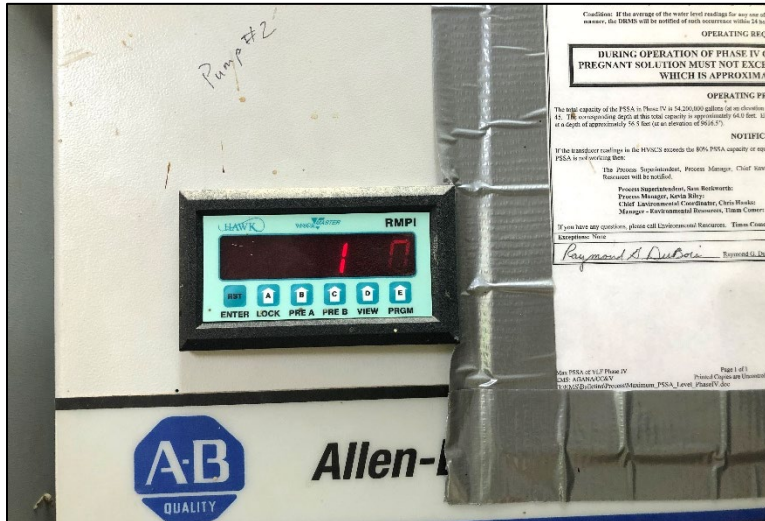
Photo 58. View of display inside VLF-1 Phase 4 LVSCS shed, showing readout for pump #2 (12.0 inches; not fully visible in photo) below cap of 24 inches.

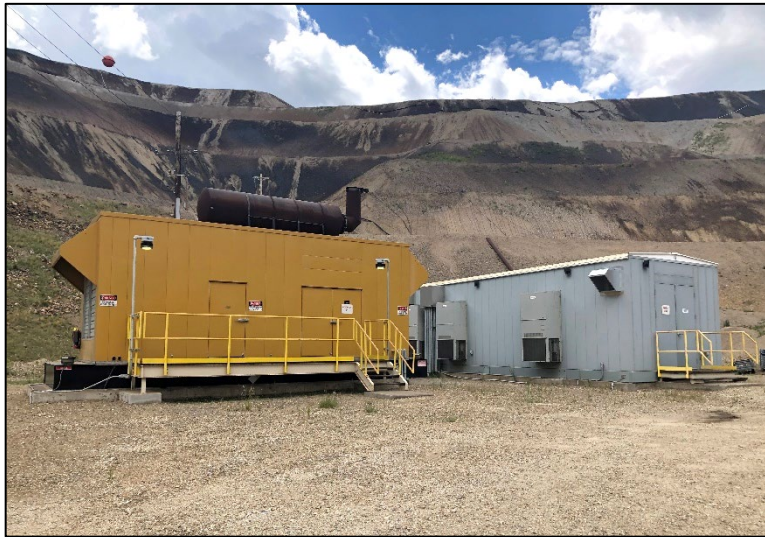
Photo 59. View looking south at VLF-1 Phase 4 HVSCS shed (at right).

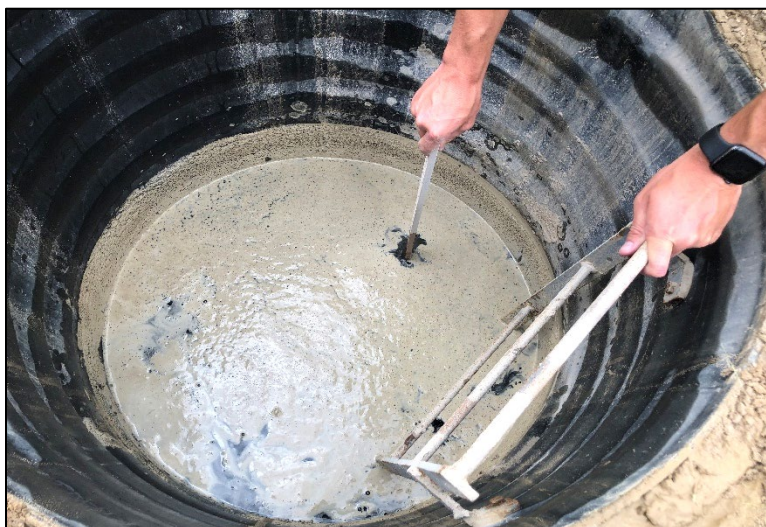
- The Sample Comment section includes “mud” and “buried” as explanations for why a sample was not taken during 9 monitoring events for LDS-12 and during 10 monitoring events for LDS-13 (from July to November 2021). As stated above, this is not an acceptable reason for not inspecting and/or sampling the LDSs. If one foot or more of muddy water is present inside the sump, per TR-127 this substance must be sampled and tested for CN_{WAD} and pH. Otherwise, the operator has no way of knowing whether at least some of the liquid present in the sump is from a leak in the VLF. The fact that these sumps are regularly infiltrated by meteoric water and sediment indicates the sumps need to be modified, which is cited as a problem in the report (described in more detail above).

Photo 66. View looking inside VLF-1 LDS-13, showing stick placed inside muddy water to measure approximate depth.

Besides the problems identified above, no other issues were observed at the LDSs and underdrains inspected. However, the Division recommends the operator work to keep the area around each LDS free from vegetation, rocks, sediment, and any other material that might interfere with the operator’s ability to properly seal the lid on the sump. Additionally, no objects (e.g., ropes, hoses) should be draped over the top of the LDS (beneath the lid), which keeps the lid from properly sealing. It should be noted, LDS-12 and LDS-13 are not the only LDSs that are installed somewhat flush with the surrounding ground surface. However, (based on the 2021 LDS summary report) these two sumps are the only ones not being sampled due to being buried or filled with mud. The Division recommends the operator work to modify any other sumps that are regularly infiltrated with meteoric water, whether it means replacing the lid and/or lifting the top of the sump higher above the ground surface.

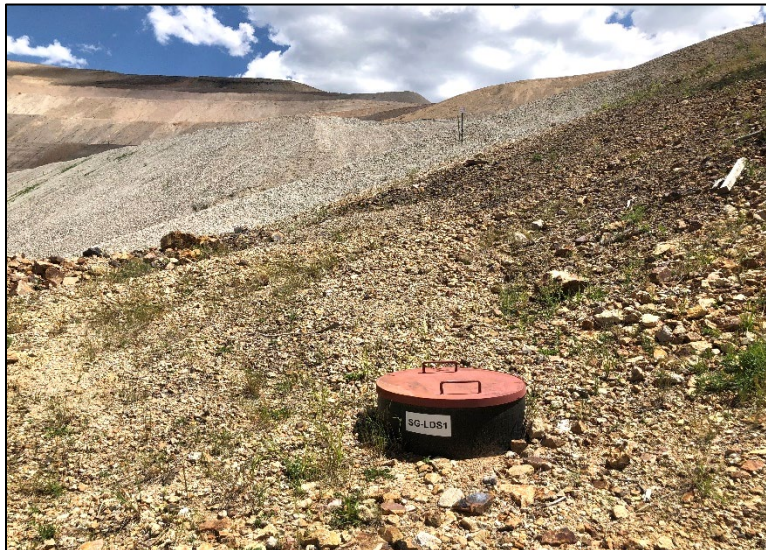
Photo 68. View looking northeast at VLF-2 LDS-1.

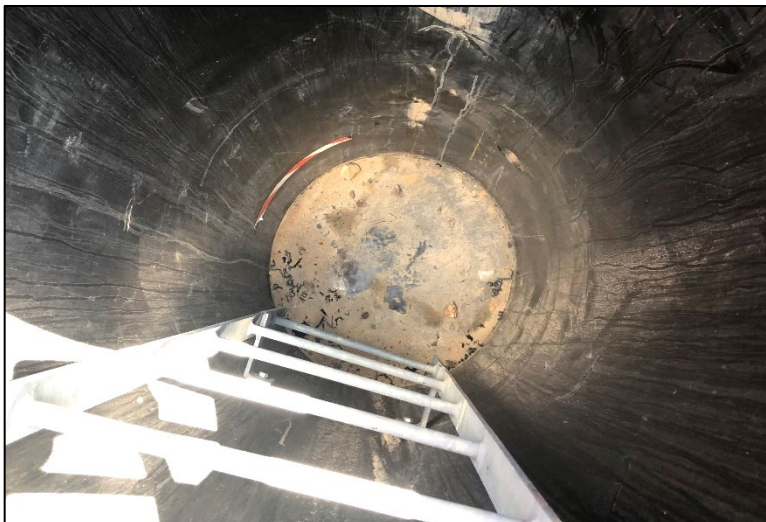
All three of the LDSs inspected for VLF-2 were dry, and no issues were observed with these sumps.

Photo 69. View looking inside VLF-2 LDS-1, showing sump dry. Note visual indicator (red/white tape) marking 1 foot from bottom of sump.

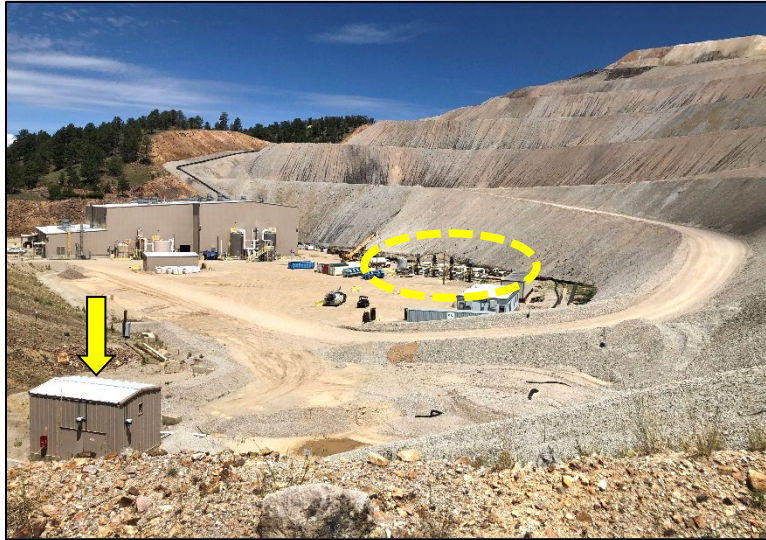
Photo 70. View looking northwest across ADR-2 facility at VLF-2, showing LVSCS shed (indicated with arrow) and HVSCS pumps (indicated with circle).

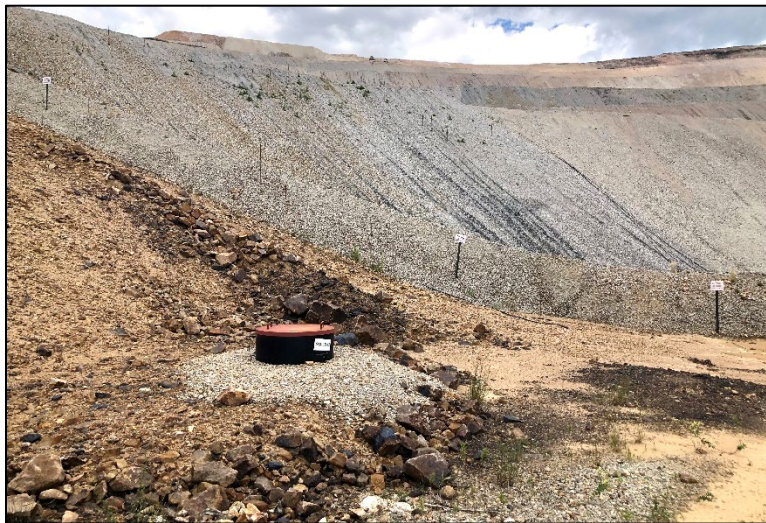
Photo 71. View looking northeast at VLF-2 LDS-2.

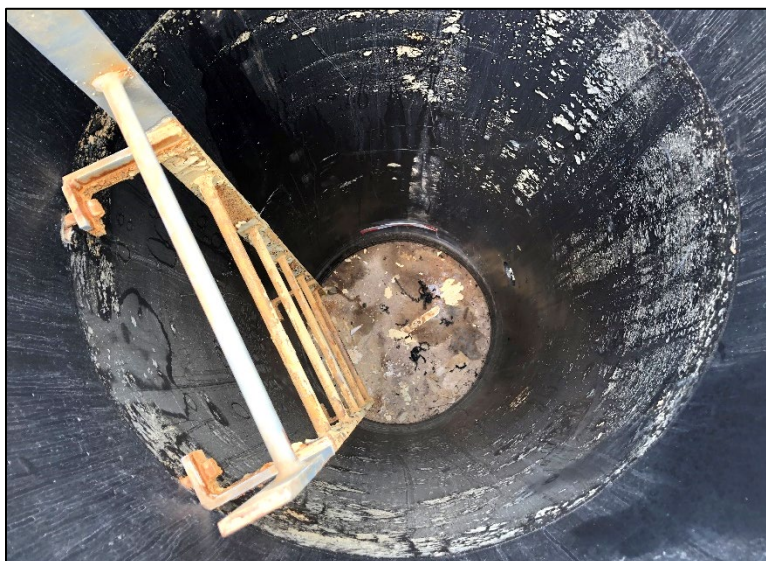
Photo 72. View looking inside VLF-2 LDS-2, showing sump dry. Note visual indicator (red/white tape) marking 1 foot above bottom of sump.

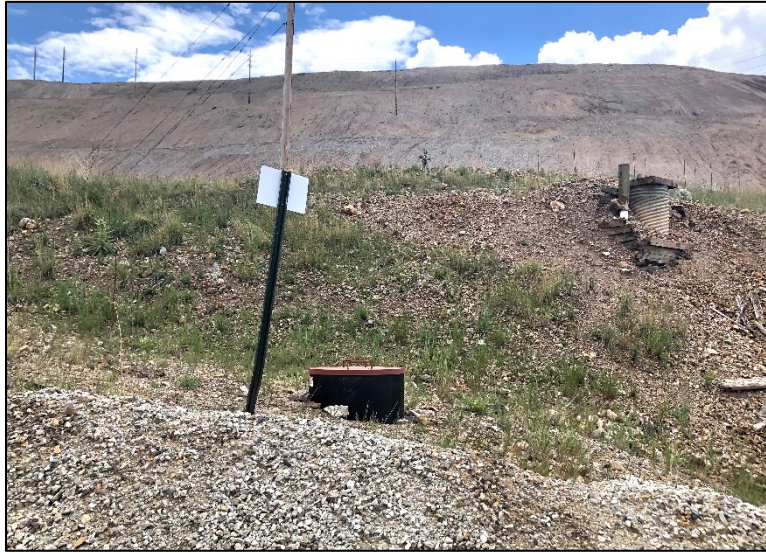
Photo 73. View looking south at VLF-2 LDS-3 (near center). Structure visible at far right is a historical feature.

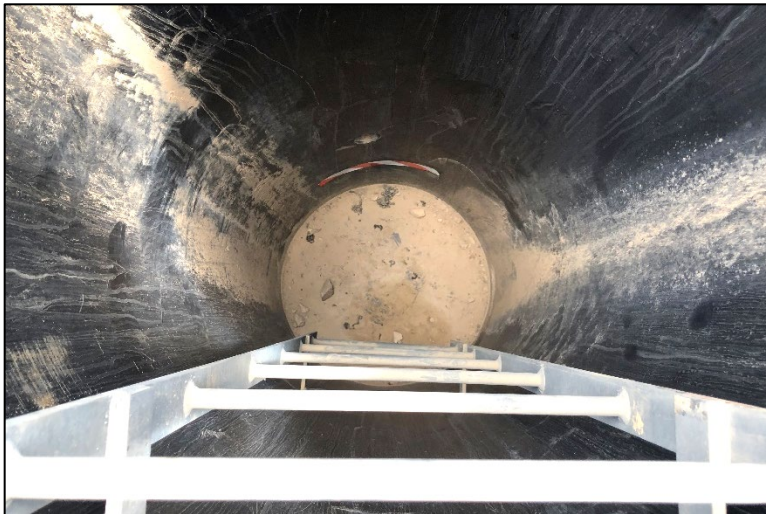
Photo 74. View looking inside VLF-2 LDS-3, showing sump dry. Note visual indicator (red/white tape) marking 1 foot above bottom of sump.

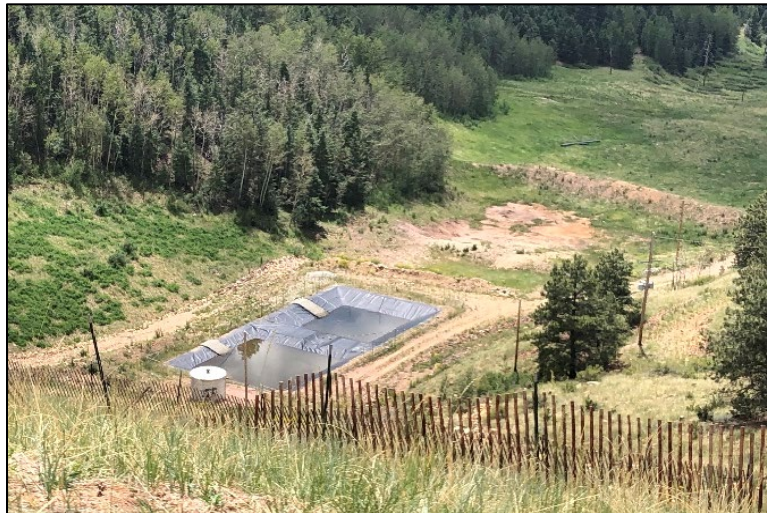
Photo 77. Closer view of VLF-2 underdrain, showing lined basins holding some meteoric water.

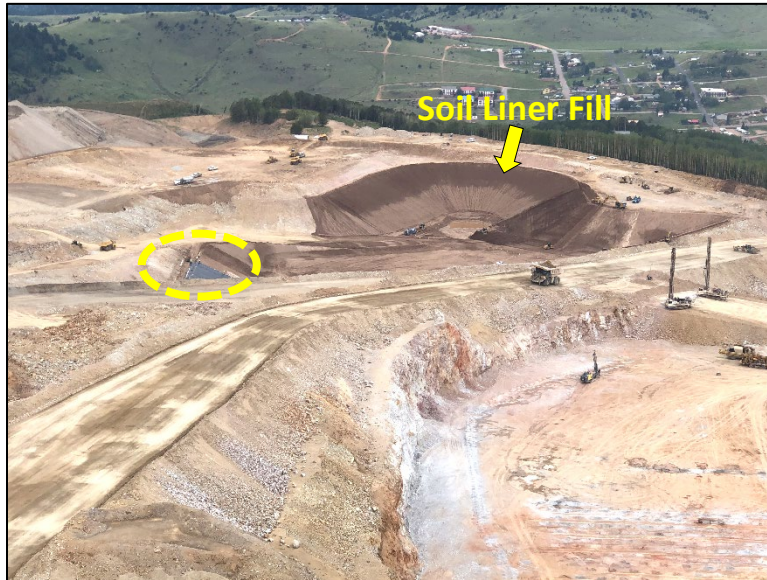
The Division observed the VLF-2 Phase 3 construction area from an overlook located to the east of this area. The operation was in the initial stages of placing the liner on top of the completed soil liner fill layer. The operator did not provide an anticipated date for completing the liner placement. However, once the project is completed, the operator will submit a Technical Revision with the record of construction/CQA report for VLF-2 Phase 3.

Photo 82. View looking west, showing closer view of VLF-2 Phase 3 (Schist Island backfill area). Note liner installation has begun in this area (circled).
