To: Jerald Schnabel  
Continental Materials Corp.  
File: July 2022 Monitoring Summary

From: Paul Kos  
Denver, CO 80222  
Date: August 26, 2022

**Reference: July 2022 Geotechnical Monitoring Summary Pikeview Quarry**

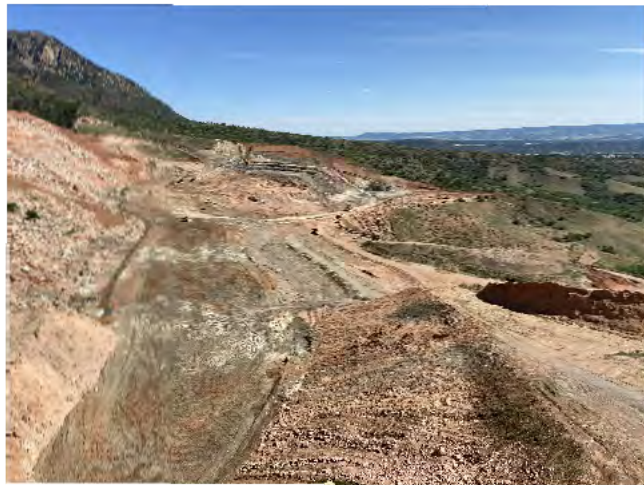
- A safety buffer zone is being kept between the active work areas and the toe of the slide to stop any rocks that might come loose during grading operations. Compacted fill is placed in the buffer zone as the buttress fill is placed. (Photo 6)

6. Compacted area in the pit looking north.

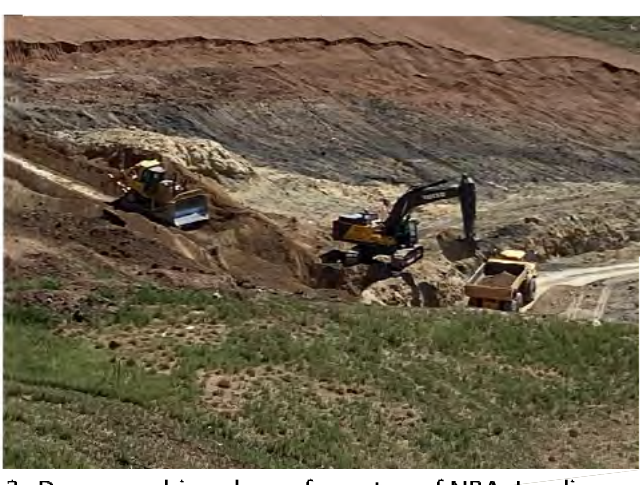
3. Dozer pushing down from top of NBA. Loading material and hauling to buttress area.

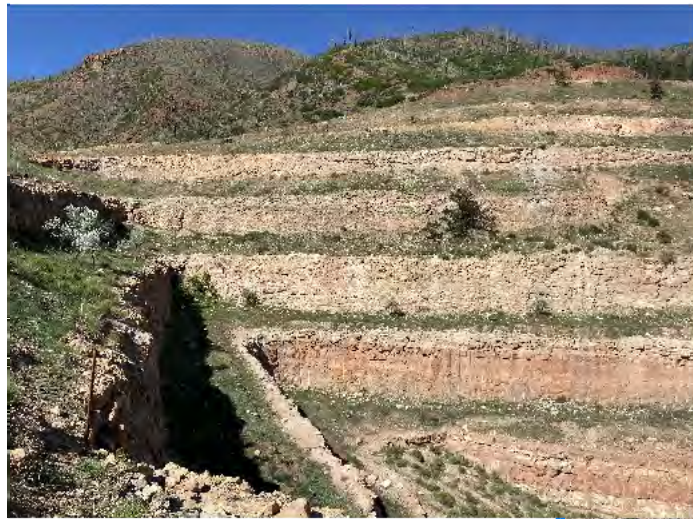
7. Reclamation benches on the south end of site.

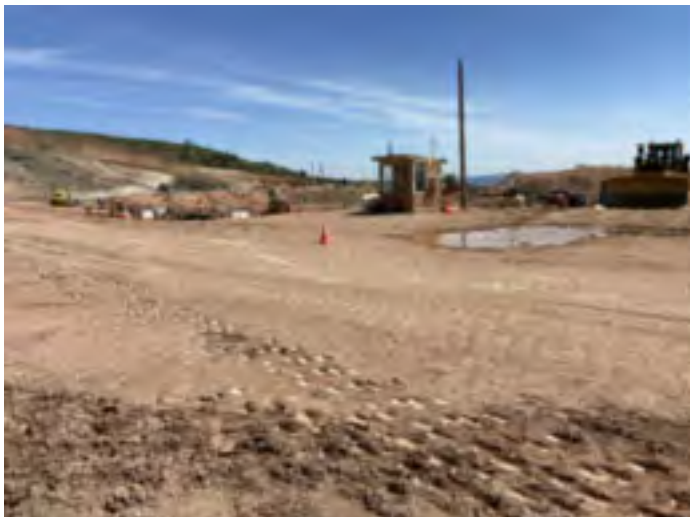
1. Shop was demolished and total station was relocated.

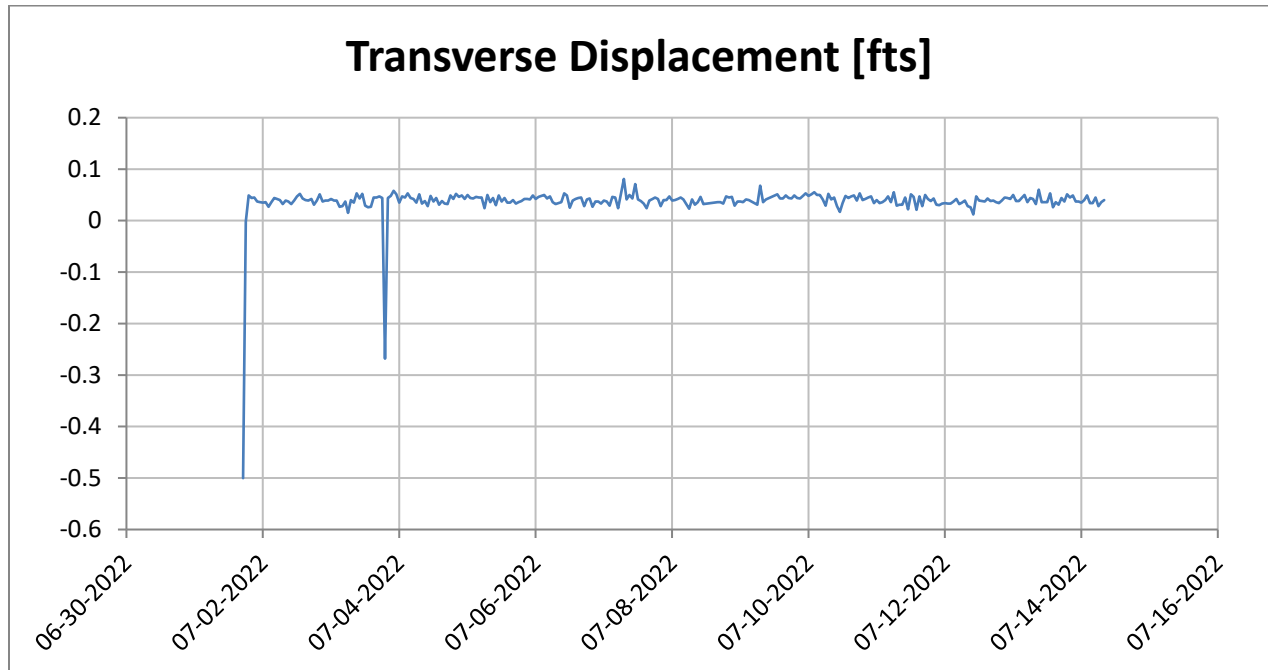
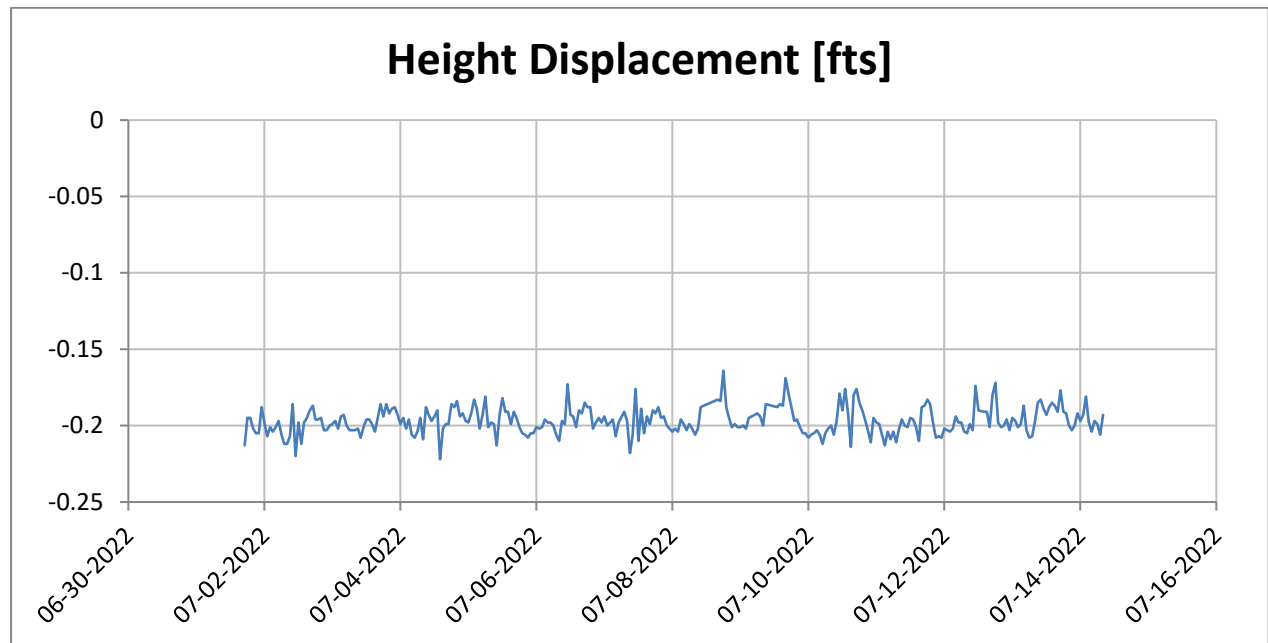
## Prism P35 (renamed as CP6)

1. Survey accuracy is +/-0.016 feet.
2. Alarm threshold is +/-0.35 feet.
3. Transverse displacement is in the horizontal direction. Positive direction means closer to the robotic station.
4. Height displacement is in the vertical direction. Positive direction means higher in elevation.
5. Exceedance alerts were received on 7/1, 7/2, 7/3, 7/4, 7/26, 7/27
6. Prism reading for 7/1/22 through 7/14/22.

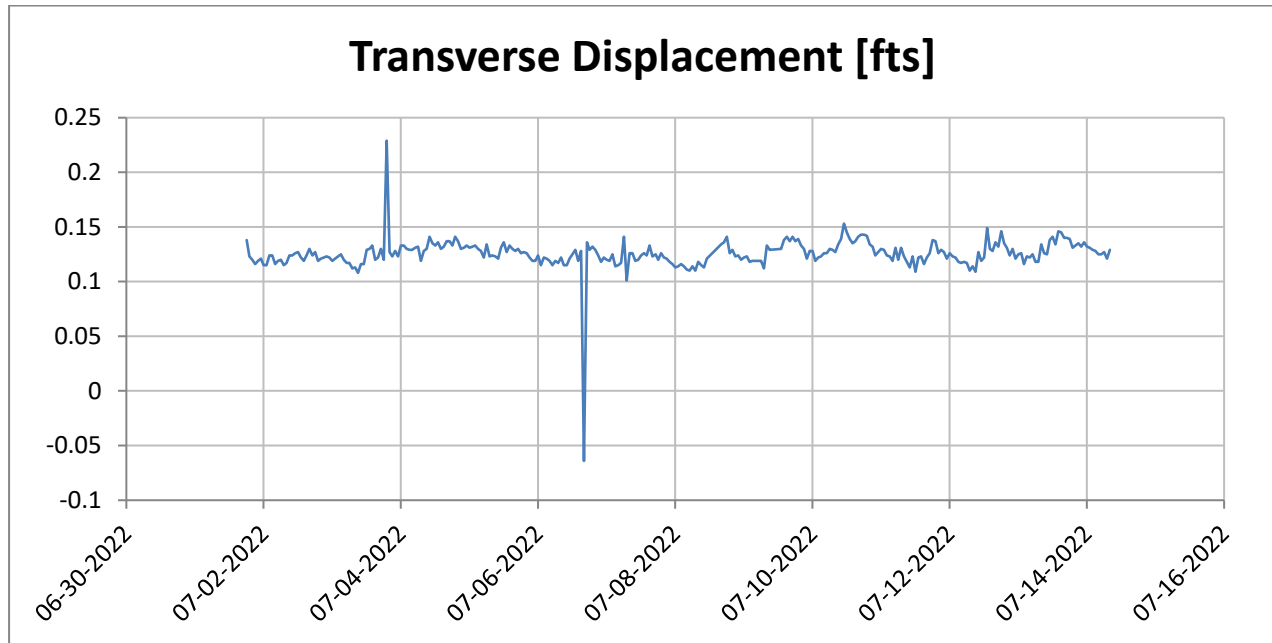
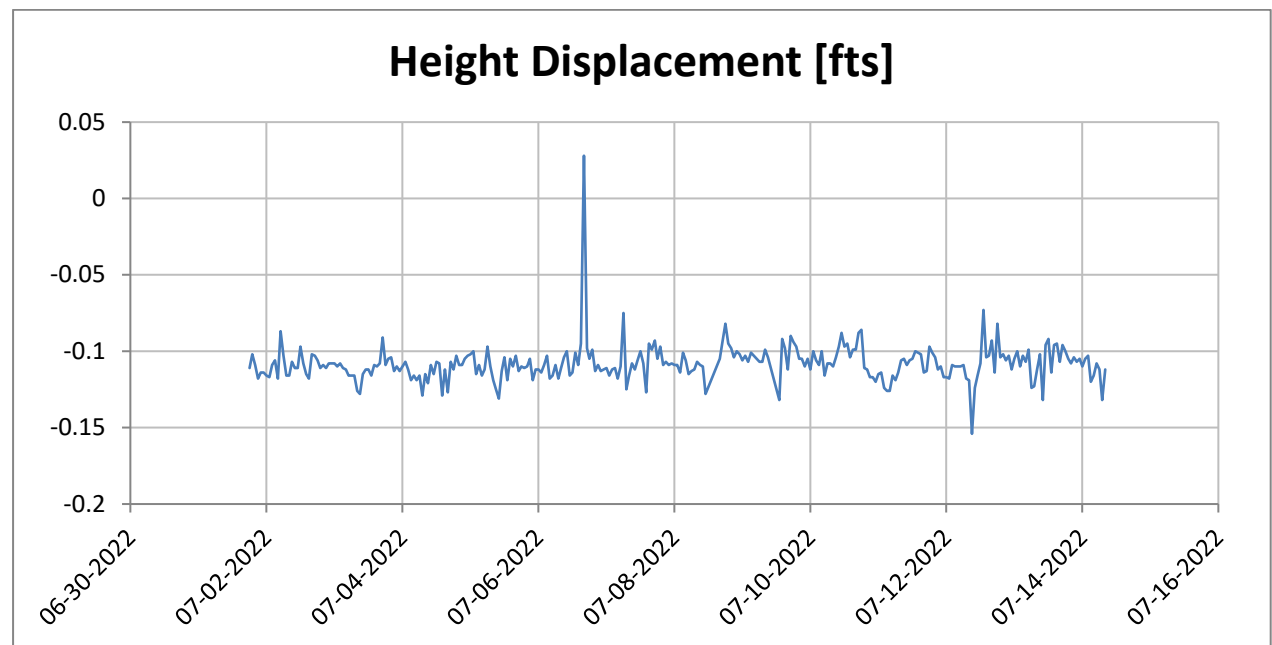
## Prism NP2

1. Survey accuracy is +/-0.016 feet.
2. Alarm threshold is +/-0.35 feet.
3. Transverse displacement is in the horizontal direction. Positive direction means closer to the robotic station.
4. Height displacement is in the vertical direction. Positive direction means higher in elevation.
5. Exceedance alerts were received on 7/3, 7/4, 7/6, 7/12, 7/26, 7/27.
6. Plot displays data 7/1/22 through 7/14/22.

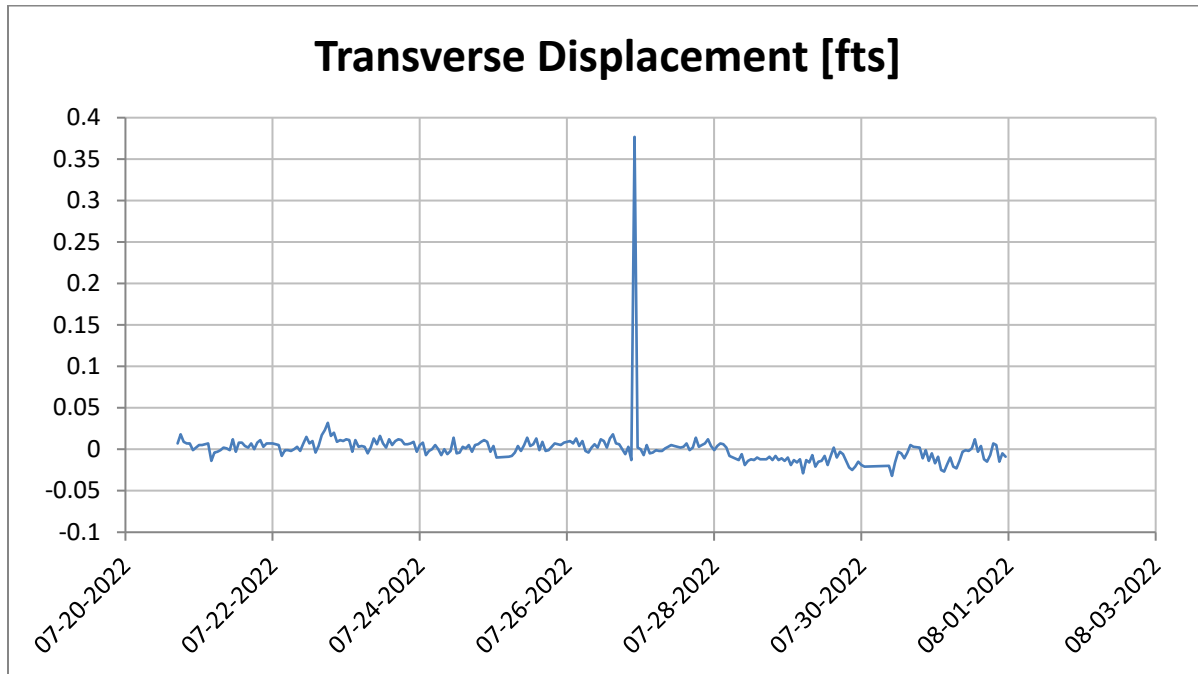
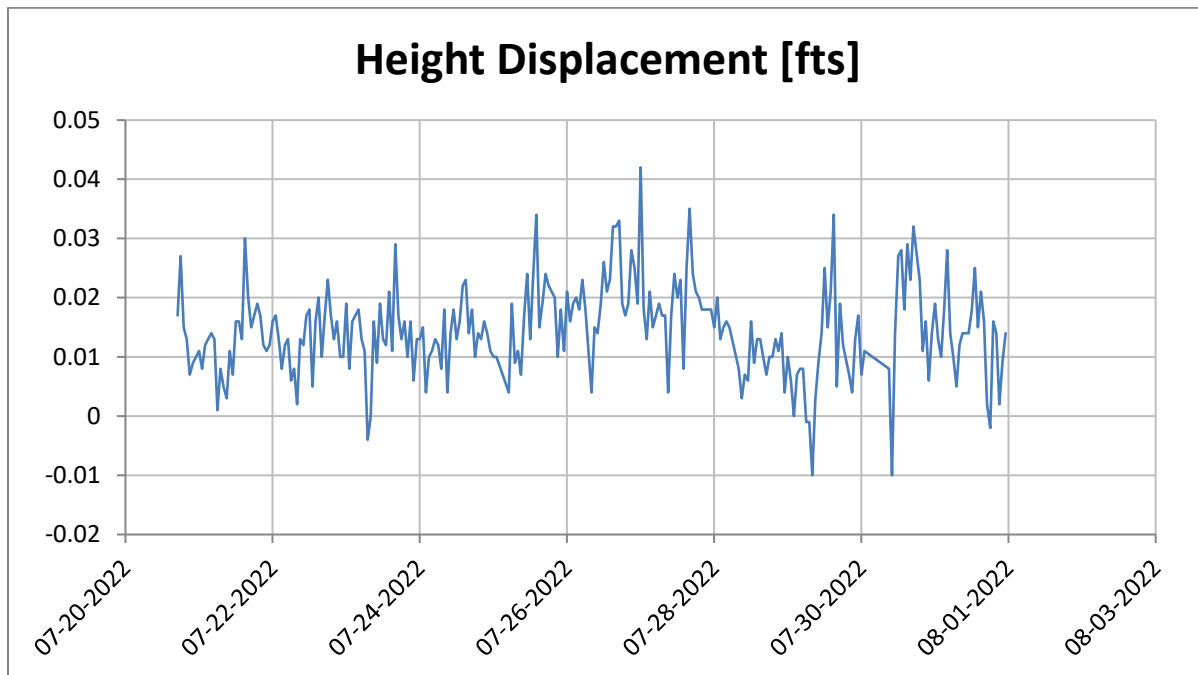
## Prism NP2

1. Survey accuracy is +/-0.016 feet.
2. Alarm threshold is +/-0.35 feet.
3. Transverse displacement is in the horizontal direction. Positive direction means closer to the robotic station.
4. Height displacement is in the vertical direction. Positive direction means higher in elevation.
5. Exceedance alerts received on 7/3, 7/4, 7/6, 7/12, 7/26, 7/27.
6. Plot displays data for 7/20/22 through 7/30/22.

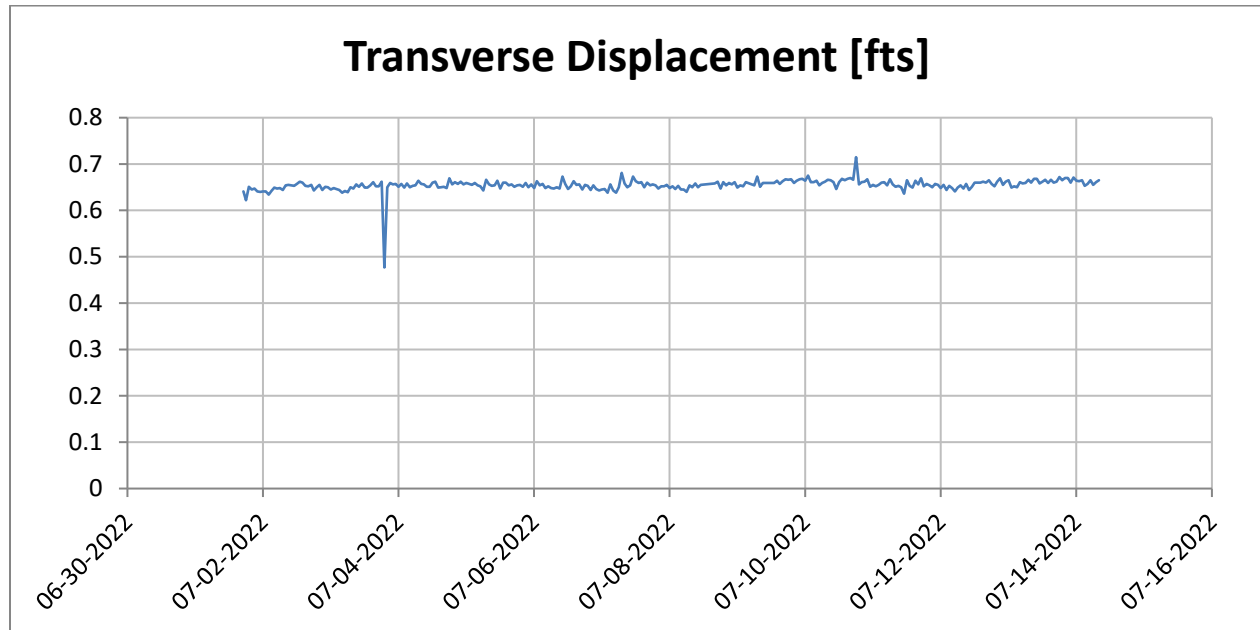
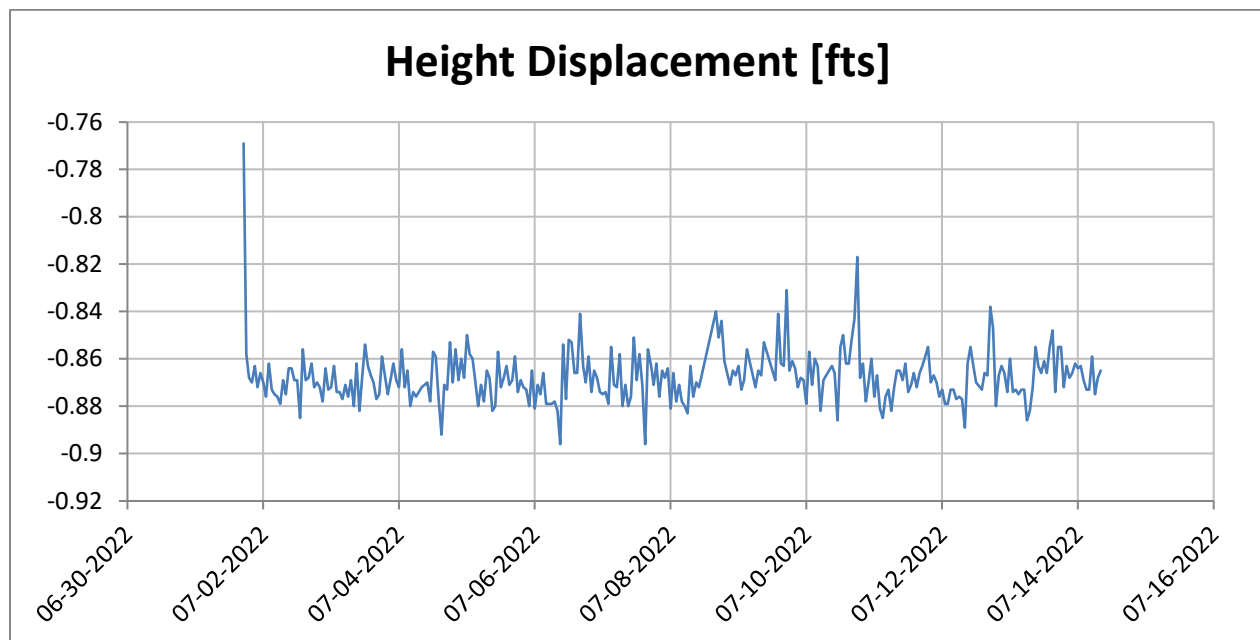
## Prism NP66

1. Survey accuracy is +/-0.016 feet.
2. Alarm threshold is +/-0.35 feet.
3. Transverse displacement is in the horizontal direction. Positive direction means closer to the robotic station.
4. Height displacement is in the vertical direction. Positive direction means higher in elevation.
5. Prism reading for 7/1/22 through 7/14/22.
6. Exceedance alerts received on 7/3, 7/4, 7/26, 7/27.

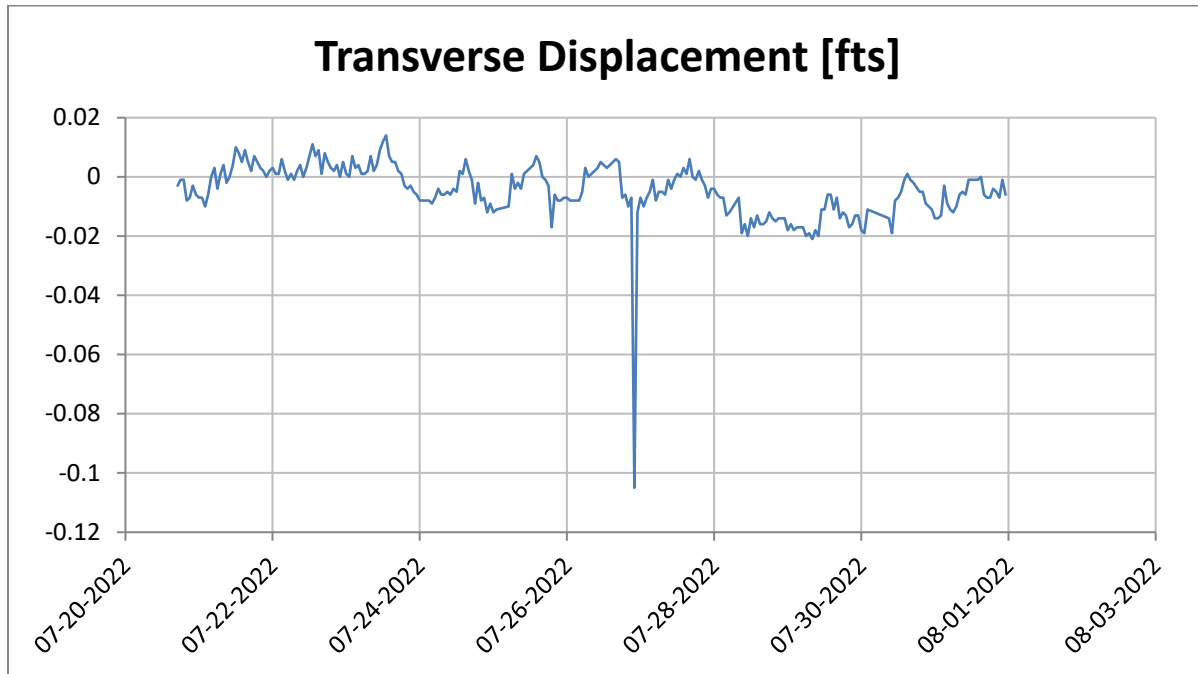
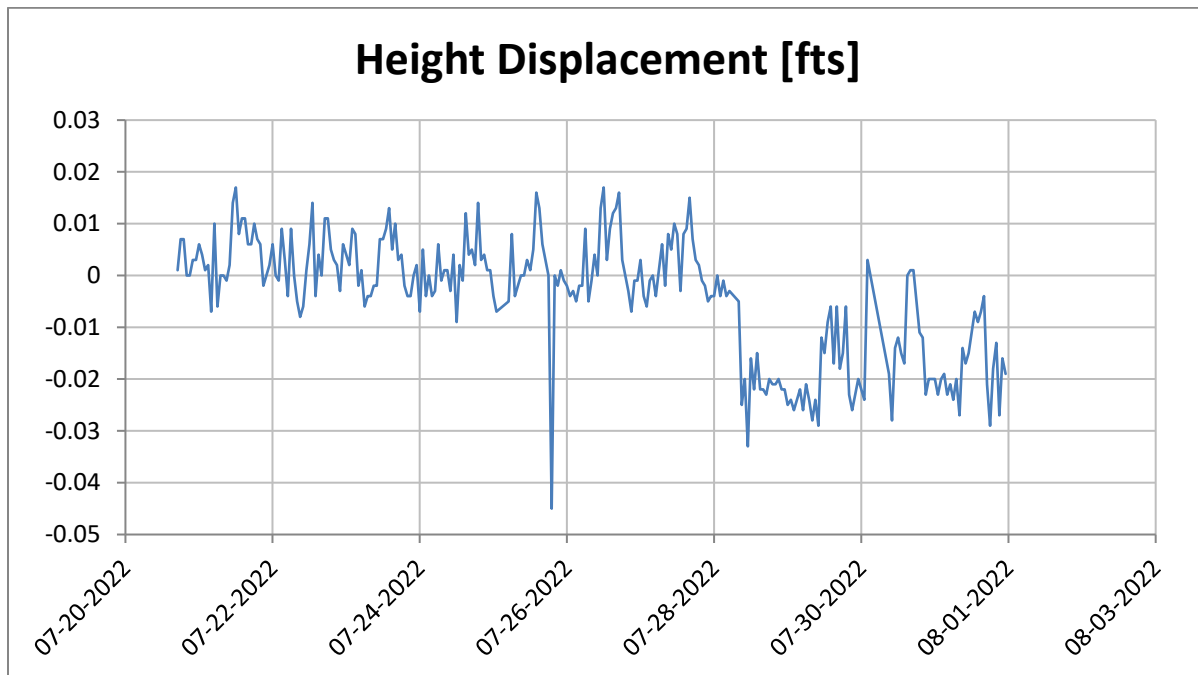
## Prism NP66

1. Survey accuracy is +/-0.016 feet.
2. Alarm threshold is +/-0.35 feet.
3. Transverse displacement is in the horizontal direction. Positive direction means closer to the robotic station.
4. Height displacement is in the vertical direction. Positive direction means higher in elevation.
5. Prism records slope creep movements with slow velocity.
6. Exceedance alerts received on 7/3, 7/4, 7/26, 7/27
7. Prism reading for 7/20/22 through 7/30/22.

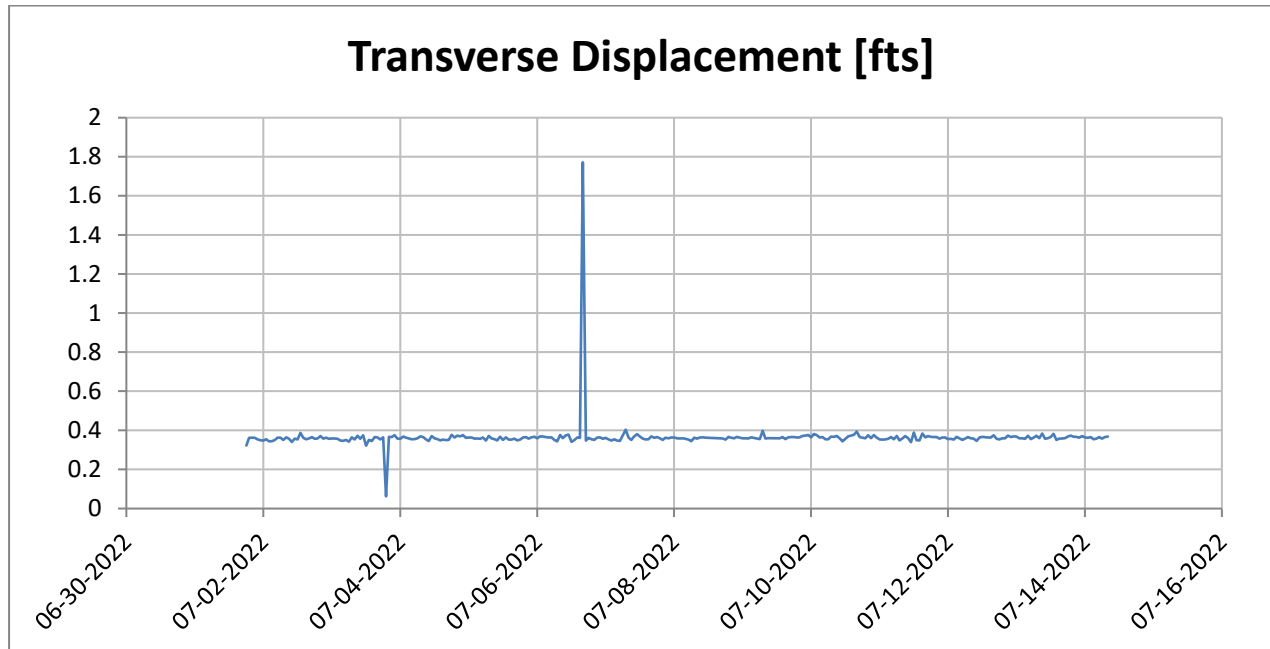
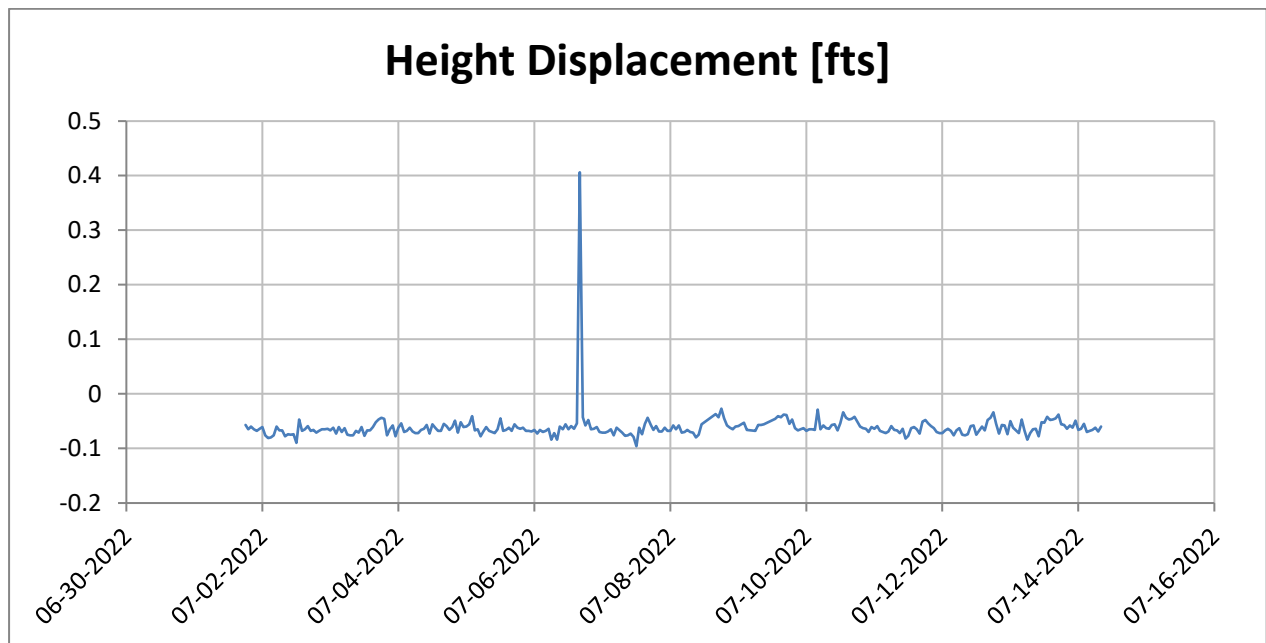
## Prism P1

1. Survey accuracy is +/-0.016 feet.
2. Alarm threshold is +/-0.35 feet.
3. Transverse displacement is in the horizontal direction. Positive direction means closer to the robotic station.
4. Height displacement is in the vertical direction. Positive direction means higher in elevation.
5. Prism reading for 7/1/22 through 7/14/22.
6. Exceedance alerts received on 7/3, 7/6, 7/25, 7/26, 7/27.

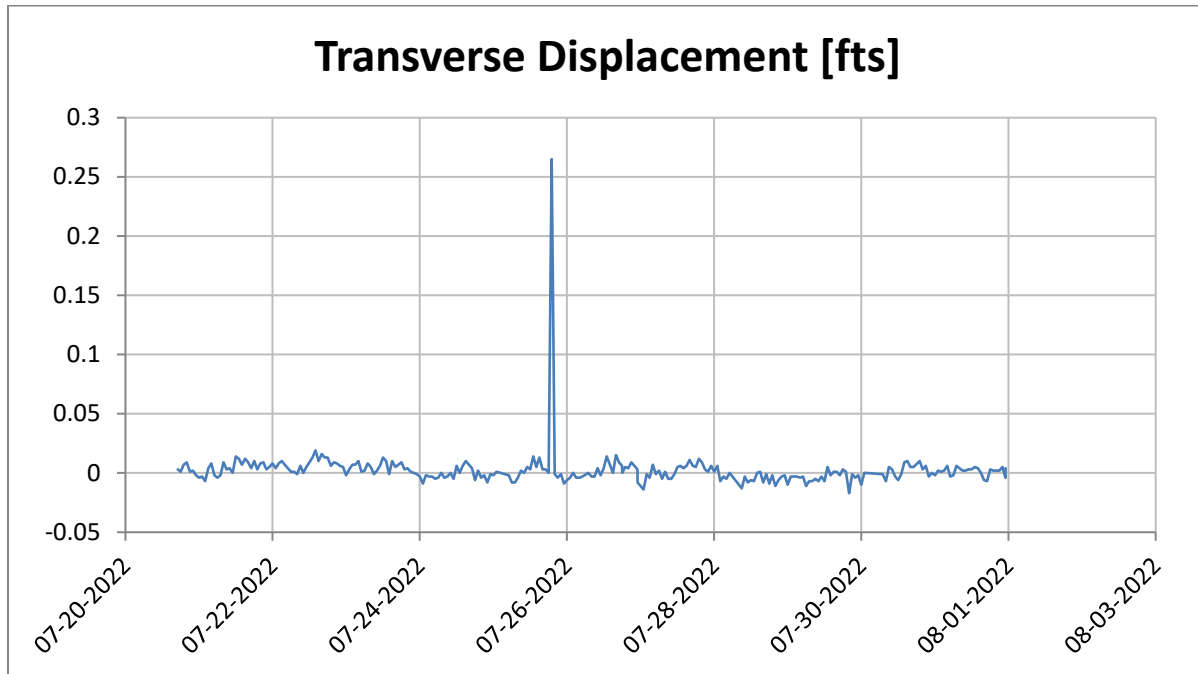
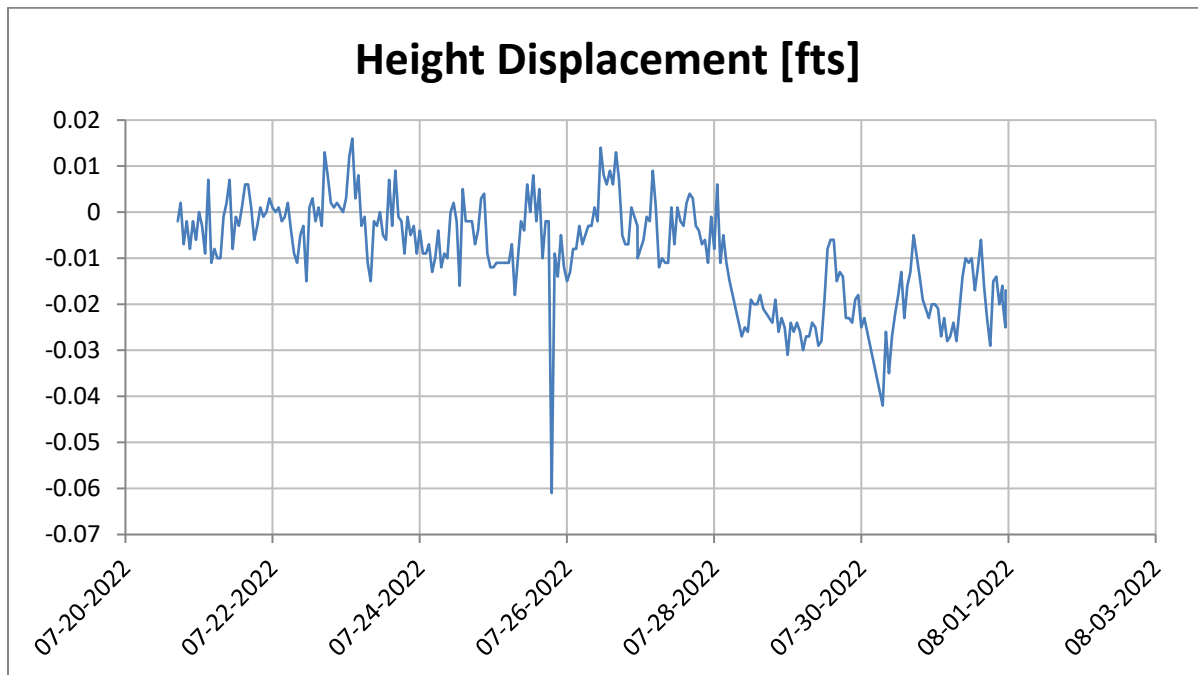
## Prism P1

1. Survey accuracy is +/-0.016 feet.
2. Alarm threshold is +/-0.35 feet.
3. Transverse displacement is in the horizontal direction. Positive direction means closer to the robotic station.
4. Height displacement is in the vertical direction. Positive direction means higher in elevation.
5. Prism reading for 7/20/22 through 7/30/22.
6. Exceedance alerts received on 7/3, 7/6, 7/25, 7/26, 7/27.

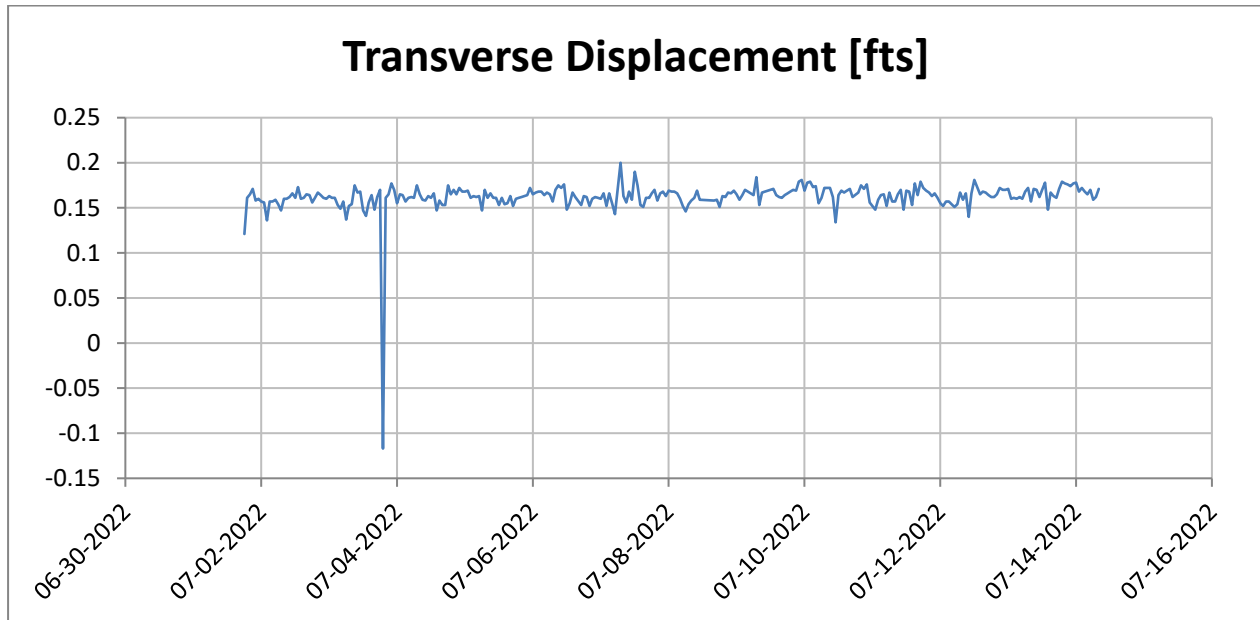
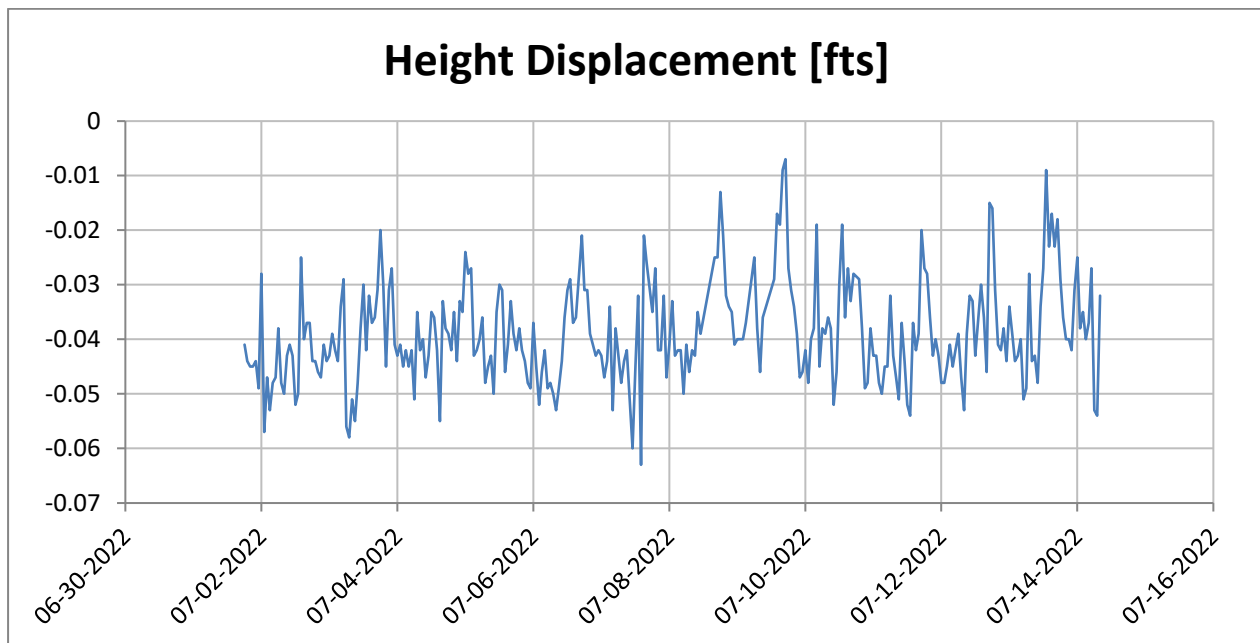
## Prism P2

1. Survey accuracy is  $\pm 0.016$  feet.
2. Alarm threshold is  $\pm 0.35$  feet.
3. Transverse displacement is in the horizontal direction. Positive direction means closer to the robotic station.
4. Height displacement is in the vertical direction. Positive direction means higher in elevation.
5. Exceedance alerts received on 7/3, 7/4, 7/26, 7/27.
6. Prism reading for 7/1/22 through 7/14/22.

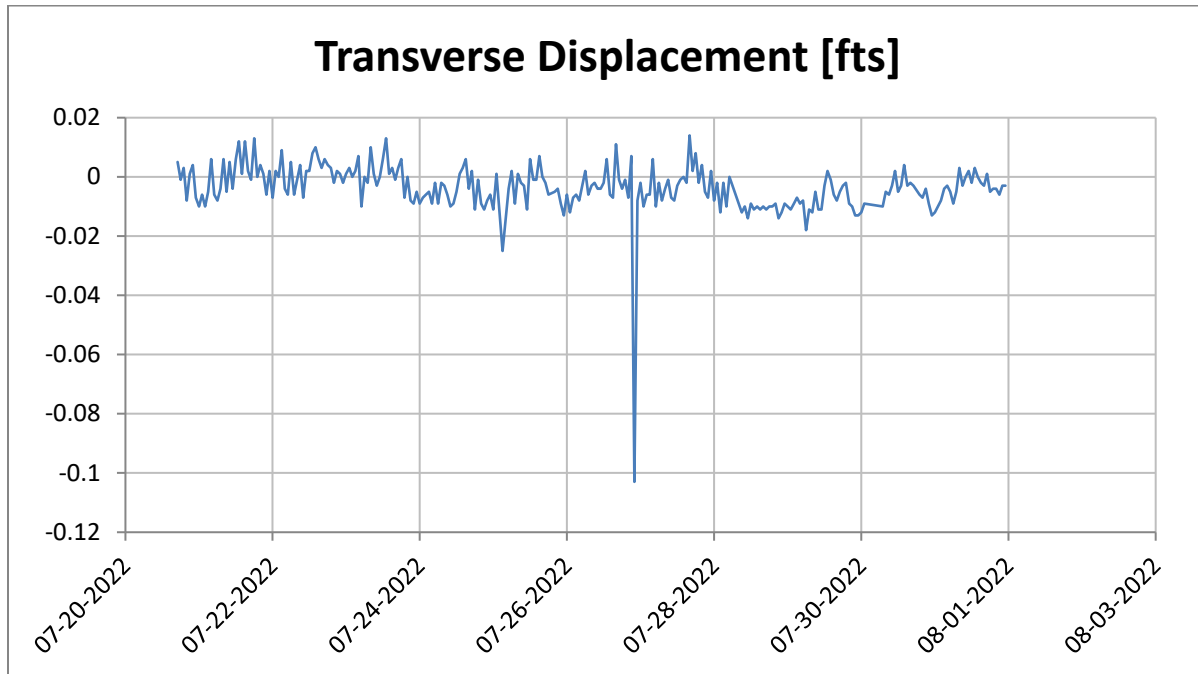
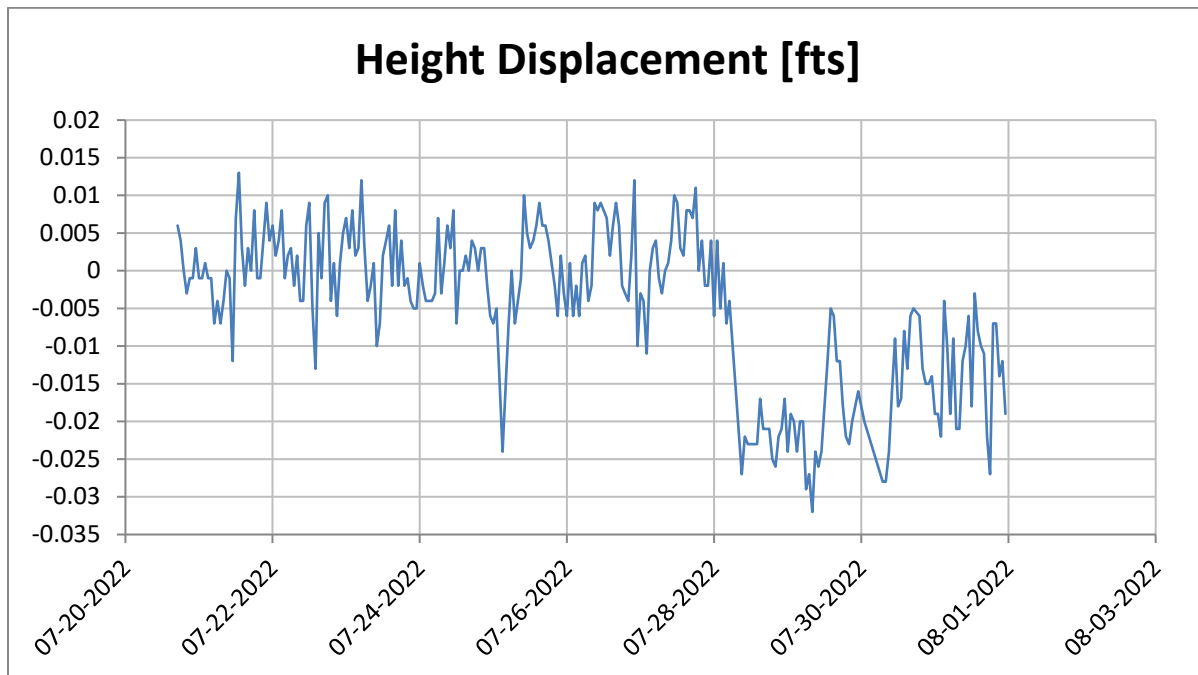
## Prism P2

1. Survey accuracy is +/-0.016 feet.
2. Alarm threshold is +/-0.35 feet.
3. Transverse displacement is in the horizontal direction. Positive direction means closer to the robotic station.
4. Height displacement is in the vertical direction. Positive direction means higher in elevation.
5. Exceedance alerts received on 7/3, 7/4, 7/26, 7/27.
6. Prism reading for 7/20/22 through 7/30/22.

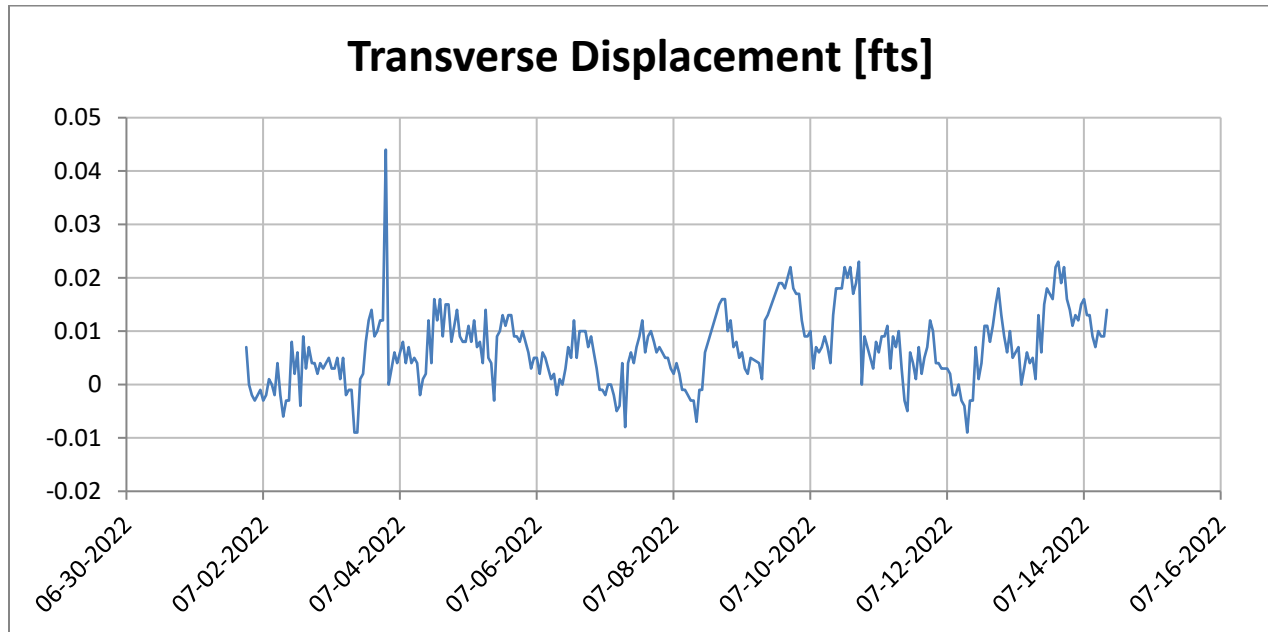
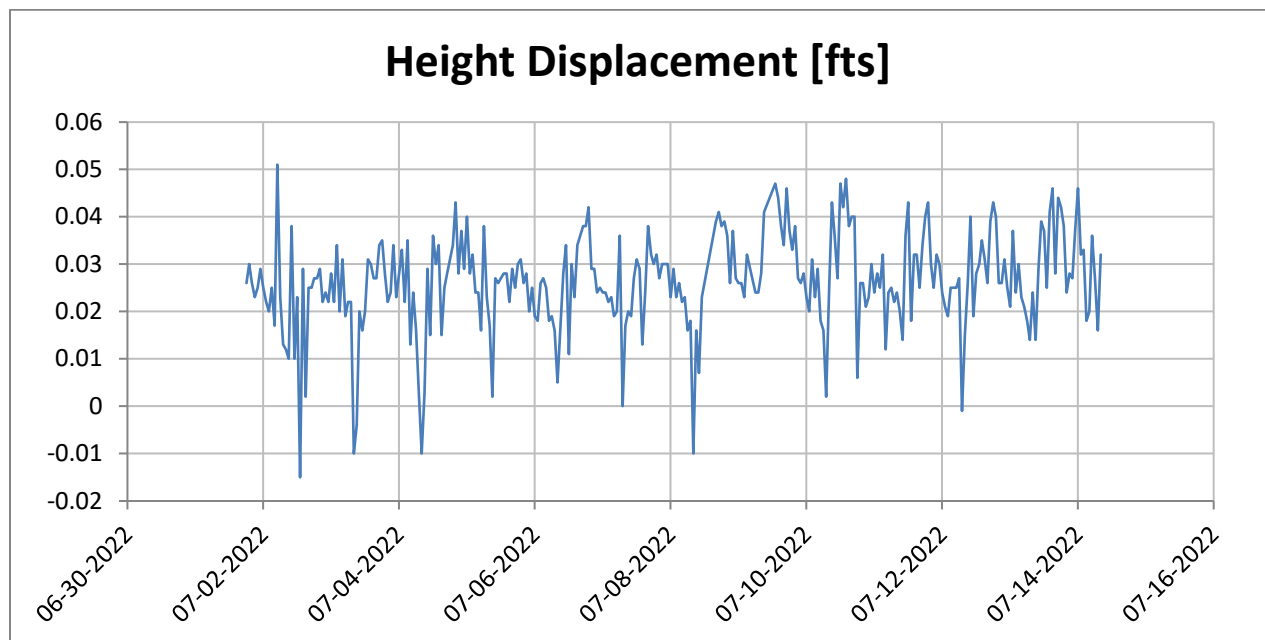
## Prism P25

1. Survey accuracy is +/-0.016 feet.
2. Alarm threshold is +/-0.35 feet.
3. Transverse displacement is in the horizontal direction. Positive direction means closer to the robotic station.
7. Height displacement is in the vertical direction. Positive direction means higher in elevation.
4. Exceedance alerts received on 7/3, 7/4, 7/7, 7/13, 7/26, 7/27.
5. Prism reading for 7/1/22 through 7/14/22.

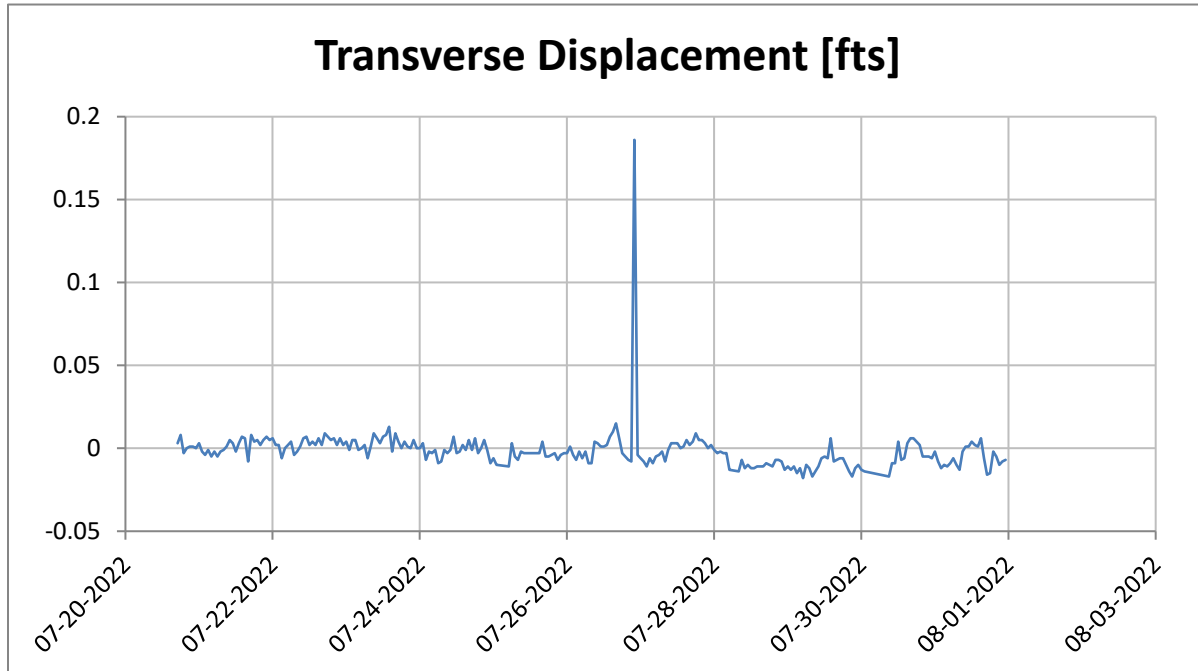
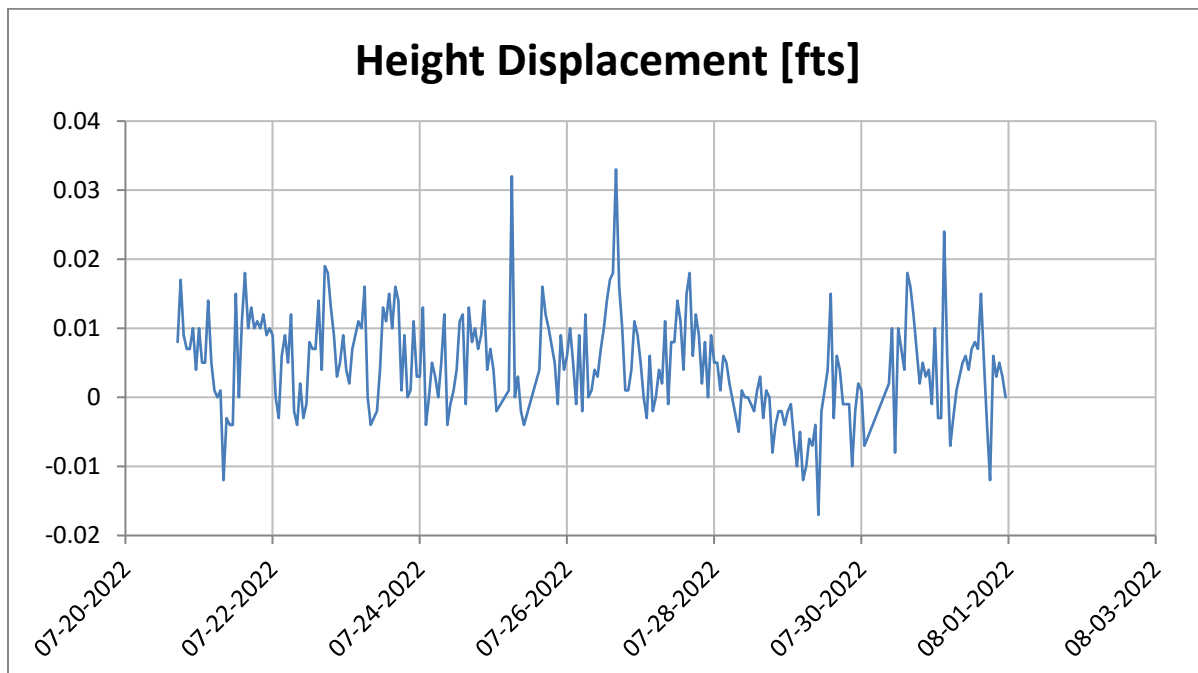
## Prism P25

1. Survey accuracy is +/-0.016 feet.
2. Alarm threshold is +/-0.35 feet.
3. Transverse displacement is in the horizontal direction. Positive direction means closer to the robotic station.
4. Height displacement is in the vertical direction. Positive direction means higher in elevation.
5. Exceedance alerts received on 7/3, 7/4, 7/7, 7/13, 7/26, 7/27.
6. Prism reading for 7/20/22 through 7/30/22.

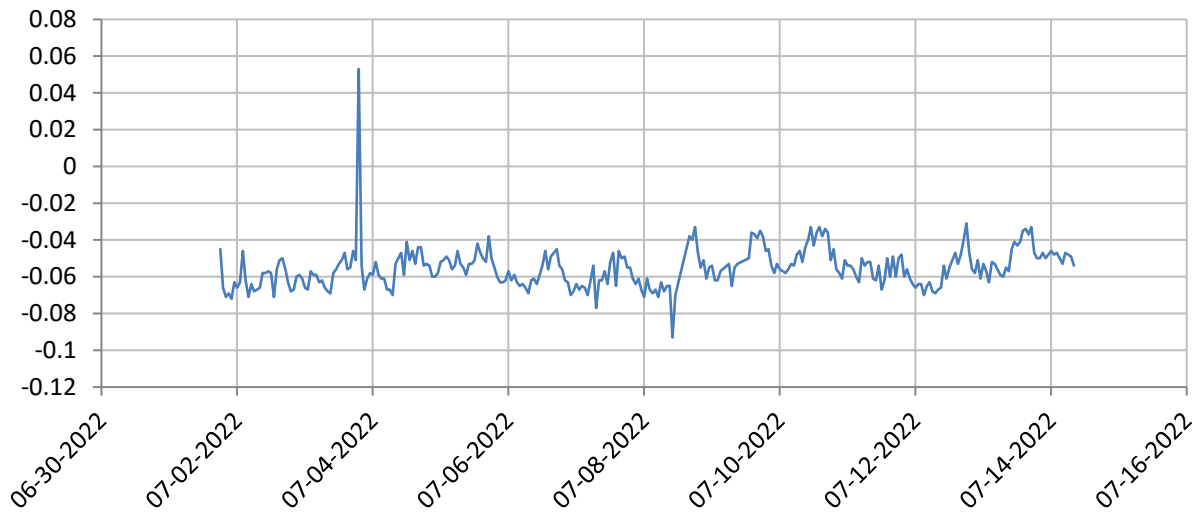
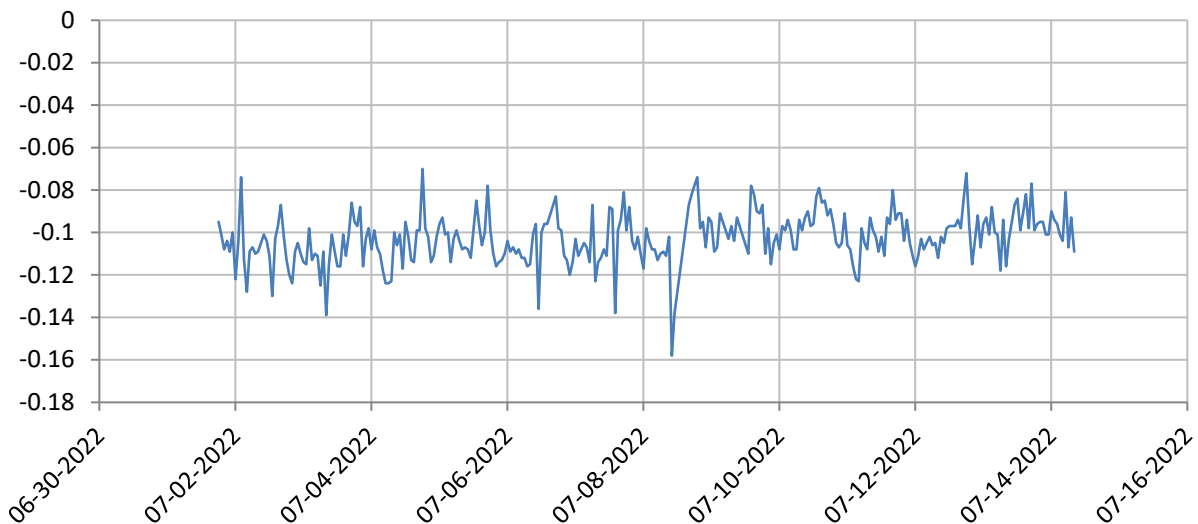
## Prism P32

1. Survey accuracy is  $\pm 0.016$  feet.
2. Alarm threshold is  $\pm 0.35$  feet.
3. Transverse displacement is in the horizontal direction. Positive direction means closer to the robotic station.
4. Height displacement is in the vertical direction. Positive direction means higher in elevation.
5. Exceedance alerts received on 7/1, 7/2, 7/3, 7/4, 7/12, 7/26, 7/27.
6. Prism reading for 7/1/22 through 7/14/22.
